Improvements for next parts

PIMS production meeting 26-27 February 2013

Reception of PIMS elements 20.12.2012 transport box

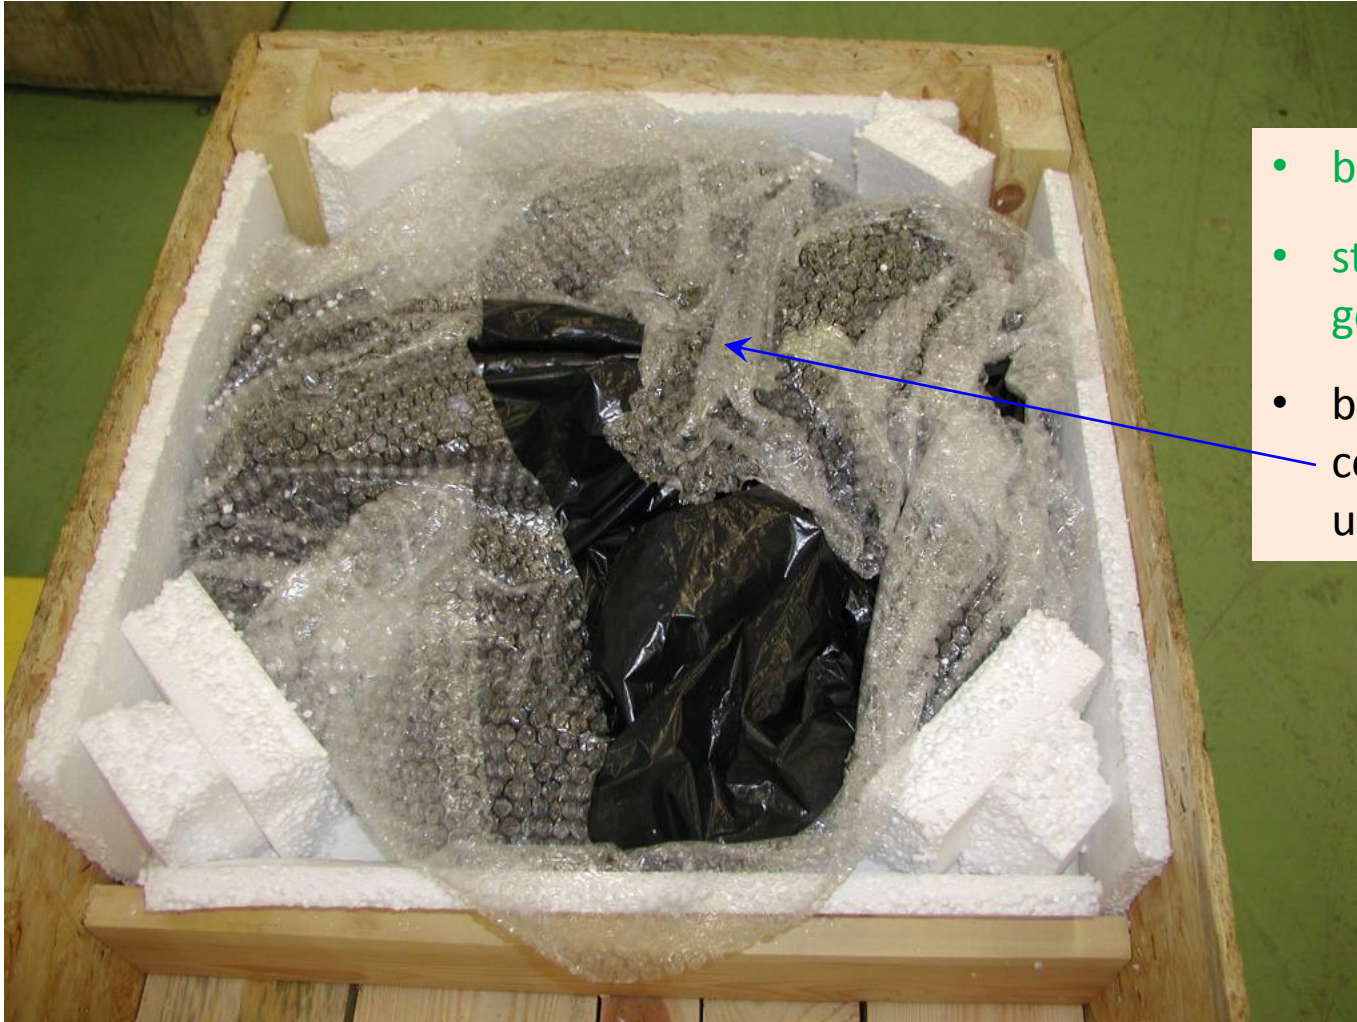
- boxes very well made !
- styrofoam protection good
- bubble wrap ok but could protect more by using larger pieces

- please use more **bubble wrap** for better protection
- please use **heat sealed plastic bags filled with nitrogen**
procedure: place PIMS element, evacuate as much air as possible out of the bag, fill bag with nitrogen (from the bottom), evacuate gas (air/nitrogen mixture; from the bottom) again, fill bag with nitrogen (from the bottom) again and finally heat seal bag
- please **follow closely** the **cleaning** procedure (EDMS 1141661)
- please **handle parts with care, particularly in CPL**. So much effort is made in reaching the required tolerances...
- please **chamfer all edges** as specified ($R \leq 0.2$), **particularly for cooling channels** (re-machining of disc M_6-7) and **alignment surface** (outside) of rings

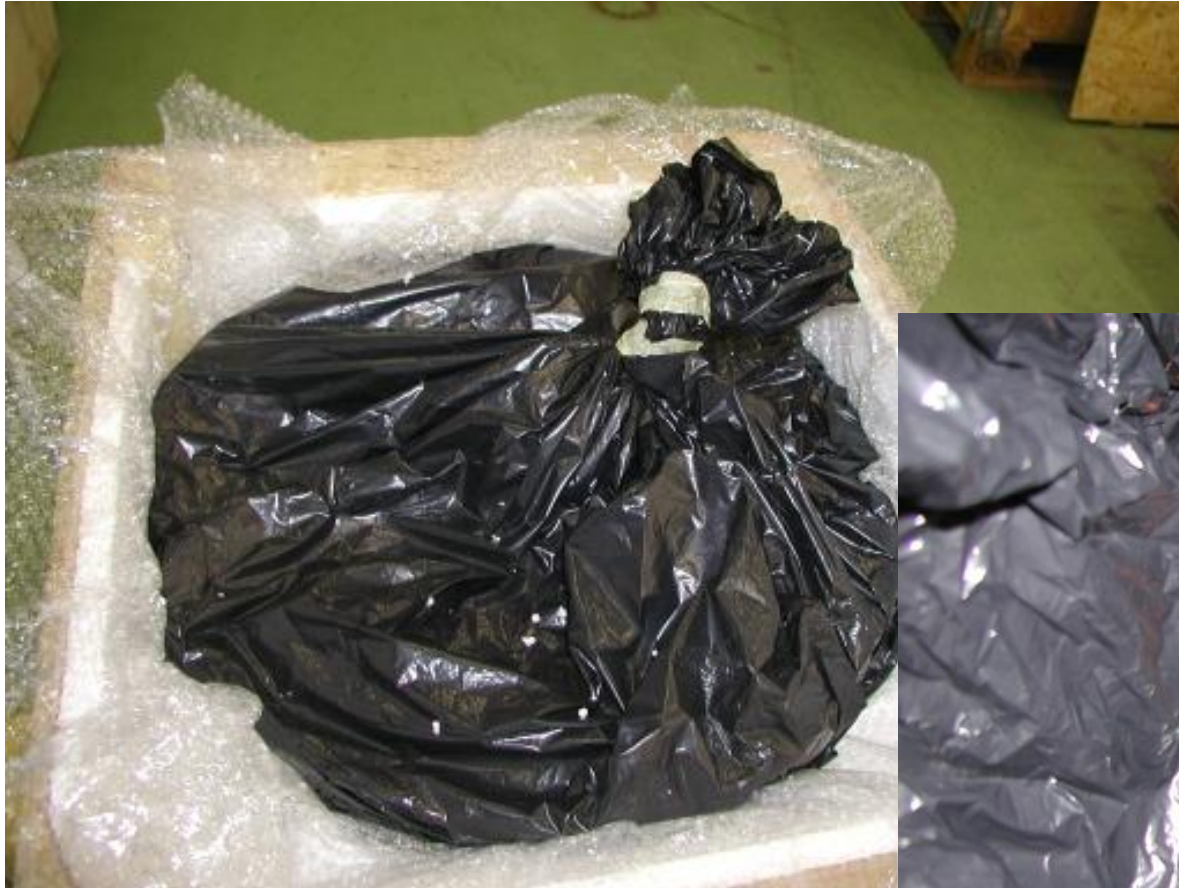
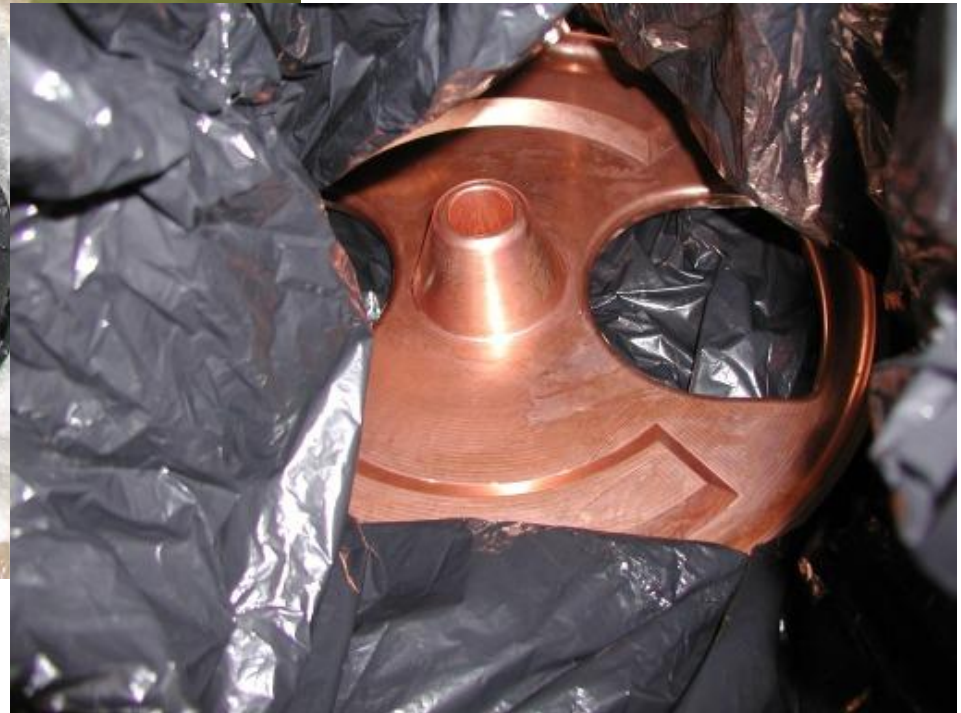
Reception of PIMS elements 20.12.2012 plastic bags filled with nitrogen

- needs to be improved
=> very important for rings and end discs as they are not foreseen to be cleaned at CERN

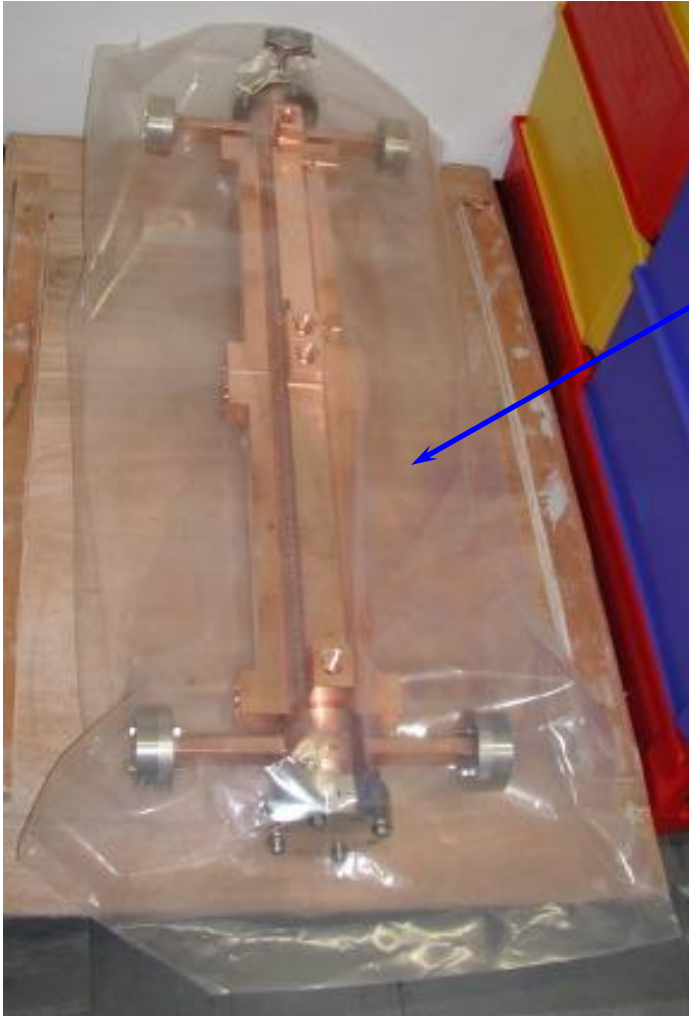
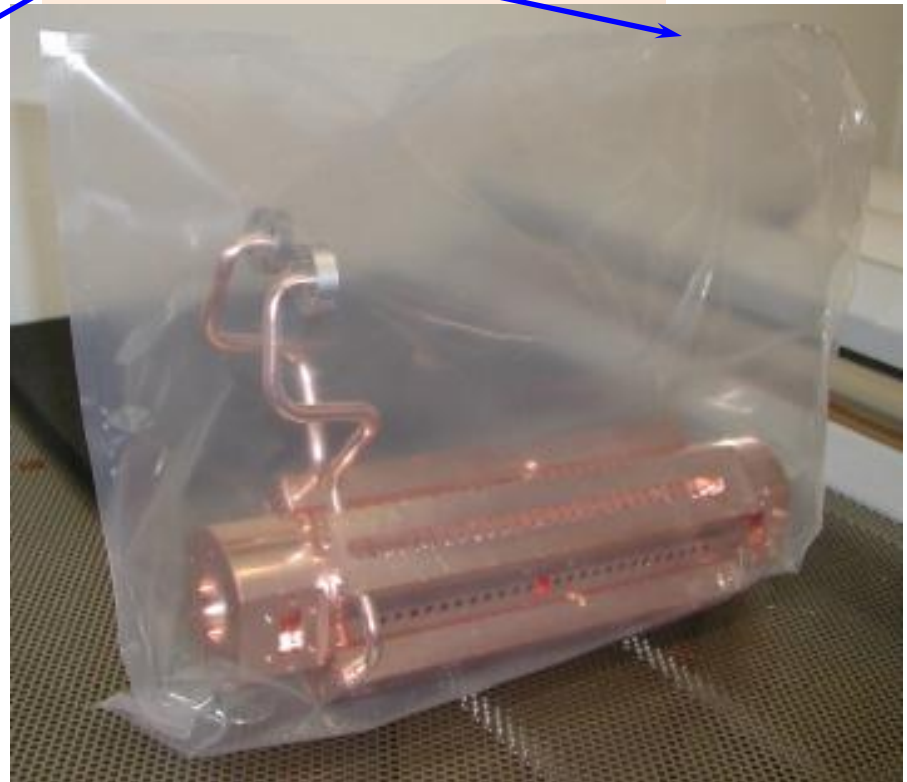
Reception of PIMS elements 20.12.2012 plastic bags filled with nitrogen

- examples of packed structures:
plastic bag filled with nitrogen and heat sealed

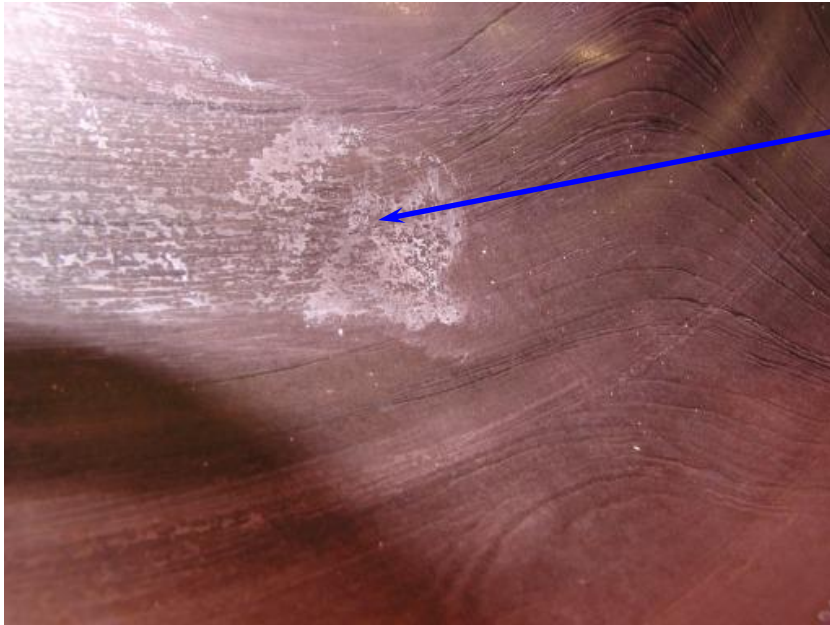
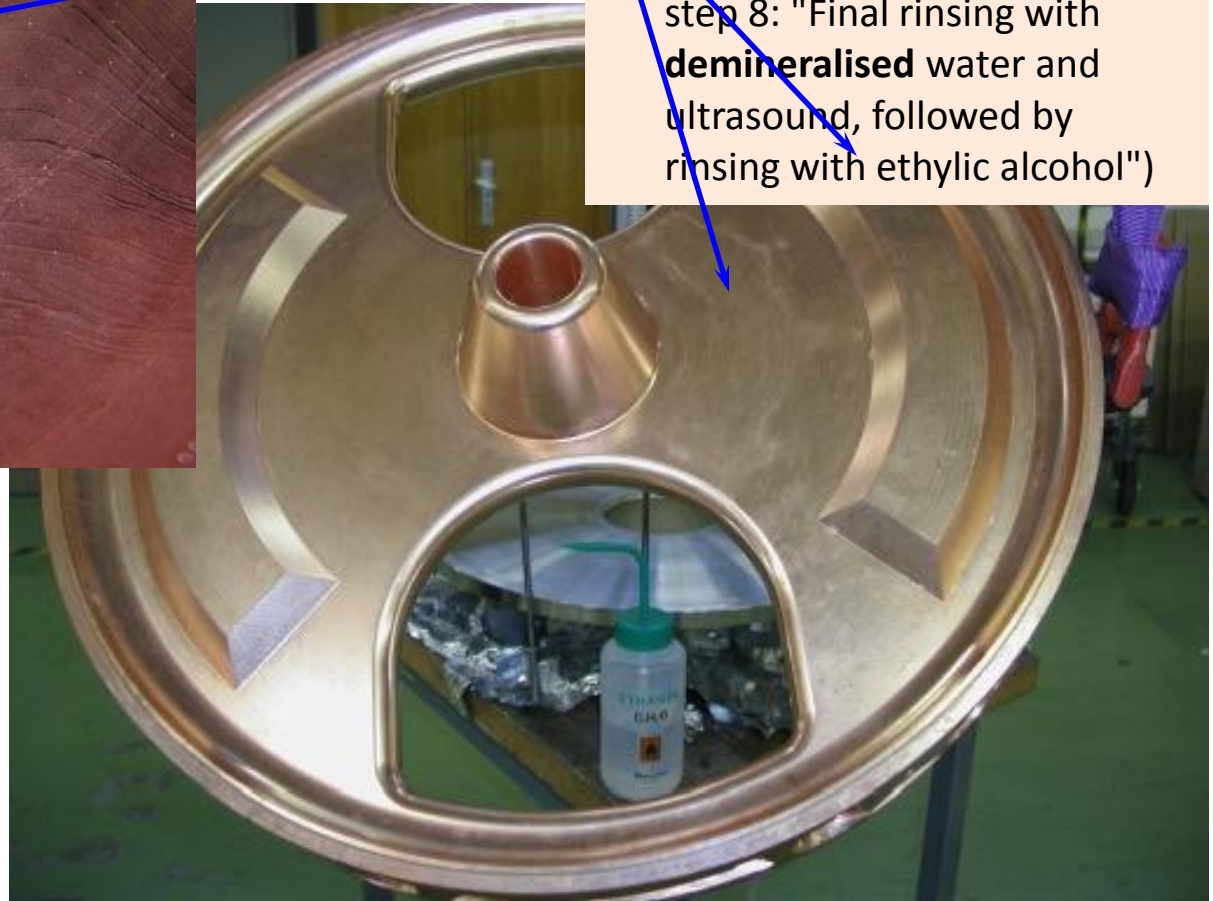
Reception of PIMS elements 20.12.2012 cleaning

- please use **demineralised water** for rinsing (cleaning procedure EDMS 1141661, step 8: "Final rinsing with **demineralised** water and ultrasound, followed by rinsing with ethylic alcohol")

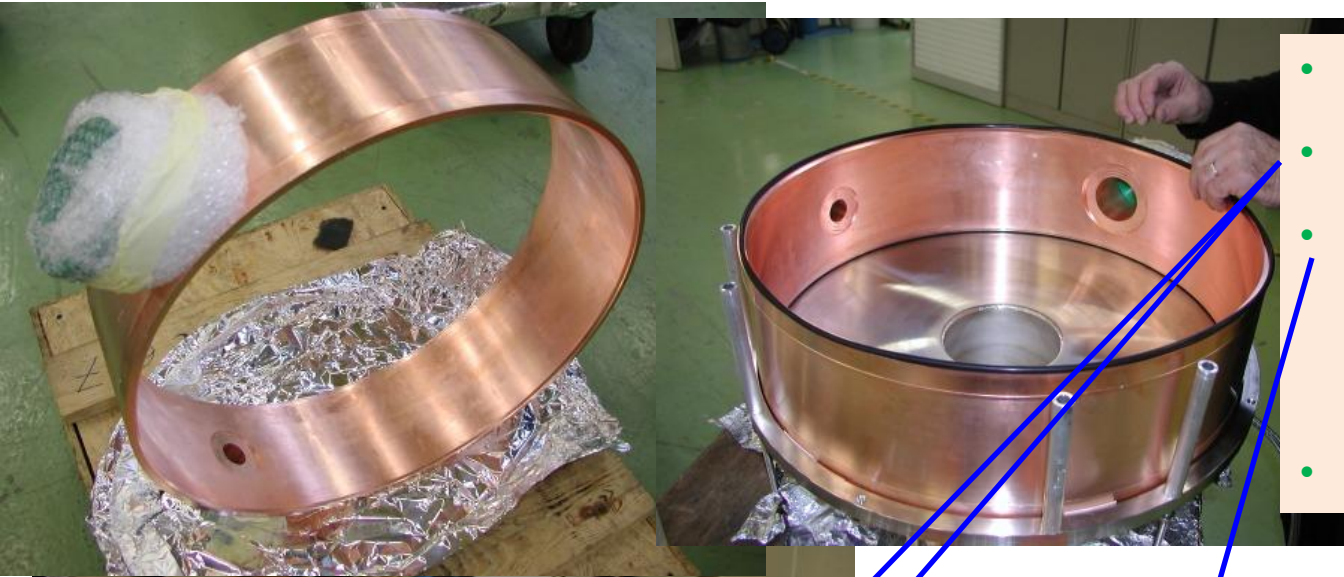
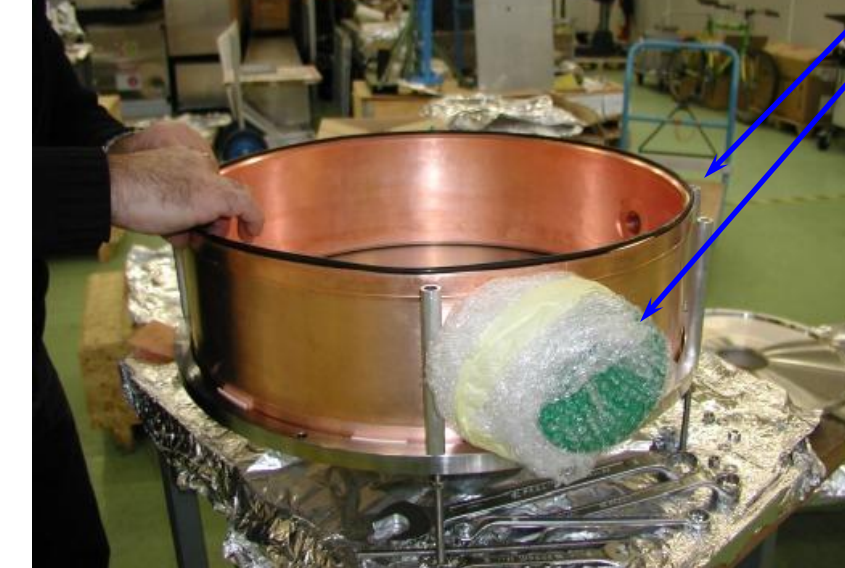
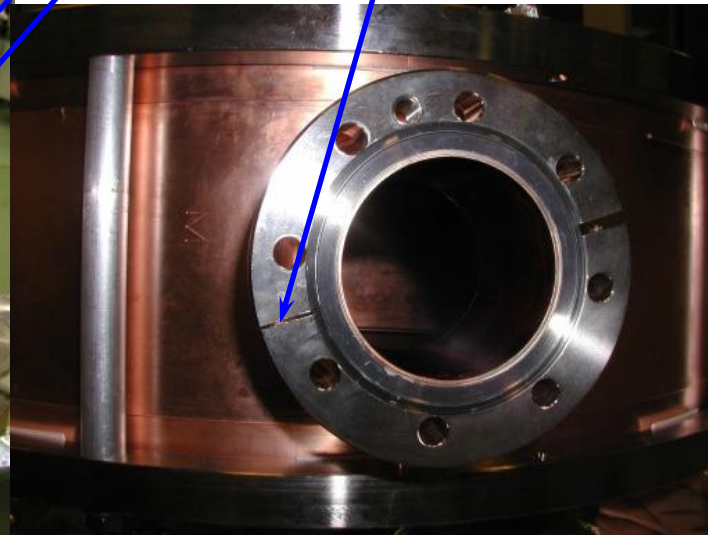
ring M_13-14

- good work !!!
- CF flanges very well packed!
- slotted rotatable UHV flanges (SPLACPMB0057, SPLACPMB0058) already included => excellent !
- welding looks good

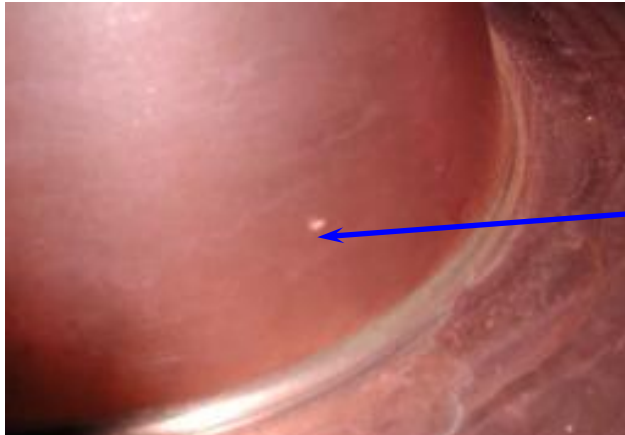
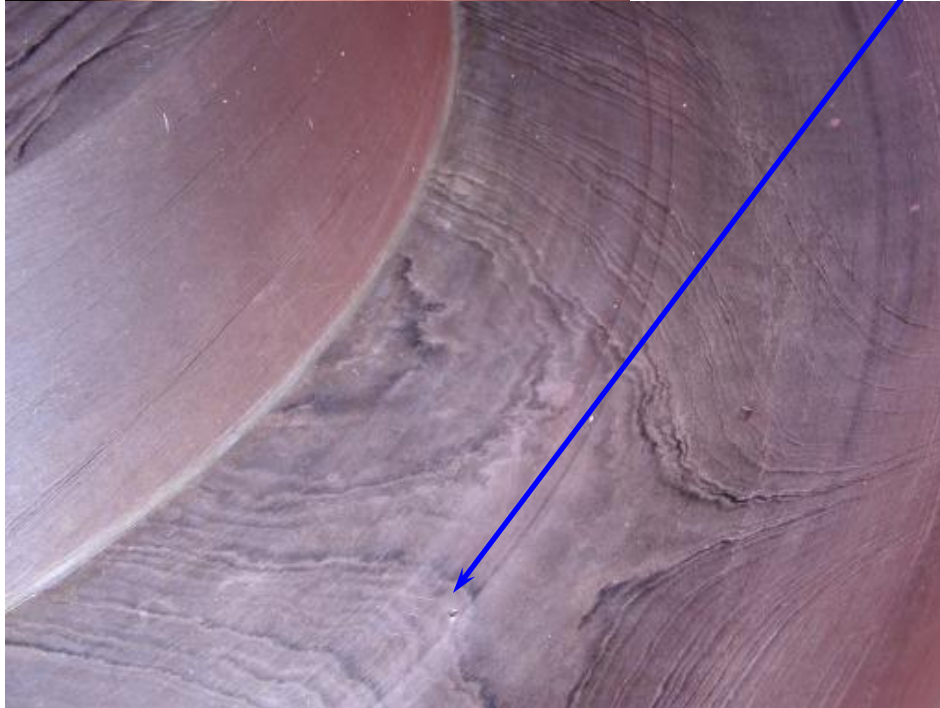
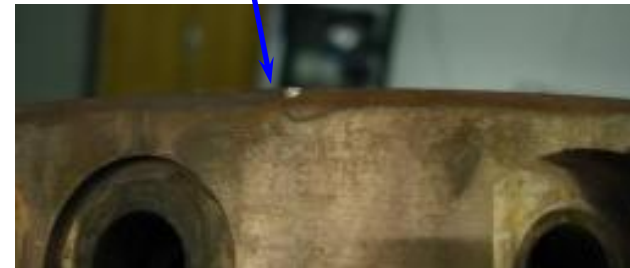
Reception of PIMS elements 20.12.2012 disc M_6-7 (CPL ?)

- plenty of **defects**, only a few are shown here
- please **handle parts carefully**, particularly in **CPL**
- please include a **visual inspection report** as specified in the Quality Assurance report for each part

- please create a **visual inspection report** for every element, for example in a separate document (simple PowerPoint, etc.)
- **radial scratches** seen on faces of ring G_13-14 where joints for vacuum check are placed => will be problematic to test similar pieces (ring G_13-14 is used for machining tests, no vacuum test needed).

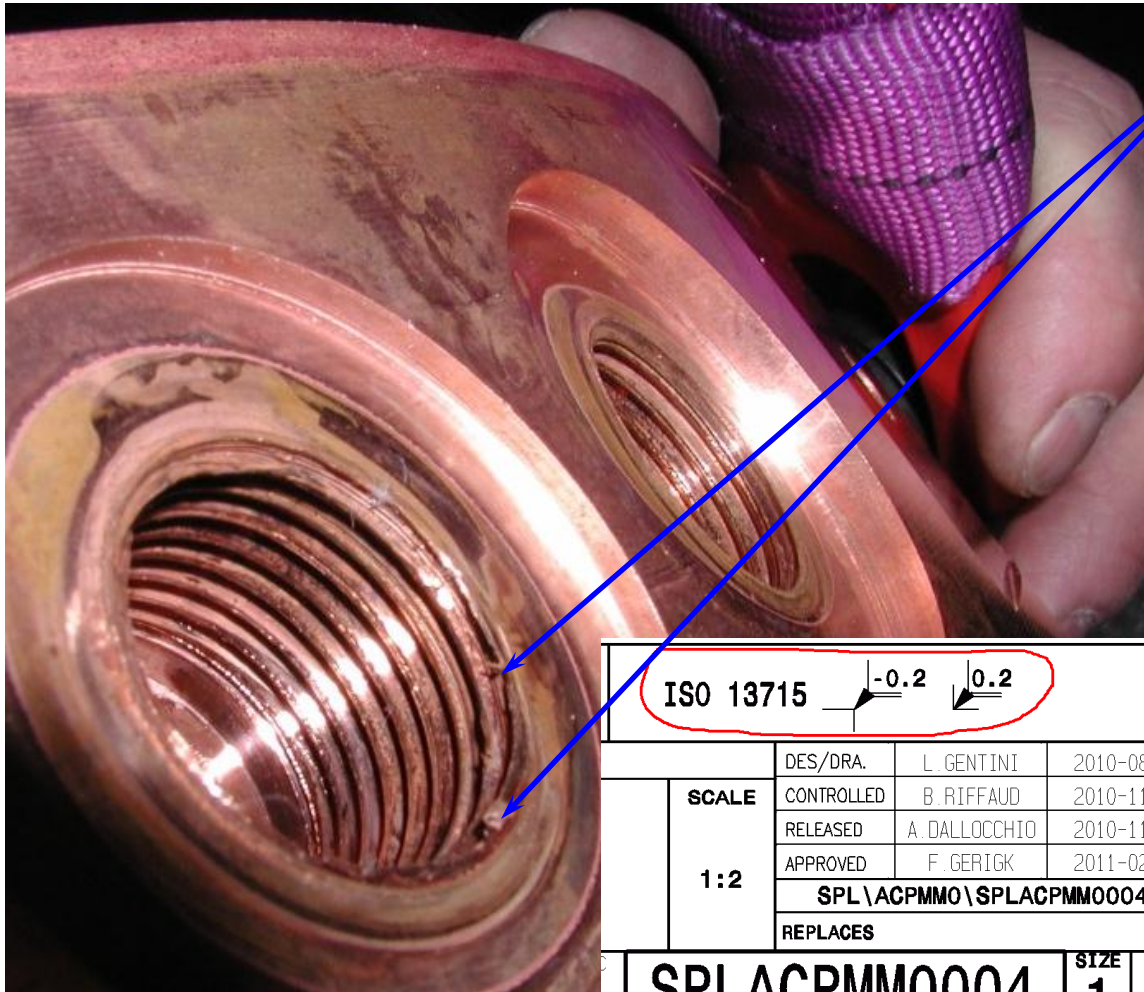
Reception of PIMS elements 20.12.2012 disc M_6-7

- **joints** for the vacuum test and for the cooling connection **will be destroyed**
- **all 16 threads** have this problem
- **important to chamfer** particularly **this edge** with $R \leq 0.2$, indicated on the drawings as well as stressed in the technical specifications

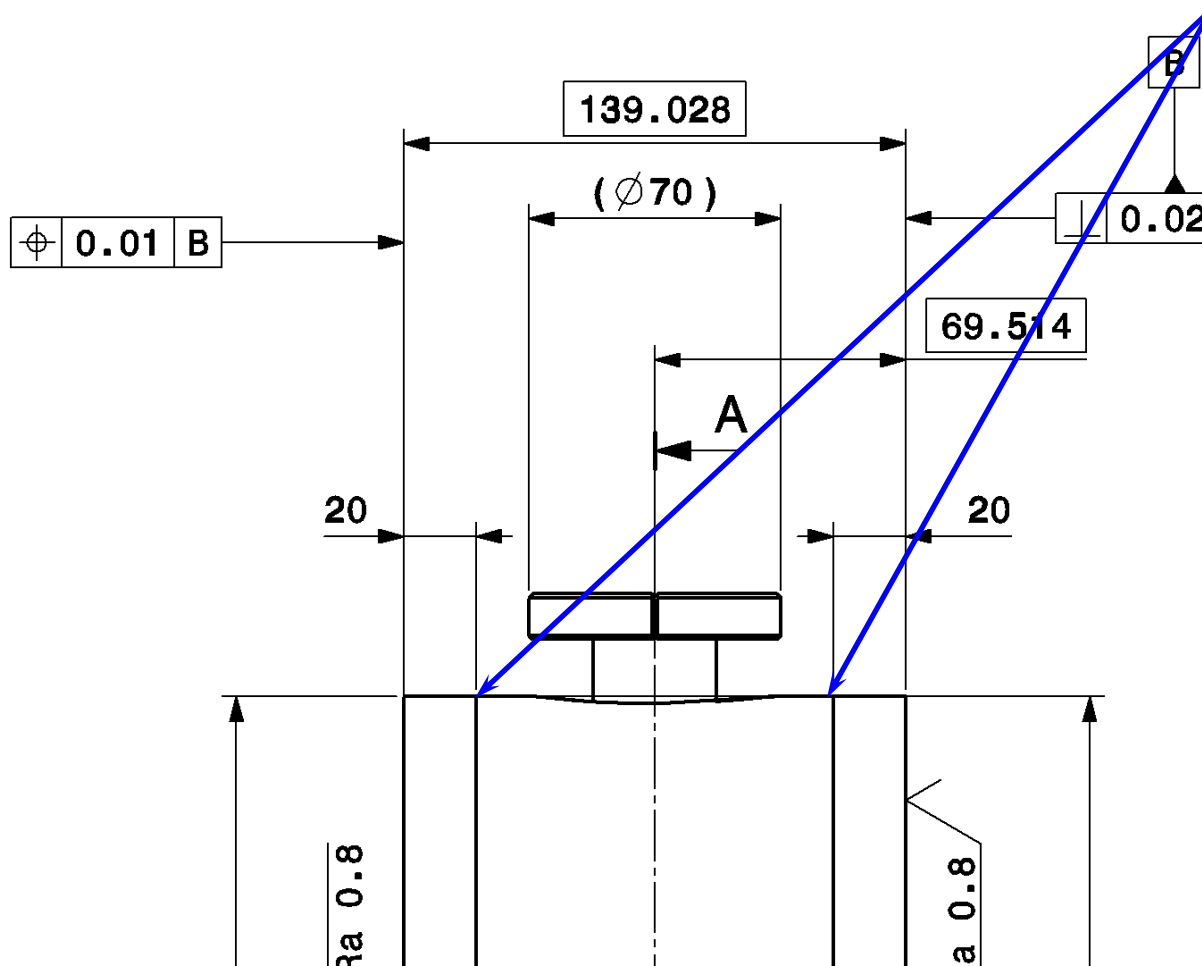
Assembly of PIMS elements burrs

- a sharp edged ring (burr) has been seen here. Please take care to **chamfer** here as well with $R \leq 0.2$ as specified => problematic for our alignment tool for welding
