# Impact of electro-chemical cleaning on the dielectric strength in sealed vacuum interrupters

**Hans Schellekens, Fabio Vianna,  
Jimmy Perrin, Carlos Vargas,  
Romain Mottin, Heyet Mankouri,  
Abdelbaki Elbrigui, Simon Oriol**

**Medium Voltage Product Development  
BU. Energy usine 38V  
Schneider Electric  
38050 Grenoble cedex 9**

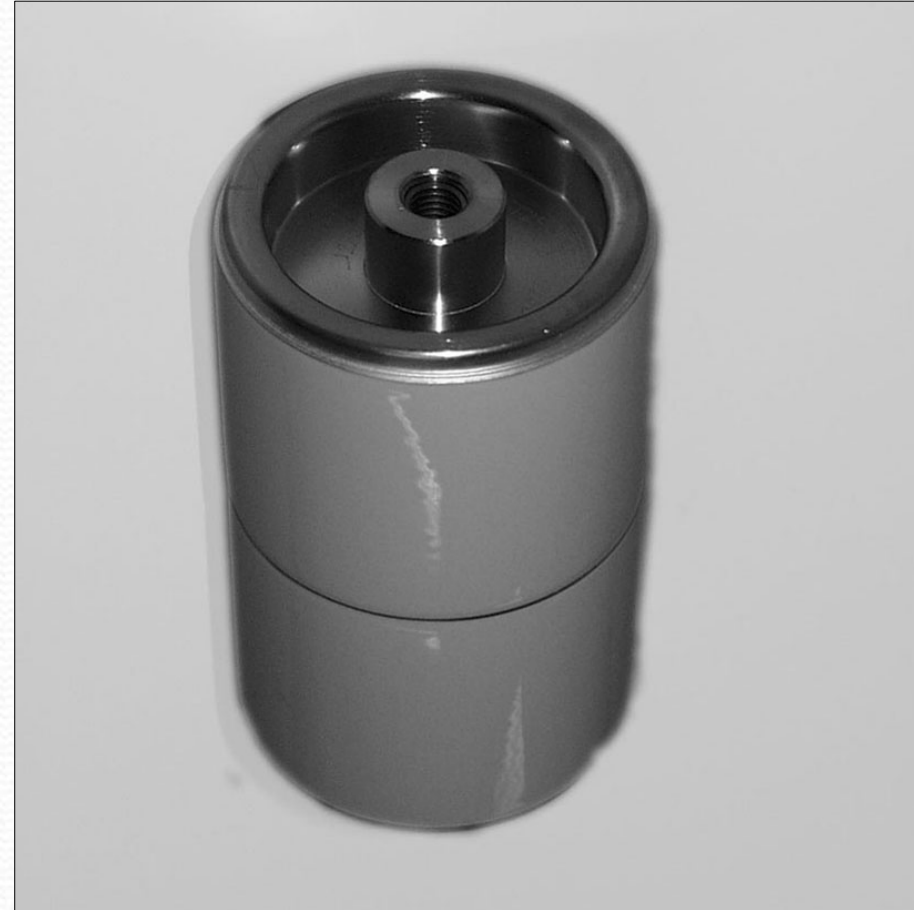
Vacuum interrupters contain the main contacts of the circuit breaker under a pressure of  $10^{-5}$ Pa to 2 Pa

Typical size

Diameter 90 mm

Length 180 mm

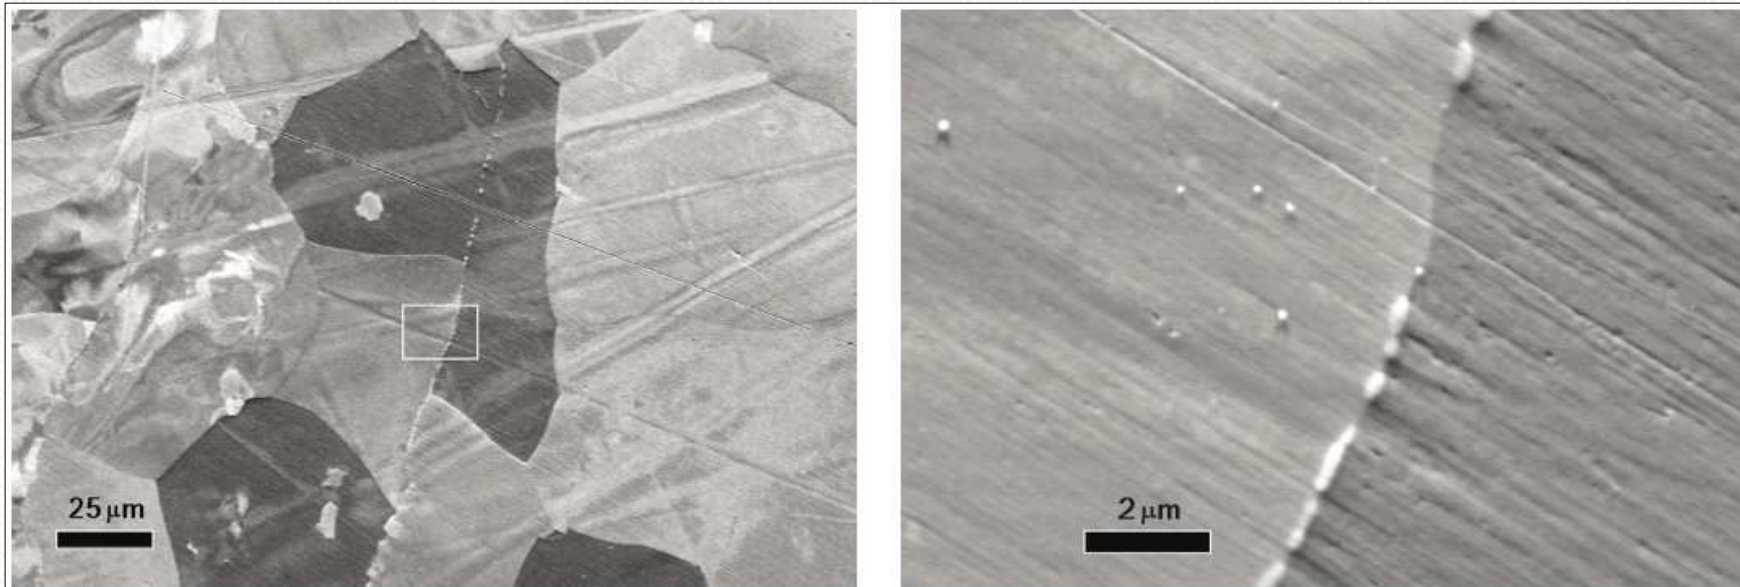
Référence: Phase identification of carbide and nitride precipitates in a ferritic stainless steel

Impuretés aux joints de grain

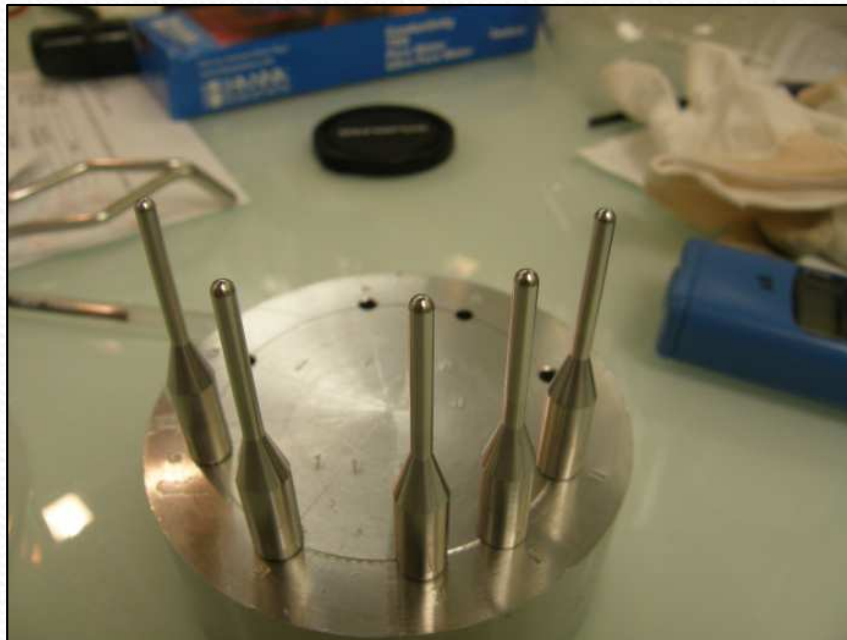
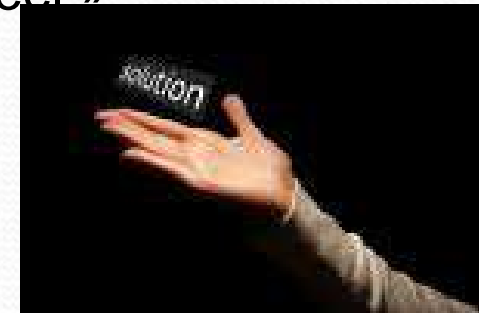
## Solutions

- Pour éviter la présence de carbure, 3 différentes solutions:
1. L'électrolyse selective
  2. Le dépôt Nickel
  3. Utilisation steel without chrome « maraging steel »

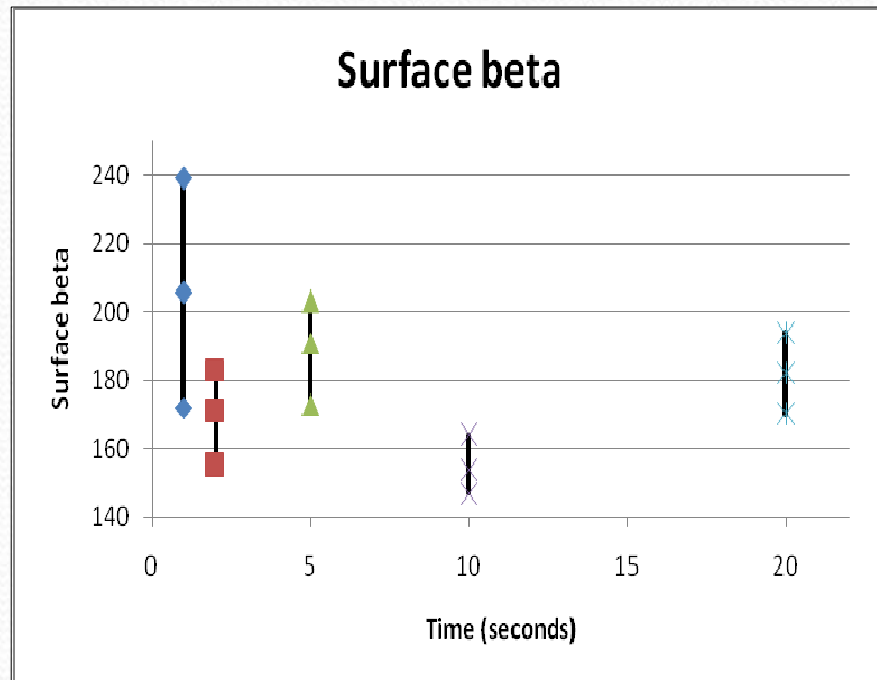
## 2- Résultats: Dépôt couche mince

→ 10 secondes = Conditions optimales

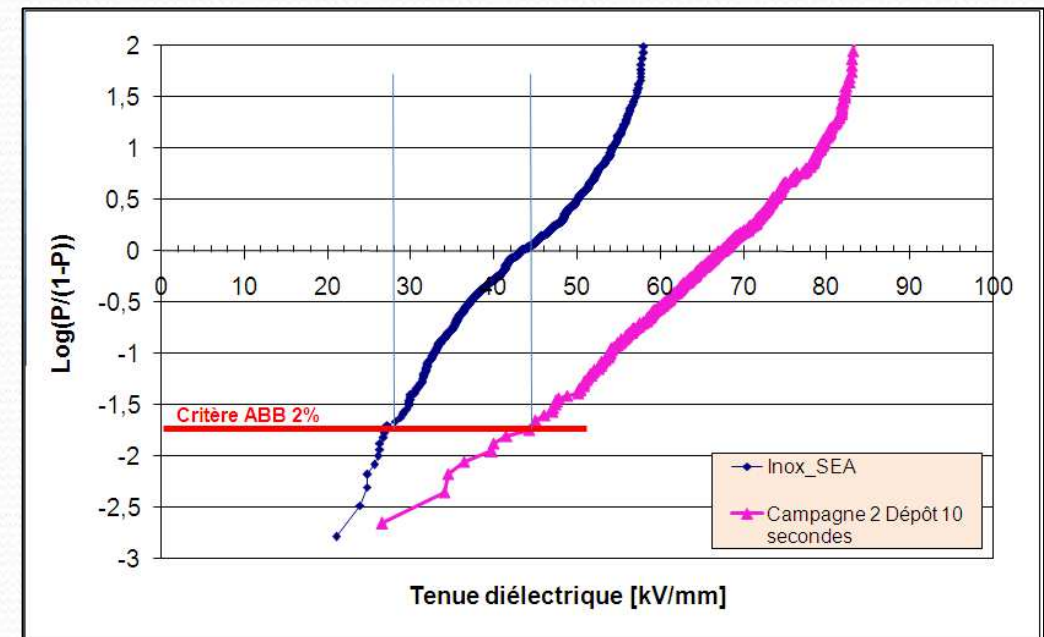
→ 10 secondes dépôt Ni électrolytique = + 44 nm sur l'aiguille

- Electrolyse sélective → 50% d'amélioration
- Dépôt Ni de 44 nm → 57% d'amélioration
- Résultats avec le maraging steel : marginal

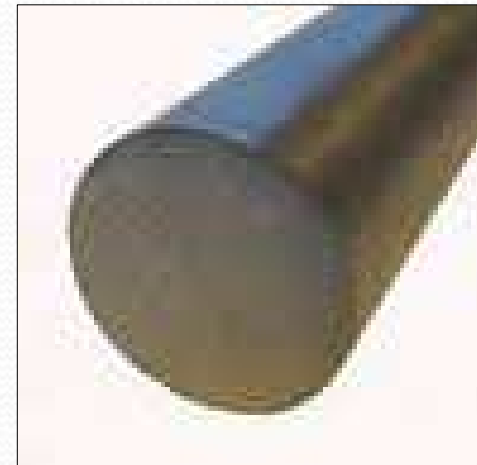
### → Composition maraging steel:

- Fer
- Nickel (18%)
- Molybdène (5%)
- Cobalt (8%)
- Carbone, aluminium et soufre (faible quantité)
