CS Tie Plate Structure Materials Characterization Update

R. P. Walsh, D. M. McRae, K. Han and R. Goddard
12/6/12

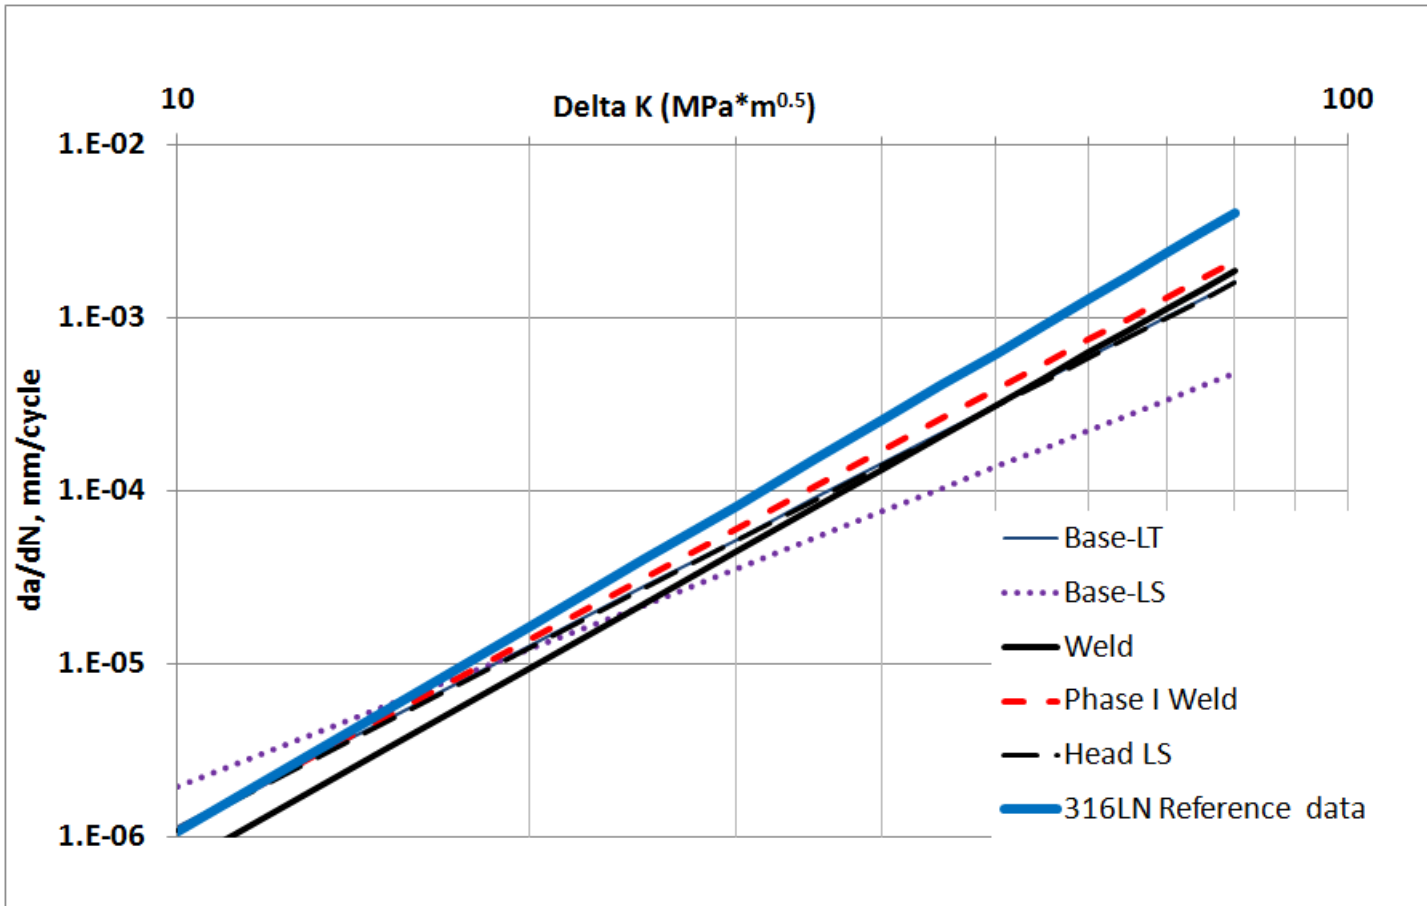
RESULTS: 4 K Fatigue Crack Growth Rate

1. The tie plate base metal and weld metal behave similarly.
2. At a given $\Delta K = 20 \text{ MPa}\cdot\text{m}^{0.5}$, the N50 base and 316LMN weld metal have a slightly lower FCGR than an annealed 316LN base reference material.
3. The FCGR data of the base metal and weld can be used in the tie plate design to determine allowable flaw size and non-destructive inspection requirements.

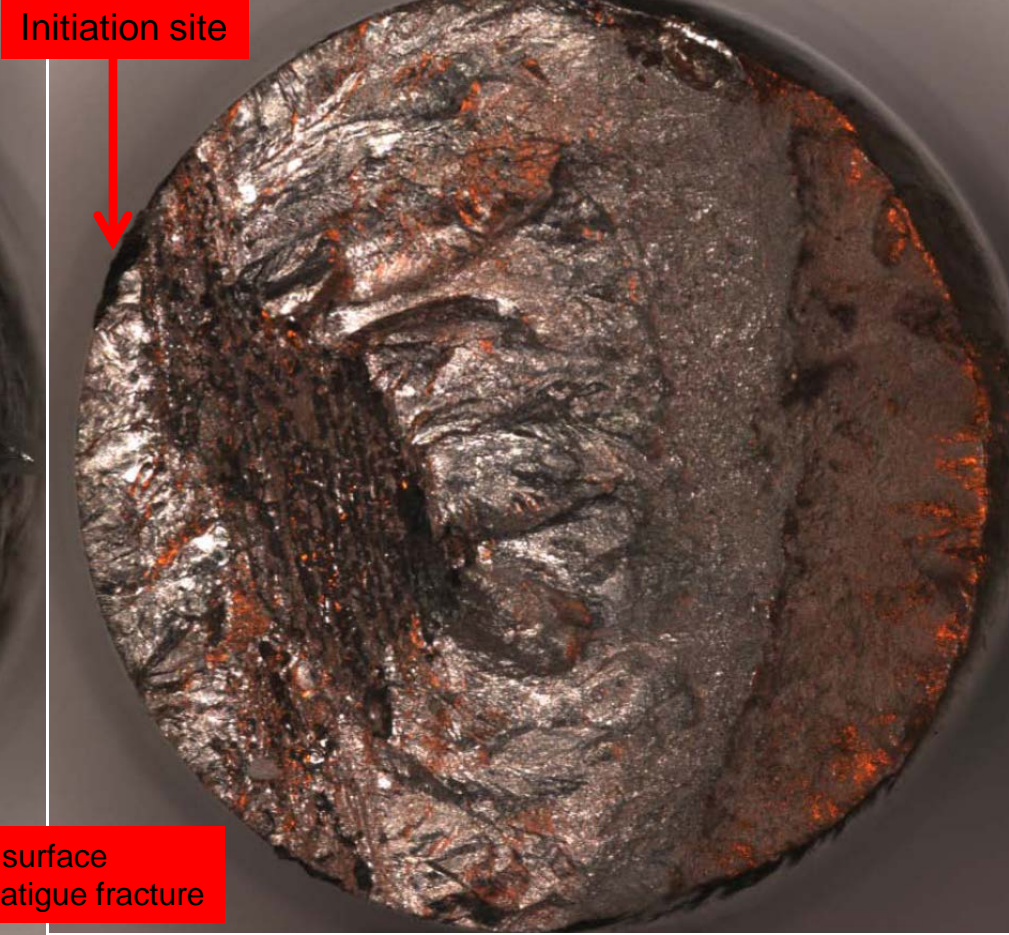
Results: S-n Fatigue Test

#28, $\sigma = 720$ MPa, $n = 8216$

#29, $\sigma = 500$ MPa, $n = 98,900$

- Fatigue crack initiates on left side of photo and proceeds $\sim \frac{1}{2}$ across before final tensile fracture.
- The fracture surface at initiation site has a dark, coarse, woody-textured appearance .

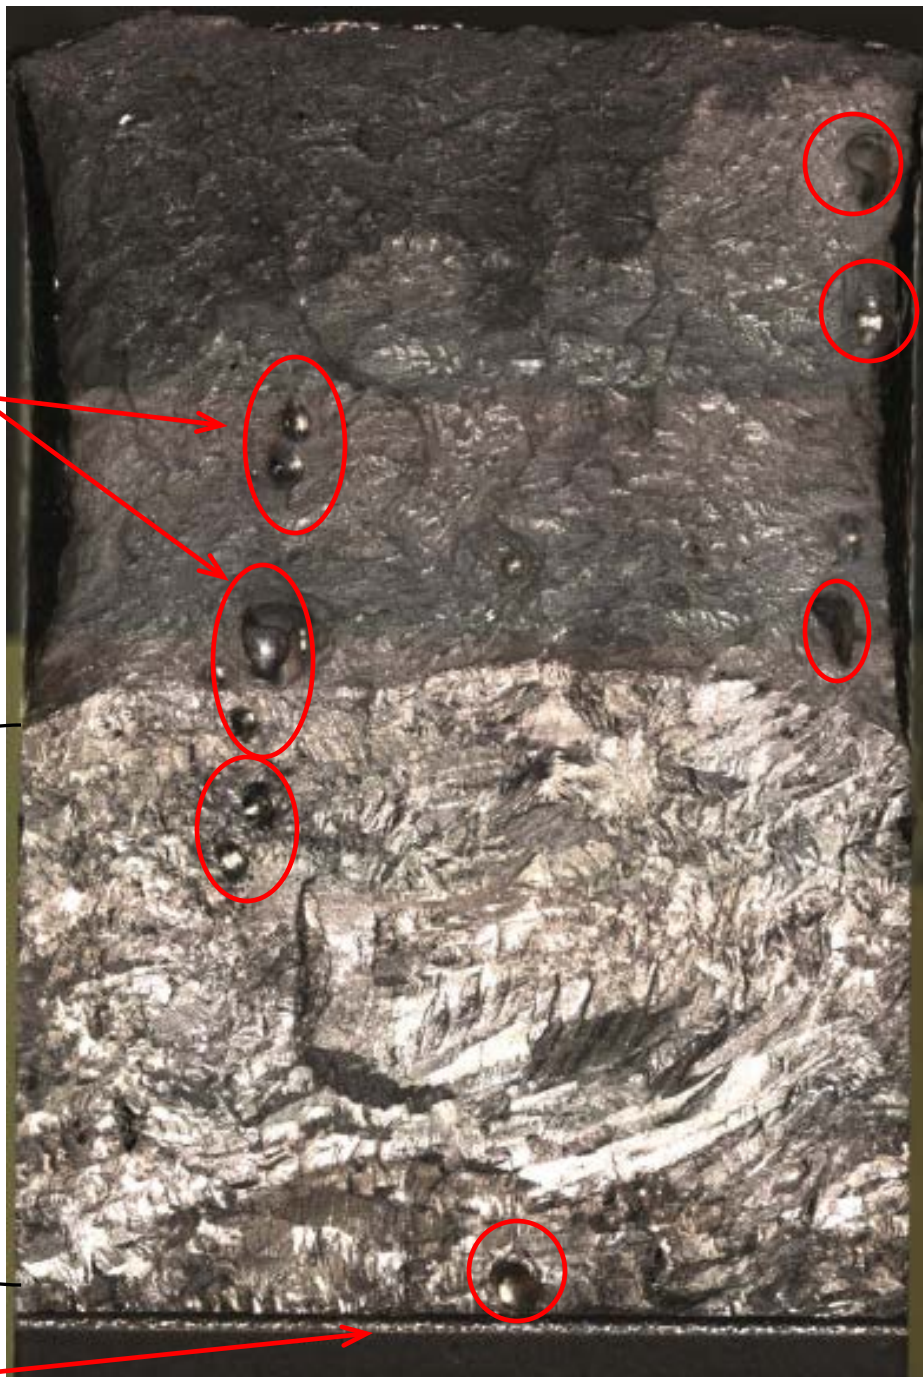
Dual purpose FCGR and Jic test Specimen #55
The CT specimen is cracked open to reveal a fracture surface that exhibits multiple voids

FCGR Region

Crack Direction

Machined Notch Tip

- b) Additionally the weld metal appears to have a significant void density, a quality issue that may not be covered in the quality control specifications. The concern is that although the void size (1 to 2 mm dia) is well below the allowable flaw size, too many of them may link up to act as one larger than acceptable void.

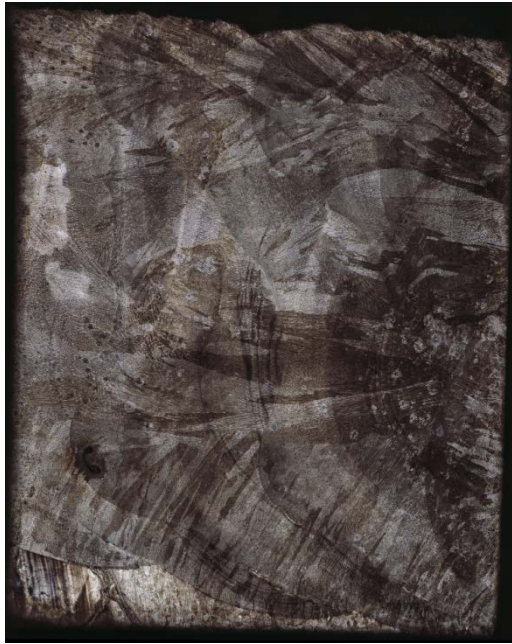
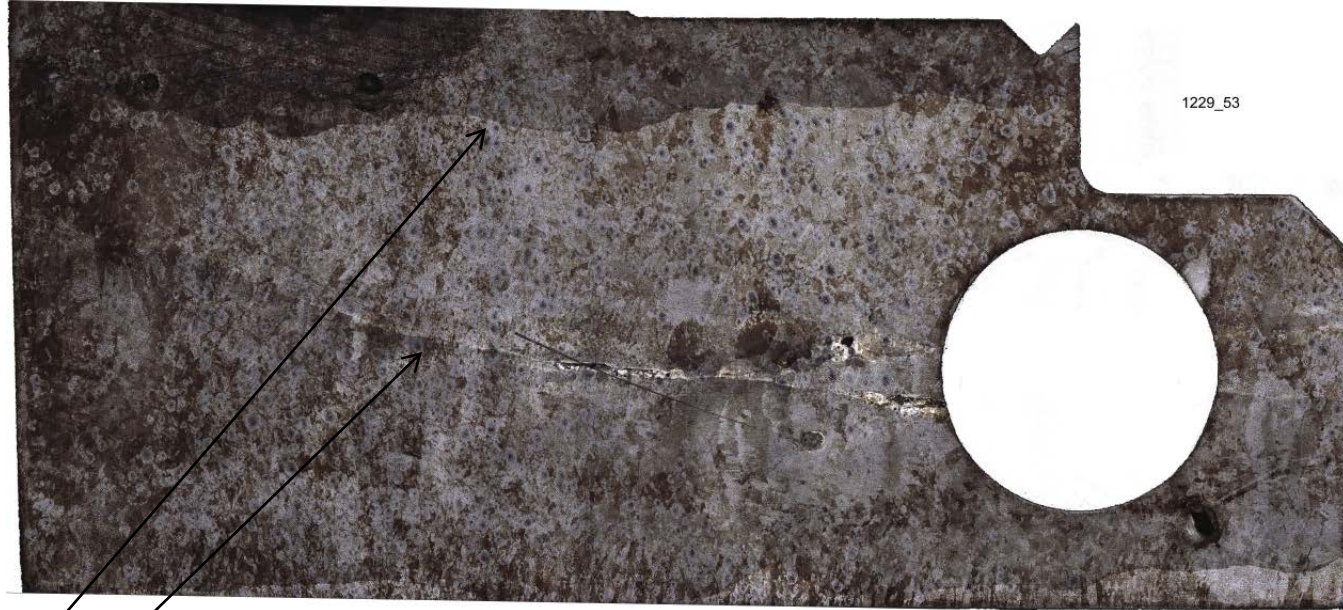
Weld Metallography - $\frac{1}{2}$ of CT Specimen # 53 is polished and etched to reveal weld microstructure

End View

Side View

Weld Pass Direction

Weld pass Interface Fusion Lines

This weld pass fusion line
has discontinuous
microstructure

- a) Metallographic evaluation of the weld microstructure reveals inconsistent microstructural appearance and chemistry at various fusion lines between weld passes. This observation may be related to the localized coarse fracture surface regions observed on S-n fatigue specimens.

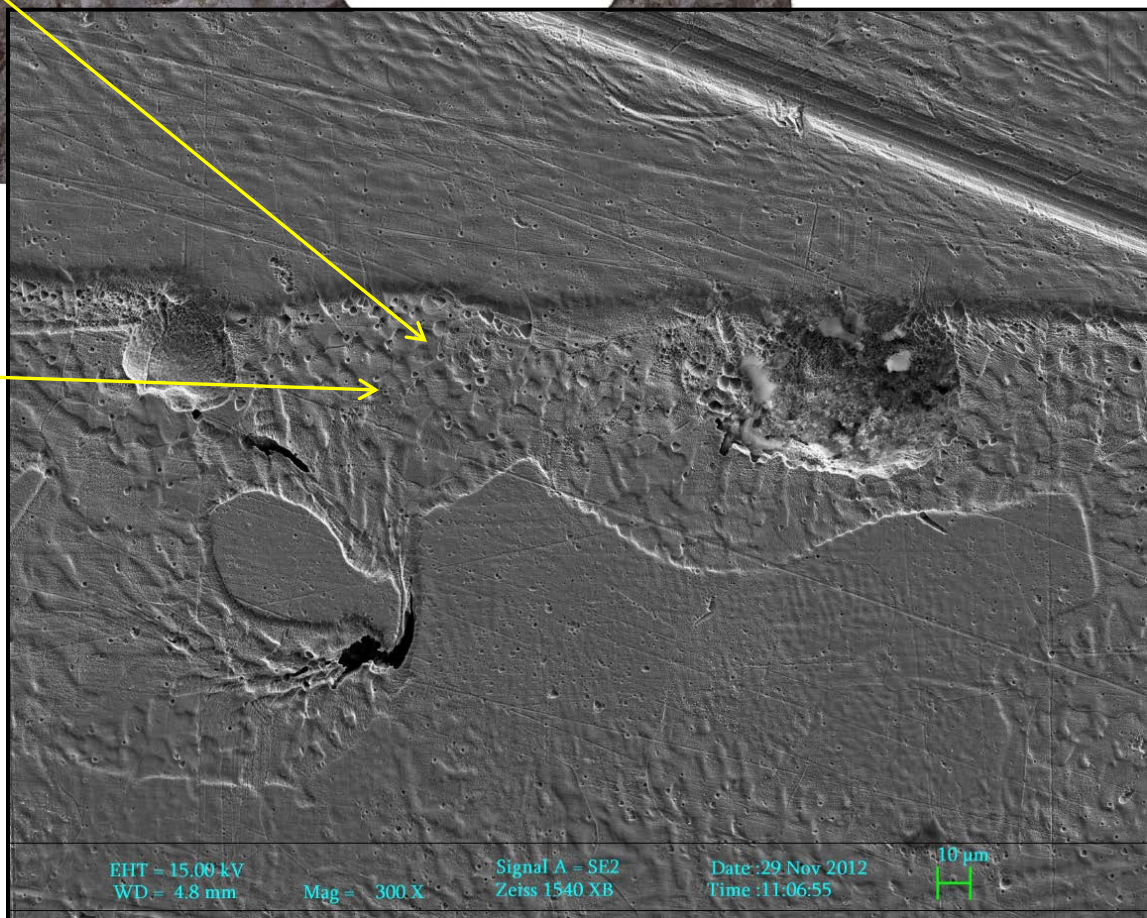
CT Specimen #53

Local chemistry mapping
indicates the fusion line is
higher in Mn content and lower
in Fe content compared to the
nominal weld composition.
