In situ SEM DC experiments in Uppsala – update 17 June 2013

Tomoko Muranaka

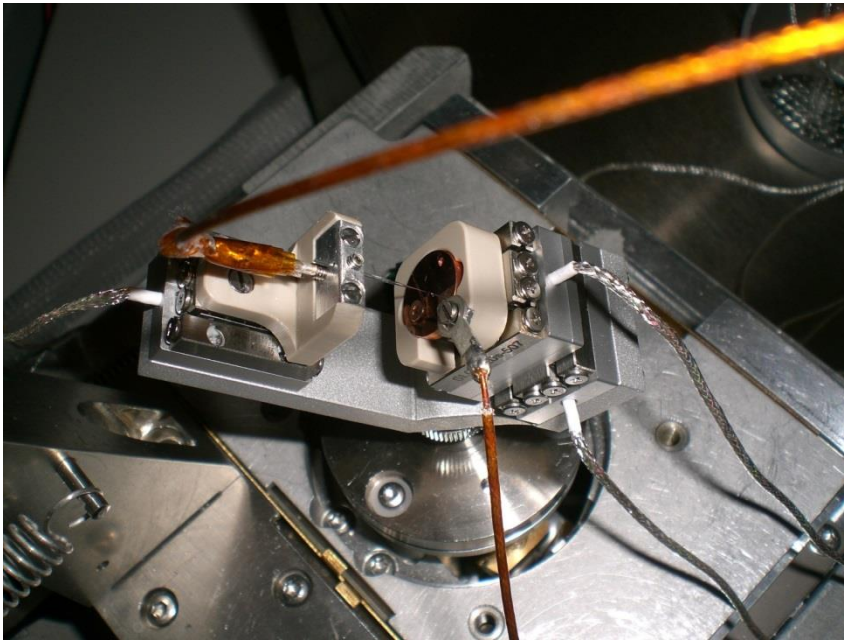
3D piezo positioner installed Oct 2012

- What we can do:
 - Target measurement spot
 - 2D scanning
 - Searching weak point

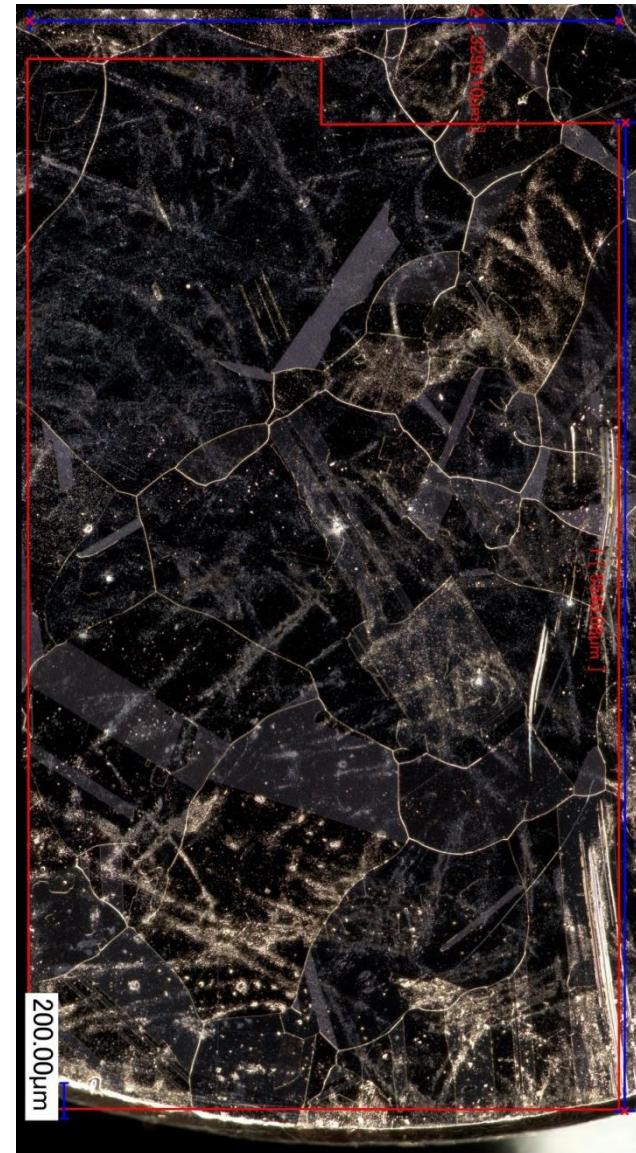
Grain identification

- (111) and (001) grains are chosen thanks to EBSD done by Anité.
- One reference spot to determine the gap (1 μ m) on the (111) grain.
- Three measurement spots on each grains.
- Voltage that the measured current exceeded 10nA were 400 to 800 MV/m on each grains.

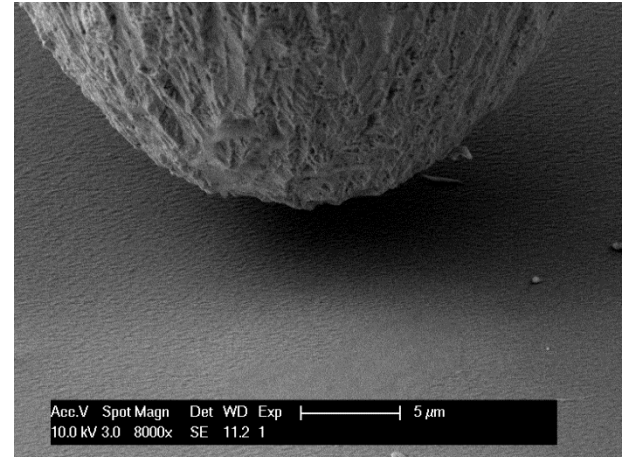
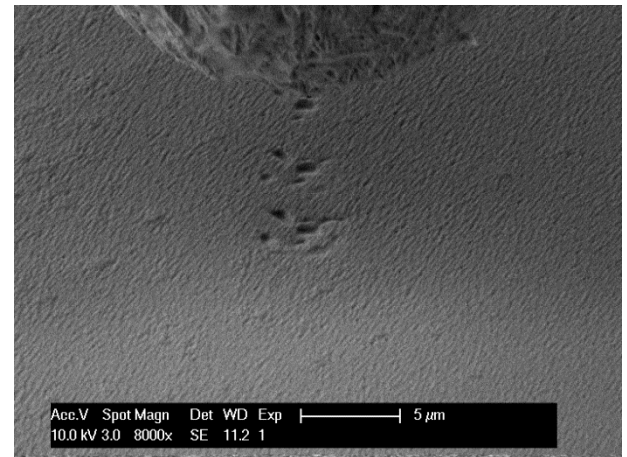
- Anode surface was ugly.
- Anode holder was probably loose due to deformation of other side of the tip (mechanical cut)

- KOH etching
- Diamond cut before cleaning
