Pion Decay Solenoid and Refrigerator Installation

T W Bradshaw
M Courthold
J Rochford
M Hills
and a massive
supporting cast

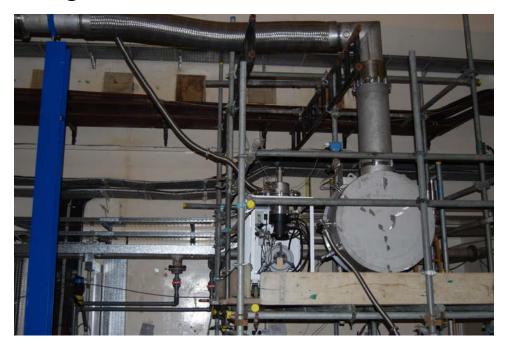
- Installation completed
- Performance checked into test cap

•34.5W guaranteed cooling power + 21.4W for current leads = 55.9W total + 10W for transfer line = 66W overall. This means that the test cap (plus transfer line) should be able to hold 56W – getting about 46W

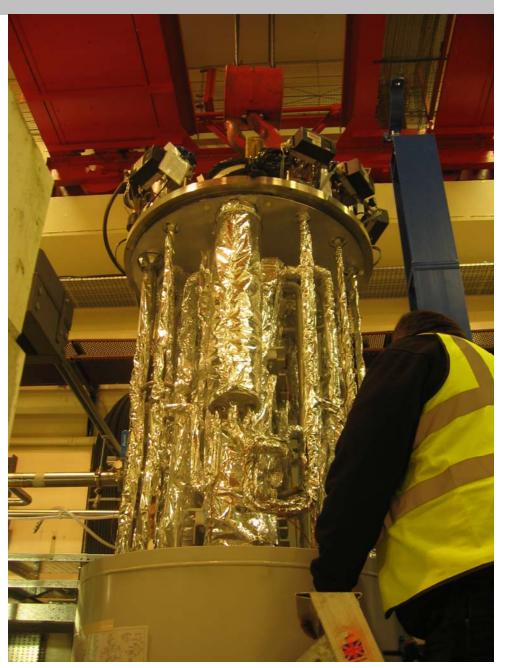
Modifications made to cold box to improve performance

After the modifications and during the tests into the cold cap it was realised that the performance was still not as expected. There was a problem with the first turbine in the cold box. This was inspected and some unspecified damage noted.

Both turbines have been removed from the cold box and have been sent back to Linde for refurbishment or replacement. The current estimate is that it will be about 10-14 days before we can get them back. They will then need re-installing and the system re-starting. It could be that this was what was causing the performance issues.
