Preliminary Observations from the V3 test

Torsten, Tobias, Rama, Pierre, Mathieu, Maria, Antoine, Alick
3 October 2013

Crab cavity test: Preliminary results

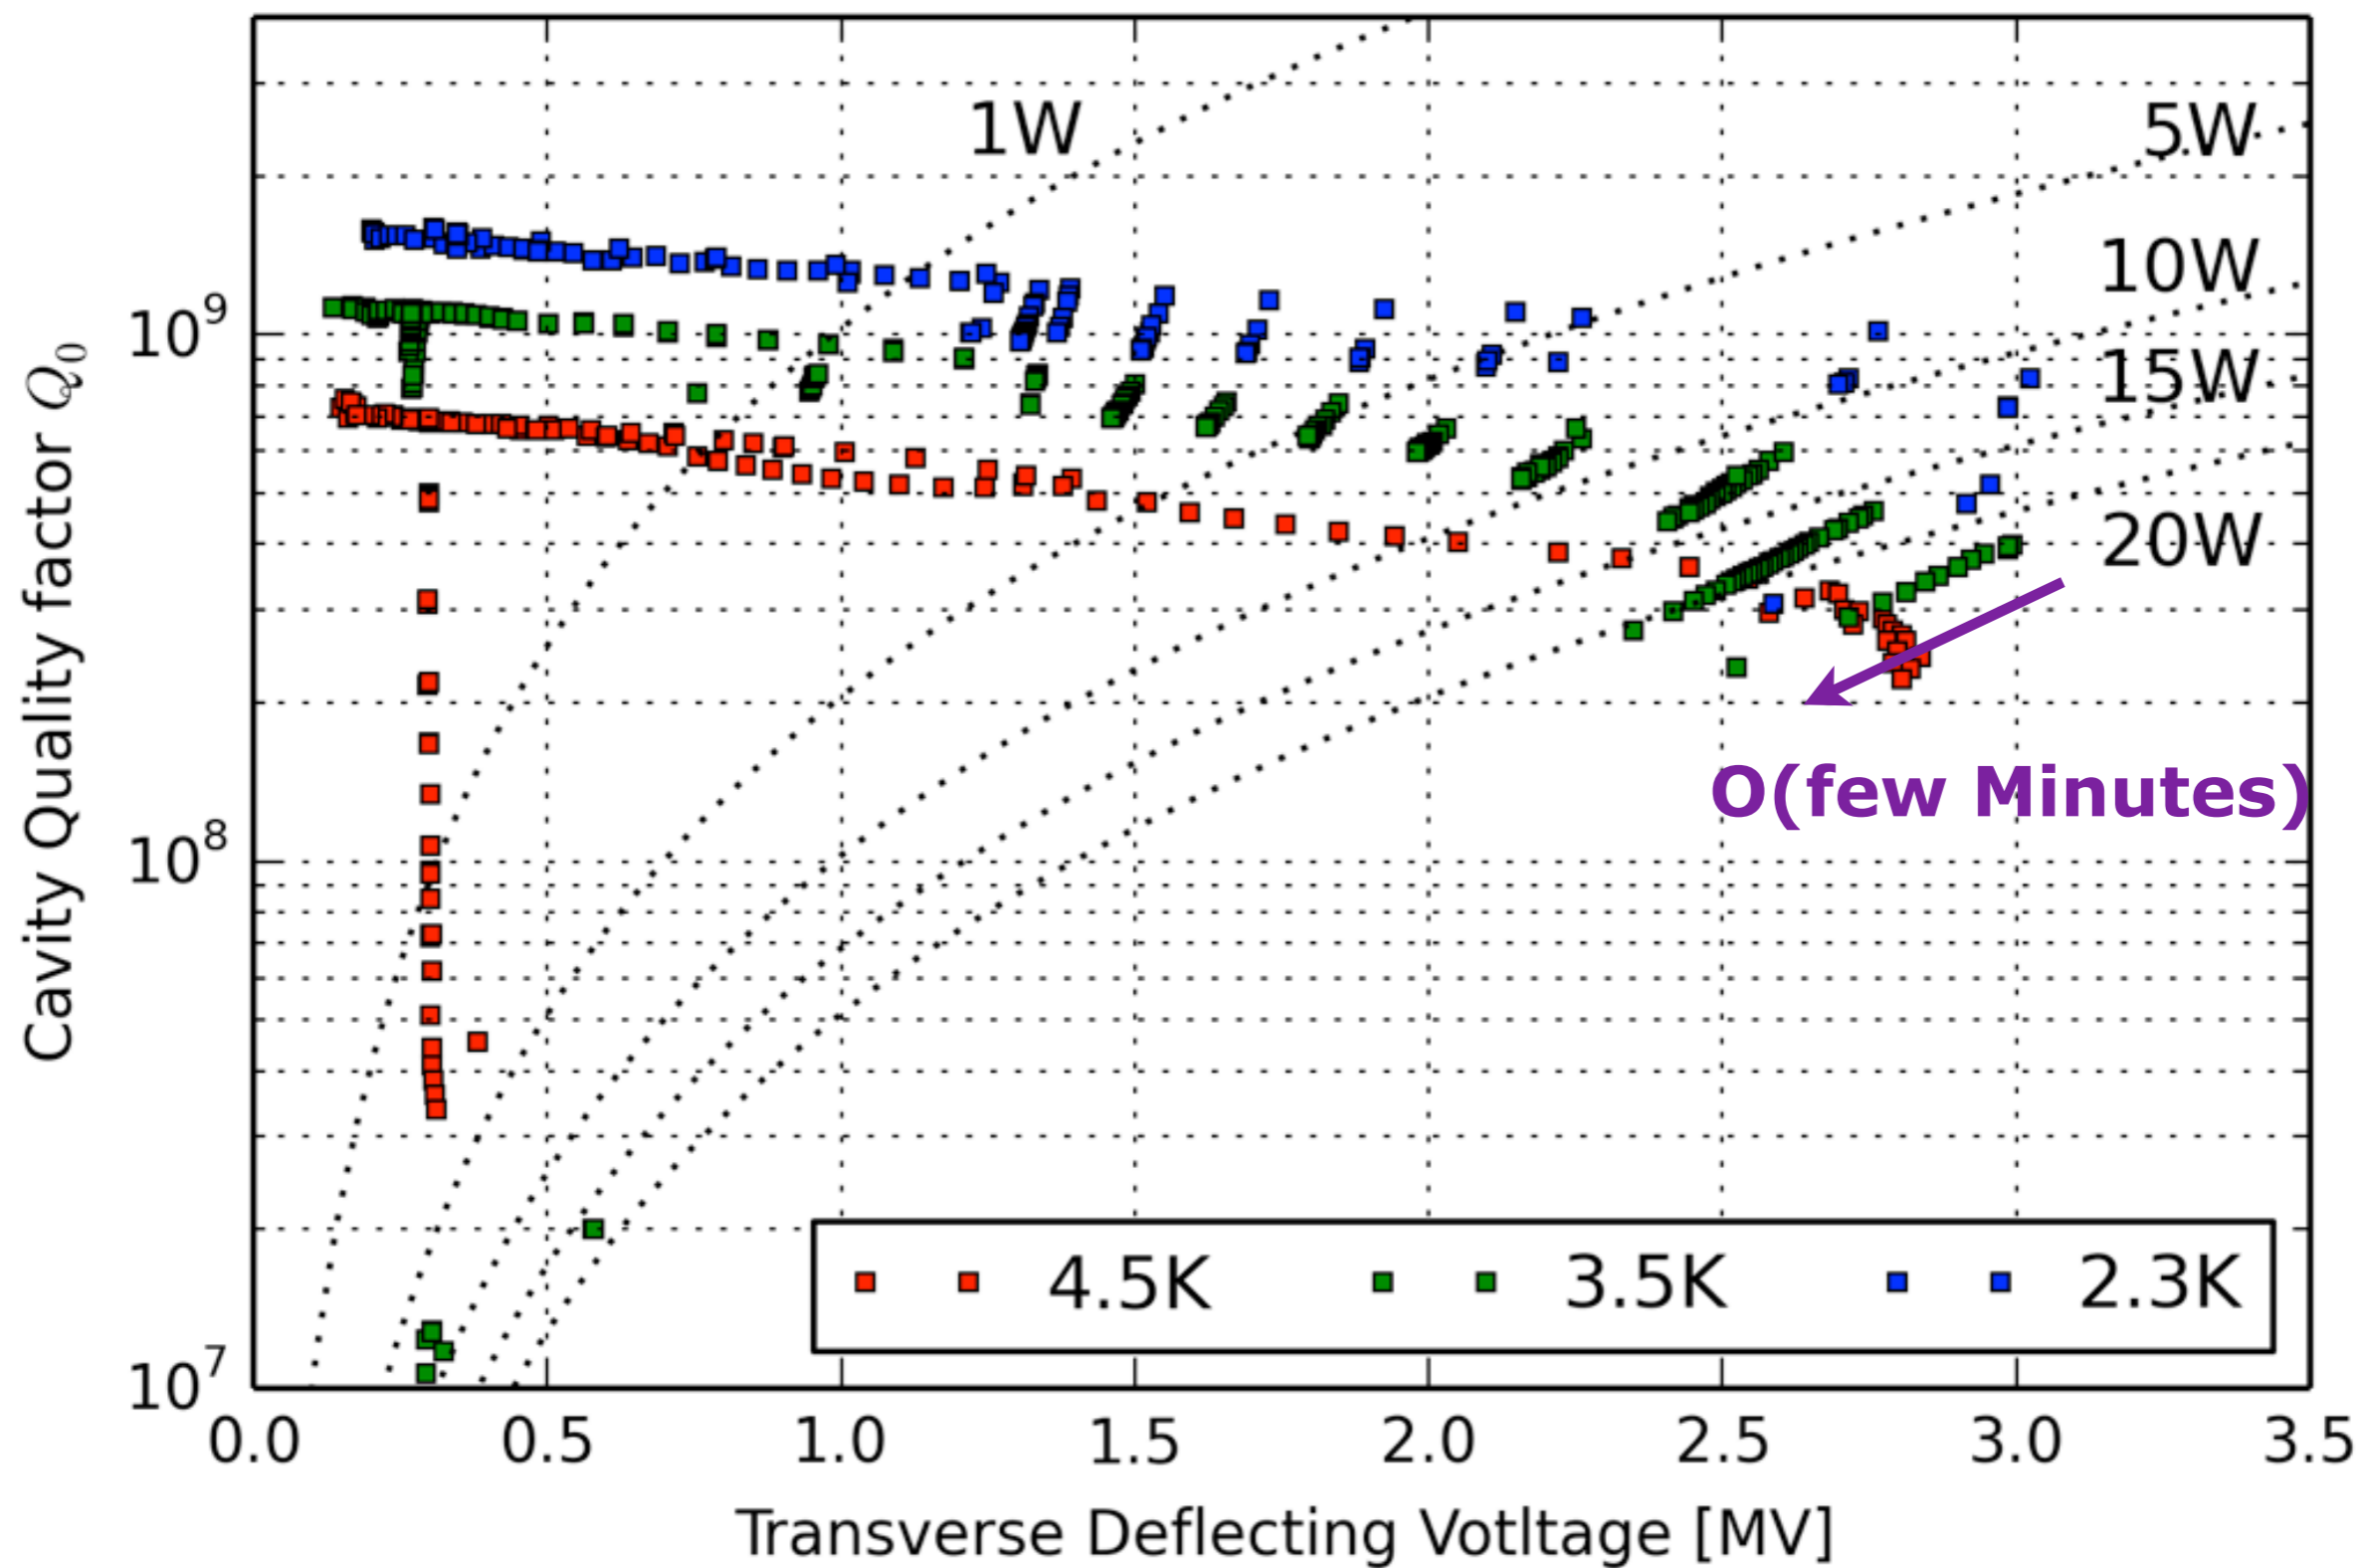
Crab cavity test: Preliminary results

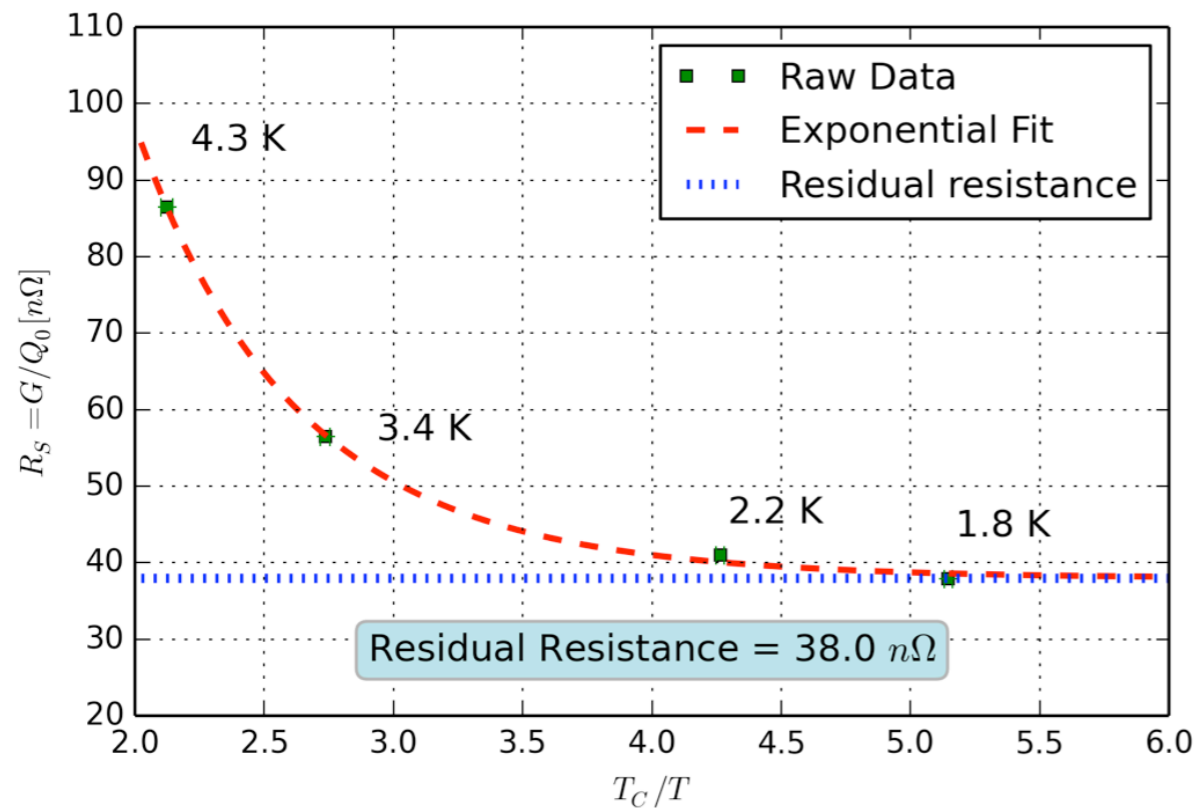
Residual Resistance

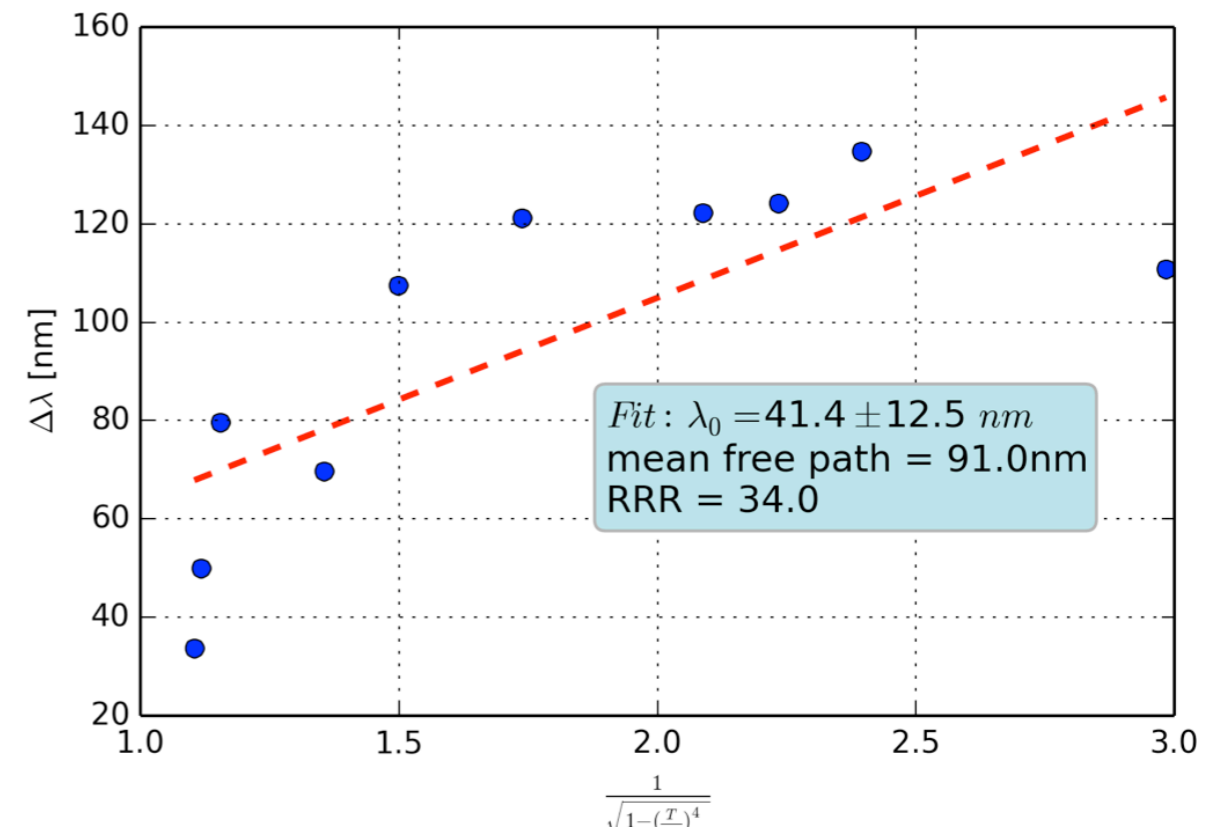
Attempt at RRR

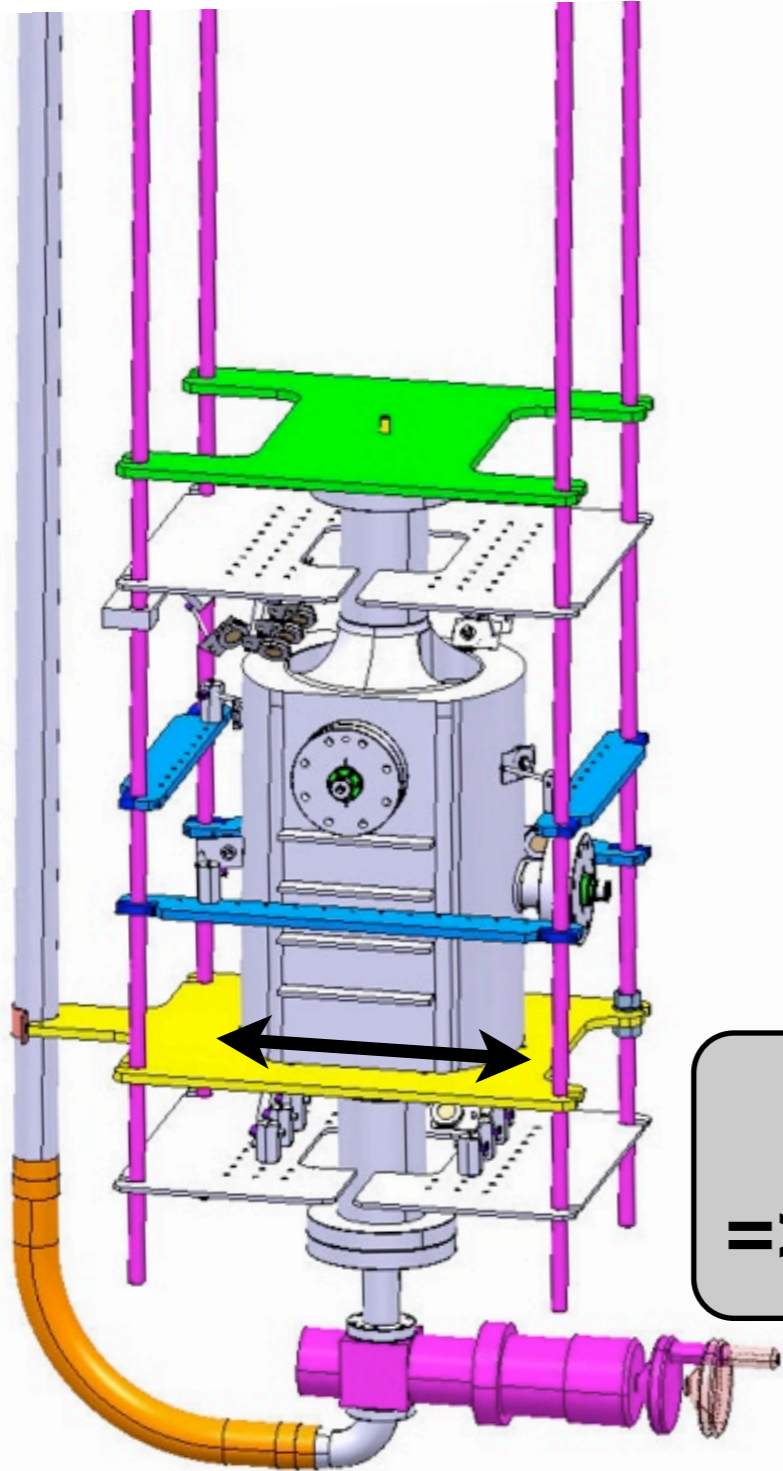
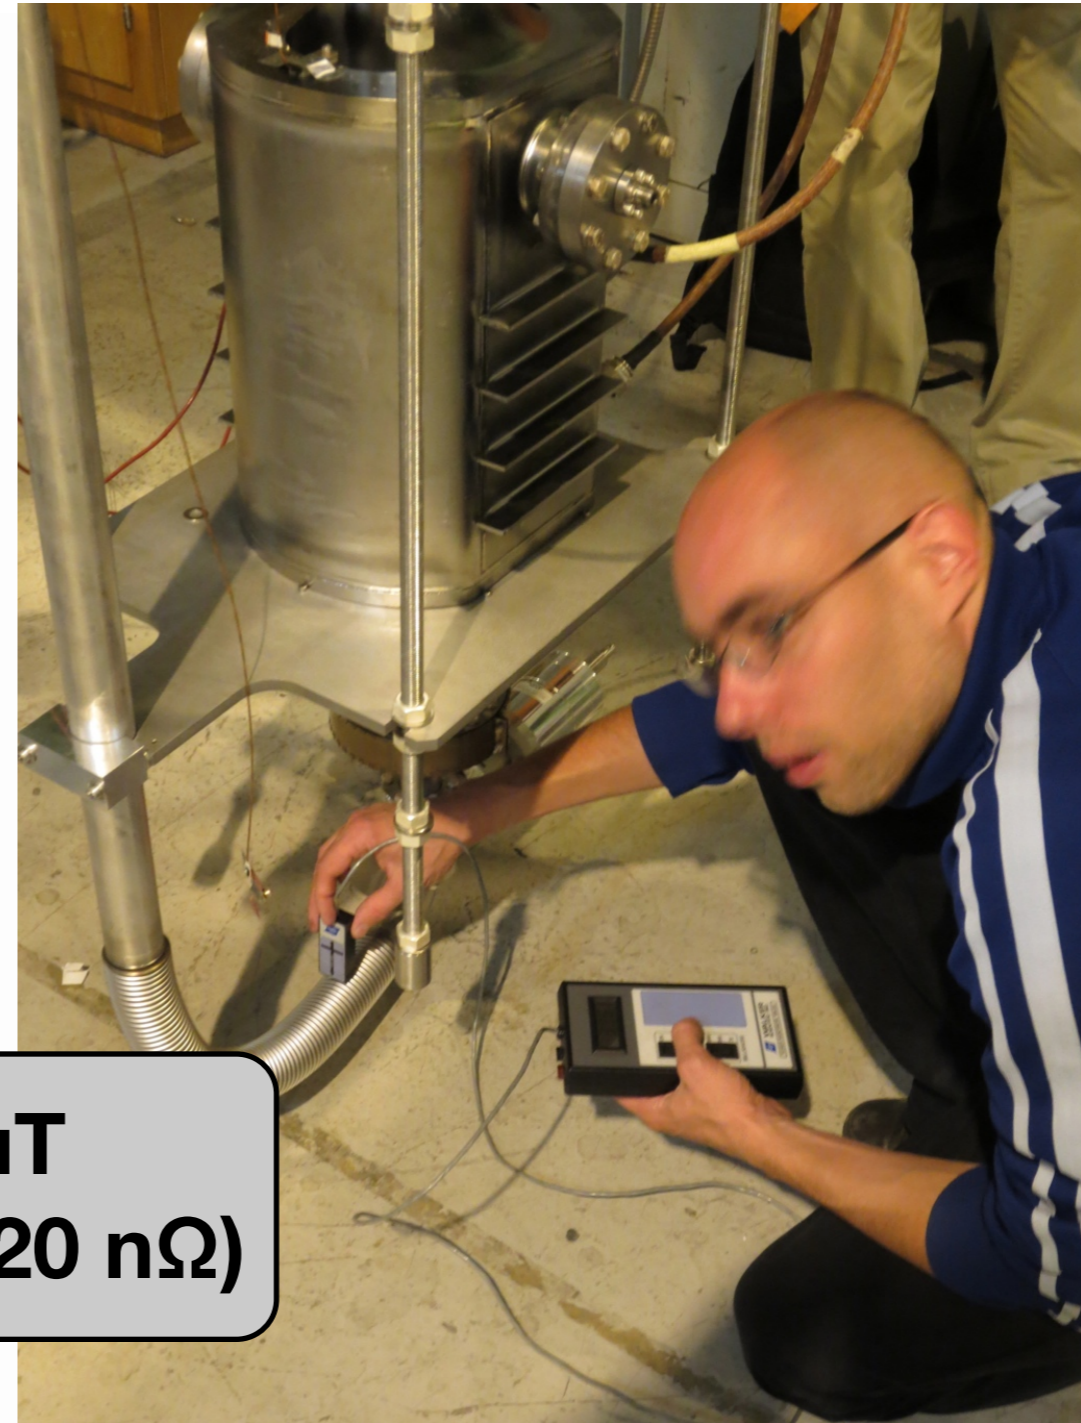
Magnetization

$\sim 10\mu\text{T}$
 $\Rightarrow O(10-20 \text{ n}\Omega)$

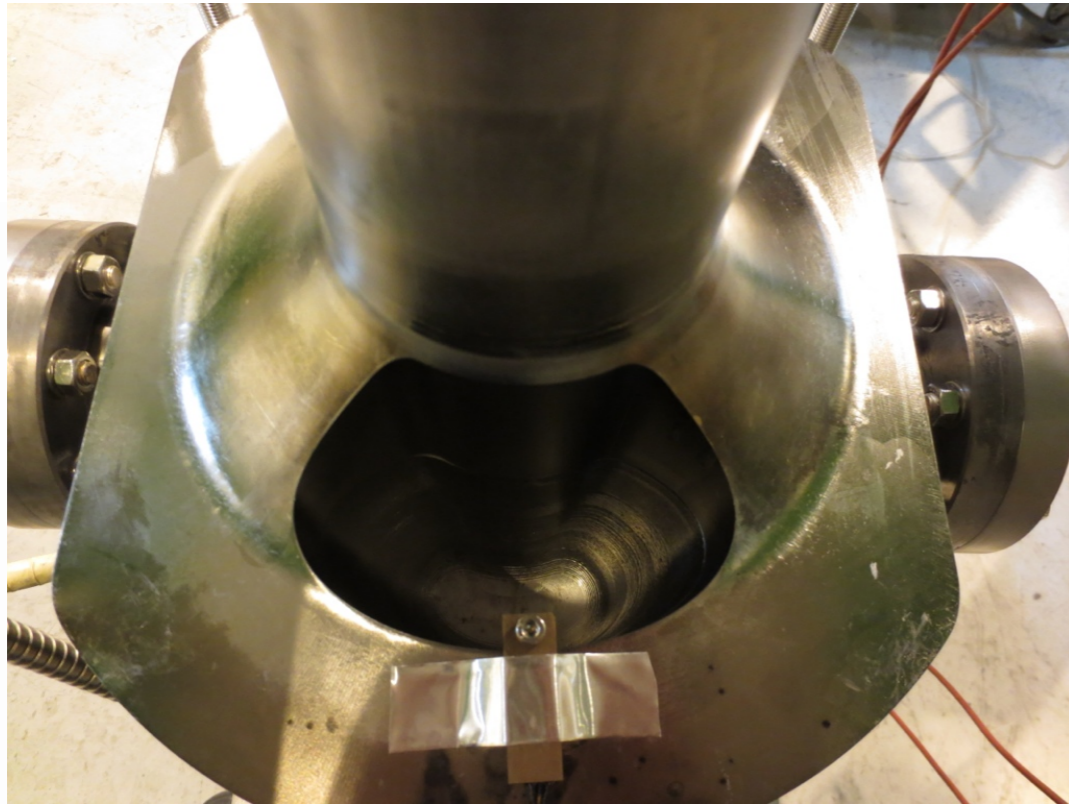
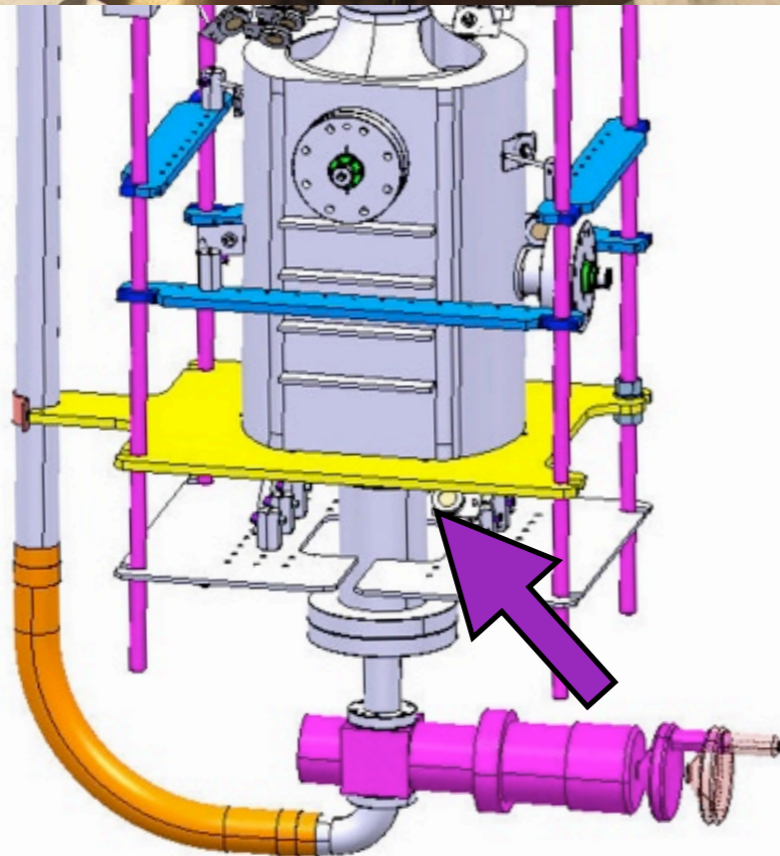
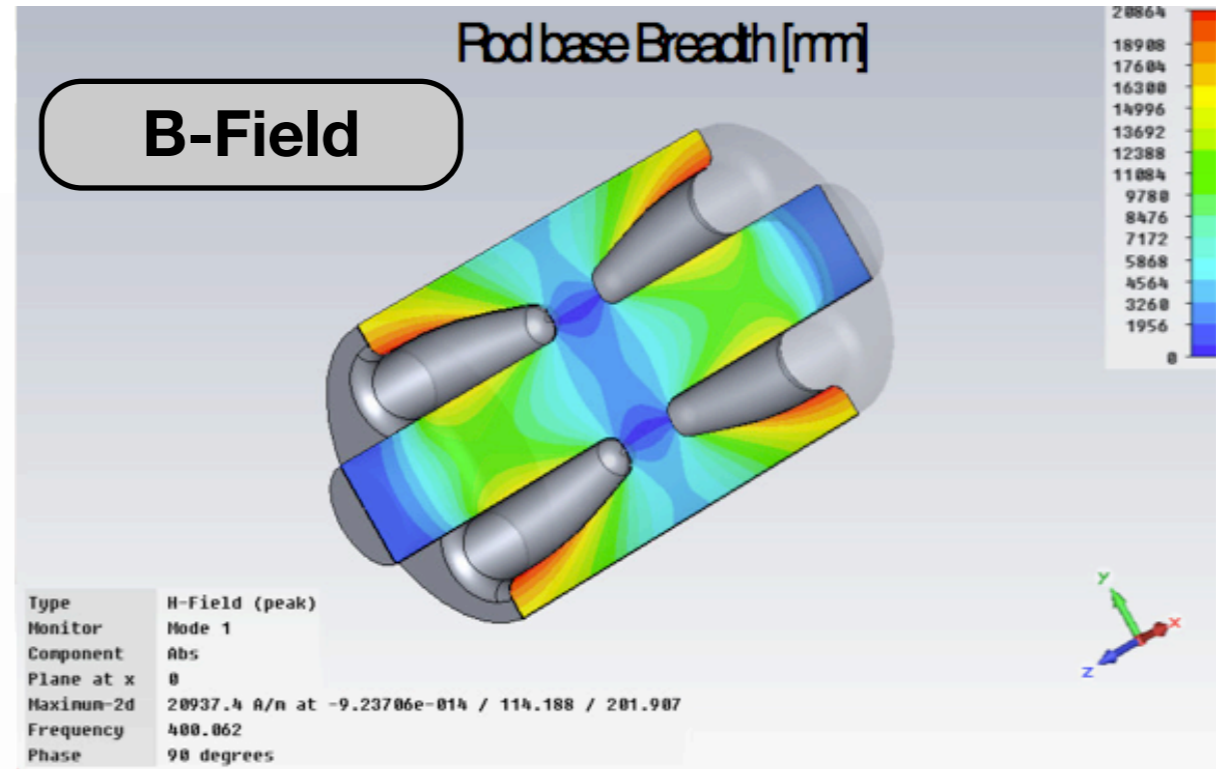
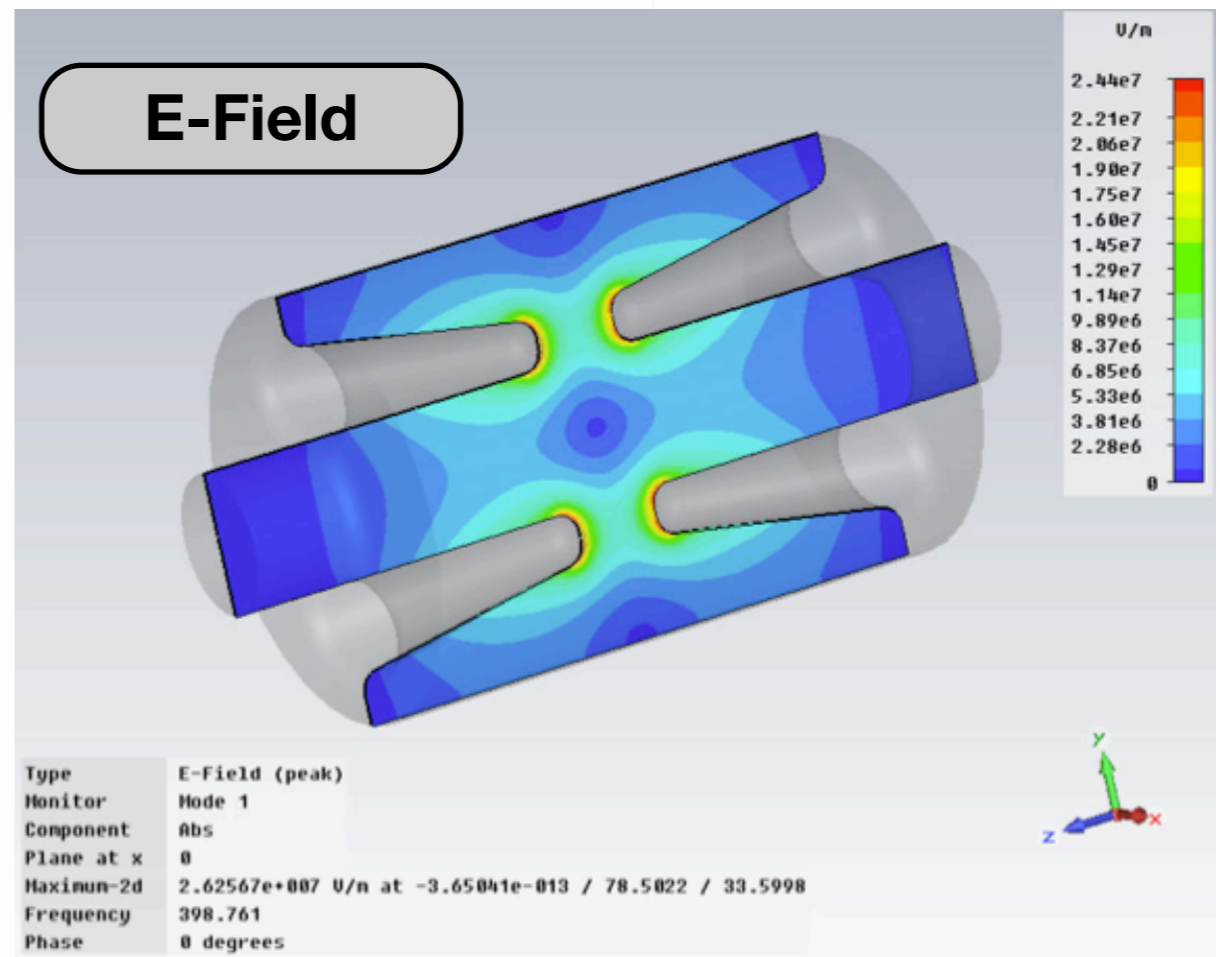
Cavity Shape issues

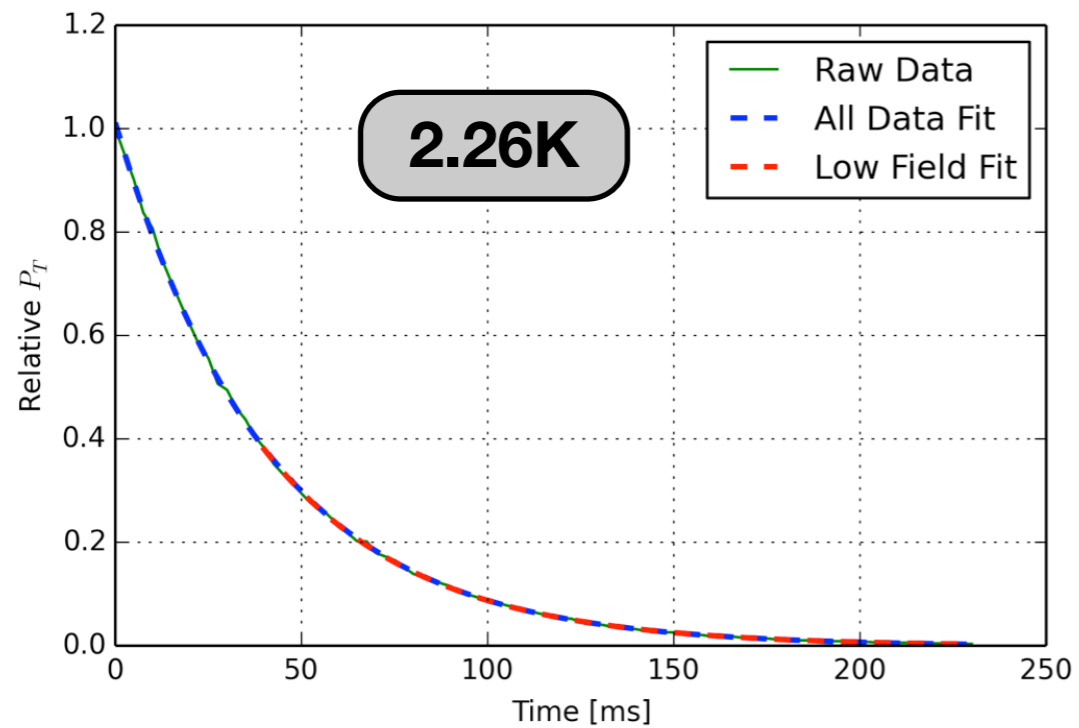
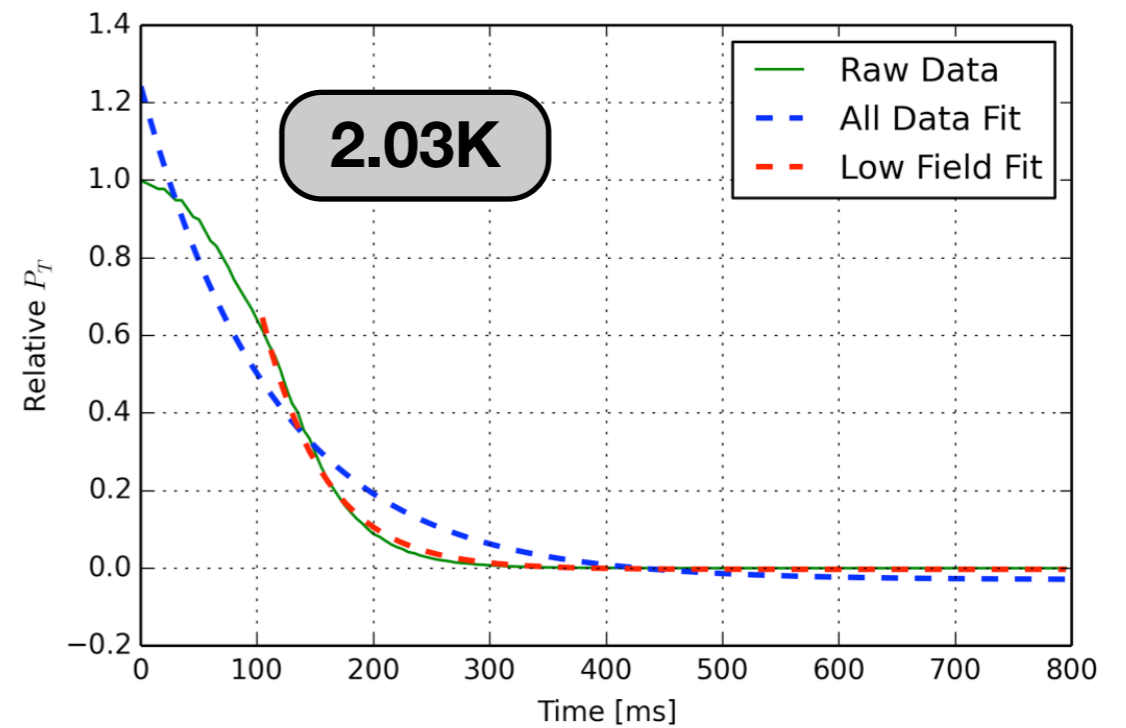
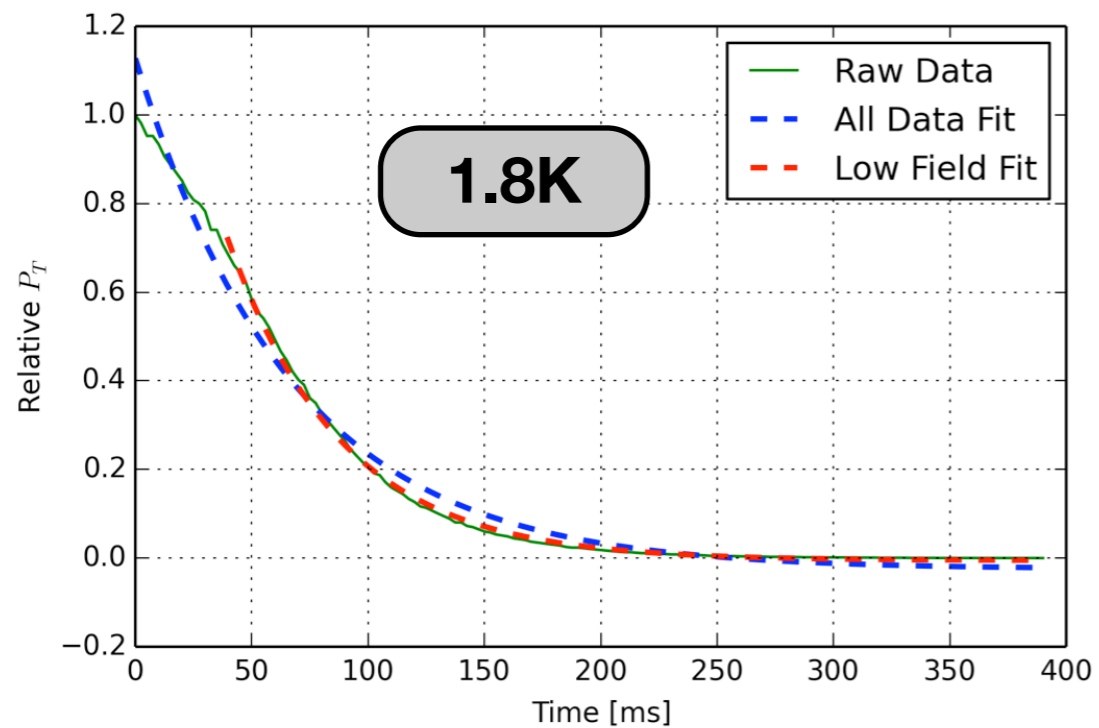
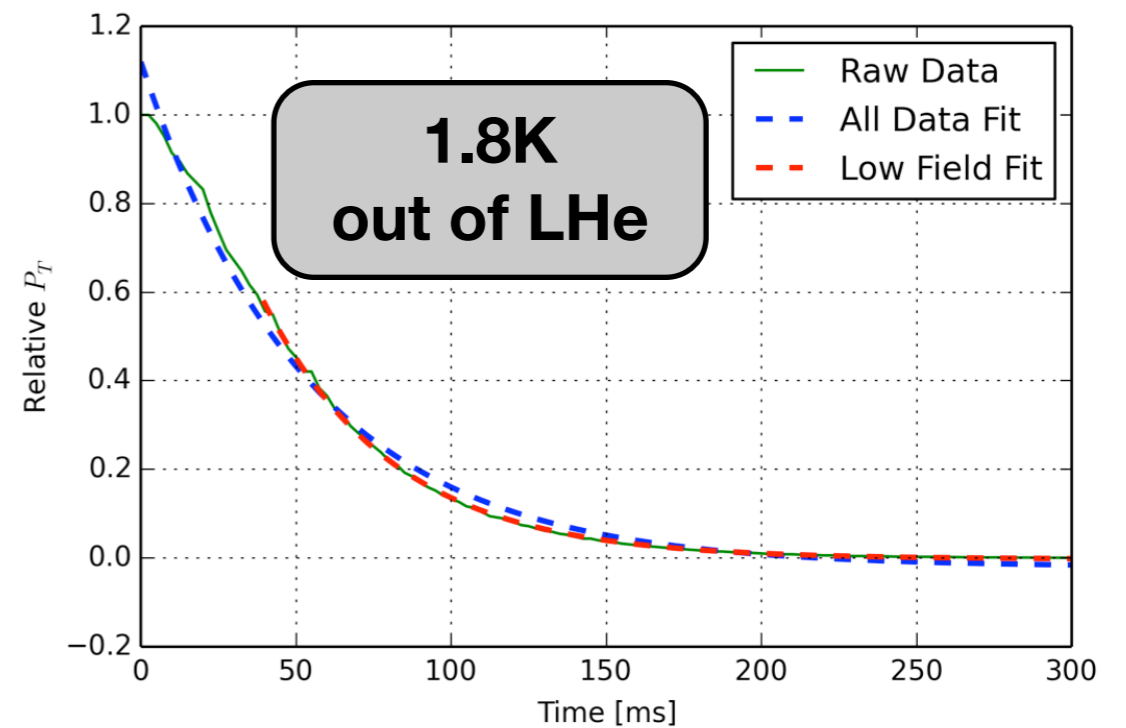
Calibration: P_T response to square pulse

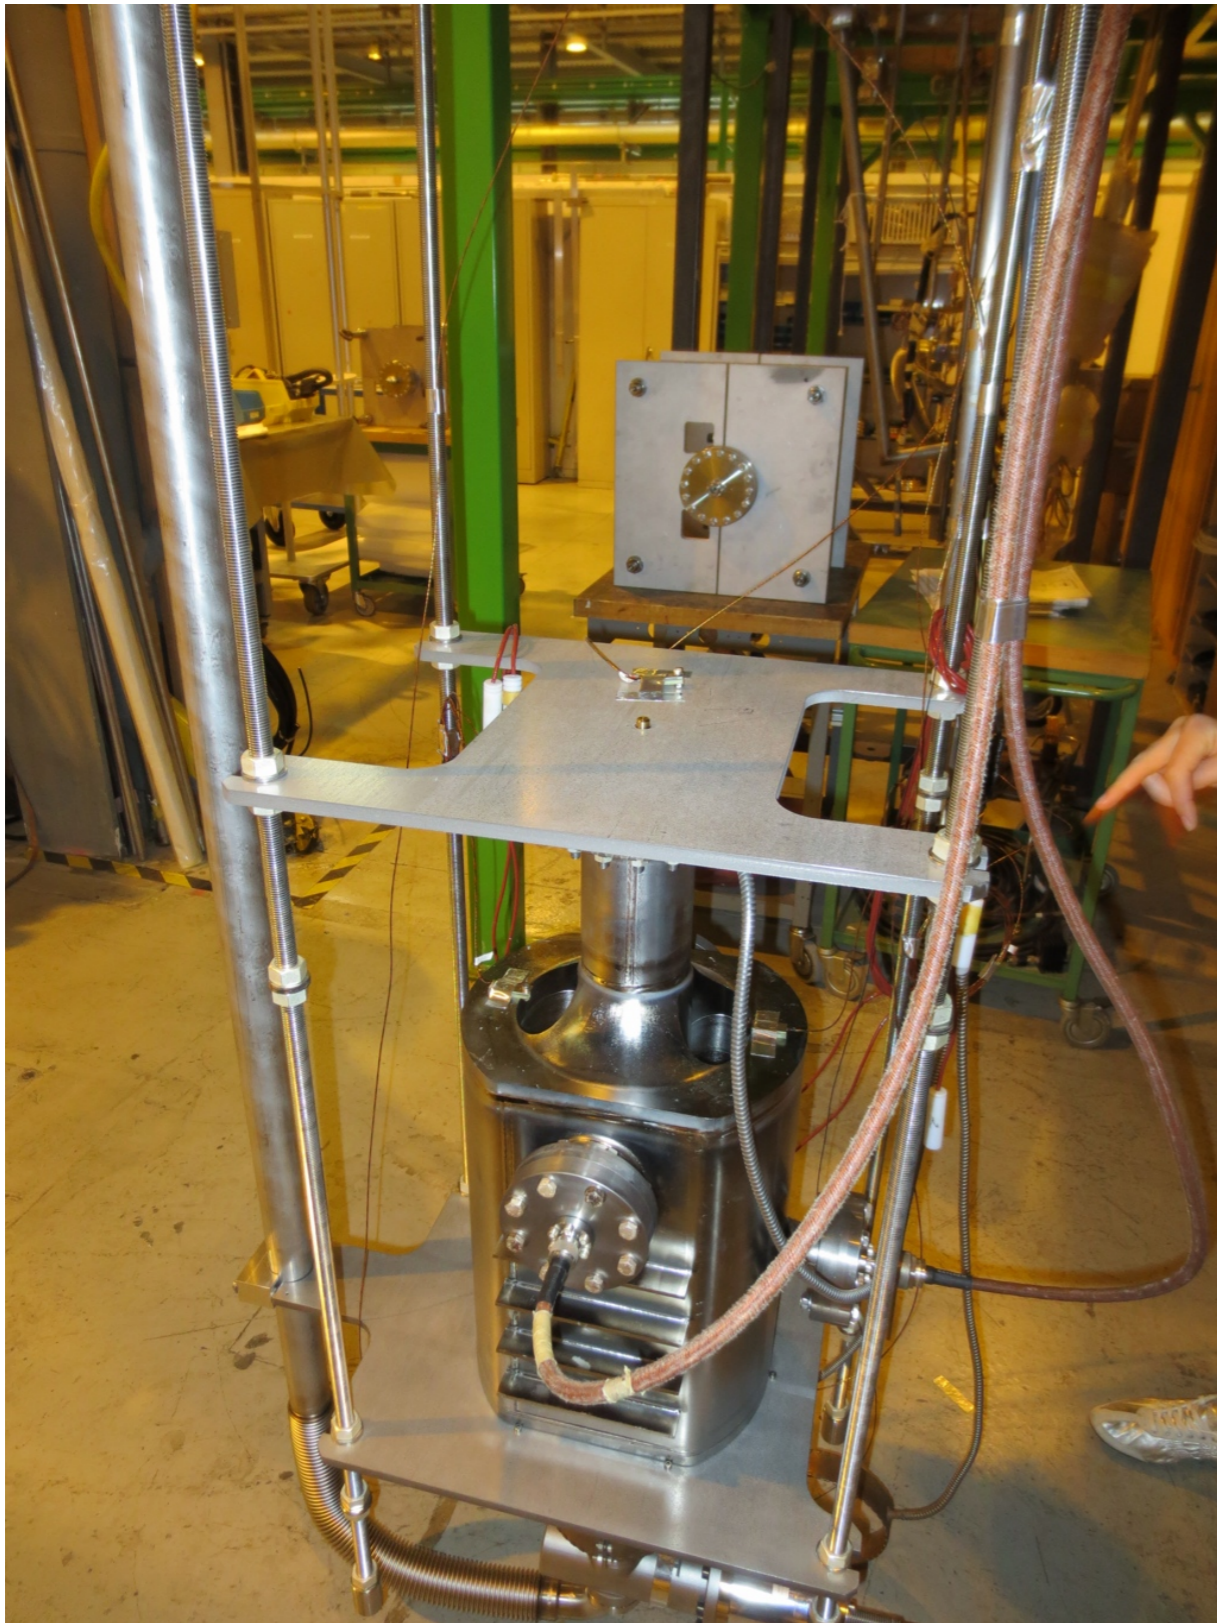
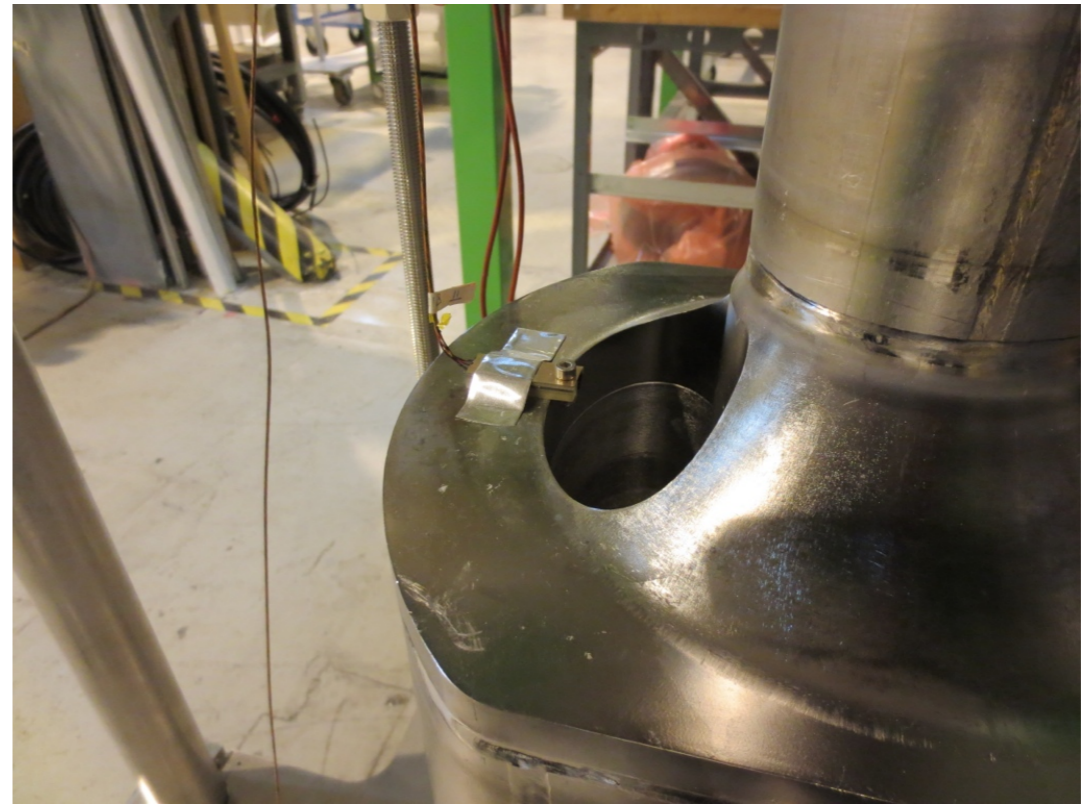
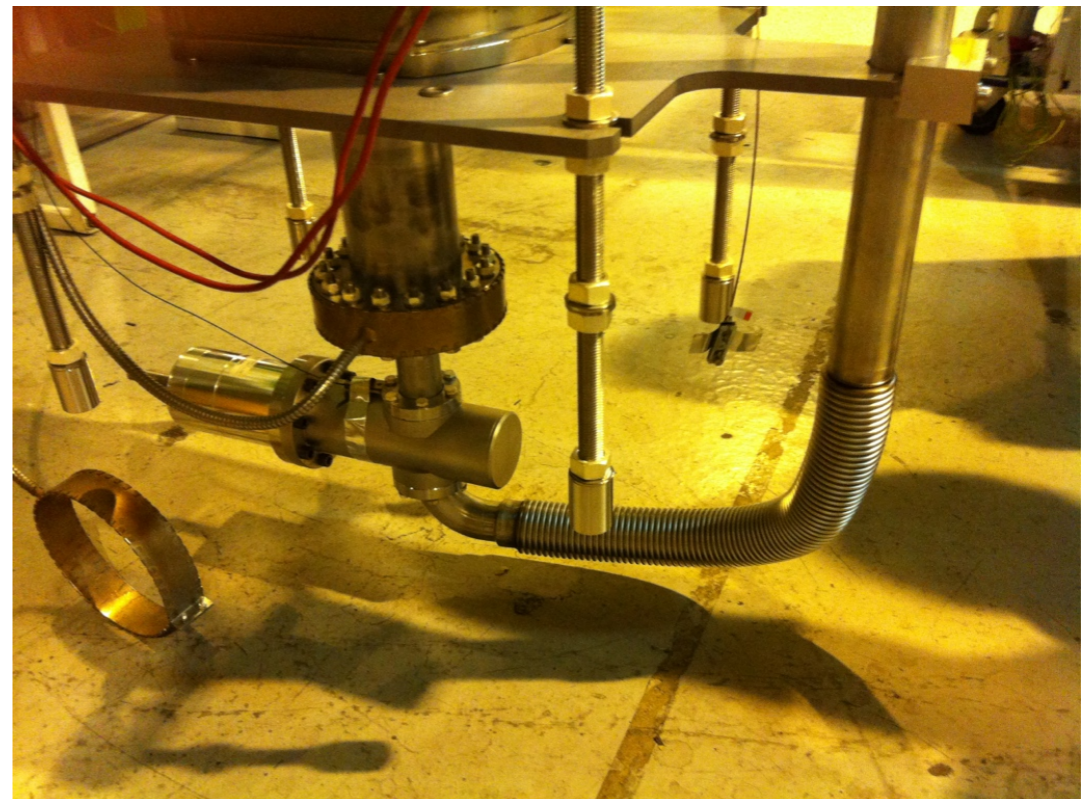
Temperature monitors

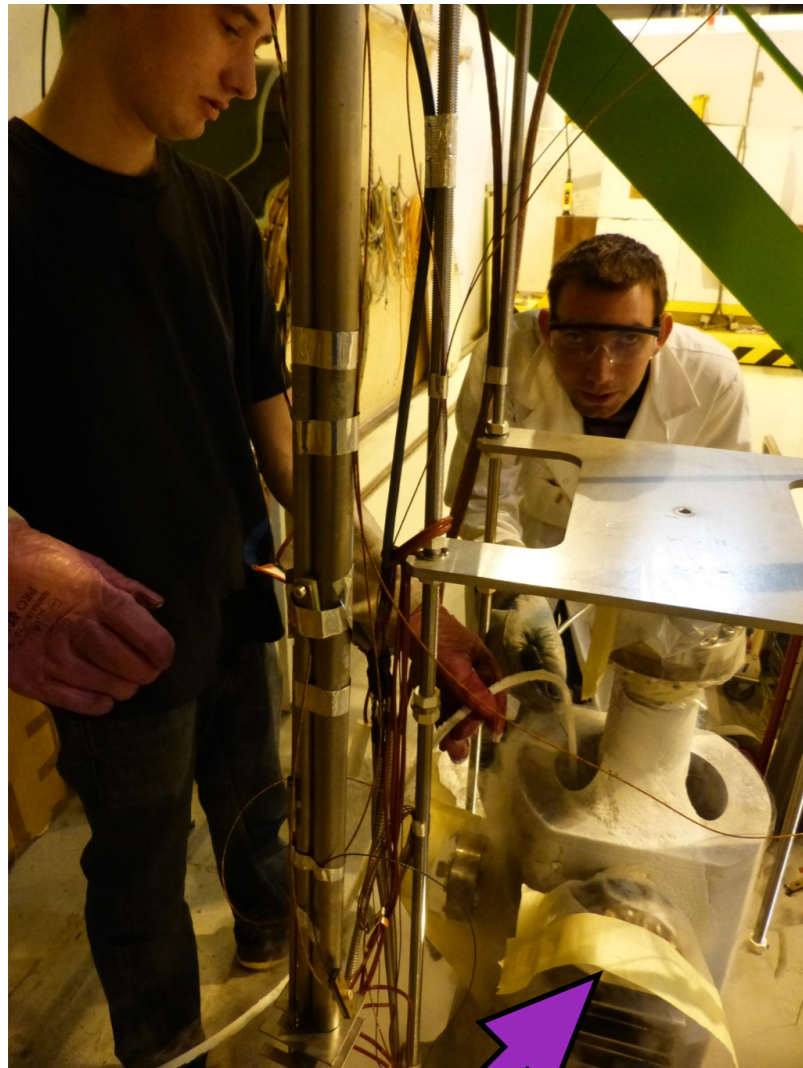
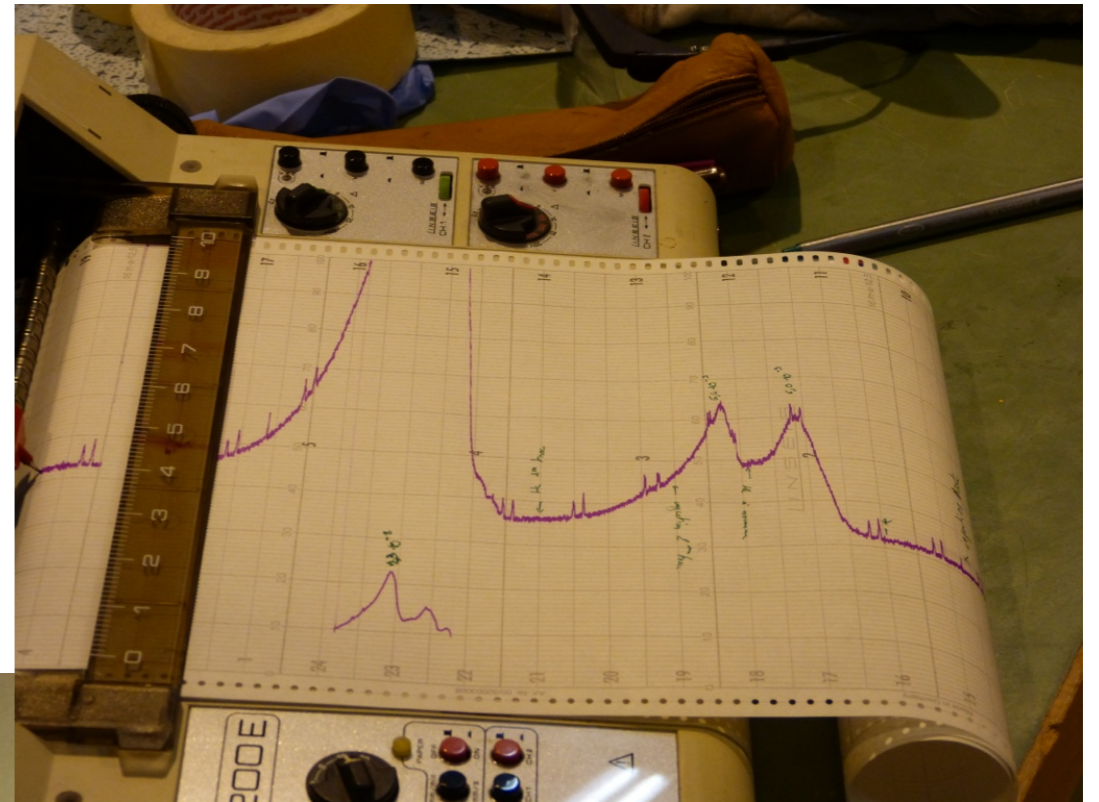
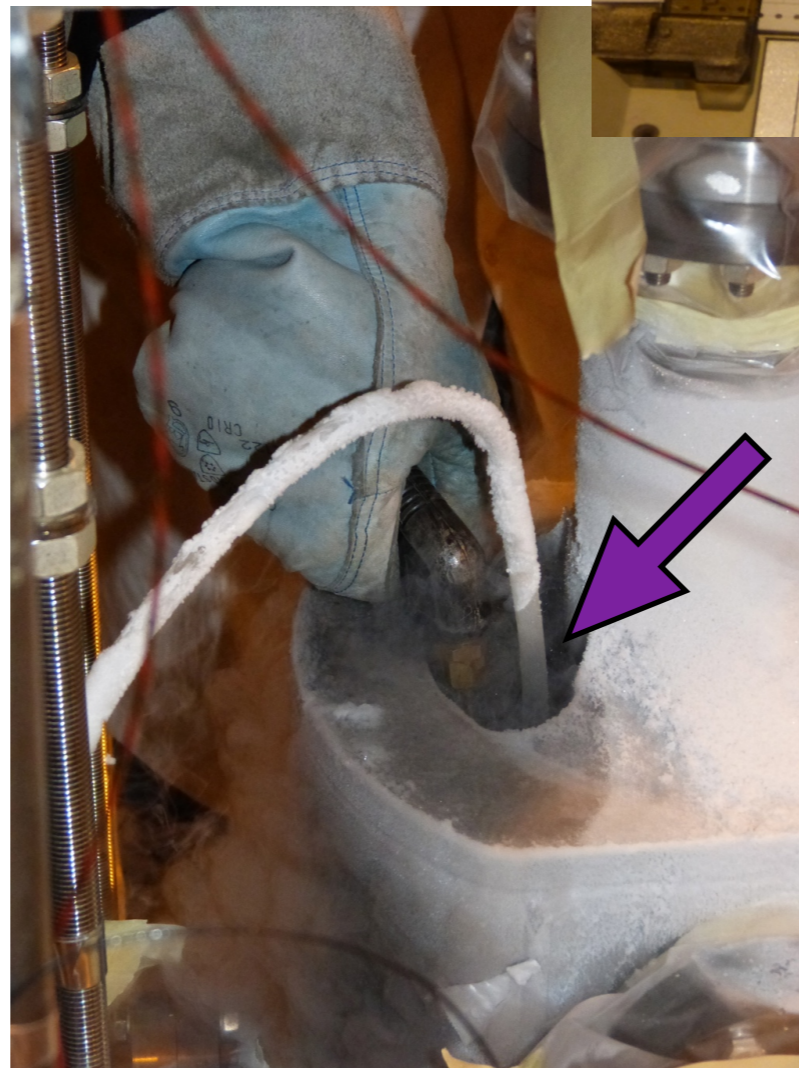
Leak tests:
