## **MICE CC Test Status**

Ruben Carcagno 11/06/13

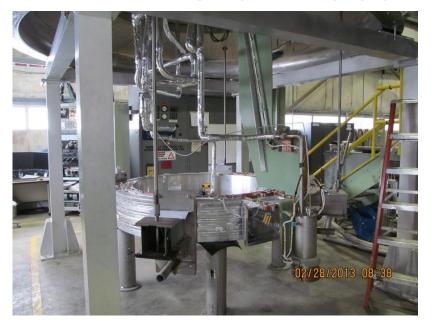
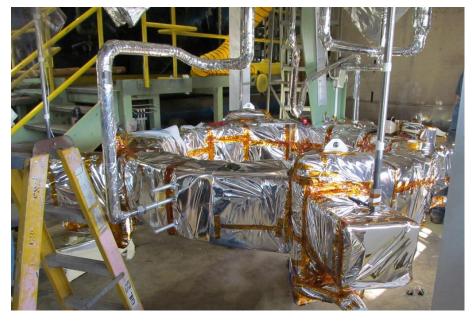
# Cold Mass MLI Installation

- Cold Mass MLI
    - Compressed MLI at some points, wrapping too tight in general
    - Possibility of trapped gasses in MLI blankets (no exposed edges, poor venting provisions), resulting in poor vacuum within the MLI blankets

- MLI thermal shorts
    - Exposed cold sections of support rods
  - Vacuum vessel MLI
    - Thermally shorted by metal grommets used to support it (came already this way with the cryostat)

- Best solution would be to add a full coverage thermal shield to the test cryostat, but this solution is costly and long lead
- Calculations show that if the cold mass MLI is installed properly, it should be adequate to keep the cold mass heat load below 15 W
- The plan will focus in improving the MLI cold mass performance and providing some margin for installation errors by adding mechanical support thermal intercepts and increasing the number of layers

- Spiral wrap cold mass with no more than 5 layers at a time to avoid thermal shorts
- Increase the total number of layers from 40 to 60
- Loosely wrap MLI around cold mass and supports
- Provide adequate venting (e.g. open edges, good communication to insulating vacuum, stitched taping, etc.)
- Install MLI on cold sections of supports
- Frequent inspection by subject matter experts during MLI installation

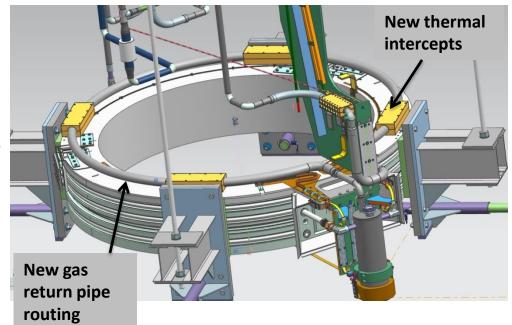
- Cold mass MLI has been removed
- Detailed design on the thermal intercept and cold mass MLI wrapping is proceeding
  - Cost and schedule will be available once detailed design is complete
    - Expect to test again before end of the year
  - Trying to avoid complexity and long lead items
  - Trying to keep cost down
- Work already started on relocation of turbo pump, instrumentation, etc.
- Have obtained quotes from vendors (Meyer Tool, Aerospace Fabrication) for MLI installation and customcutting.
  - Expensive, long lead time
  - Recommend to proceed in-house
