Almost 40 years of operation with tetrodes in the CERN-SPS

CWRF workshop 2014, Trieste

Eric Montesinos, CERN-RF, on behalf of RF-SPS team

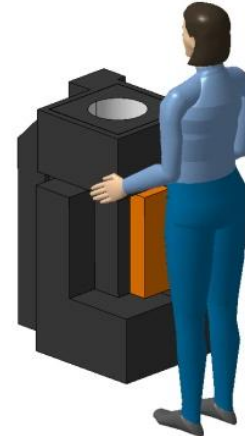
1978
prototype Philips Amplifier
YL1530 tetrode
35 kW CW @ 200.2 MHz

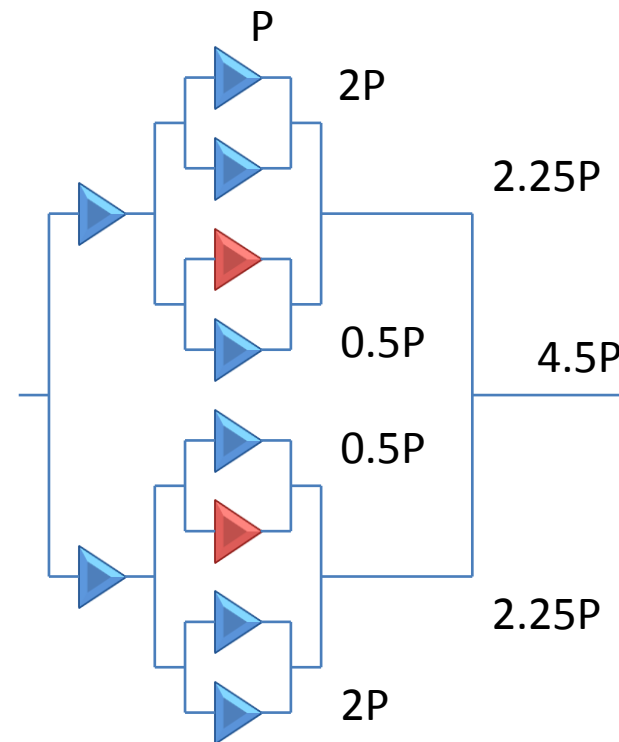
In normal operation, one tube delivers $600 \text{ kW} / 8 = 75 \text{ kW}$

Systems have been designed (1976) to deliver full voltage into the cavity even with $3/4 + 3/4$ tubes

In case of two tubes 'OFF Line', remaining tubes shall deliver $75 \text{ kW} \times (8/6)^2 = 133 \text{ kW}$

RS2004 tubes are rated 137.5 kW , just ok

$$P_{out \text{ 3dBCombiner}} = (A+B)/2 + \text{SQRT}(A.B)$$

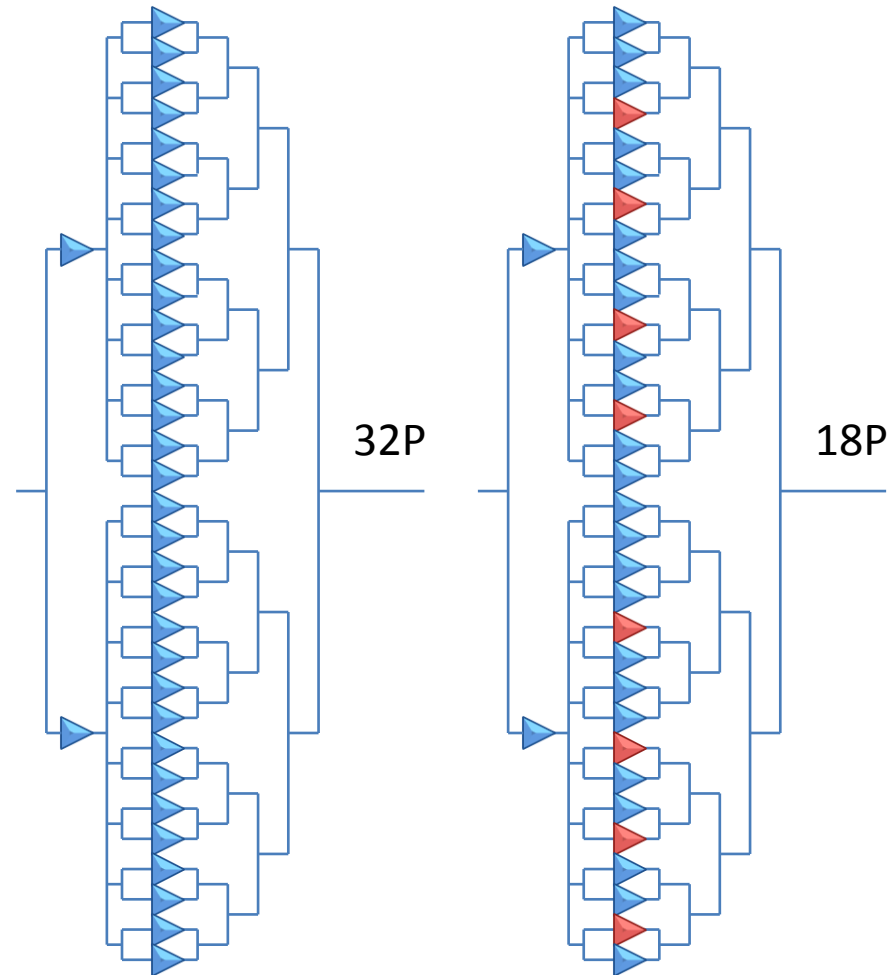
The same philosophy applies to Philips amplifiers, in normal operation, one tube delivers 600 kW / 32 (+ 3 dB combiner losses) = 20 kW

In case of 2 x 4 tubes 'OFF Line', remaining tubes shall deliver
 $20 \text{ kW} \times (32/24)^2 = 36 \text{ kW}$

YL1530 tubes are rated 37 kW

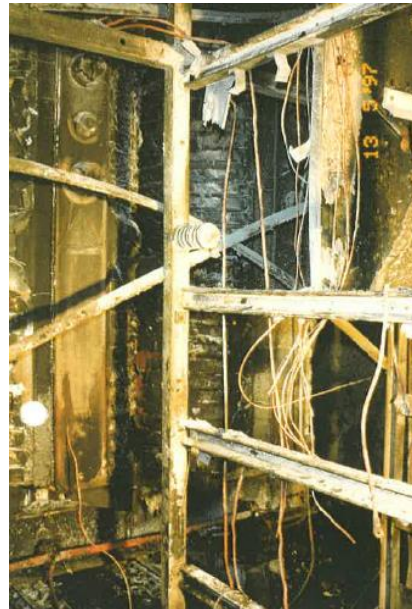
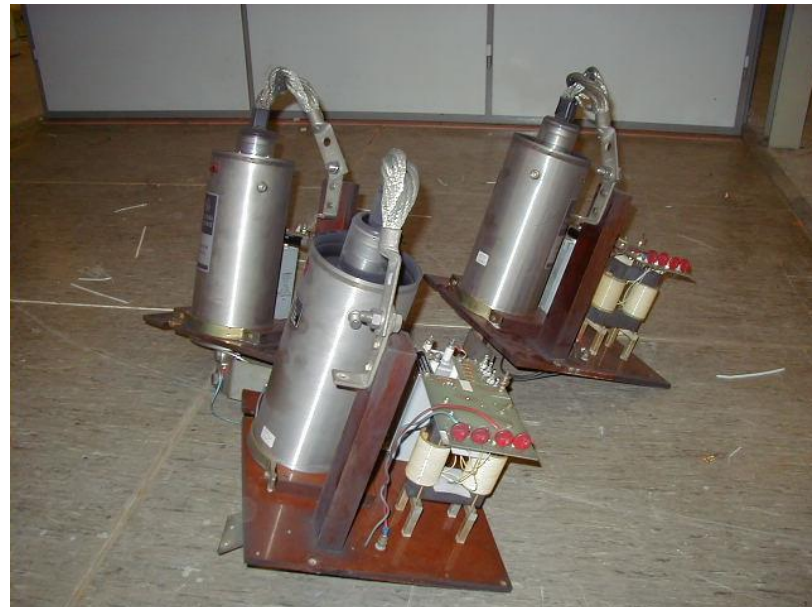
HVPS 18 KV-AC capacitor explosion

Spring 1997, after few weeks of operation, explosion of a HVPS (18 kV-AC capacitor)

Fire in the cubicle

Mercury crowbar system vaporised

SPS stopped for 3 months

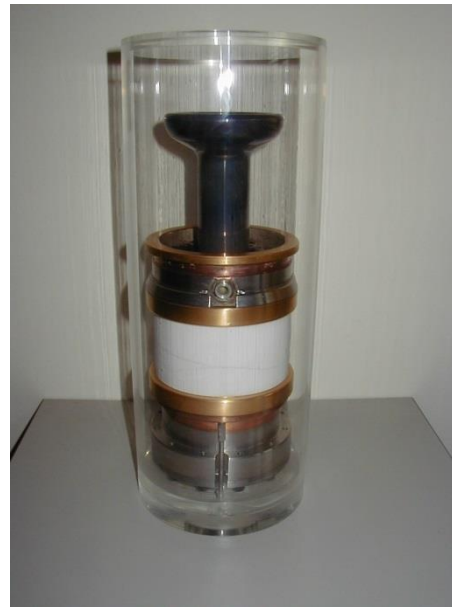
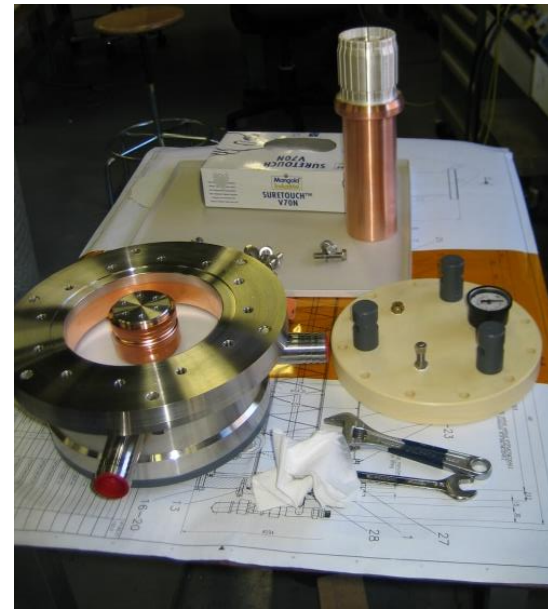
Ceramic failures with the Fundamental Power Couplers

- 1994
- 1998
- 1999

We made a new design, more powerful, based on a Thales klystron disk window, still in operation

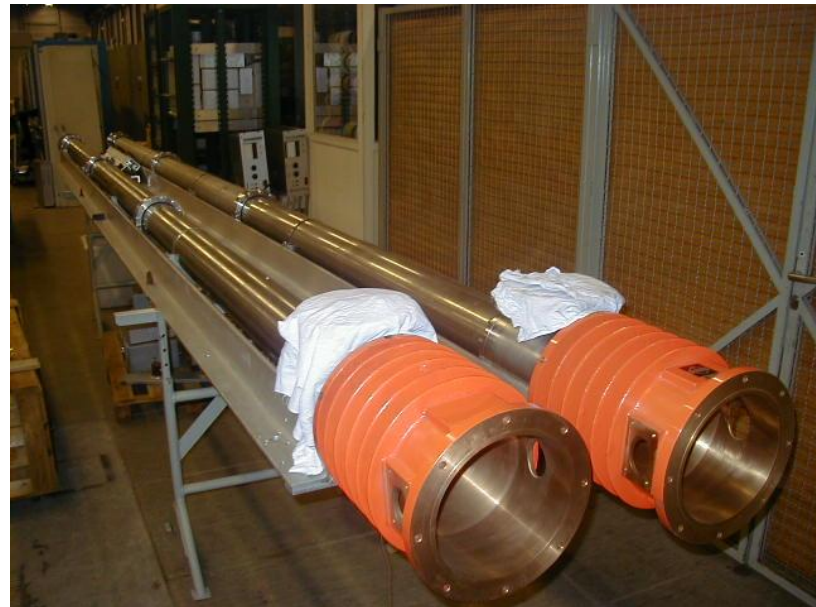
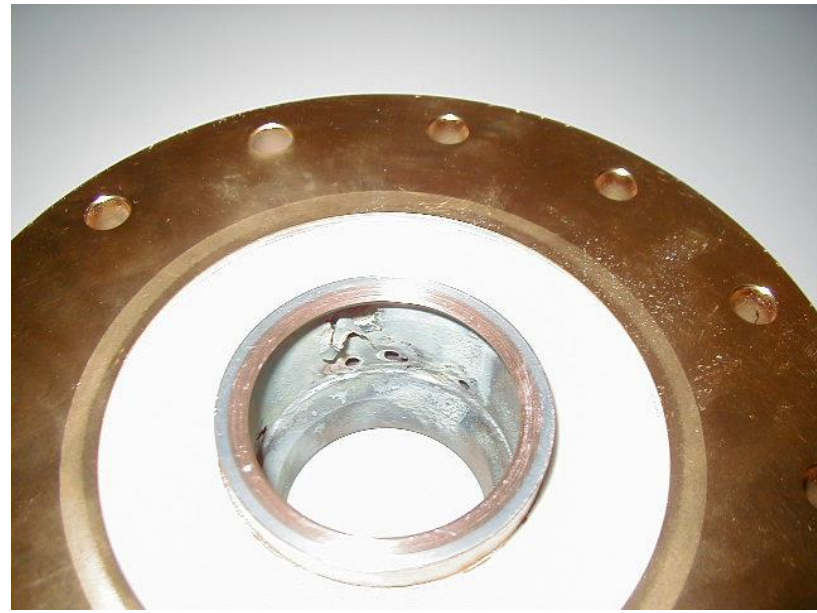
Power load window failure

After 20 years of operation, we had three failures with the window of our power loads

- First one on the Siemens amplifier (1998)

- Two on the cavities (1999)

We made a new design, without a molybdenum junction, thanks to new brazing possibilities

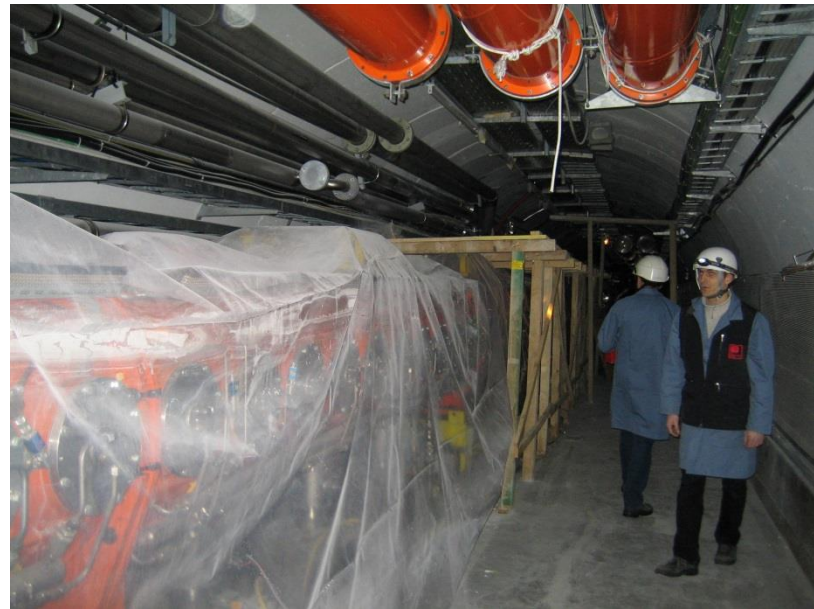
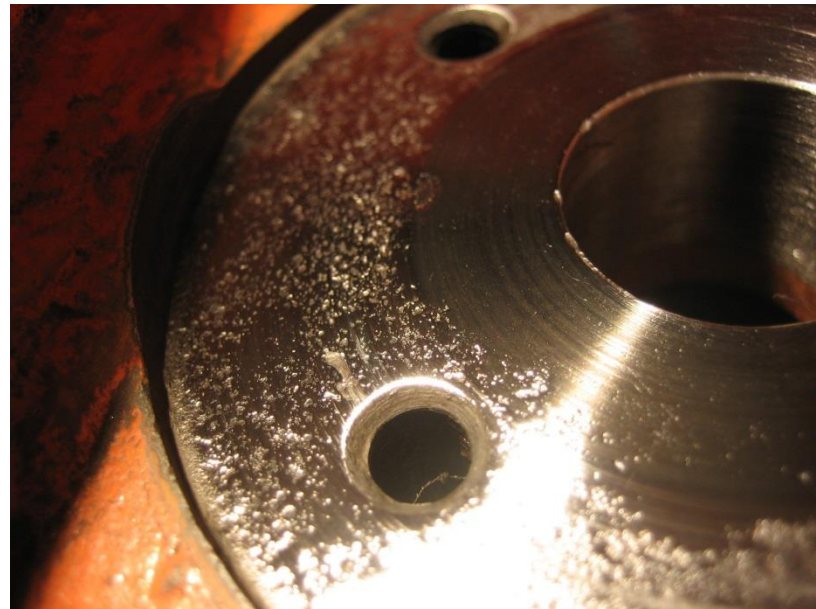
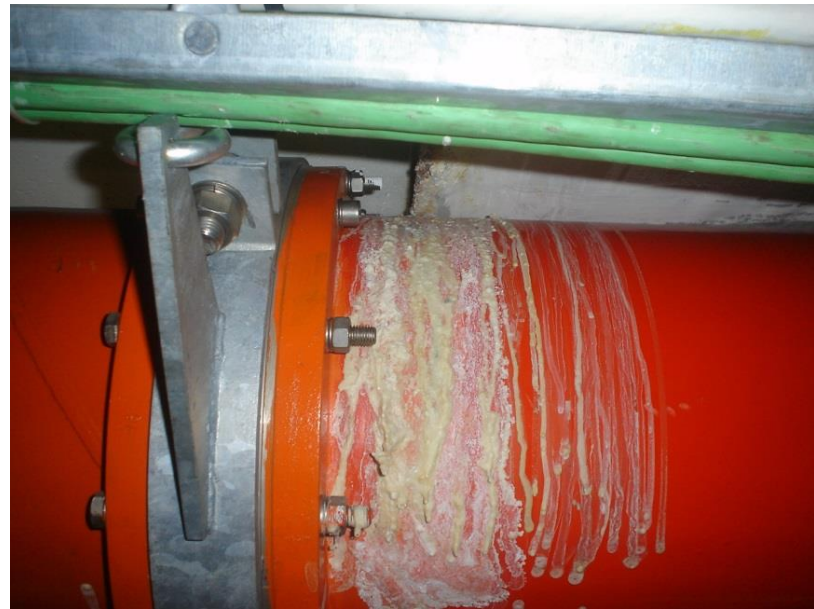
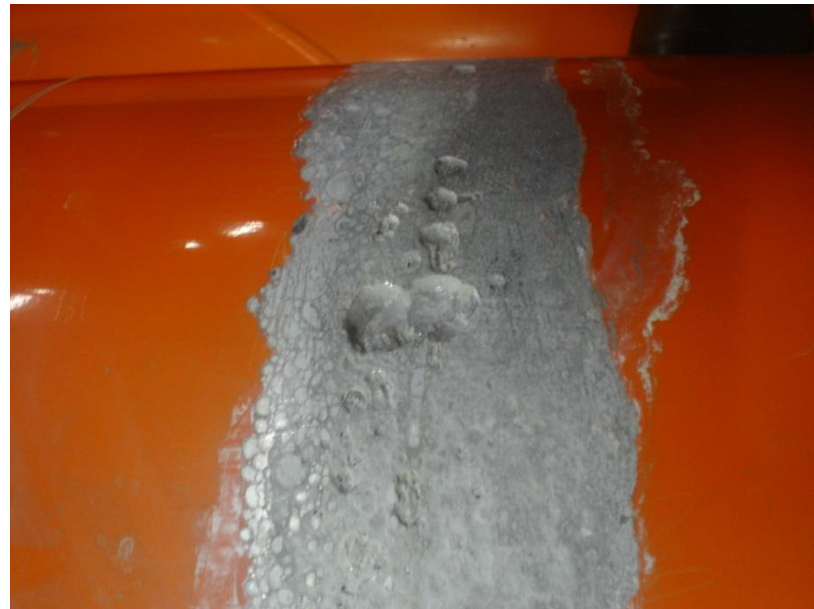
Near miss coaxial lines

During the 2005 one year shutdown, we had to repair the vault above the cavity#2 (water infiltration)

Some of the vacuum seals on the cavity were damaged

The coaxial lines were about to be perforated

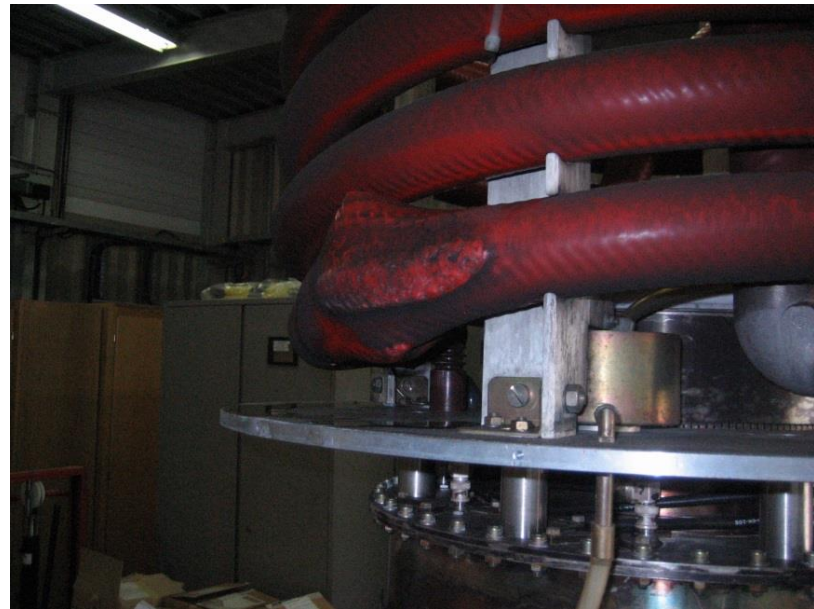
Crowbar/water pipe

Two faults with the same symptoms

New GTO crowbar system unstable (10 kV)

A water pipe intermittently arcing between HVDC and GND triggering the crowbar

It took us a long time to fix these, explanation for bad statistics during 2008 to 2010

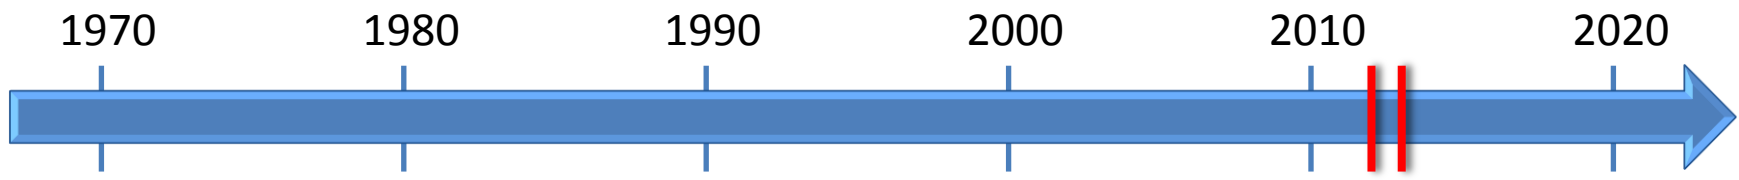
HVPS Transformer failure

We had two majors faults with the HV transformers

2012 near miss

one connection of the coil started to burn

Transformers have a lifetime and replacement must be correctly scheduled on old machines

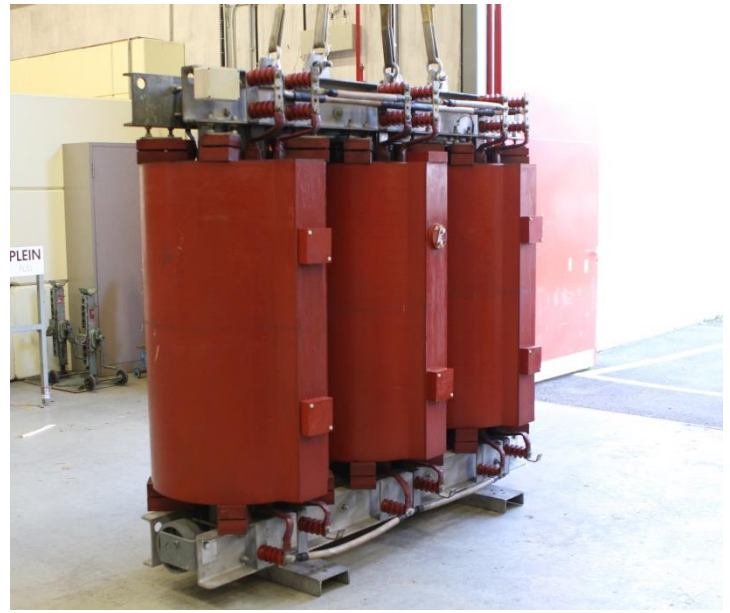
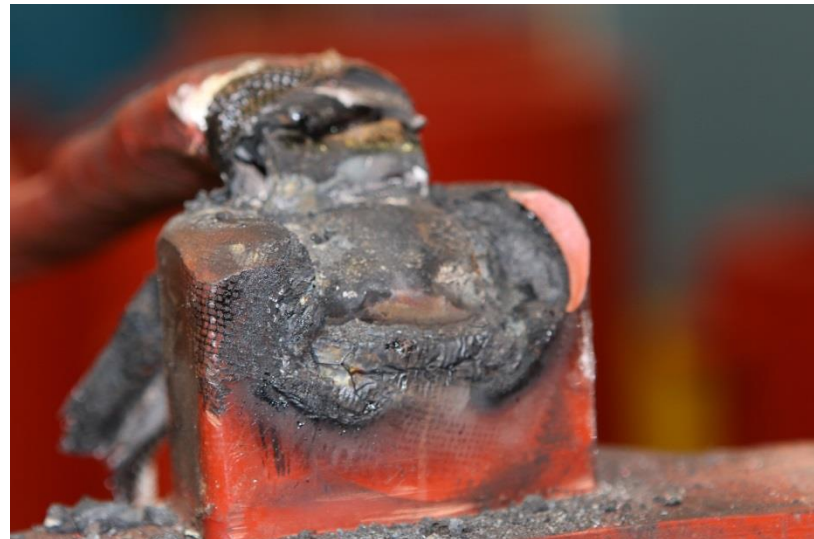
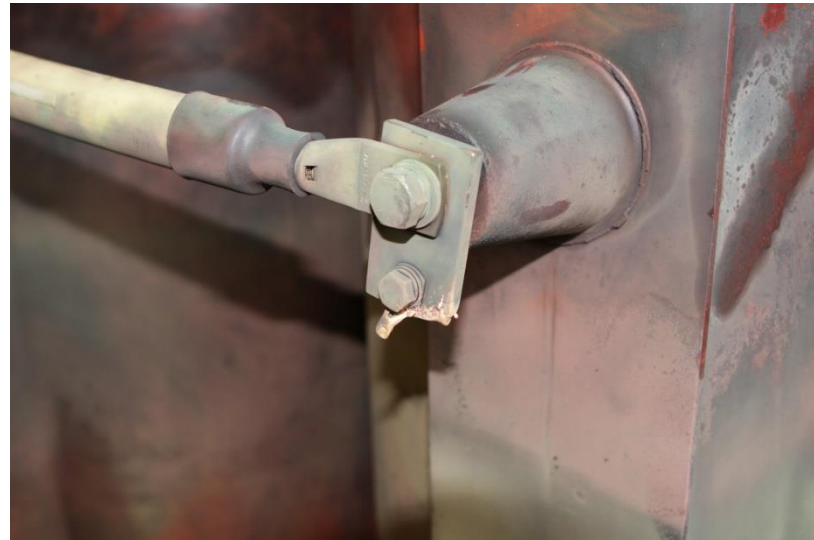
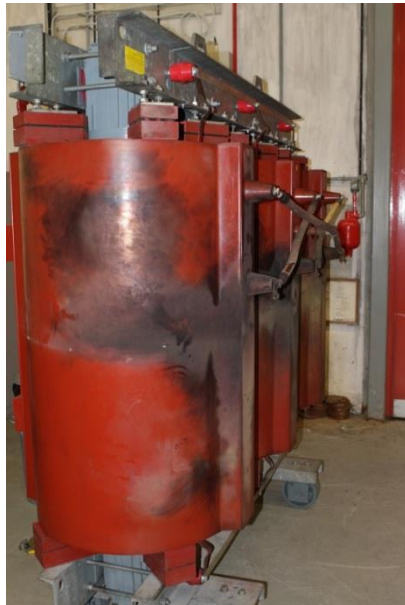
2013

Measuring cable connection broke and 18 kVAC accidentally touched GND

We exchange the transformer before any accident

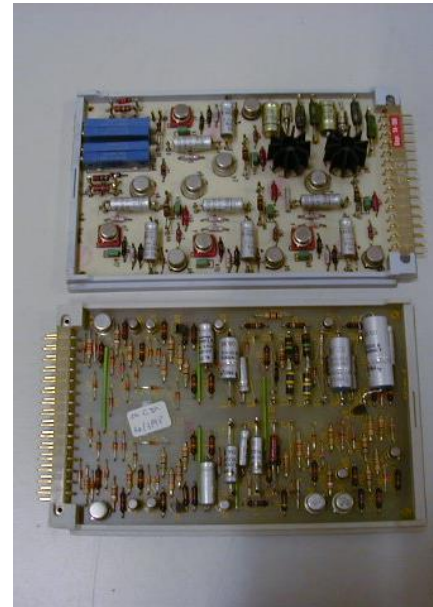
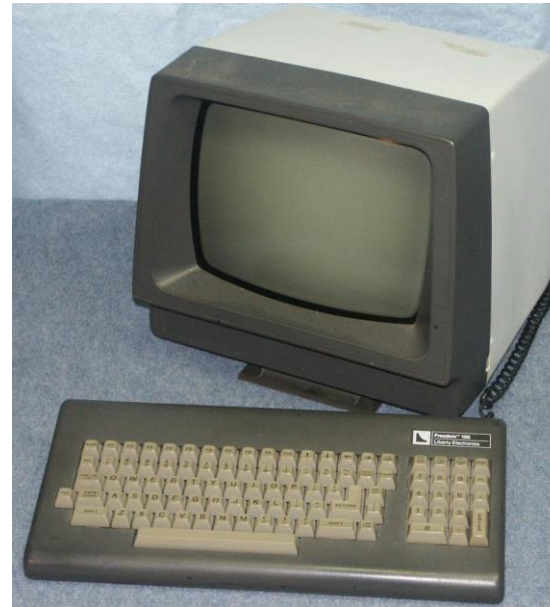
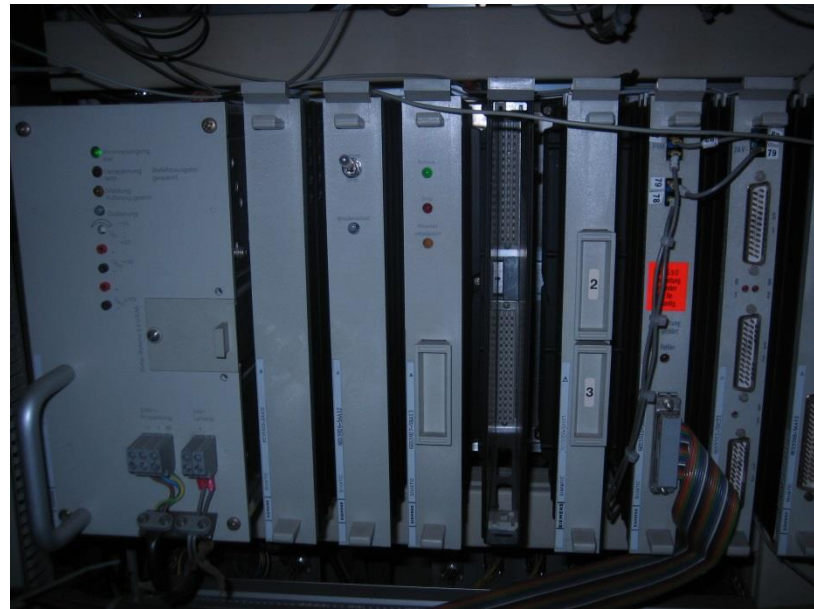
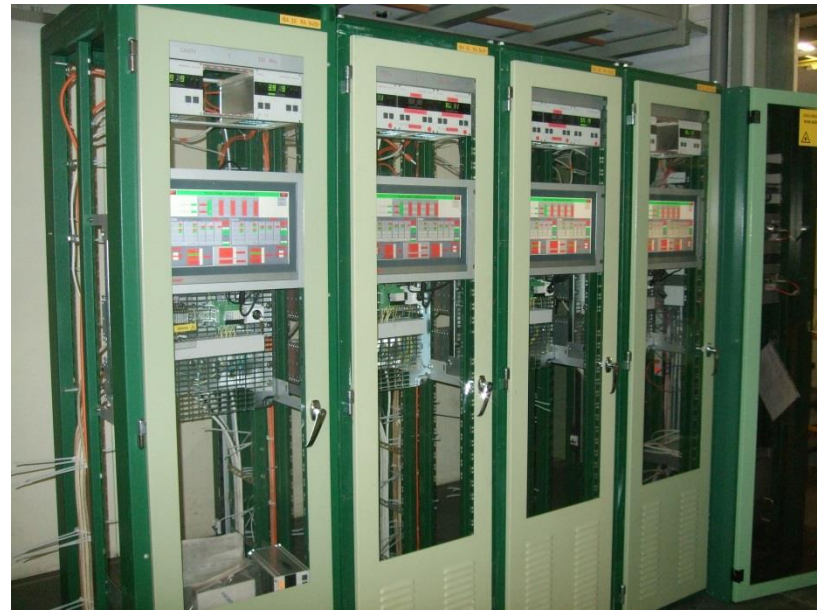
Local/Remote control

Local electronics are still the same since the beginning, faults are very rare (electricians of the team are able to repair it)

Remote systems had to be upgraded as not robust enough (specialists needed)

1970-1991	Nodal
1991-2013	Siemens S5
2014-...	Beckoff

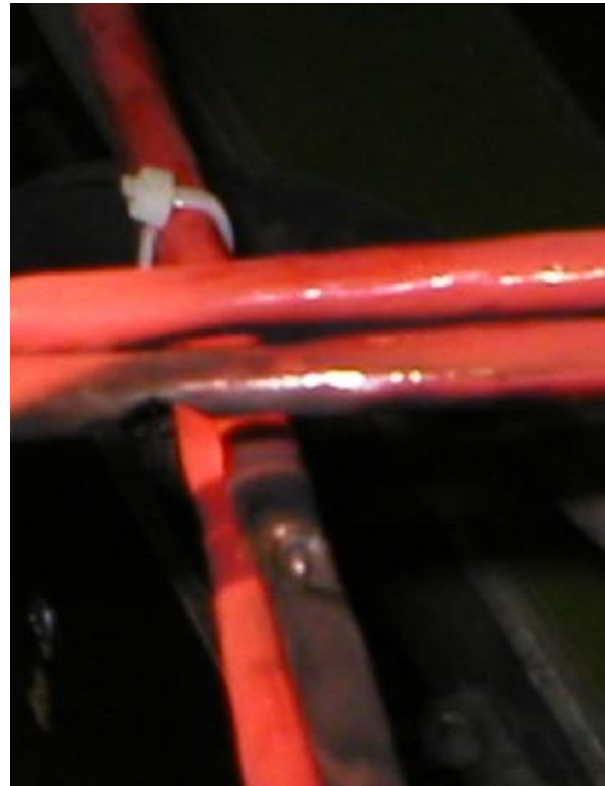
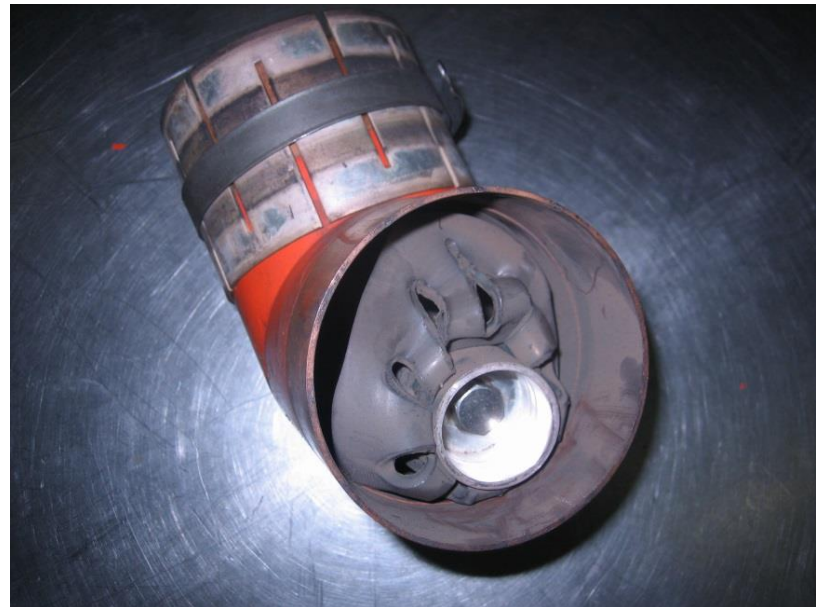
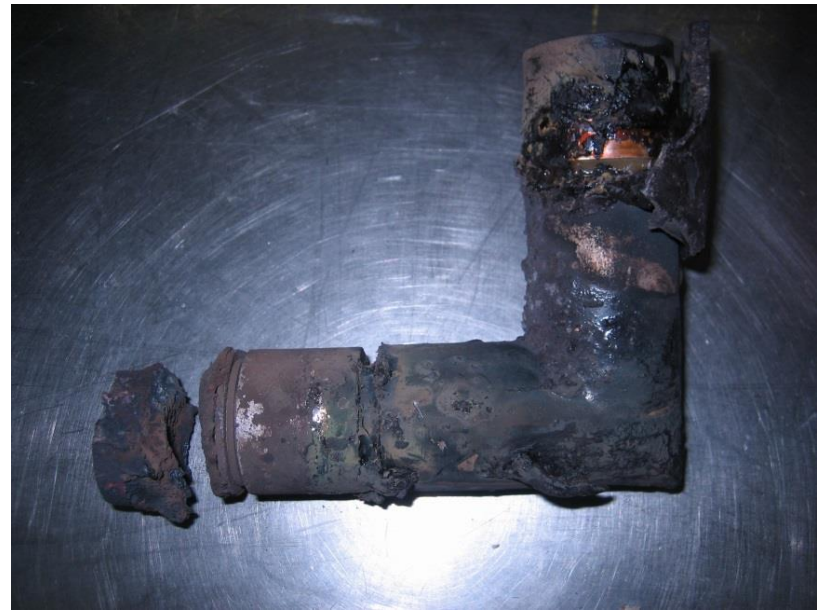
Miscellaneous

We had several troubles
with usual suspects

- HV wiring

- High Power transmission line
connections
