Carbon Fiber Laminates: Non destructive testing and inspection

Presented by Eric Anderssen
Lawrence Berkeley National Lab

The ATLAS Phase-II Silicon Strip Stave

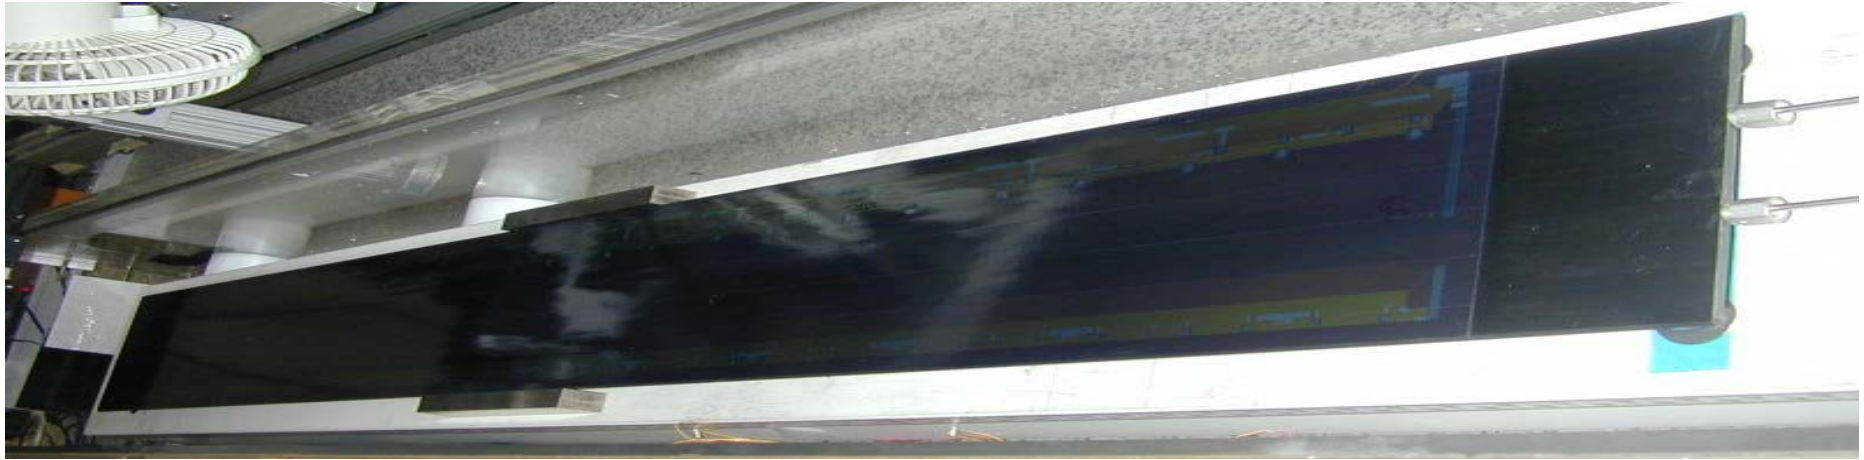
A full size stave

The stave is a supporting structure where the modules are mounted. It also provides data and power transmission between modules and End-Of-Stave (EOS) electronics by way of a co-cured flexible cable. Typical dimensions 1300 x 130 mm

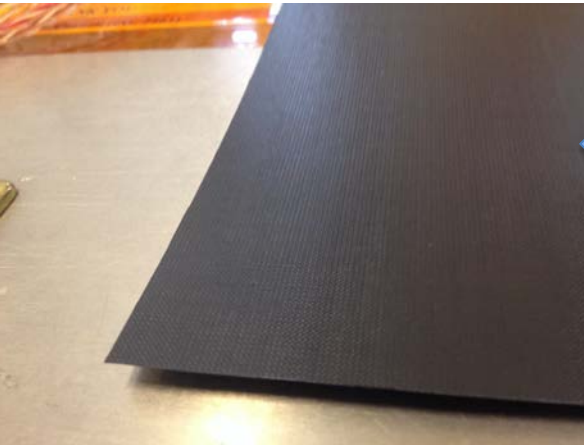
Bus tape: multilayers of kapton, copper, and glue that are co-cured

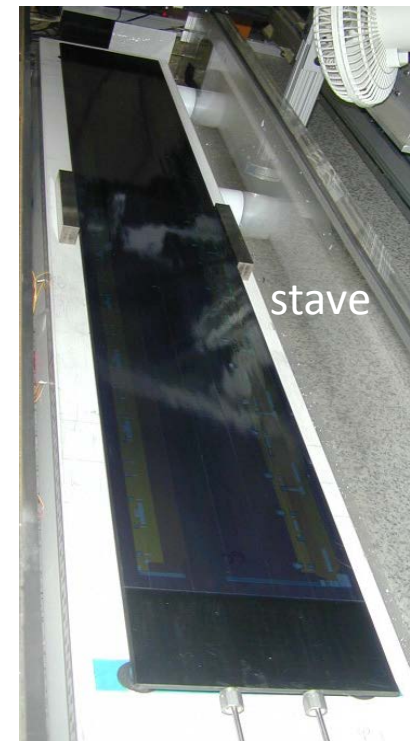
Carbon fiber facing: three layers of carbon fiber that are laminated

Titanium cooling pipes
High thermal conductive foam

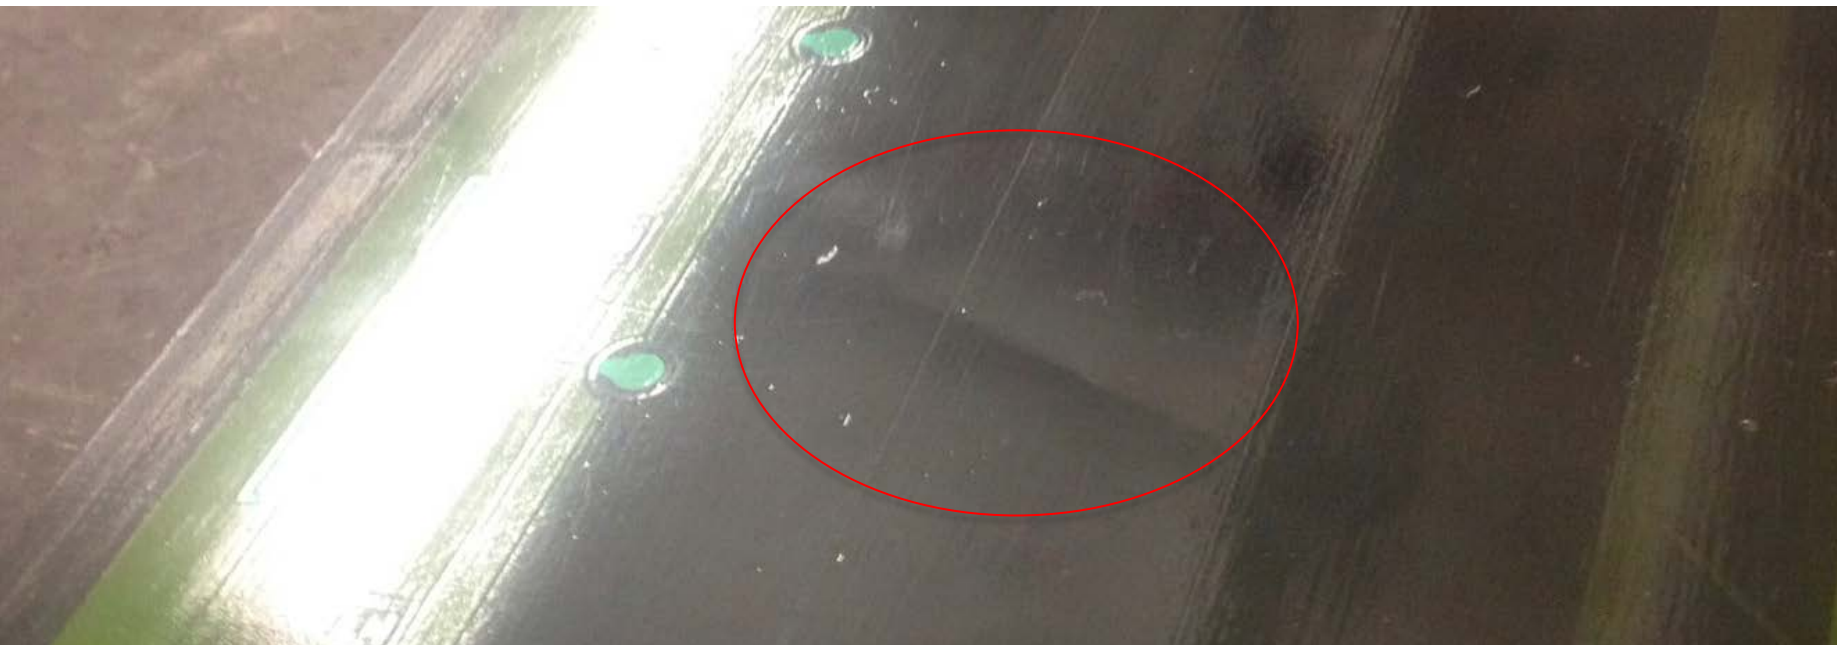
Example of defects on the stave

A defect found on the full size serial power stave.

Distance between HV contacts on the stave for two adjacent modules

This particular defect was believed to exist on the laminated facing but made its way to the stave.

Defects like this speak of the necessity of building a quality control system.

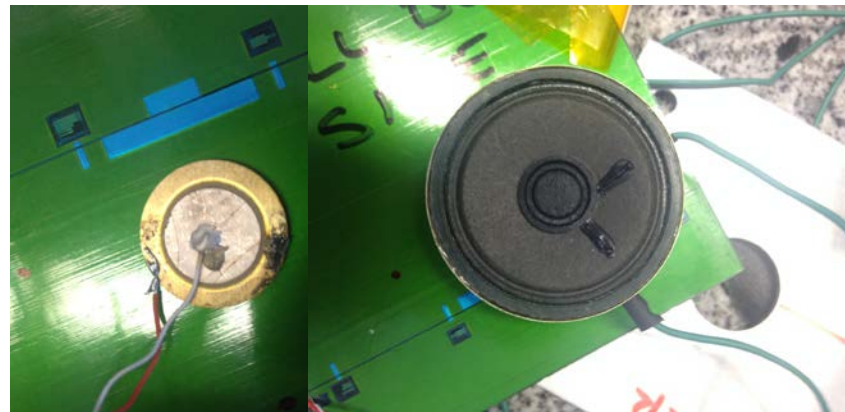
Concept of the acoustic detection system

Laser Displacement measurement device. $\sim 0.5 \mu\text{m}$ precision.
Later will upgrade to a confocal microscope with nm precision.

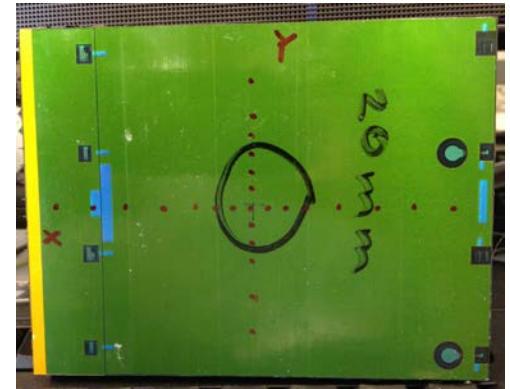
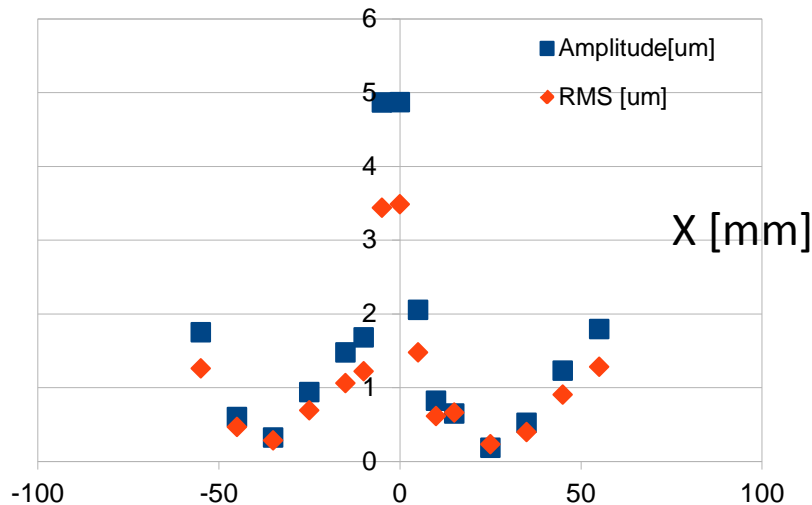
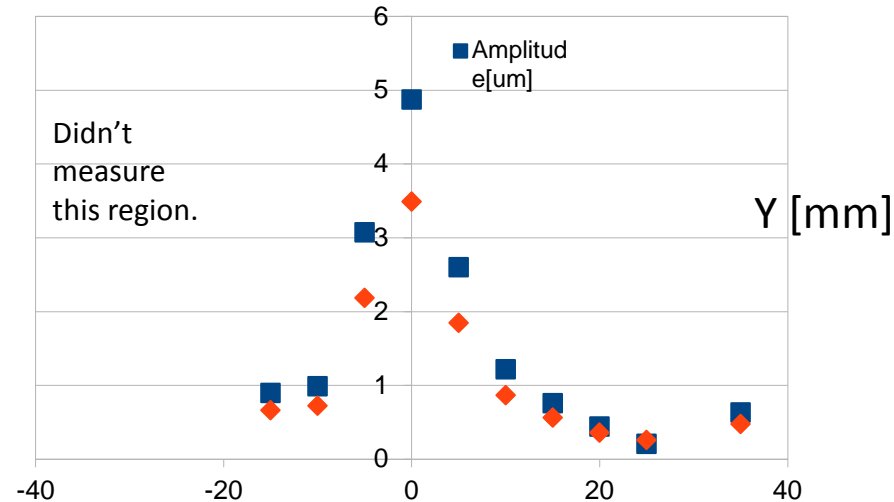
Measurement from Sample 1 (20mm)

- Point the laser to the center of defect and tune the frequency to find the maximum displacement.
- Use this “resonant frequency” as input, scan the surface of the stave sample.
- Resonant frequency found at ~ 7500 Hz
- Edge effects due to lack of closout

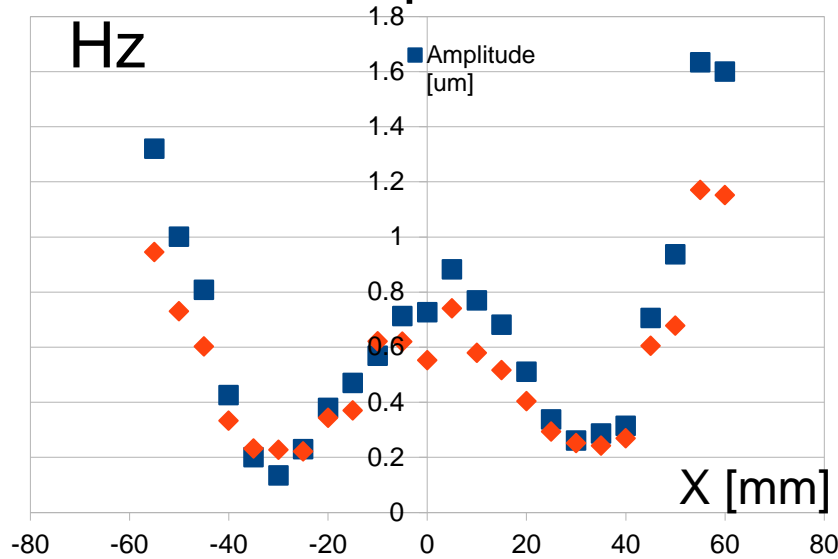
10 mm sample at ~7500

- Similar results were found.

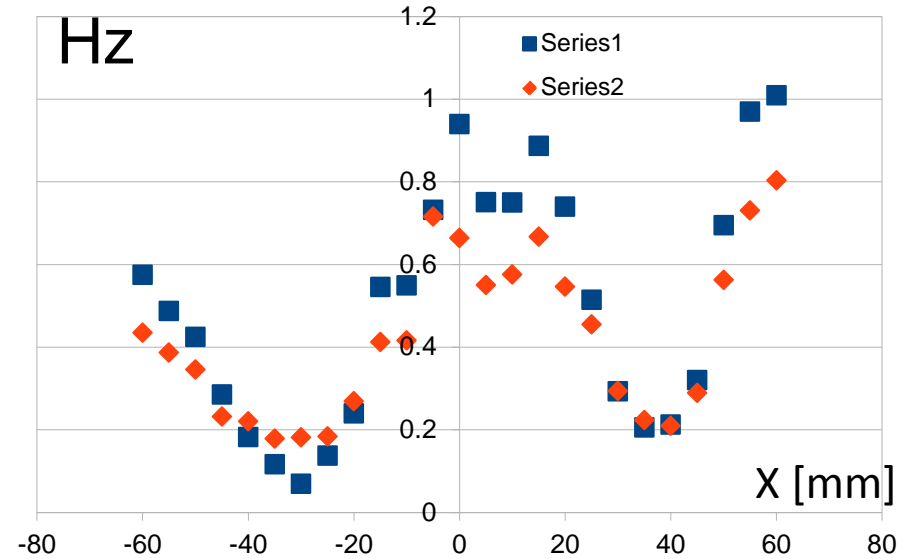
5 mm sample at ~8500

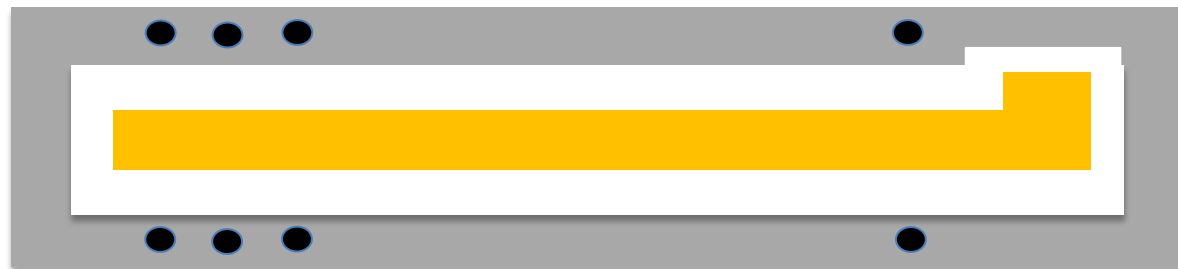
Design of Large Inspection Station

- The methods show sufficient promise that we are scaling them up to a full sized system.
- Once tapes are co-cured they need to be measured flat as well.
- A Stave frame: a tool to hold facings and staves
 - Local fiducials near each sensor to establish ref.
 - Vacuum base has peizo array built in for optional vibration
- Probe Set
 - Video camera for alignment and inspection/doc
 - Line scan for high speed metrology and trace inspection
 - Confocal for precision depth profiles and vibration measurements for defect finding
 - Laser for fast profiling and defect finding

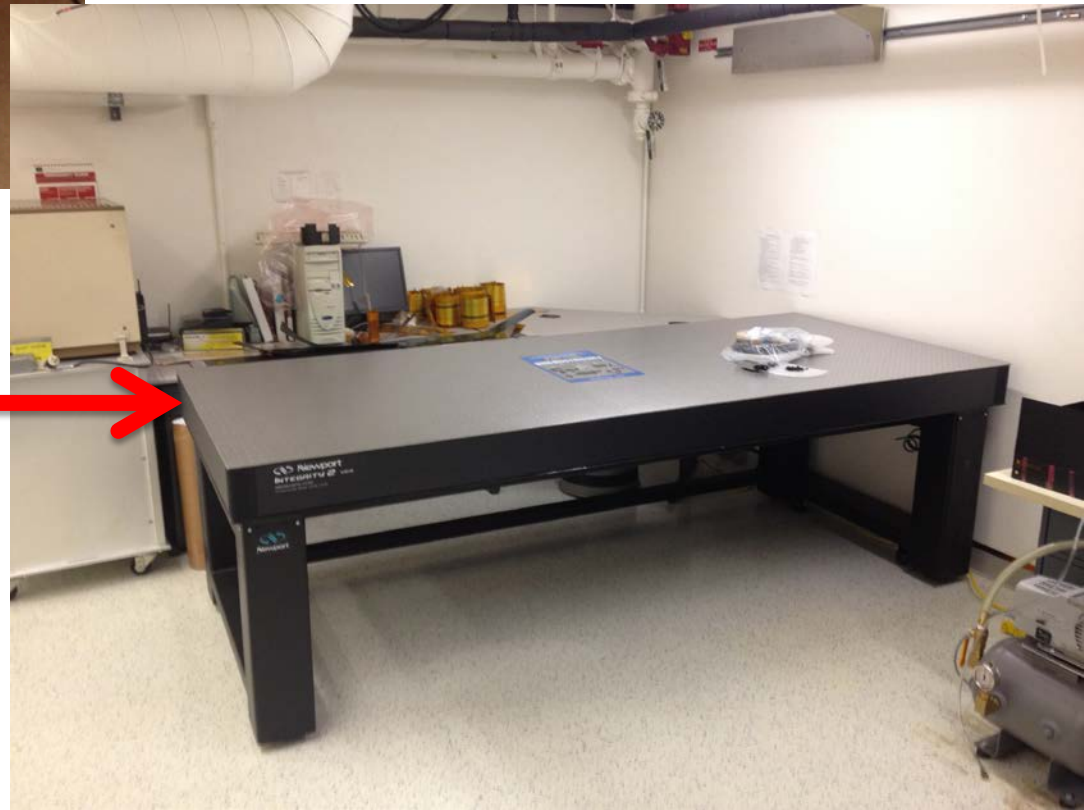
A 1.5 m long stage where the inspection system will be mounted.

An optical table that will host the stage and the inspection system.
