# BEAM INCIDENT: TT40 TRANSFER LINE AT THE SPS

USPAS Newport Beach 5-14 Nov 2014

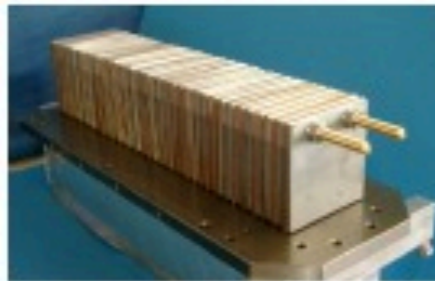
The knowledge of the accelerator equipment damage limit is of importance. Test result at 450 GeV with LHC beam:

Intensity	# protons	Comments
A	1.2e12	No effect
B	2.4e12	Decolouration
C	4.8e12	Melting
D	7.2e12	Fragment ejection

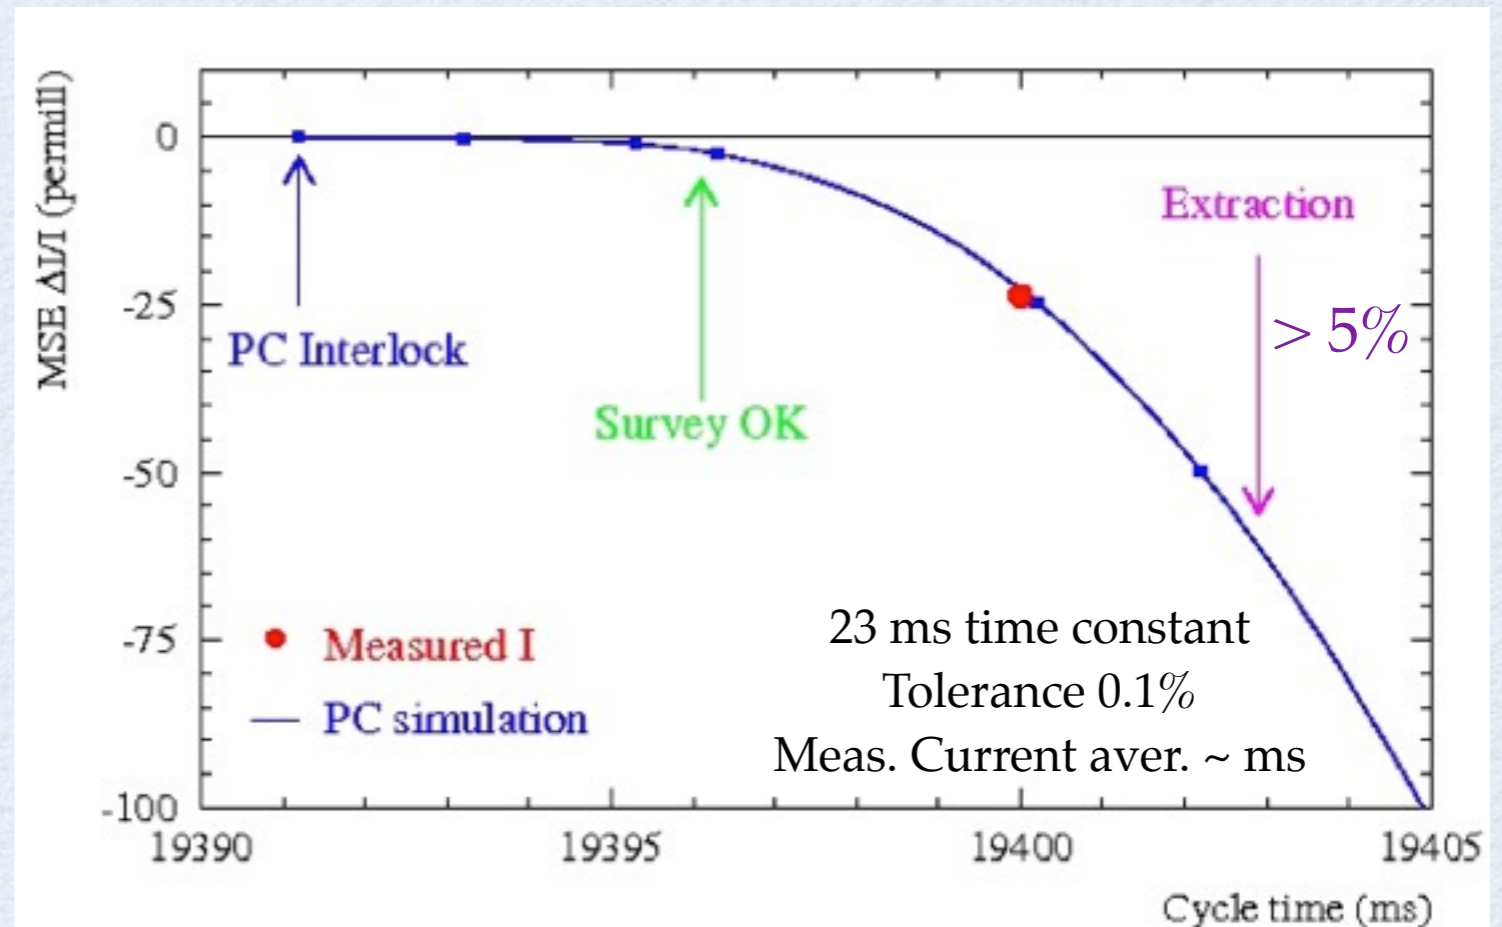
- Some temperature probes on the septum where triggering the beam interlock due to induce e.m. noise from the high intensity beam.
- It was decided to mask these signals in the PLC (controller of the septum). It was (mistakable) though that we would be protected by the interlock the surveillance of the septum current.
- At the next extraction the PLC generated an interlock that switch off the septum, but as the current is going down slowly the surveillance did not pick-up this change and extraction was not inhibit.
- By the time the beam pass through the septum, the current was 5% of the nominal value, not sufficient to extract the beam and hit the quad after the septum.

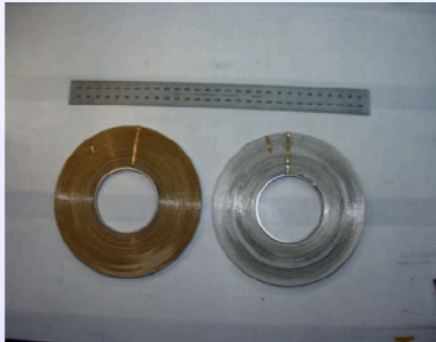
Two double pancake NMR coils, one with kapton insulation and the other with stainless steel.
