**JRC-CERN Collaboration Workshop  
27 January 2014, CERN**

# **Material and Surface Characterisation, Materials in Aggressive Environments**

Stefano Sgobba  
EN-MME-MM

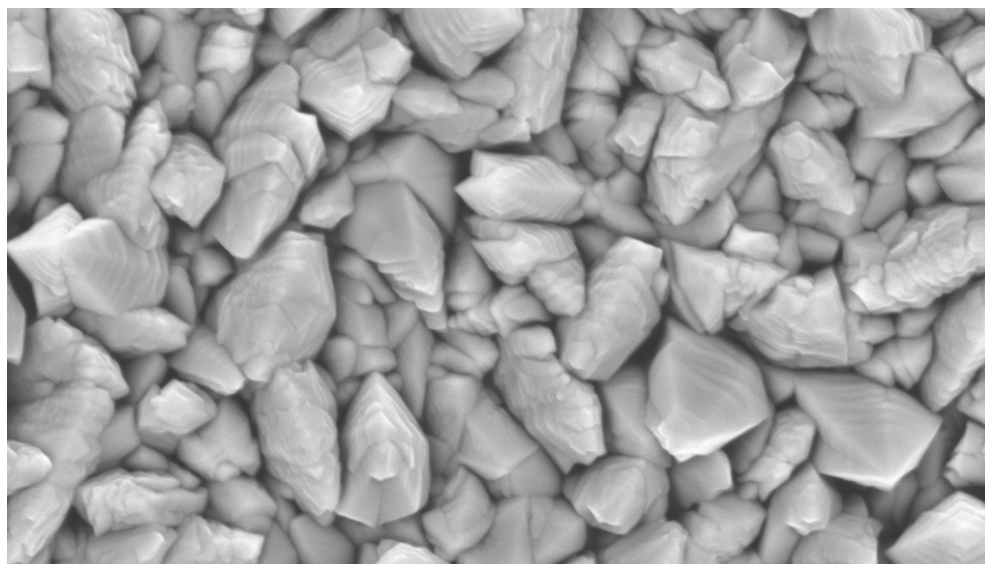
**Morphology of a Nb coating on Cu structure, original magnification 50000 x**

EHT = 5.00 kV WVD = 2.9 mm Signal A = InLens Chamber 190 mm x 500 mm x 265 mm	HIE-ISOLDE cavity Nb coating on Cu Test 43 - Be3 - pt 4	Mag = 50.00 K X Maud Scheubel Date :6 Jul 2011

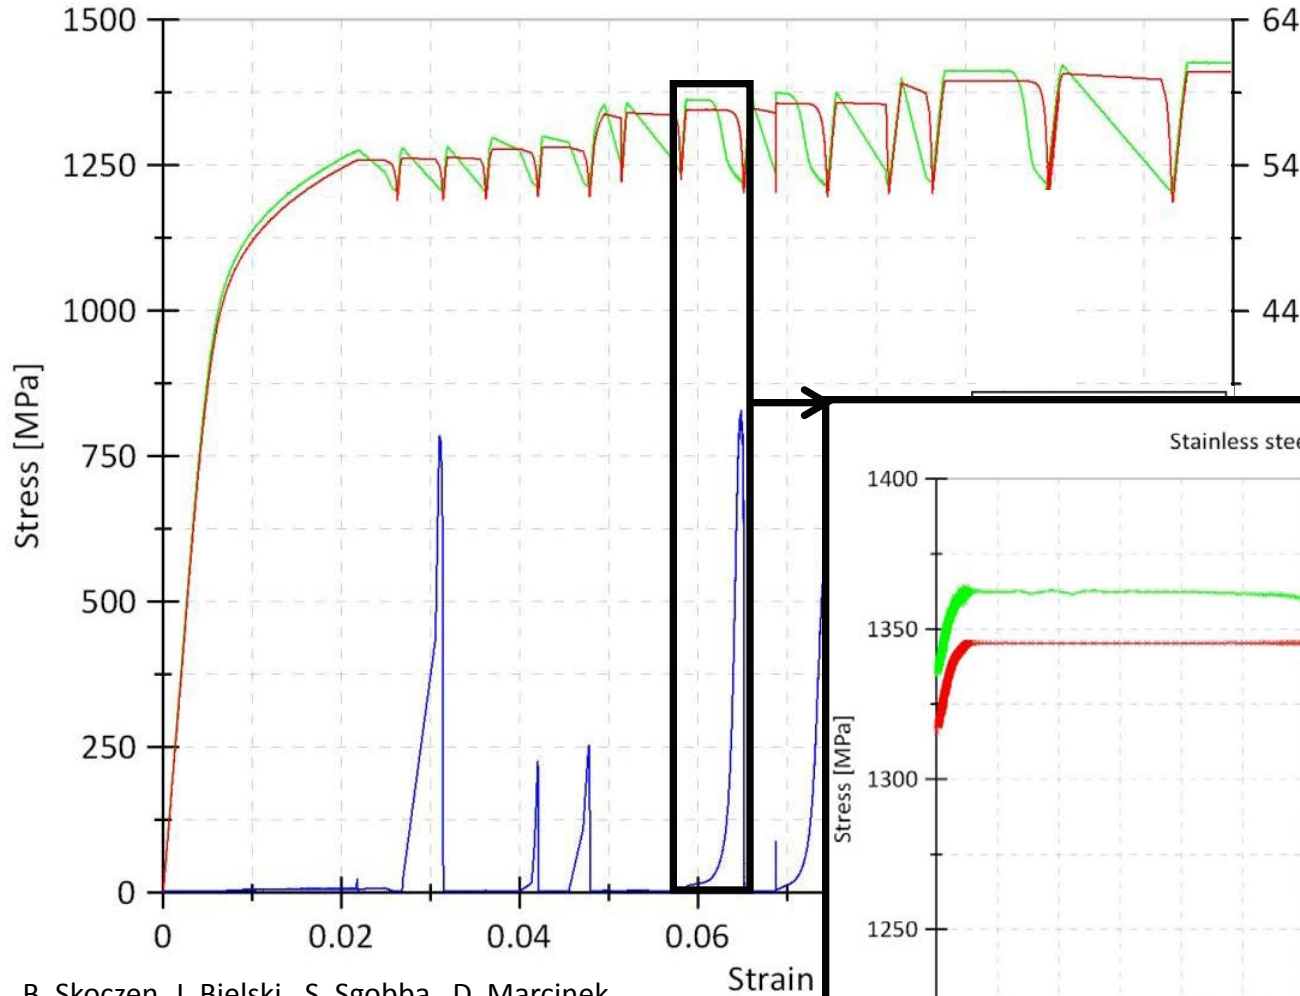
Stainless Steel 316LN - sample 1

D. J. Marcinek, *Experimental Study of Discontinuous Plastic Flow, Phase Transformation and Micro-damage Evolution in Ductile Materials at Cryogenic Temperatures*, Master of Science Thesis, CERN and CUT, 2009

Sampling frequency up to 20 kHz!

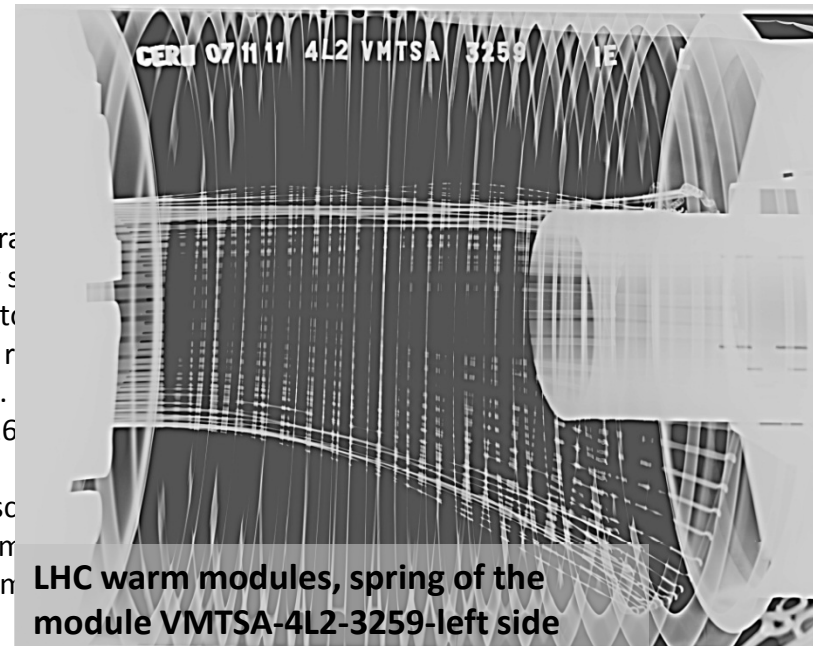
LHC warm modules, spring of the module VMTSA-4L2-3259-left side

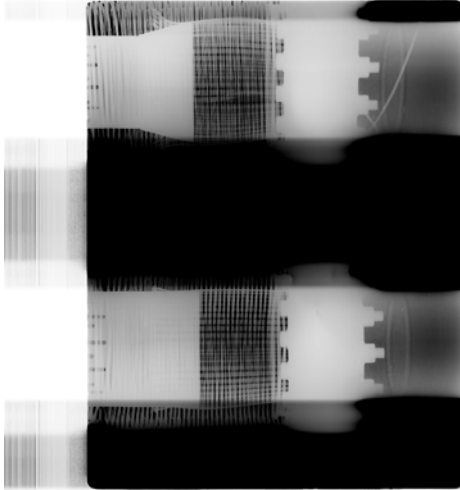
⇐ Computed Radiography Testing (RT) of LSS warm modules. Completion of the radiography campaigns during LHC technical stops. 1767 modules examined, 107 non-conformities identified to be repaired during LS\_1, 46 nights.

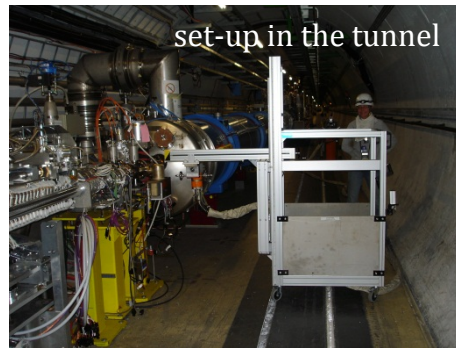
⇓ Computed RT of CMS RF modules

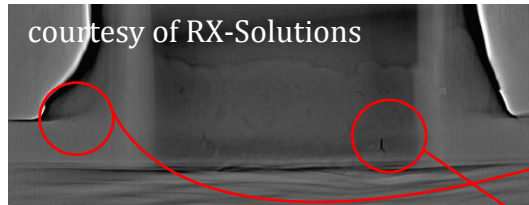
X-Ray tomography of ITER CC He-inlets: thin defects precisely identified and confirmed by metallography

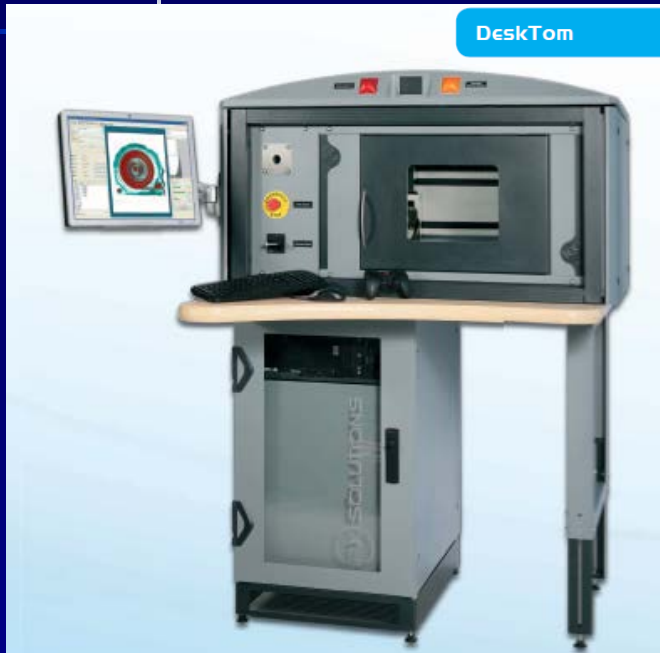
- Specimens placed on a mobile and rotatable stage
- Motorized zoom
- Full inspection of samples up to 240 mm length
- Sealed microfocus source, max. tension 150 kV
- HR area image sensor, 1920 pixels x 1536 pixels
- Detection surface: 200 mm x 250 mm
- 14 bits – 16000 gray levels
- 1-30 images /s

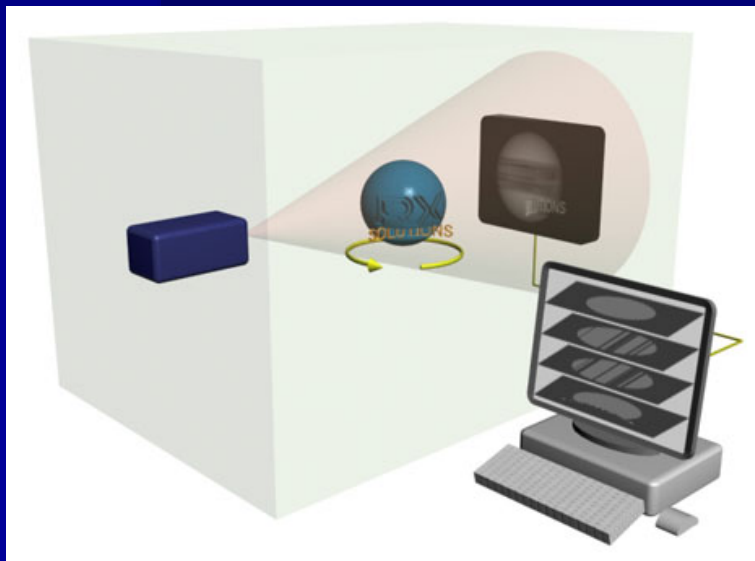
2nd sample of the VPI

11 separate 360° scans were combined to compile a final single 3D object reconstruction while avoiding shadows due to steel conduits

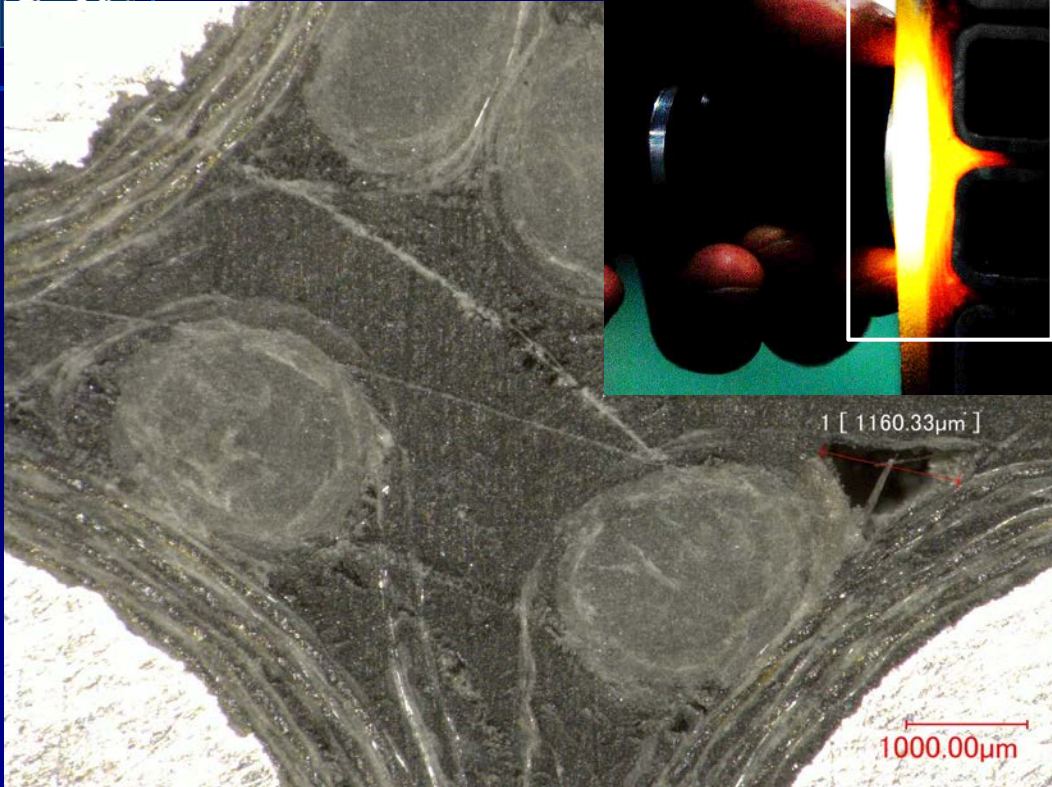
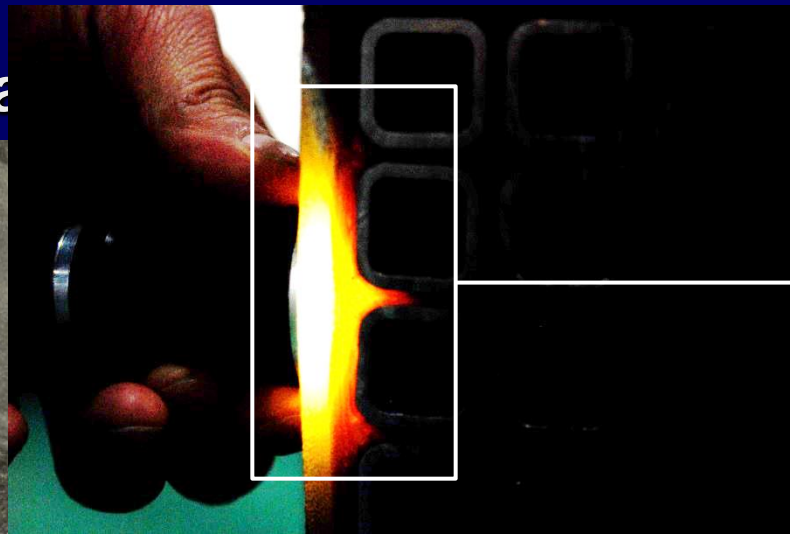
⇐ lack of resin  
in the cross-  
section

areas of pure  
resin ⇒

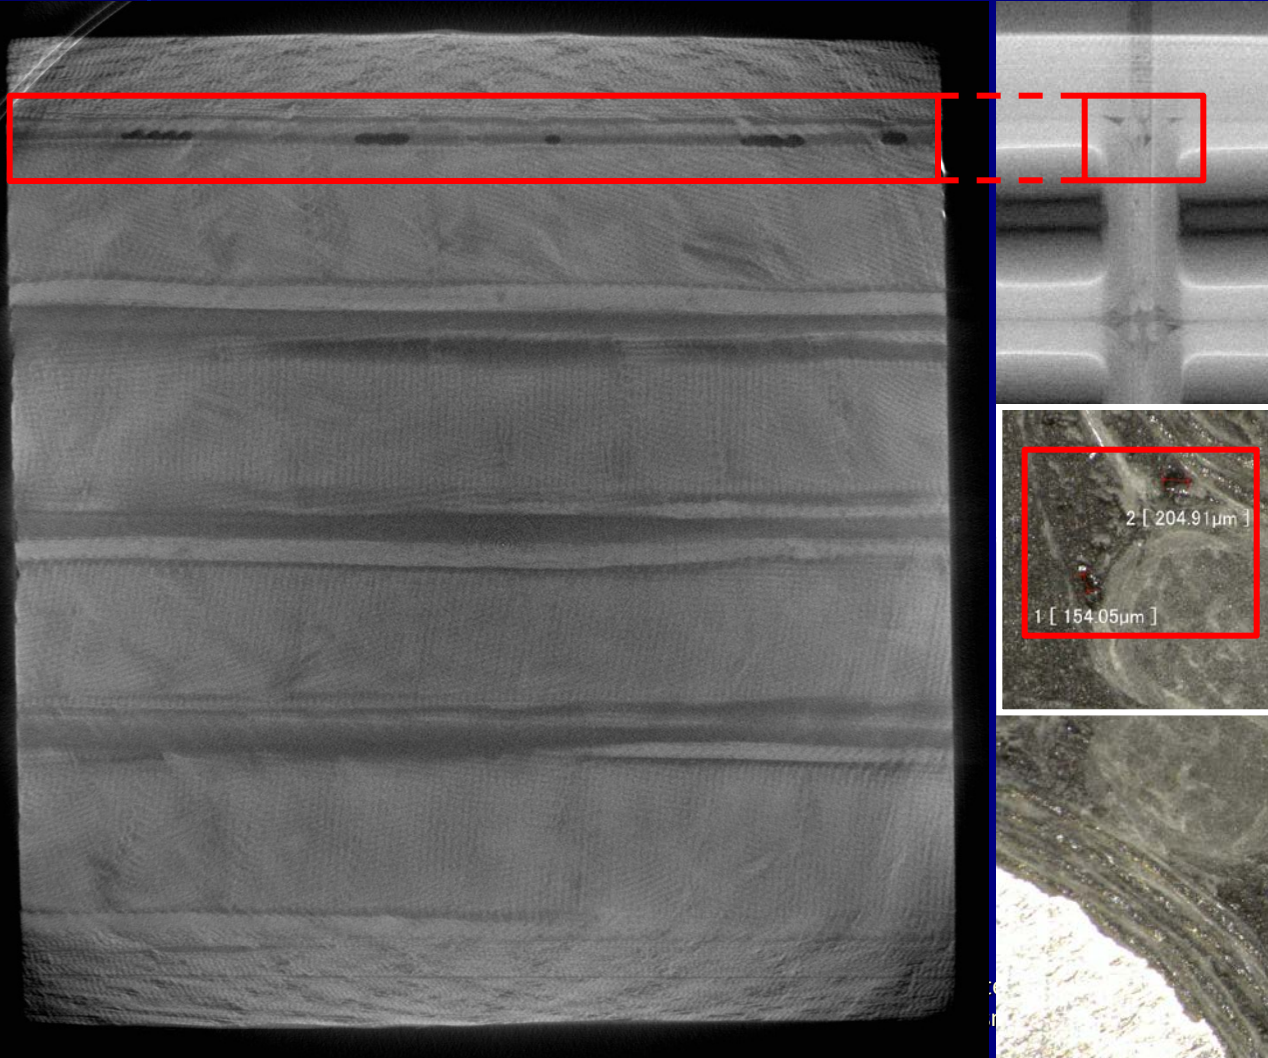
**Elongated voids in resin  
along glass ropes  
between the steel  
conduits**

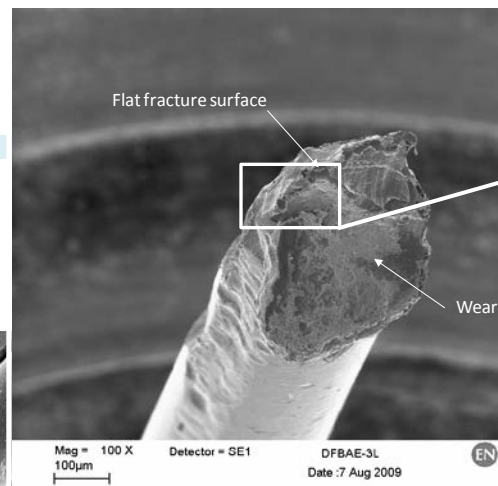
⇐ **Complex failure analysis of DFBA flexible metal hoses, TE-TM, 01/09/2009**

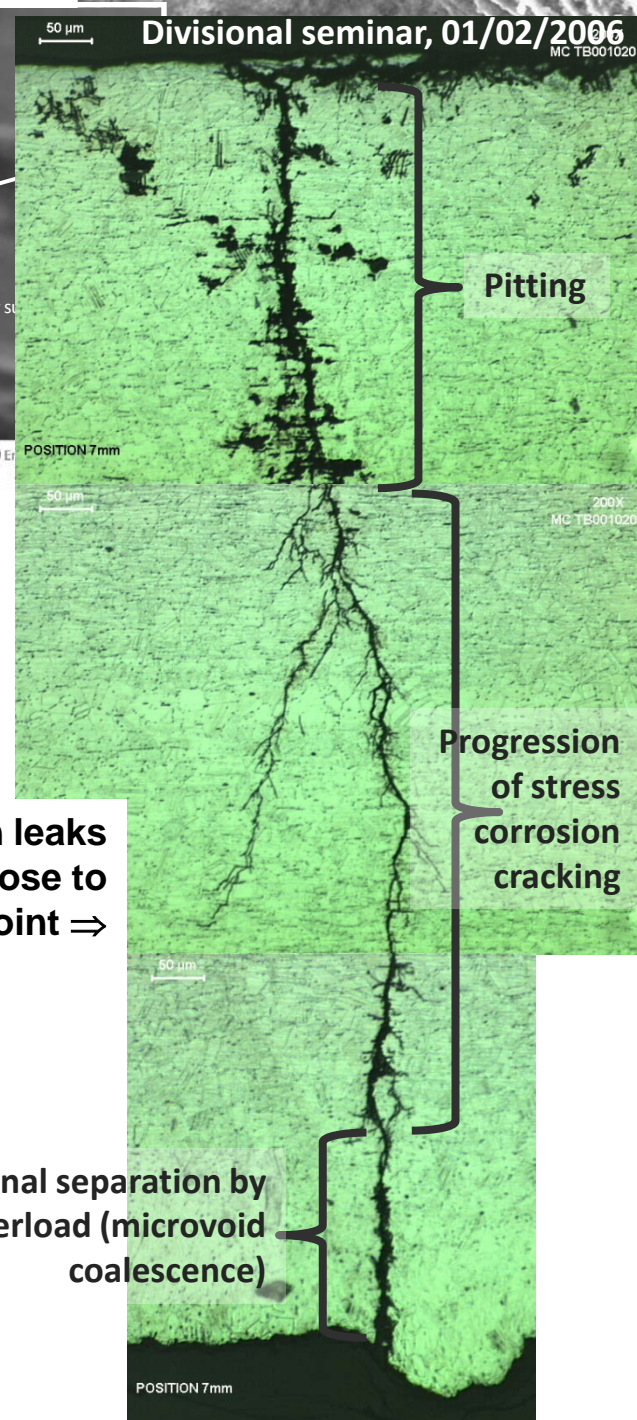
**QRL: corrosion leaks on the tube F close to the fix point ⇒**
