# Irreversible strain in Nb<sub>3</sub>Sn conductors

M.C. Jewell, P.J. Lee, D.C. Larbalestier  
*Applied Superconductivity Center*  
*National High Magnetic Field Laboratory*

CARE-HHH-AMT WAMSDO 2008  
May 20, 2008

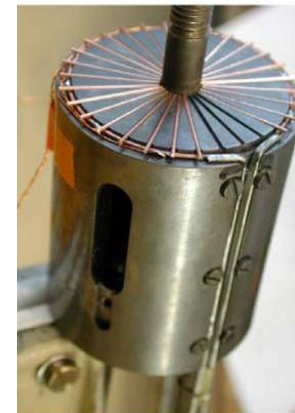
- Strand damage shows up in I-V curve by degraded  $J_c$  and n-value. N-value is more sensitive.
- Studied both EAS and OST-II using the 5mm bend rig and crossing strands (x-strands) rig
- We receive extracted, post-testing strand and examine damage metallography
- The samples have been severely deformed -  $J_c \sim 0.1J_{c,max}$
- Control sample ensures no damage from polishing procedure

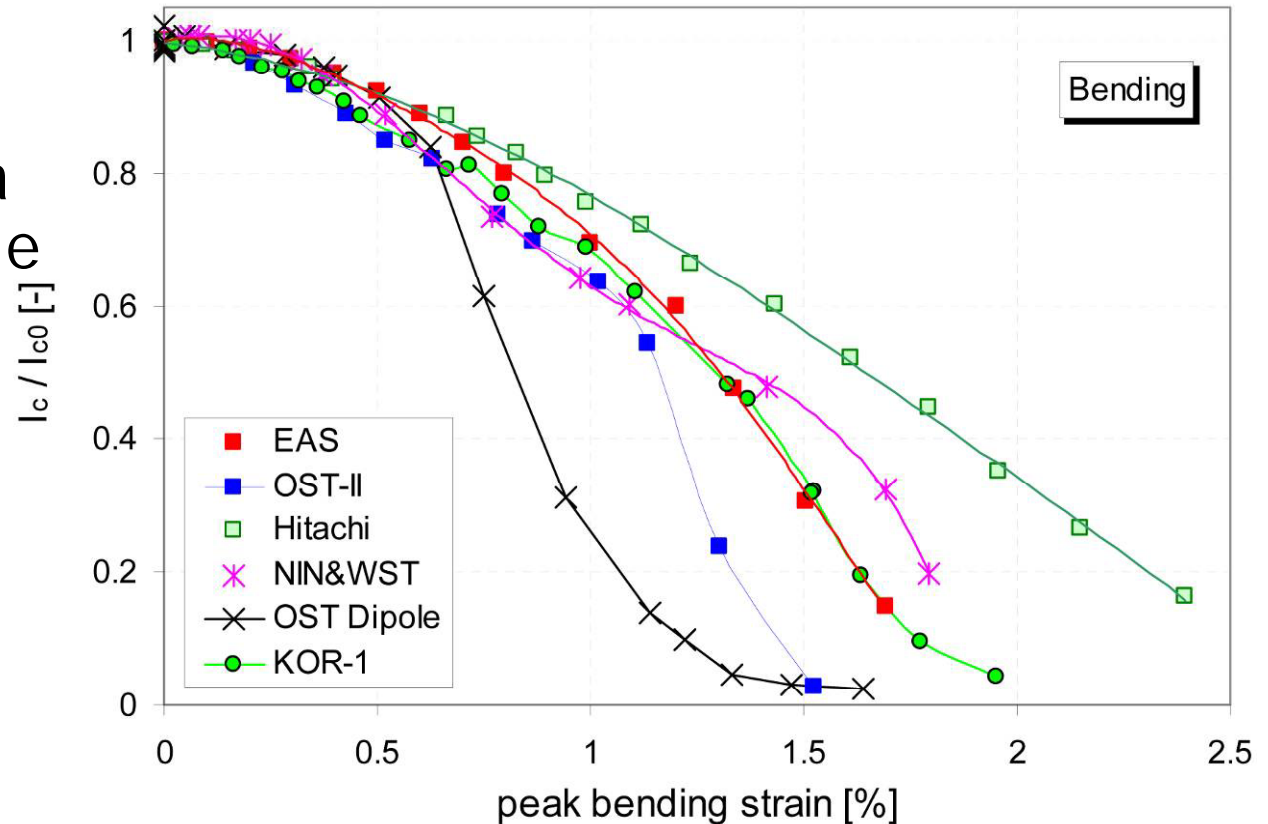
- Clearly, agglomerated structures have a higher irreversible strain sensitivity than well-separated structures
- Not as simple as bronze vs. IT, though!

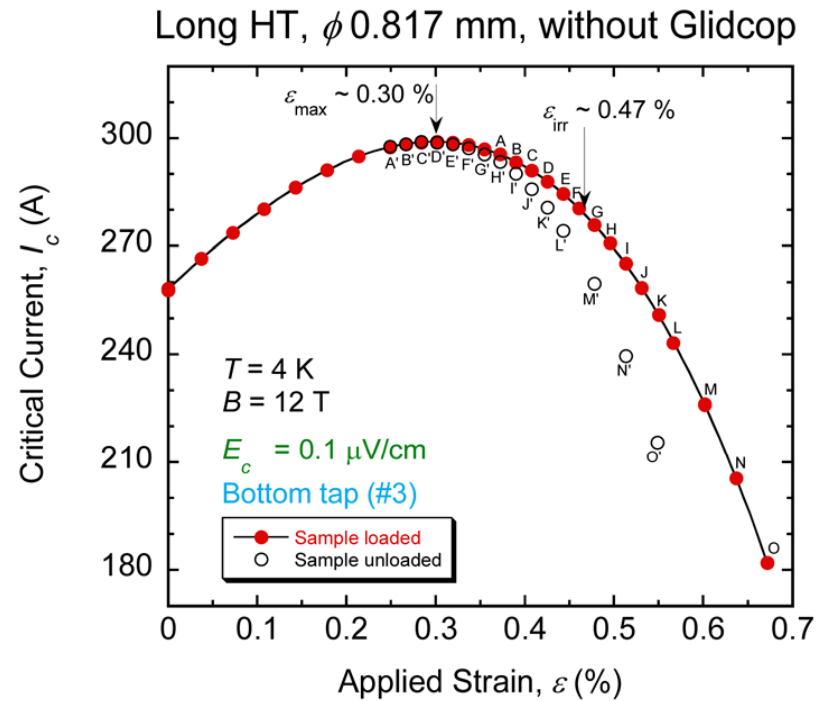
0.0% strain  
0.5% strain

0.3% strain  
0.7% strain

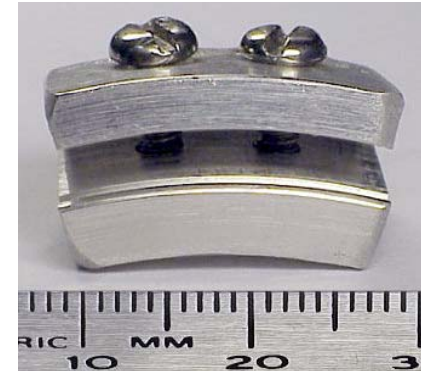
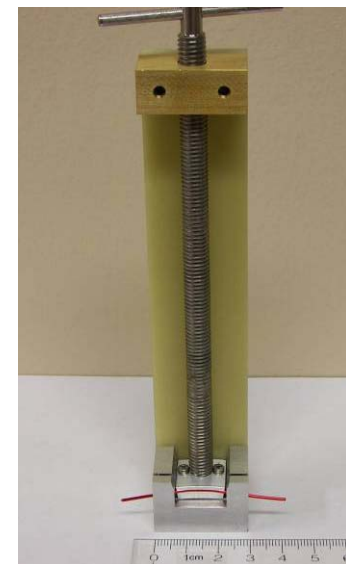
- 1 cm-long samples were mounted in Al clamps with a variety of radii and bent at 77K
- Samples removed from clamp after warming and longitudinal face hot-mounted, ground, and polished to  $0.05\ \mu\text{m}$
- Samples etched in 37%  $\text{HNO}_3$ , 13% HF for  $\sim 5$  sec. to reveal crack location – but not enough to create false voids.
- Images acquired on field-emission scanning electron microscope and light microscope
- All wires received manufacturer recommended heat treatment
- Today I will show results from 1.5% bend strain
