Tuner simulation, assembly and test for the single cavity module

Luca Somaschini

Università degli Studi di Milano - INFN Pisa

23 February 2014

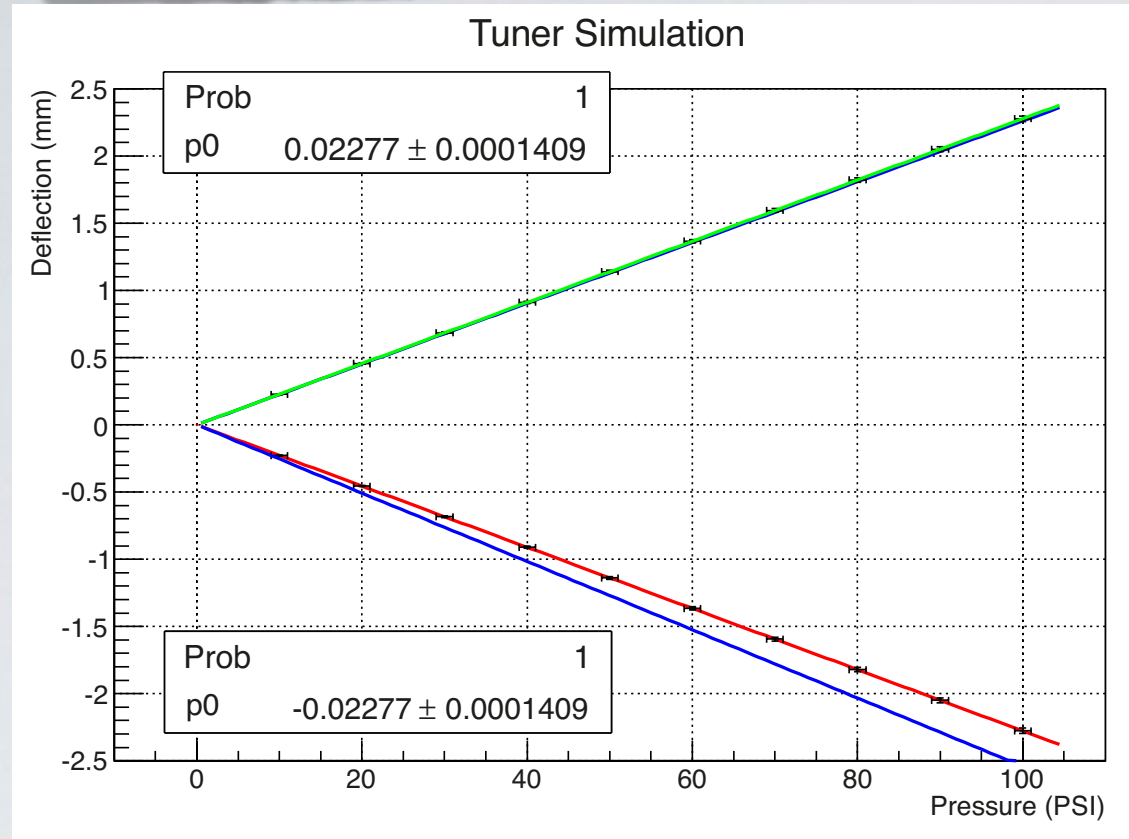
MECHANICAL SIMULATIONS ON TEST STAND

- Good agreement between data (blue) and stretch simulation (green)
- Worse agreement between data (blue) and squeeze simulation (red)
- Simulated data are symmetric for stretch and squeeze mode. Data are not.
- Simulations realised with ANSYS workbench by L. Somaschini, A. Lambert and A. DeMello.

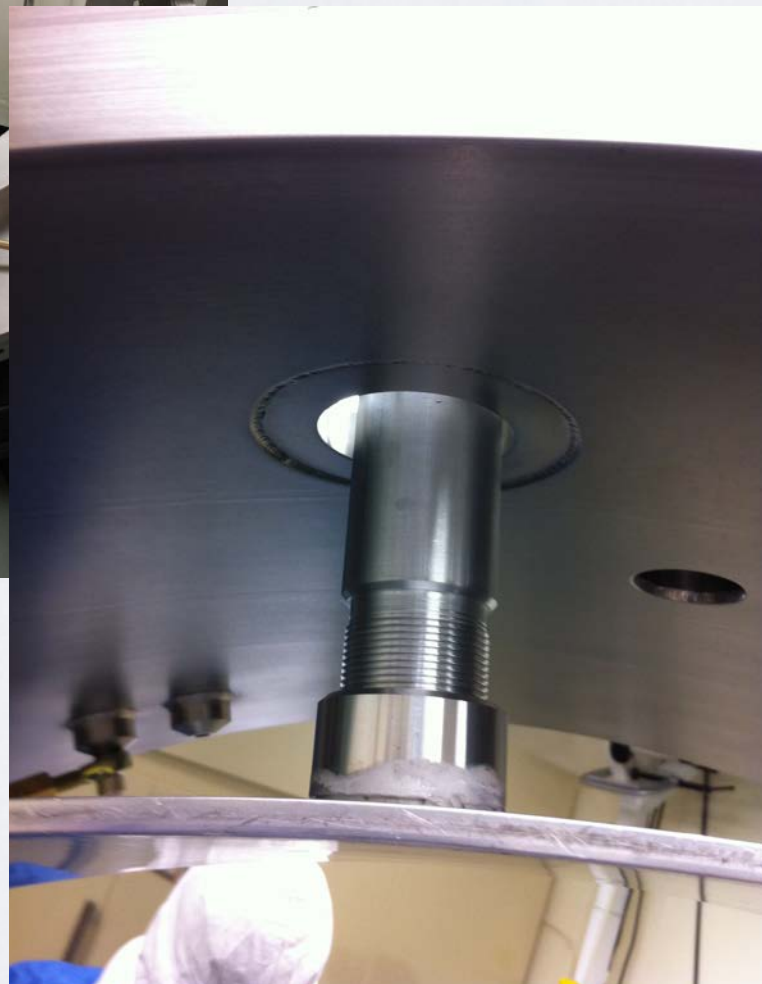
ACTUATOR ASSEMBLY

Here are most important results from assembly:

- Cavity has been laser scanned but all forks are machined to provide same gap from pad to pad.
- Stainless Steel shimming is adopted to create proper contact and to facilitate assembly.
- Initial struts position is achieved with a test aluminium hoop and alignment tools

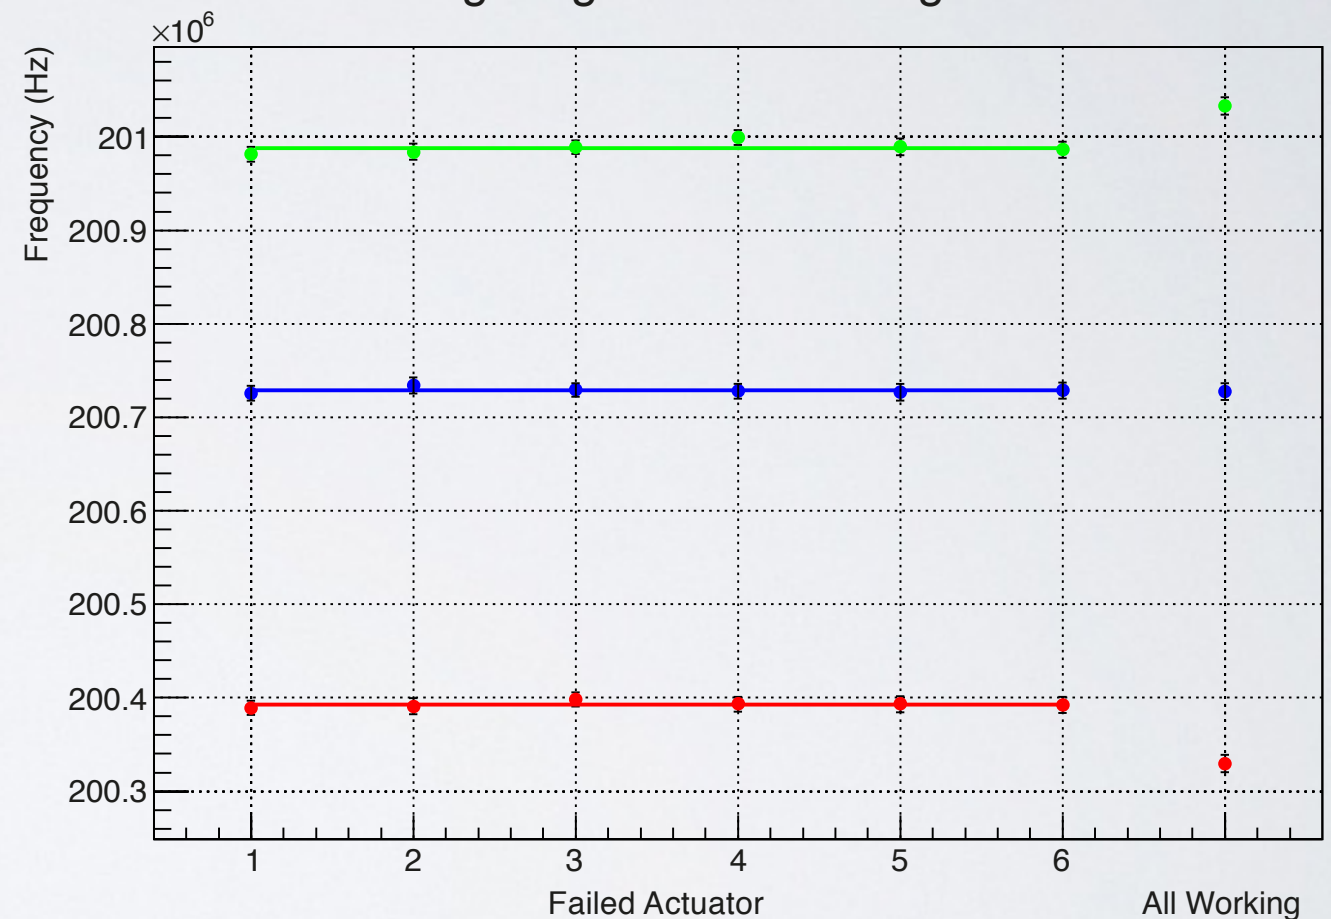
IN CASE OF FAILURE

Air supply cut to ONE actuator at a time

Actuator 5 failed - Beryllium Windows

Tuning range in case of single failure

System is still working with a tuning range reduced of 100 KHz, independently of the failed actuator. Aj DeMello says that more than one failed actuator can result in plastic deformation of the cavity

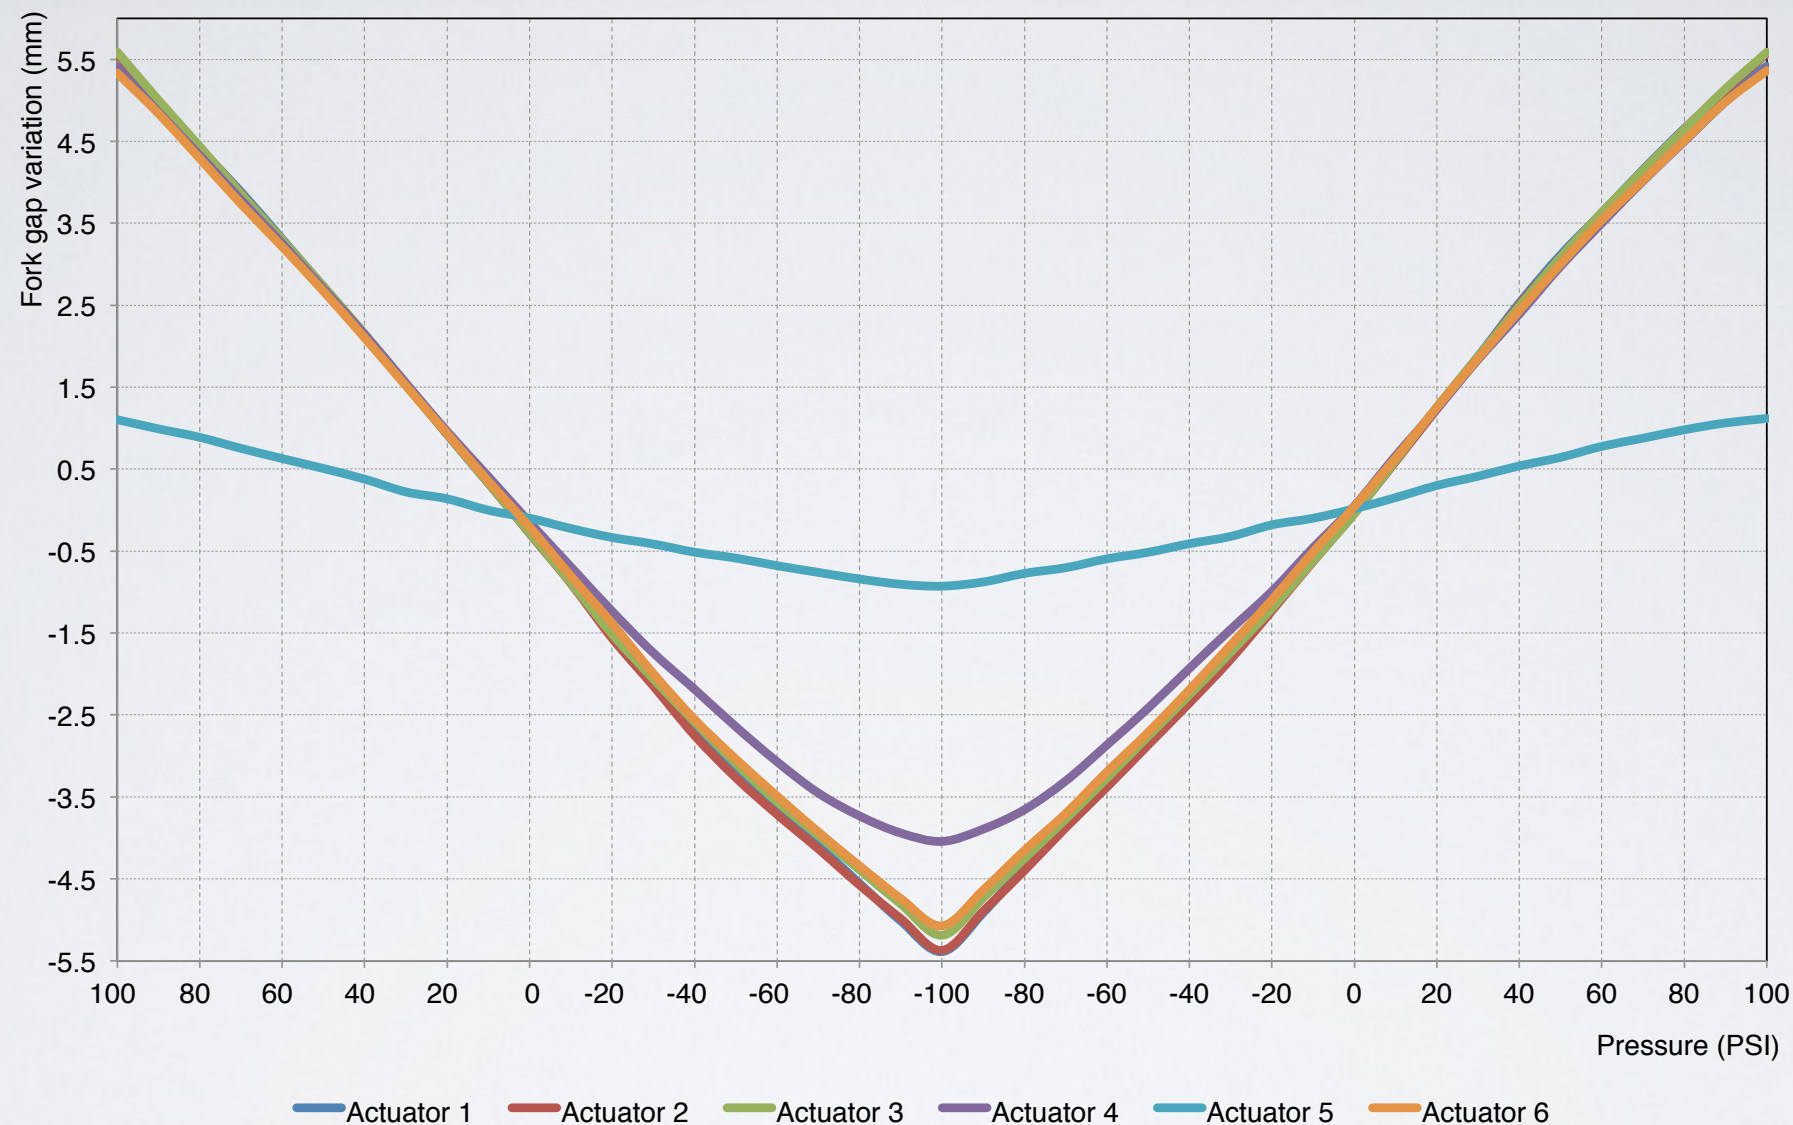
IN CASE OF FAILURE

When actuator 5 fails (air leak failure) its actuator shaft is still moved by the action of other 5 working actuators
