# Reliability of Static Var Compensators

**Karsten KAHLE**

**CERN, Electric Power Distribution Group**

# The Static Var Compensators for SPS in 2008

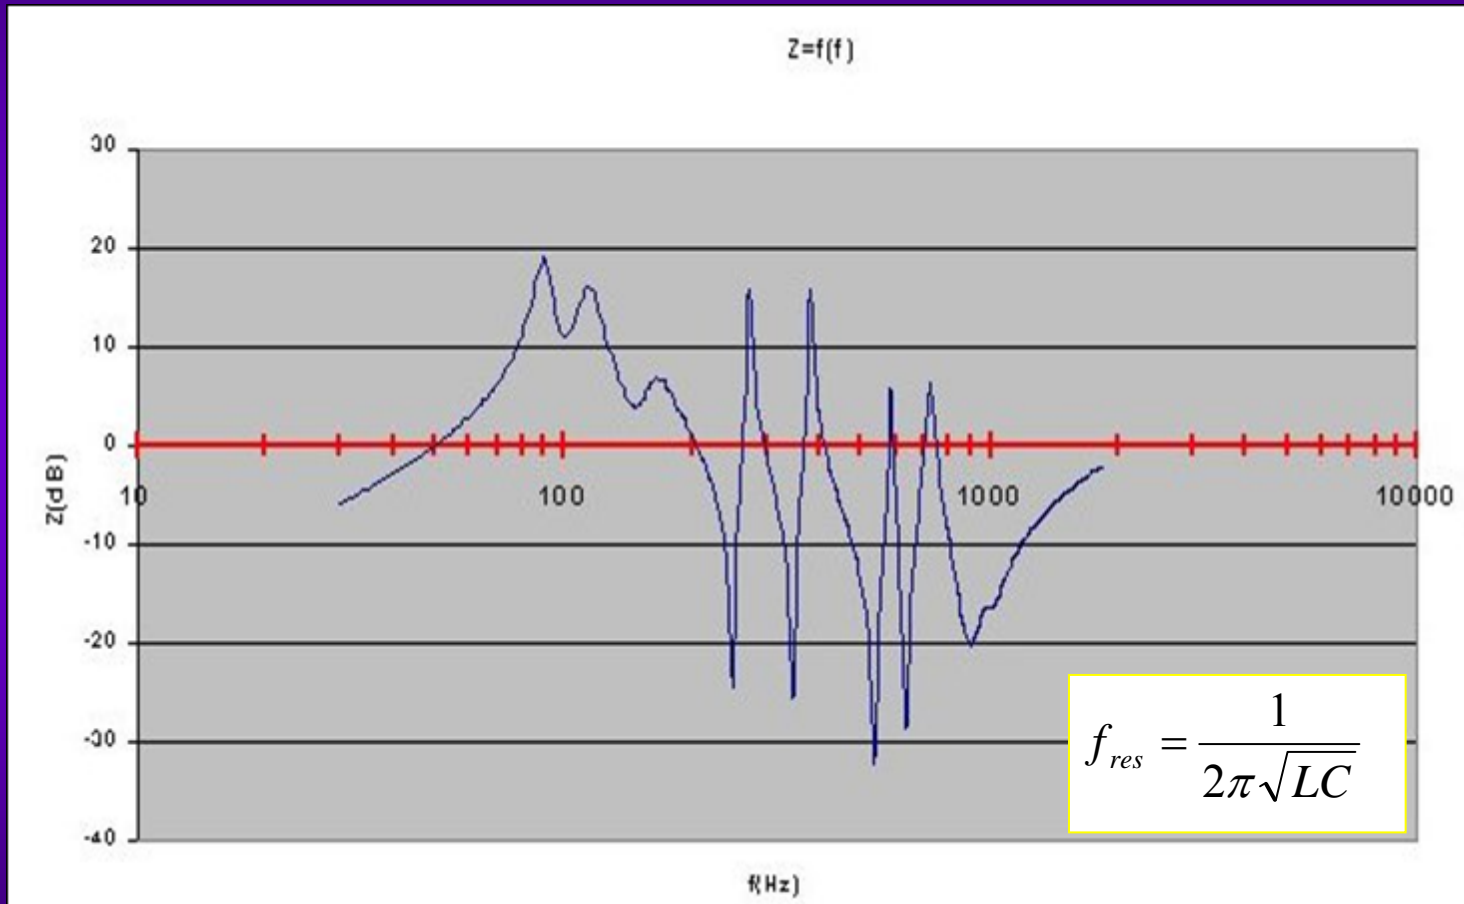
# Harmonic filter design

Impedance diagram  $Z = f(f)$

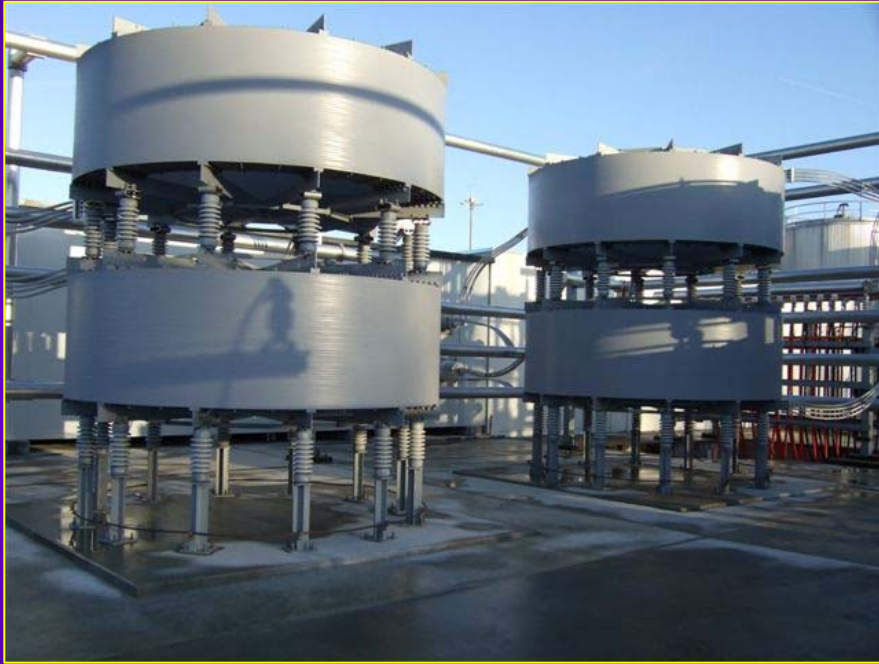
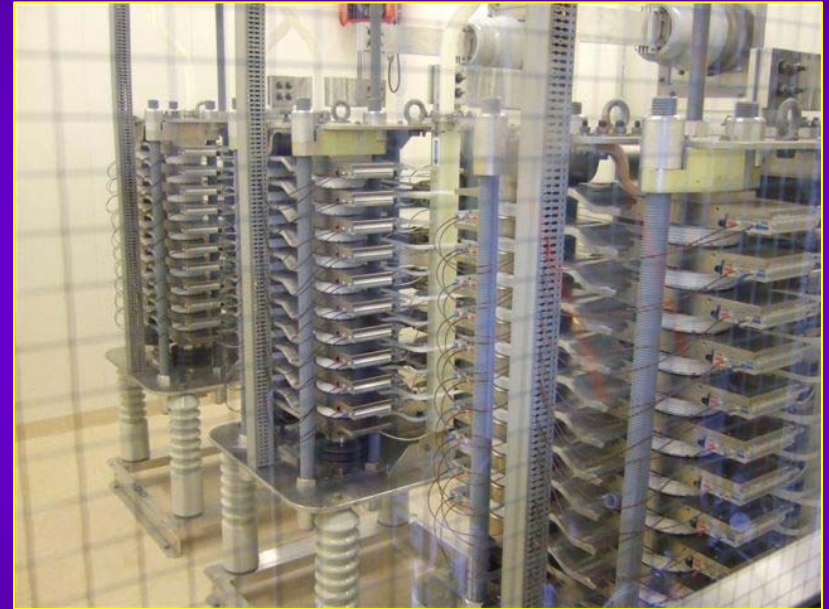
Thyristor controlled reactors (TCR) and thyristor valve

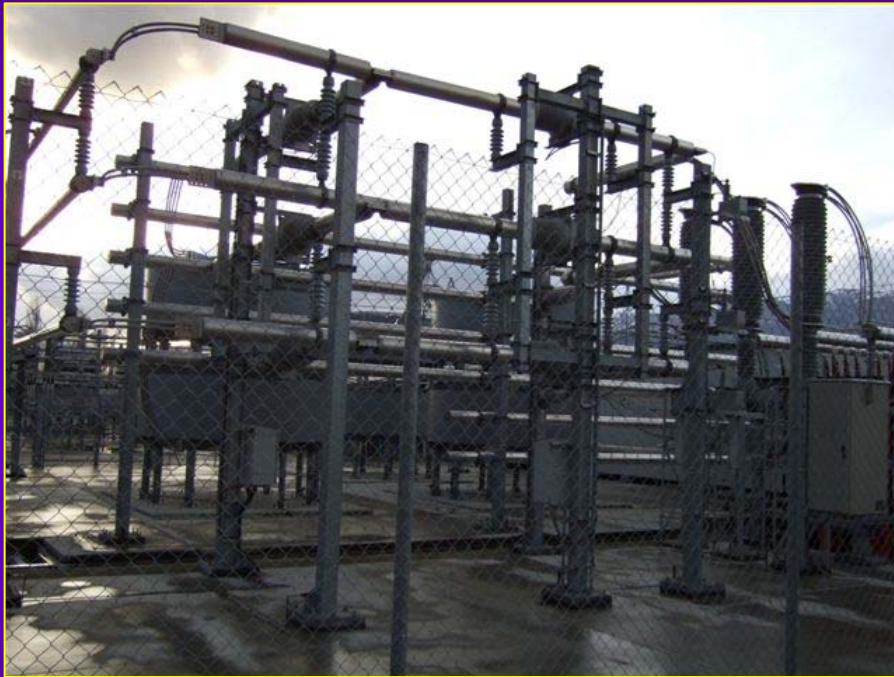
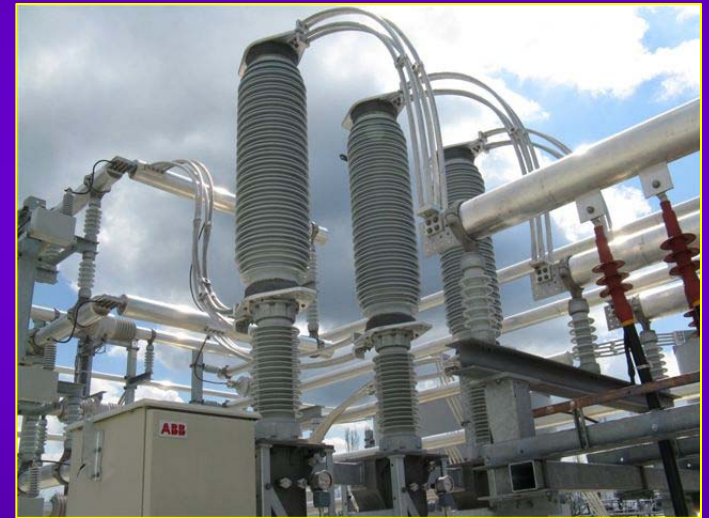
18 kV busbar system for TCR and 72 kV circuit breaker

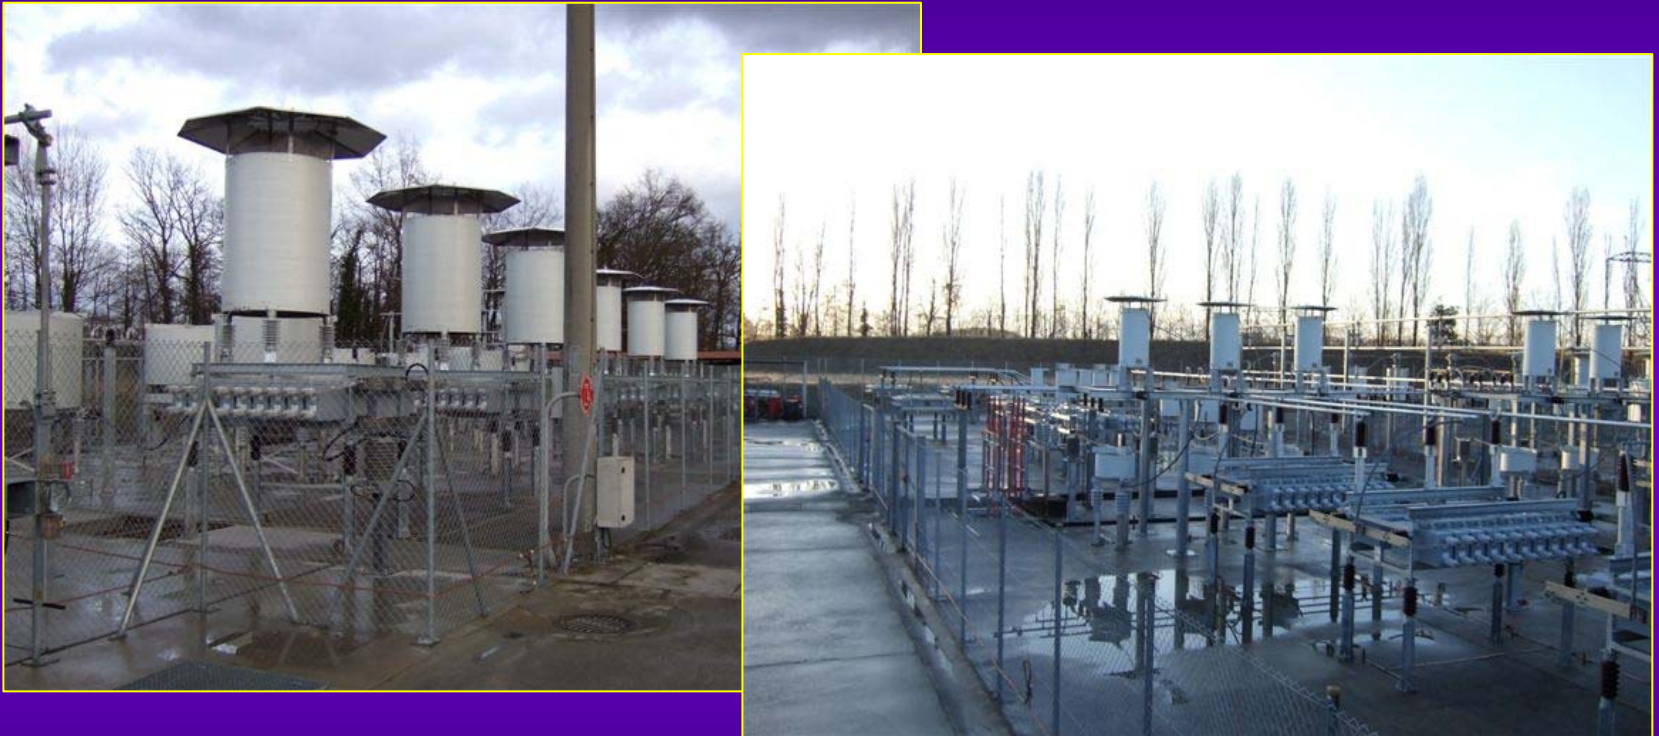
8 Harmonic filters in total

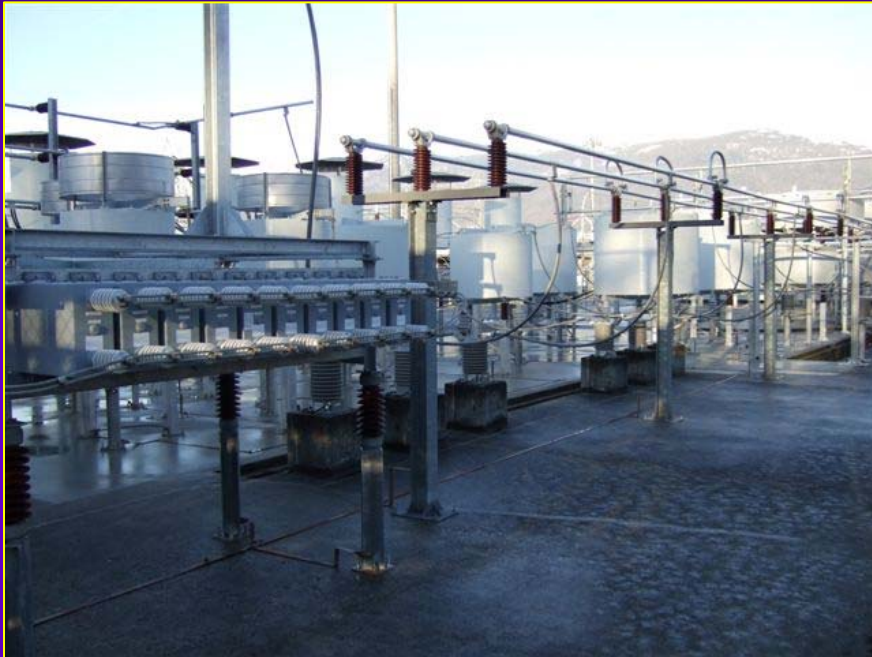
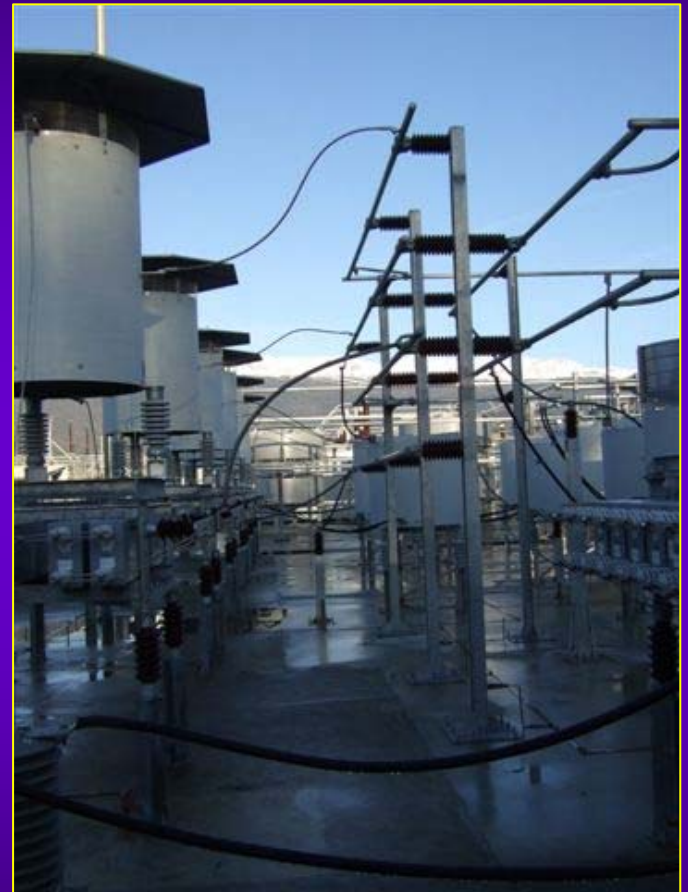
18 kV outdoor installation  
(attention to thermal expansion of bars!)

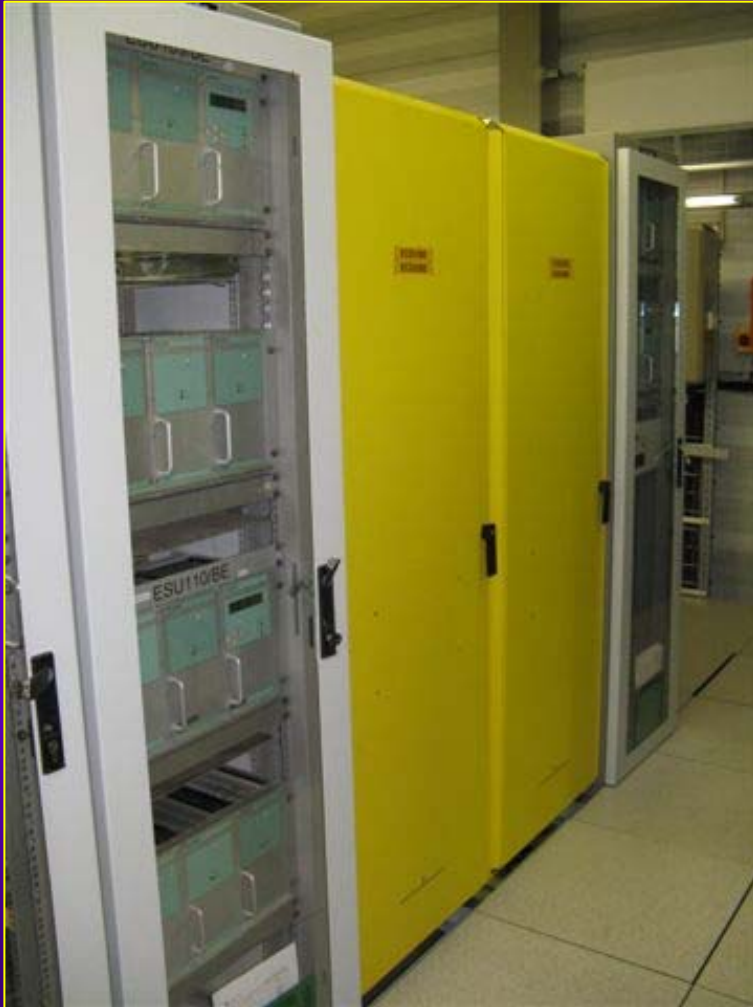
Auxiliary supply for 400kV station at CERN:  
Two redundant systems with automatic coupling

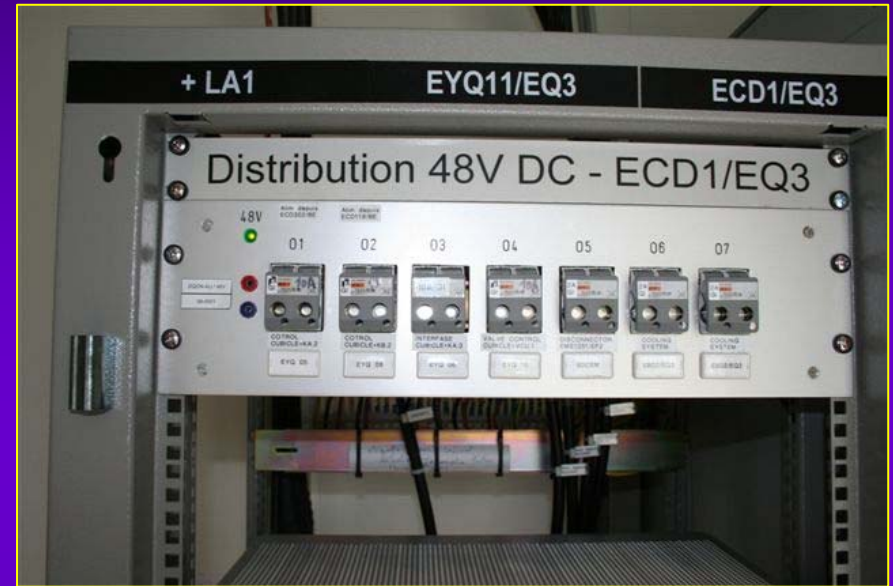
Distribution chassis with two independent sources,  
via diodes

For critical installations:  
Two redundant sources of auxiliary power

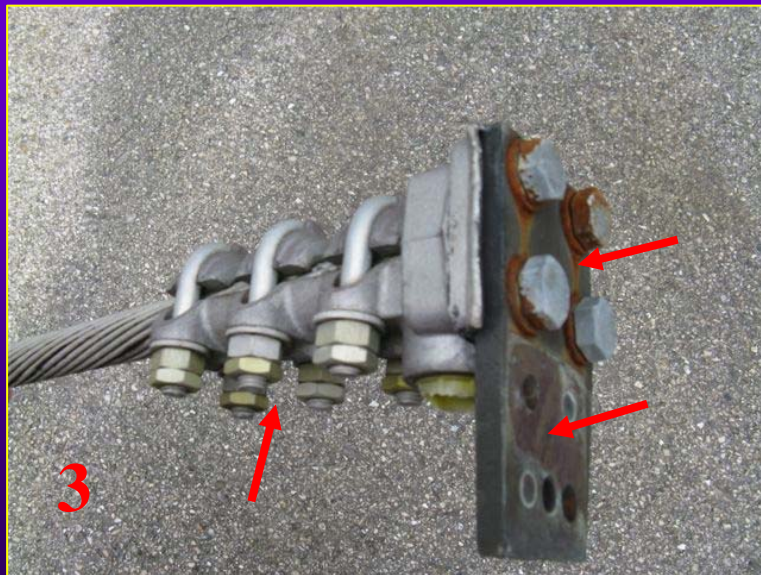
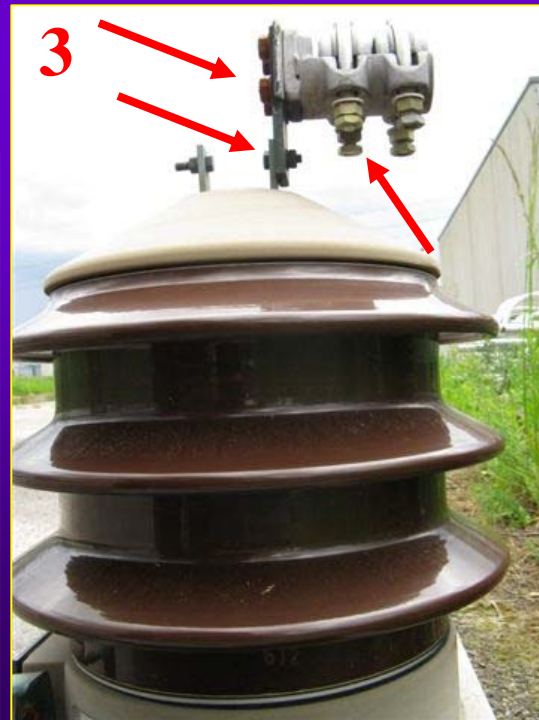
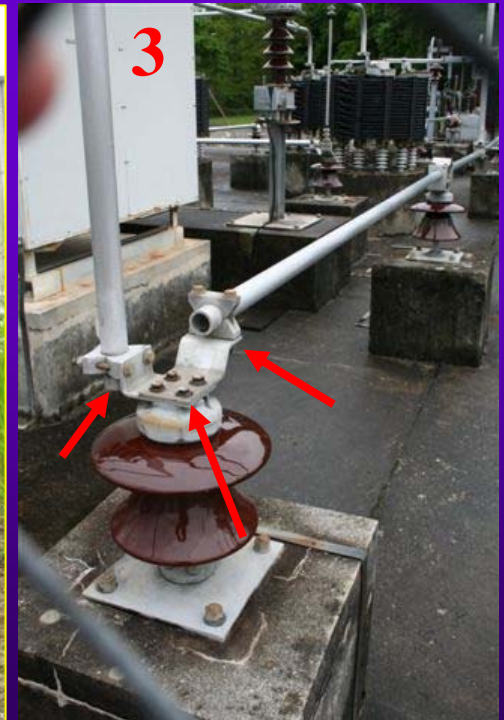
# Reliability of power connections (bad examples)

Connection of two conducting elements should ideally have only one connection point, max. two

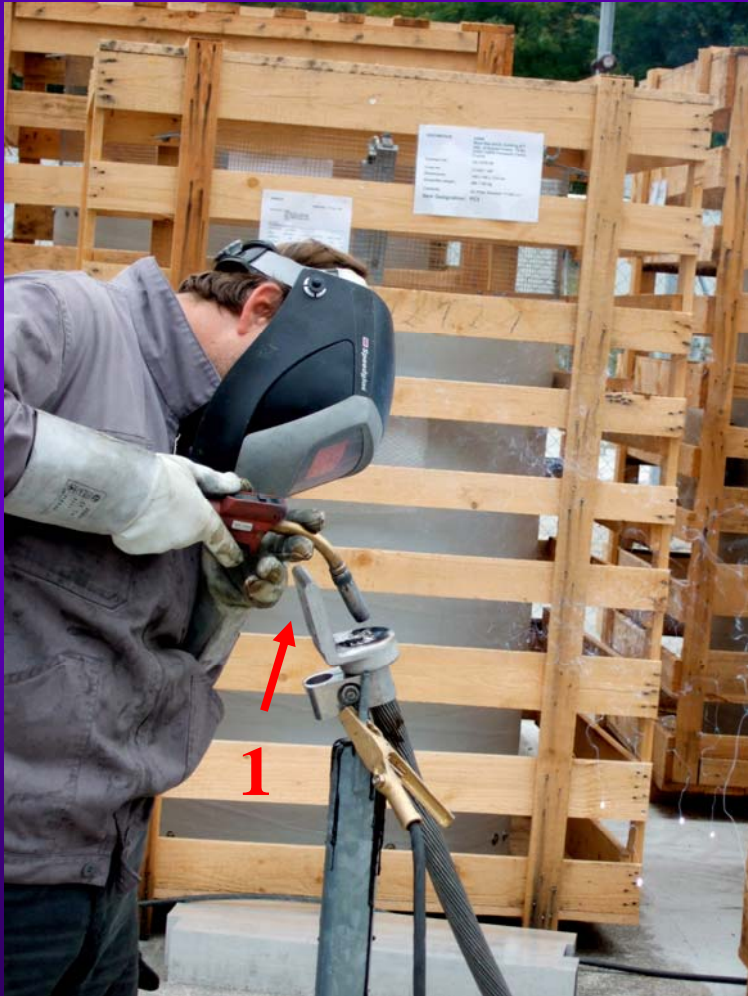
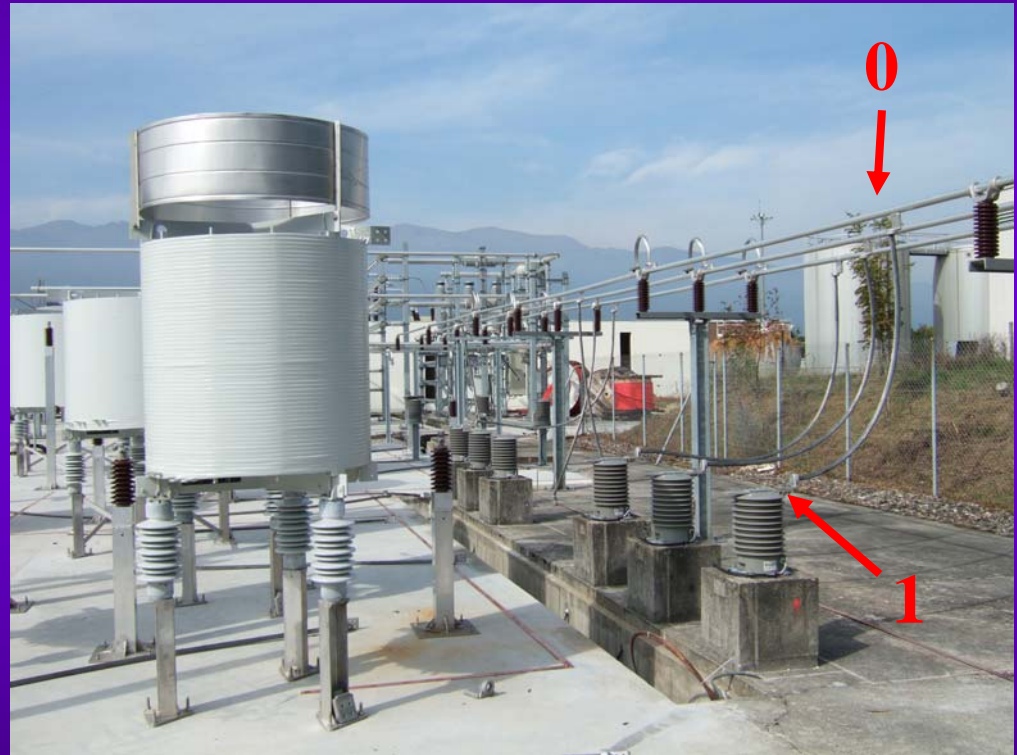
# Reliability of power connections (good examples)

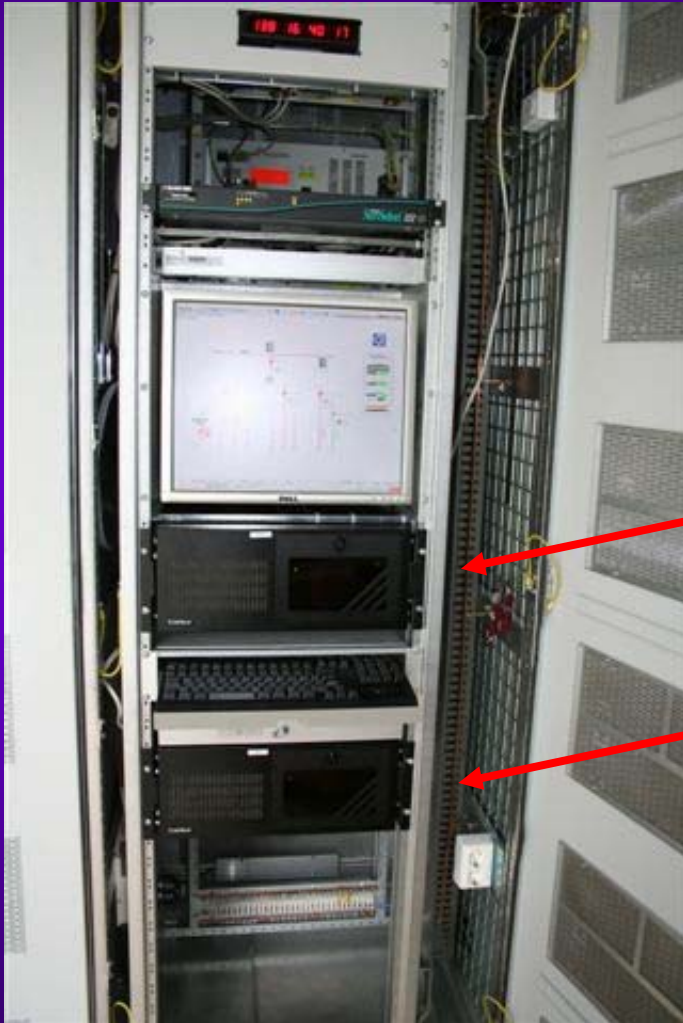
# Redundancy and modular design for easy repair

- Two redundant computers (hot stand-by)
  - \* automatic switch-over without SVC trip
- One spare computer for each unit,
  - \* plug-in connections,
  - \* spare computers fully commissioned,
  - \* detailed instructions how to replace,
  - \* automatic start-up of new computers,
  - \* can be replaced by operator without computer knowledge (within 2 hours)

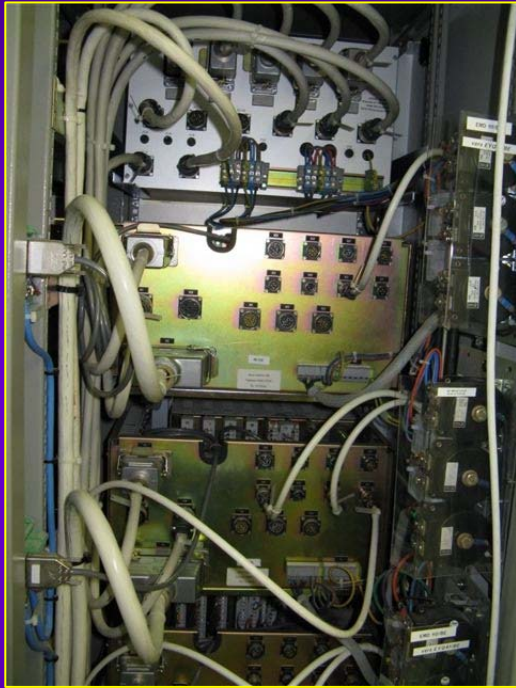
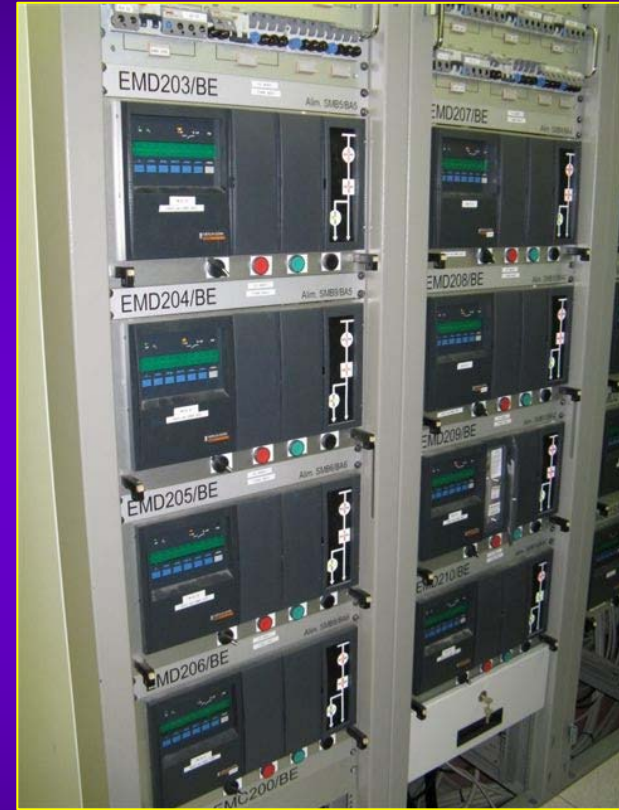
# Reducing cabling errors by design

Example: protection relays:

- in factory: Chassis cabled and fully tested
- on site: standardised cabling connections via BURNDY connector
- time reduction for commissioning (time reduced by 50%)
- reduction of cabling errors (less than 1 error per 10 HV feeders found during commissioning)

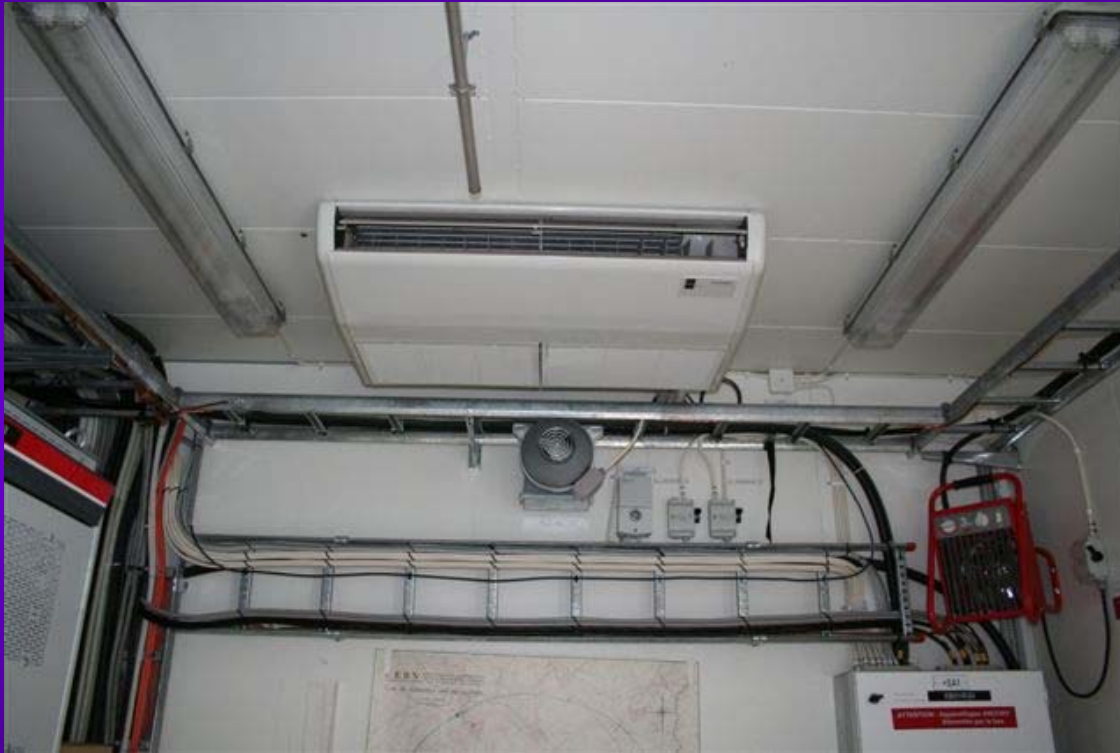
Example: Air-conditioning unit in SVC control room  
(without A/C, temperature in control room rises above 40°C and computers shut down)

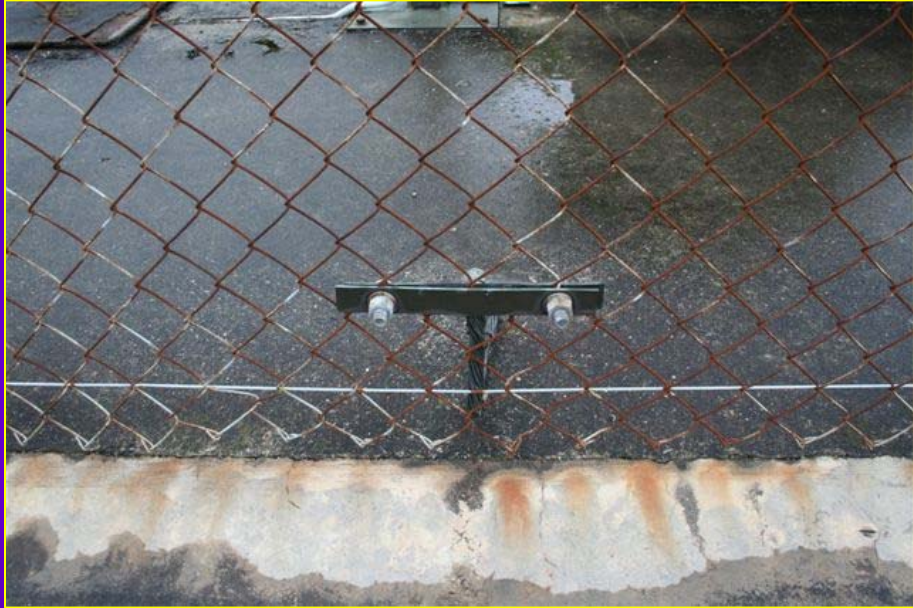
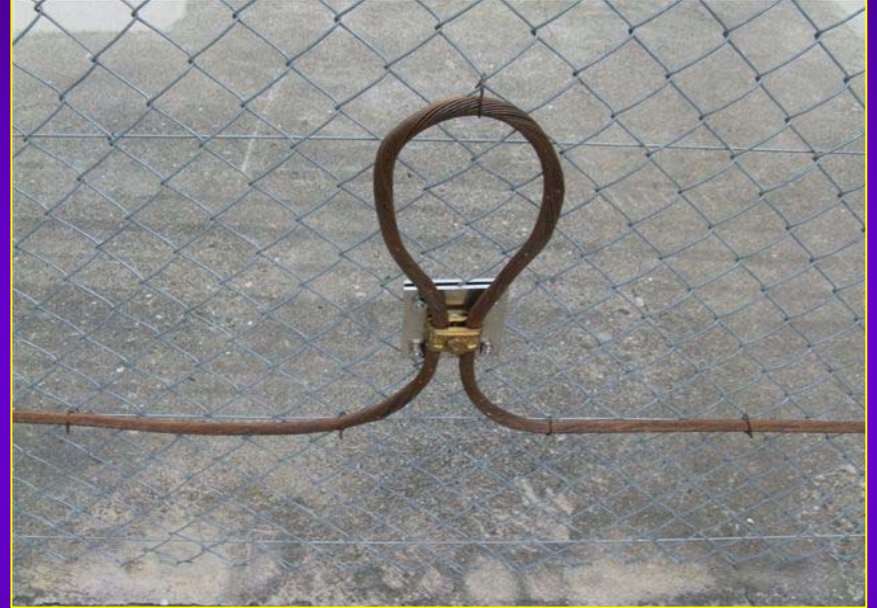
Example: earthing of fences  
(attention to choice of materials!)

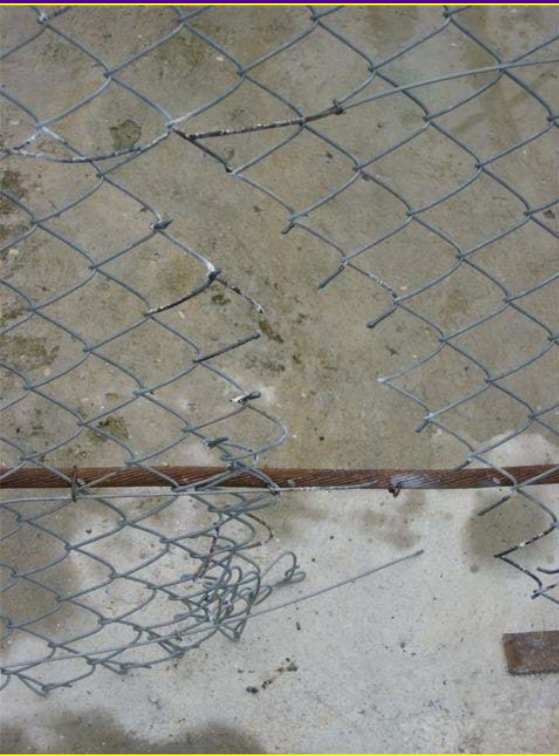
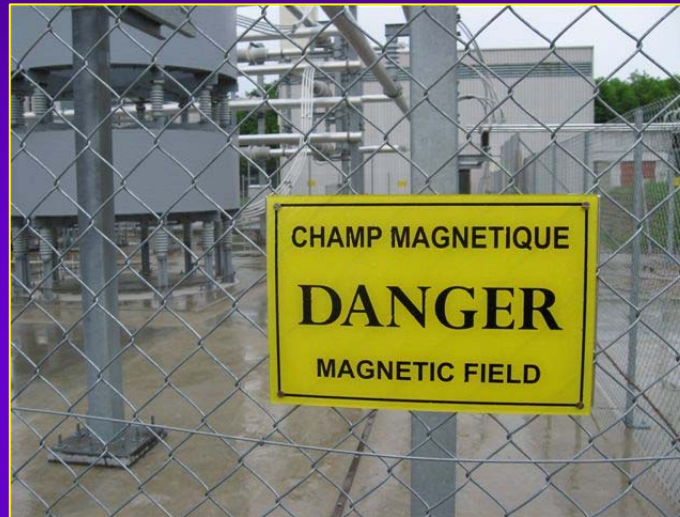
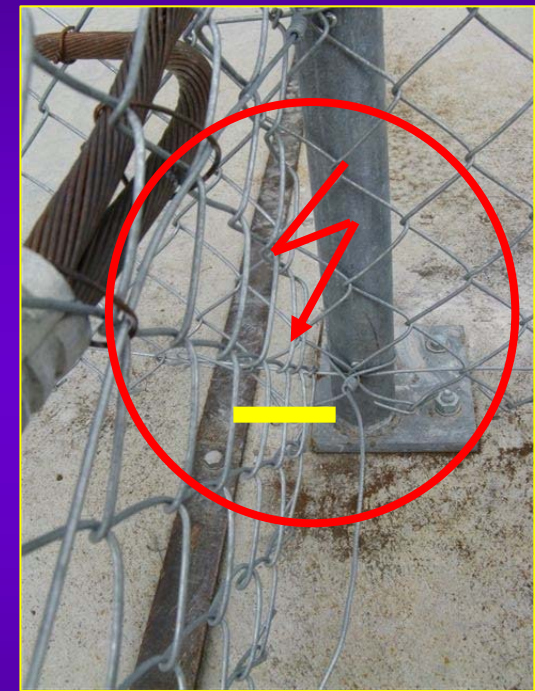
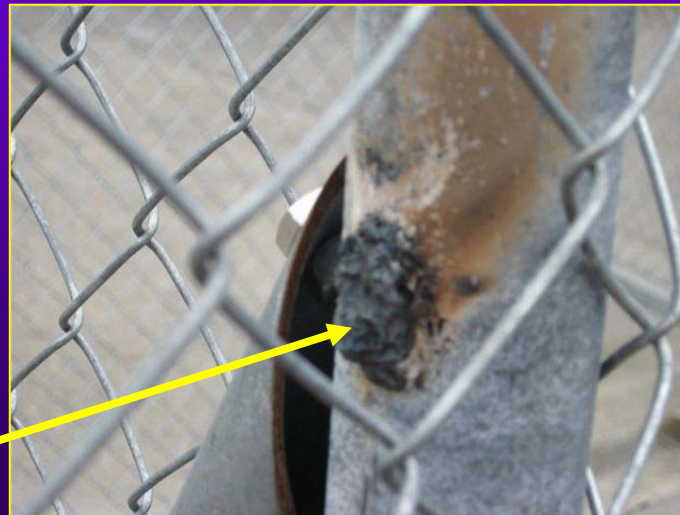
## Example of overheating due to induced currents in a closed earthing circuit

Burned fence

Cause:  
unwanted interconnection  
of two earthing circuits

Melted bolt M10

Event No. 9 description:  
 The CCC was called by contractor of SOTEB working in the vicinity of SVC3 main busbar around the fence close to earthing switch EMC101. The CCC site TS-EL-OP stopped the SVC3.

Immediate inspection by TS-EL-OP, K. Kahl, D. Demassis, and the following:  
 - fence (metal) partially melted,  
 - both holding the diagonal support bar for the fence completely melted,  
 - fence (metal) touching the earthing bar of EMC101 partially melted,  
 - two C-connections of the earthing cable of the fence were also found having a temperature. This needs to be monitored.

The damages were caused by currents circulating in the earthing system (main earthing busbar) had been installed by CEREN during the SVC3 commissioning phase. The following actions were taken:  
 - replacement of damaged fence (metal),  
 - removal of diagonal support bar. The stability of fence is assured without this installed during next winter shutdown.

Conclusions: Avoid closed loops in the earthing system!

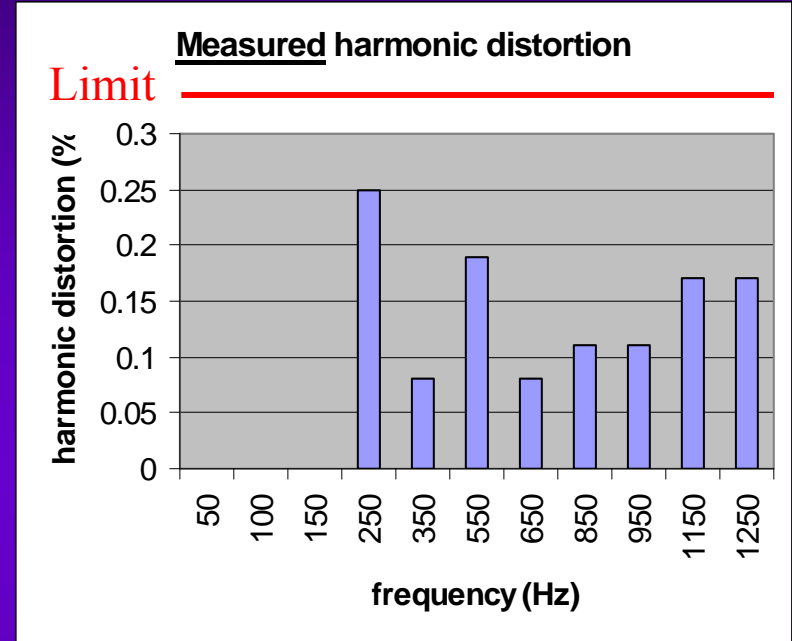
Measured THD (18kV)  
0.49 %

(e.g. for pulse 450 GeV FT 3s)

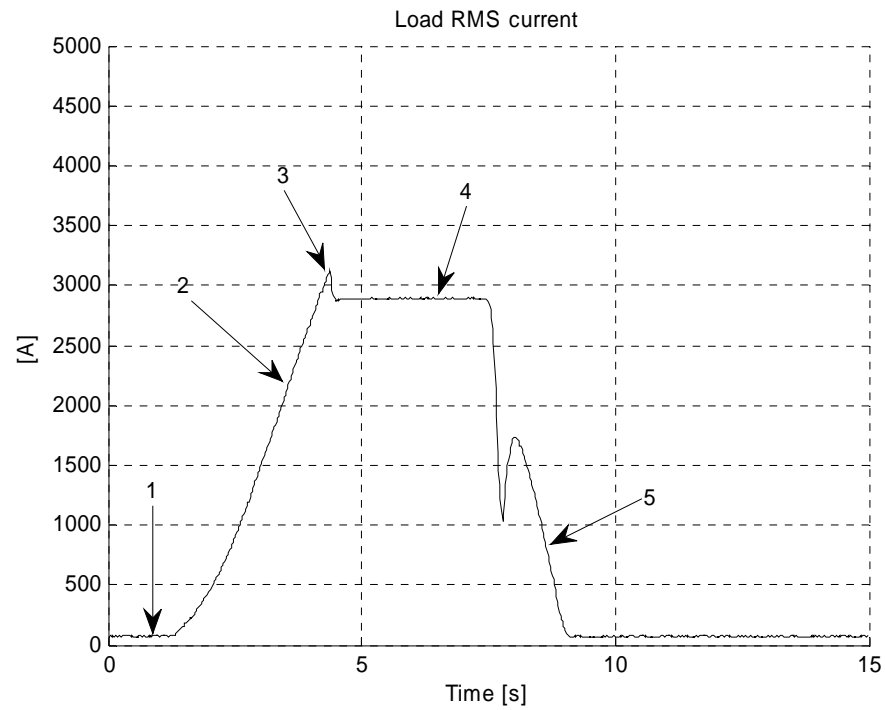
Current of SMD's (450 GeV FT 3s)

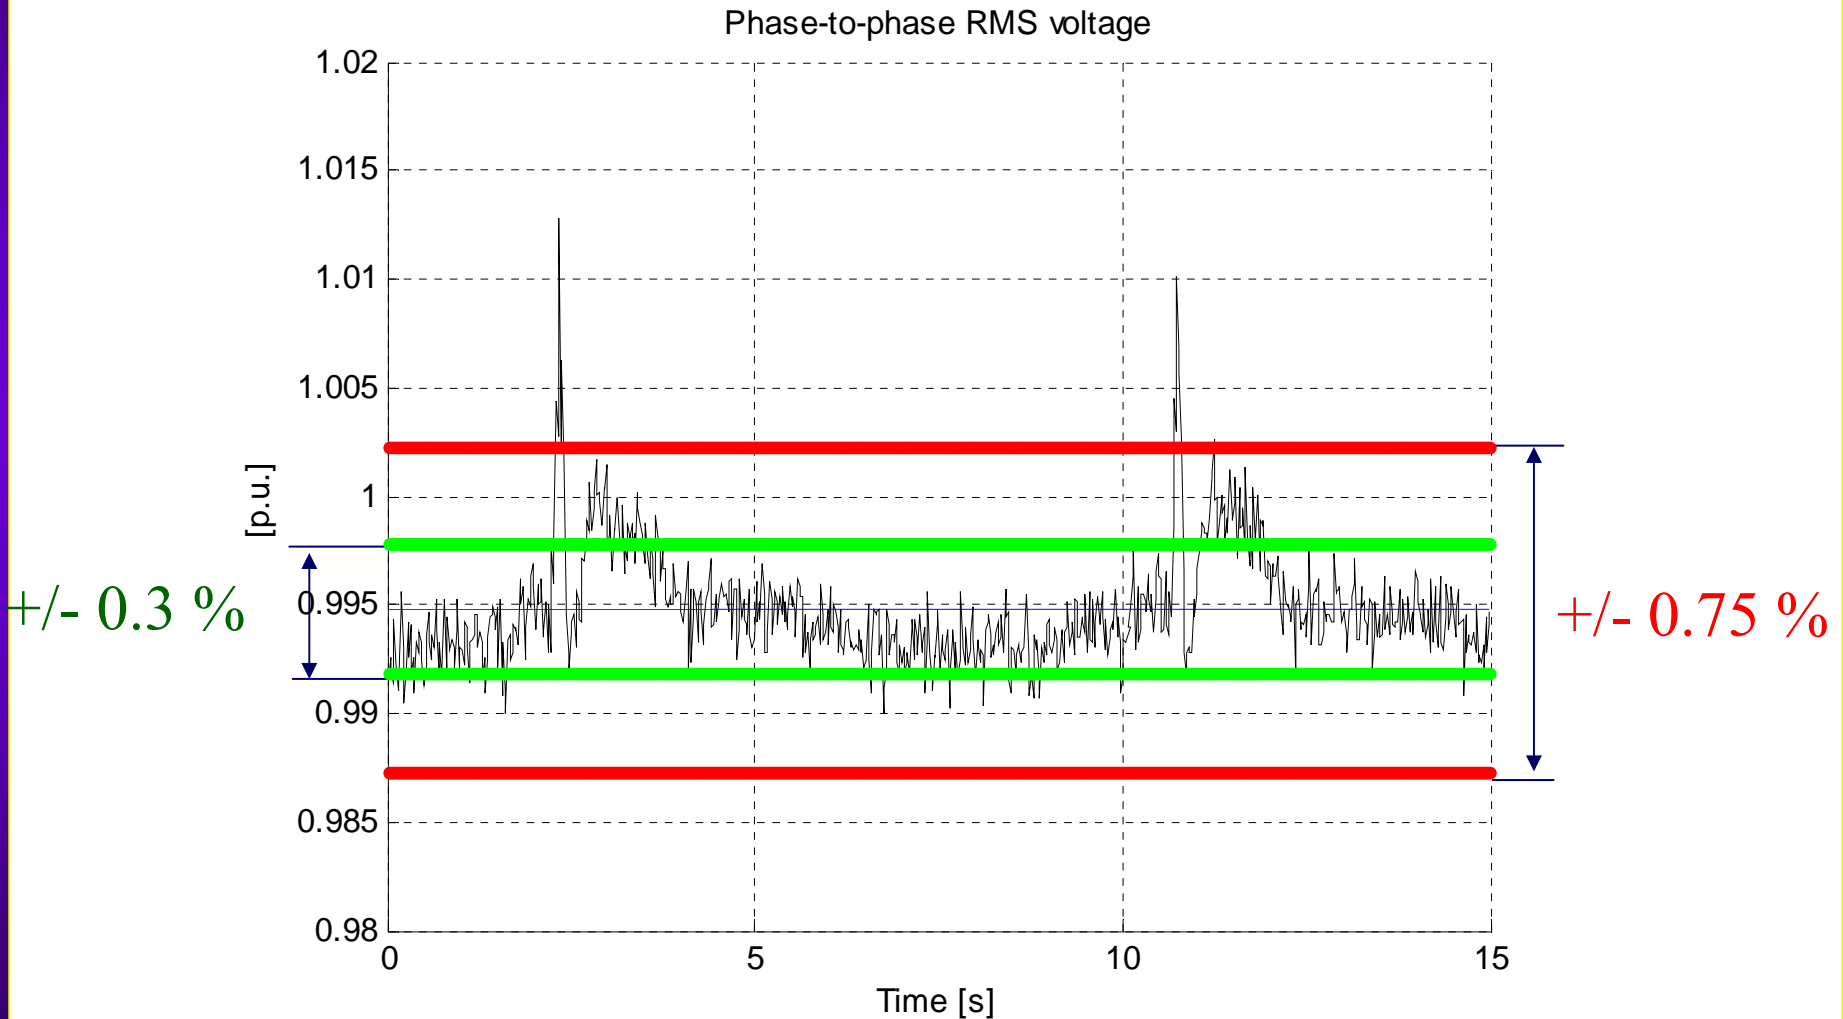
SVC3 regulation error: 18 kV network voltage response (is now repaired)

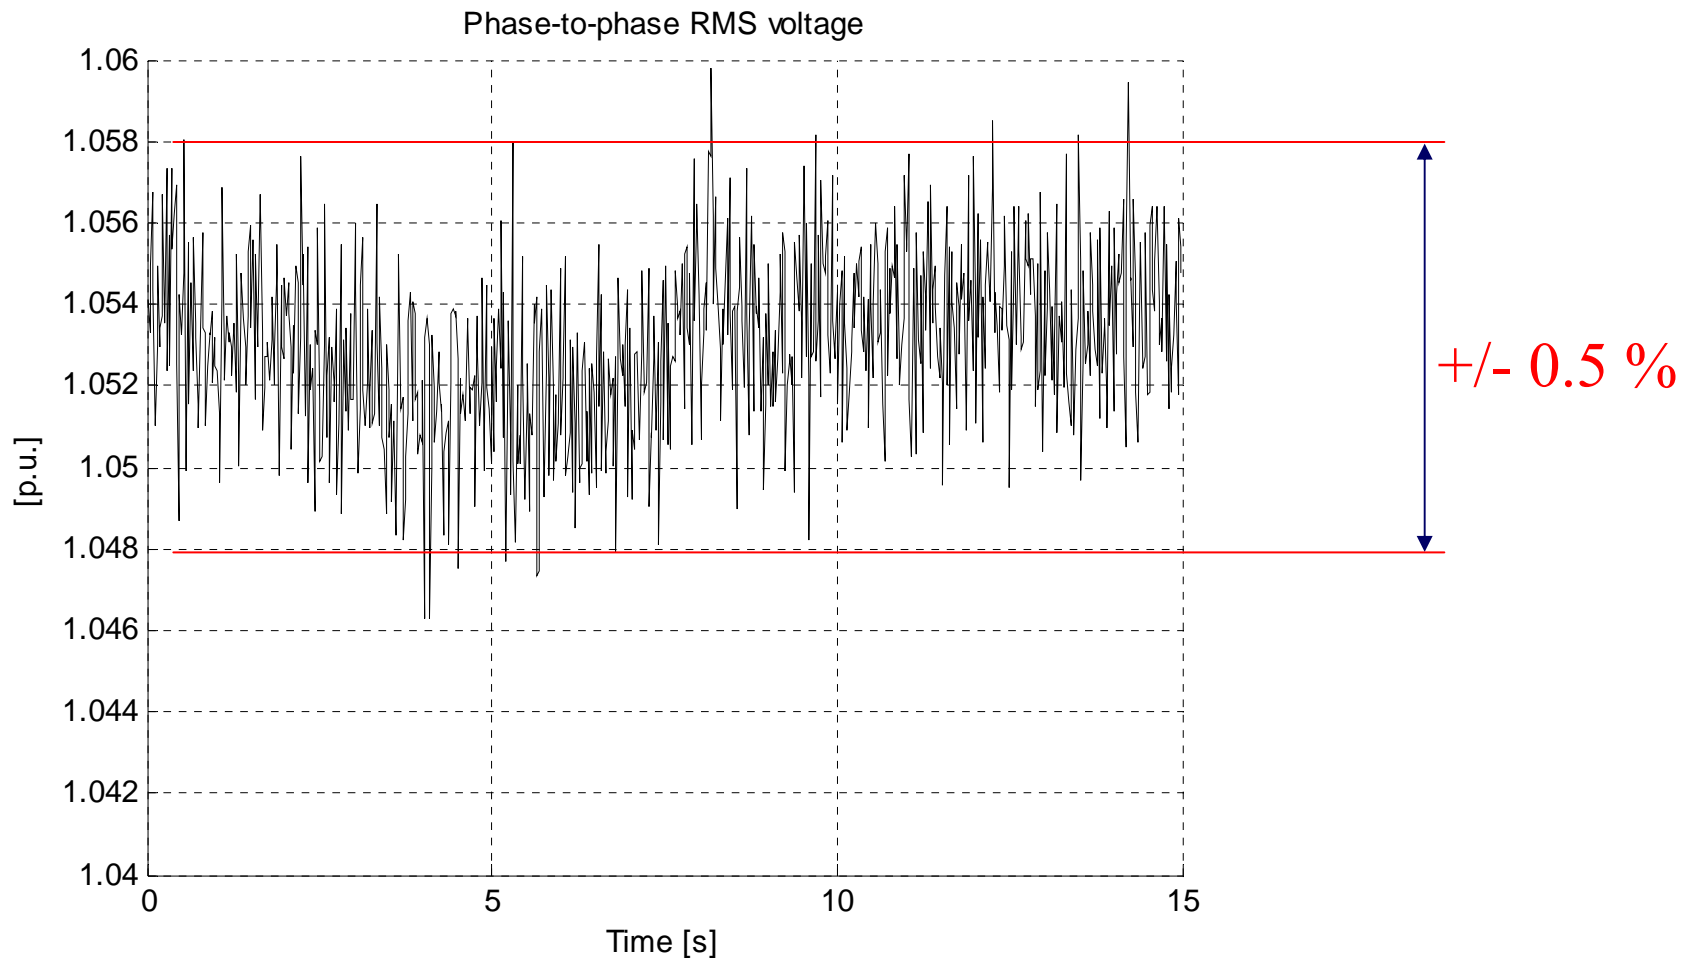
voltage response 400 kV
