Plug or Socket Problem?

Investigate other connectors....

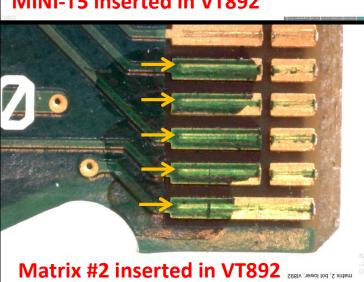
Other end of connector OK

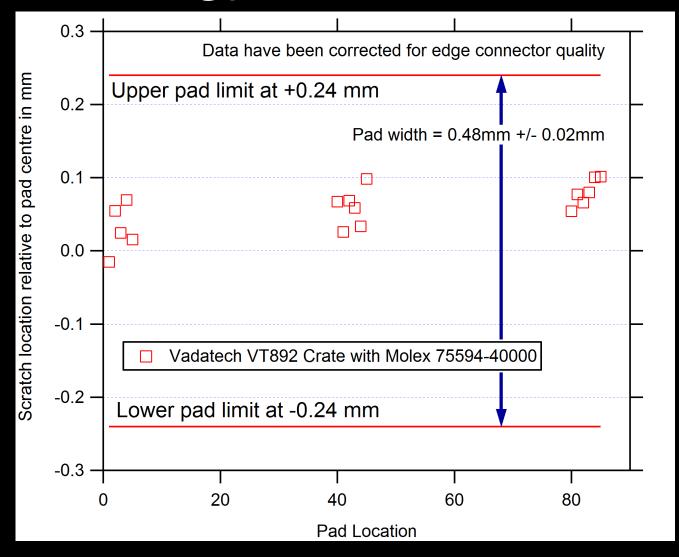
Metrology measurements

Scratch location relative to pad centre

Includes corrections applied for PCB scaling & offset

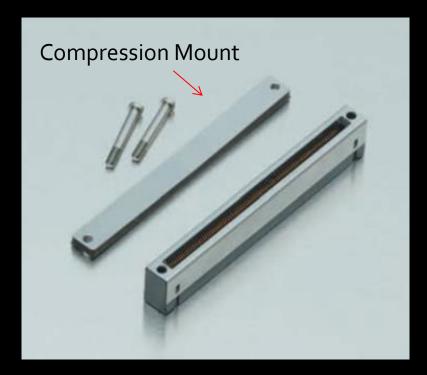
Yamaichi CNo8o *

* Not yet confirmed whether Elma use this exact part

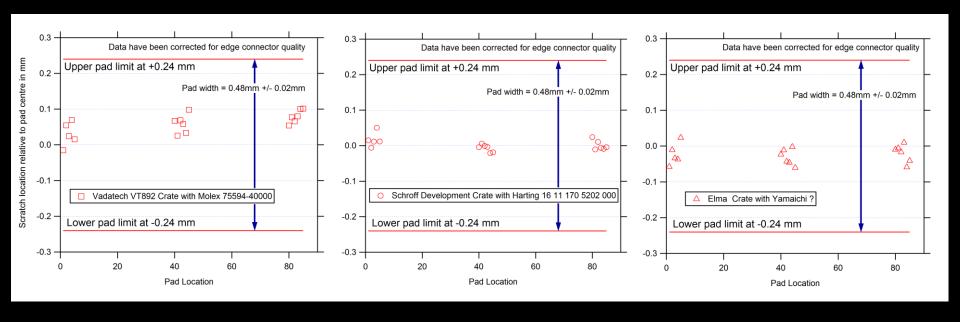
More Metrology measurements

Vadatech / Molex

Schroff / Harting

Elma / Yamaichi

Card inserted 5 times into the same slot

*** Note this is a very limited study. Would be good to have cross-check by another group ***

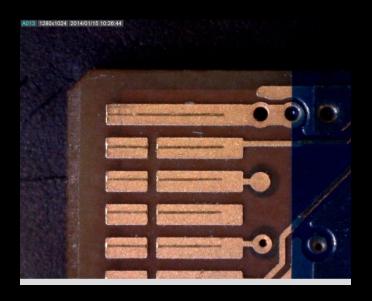
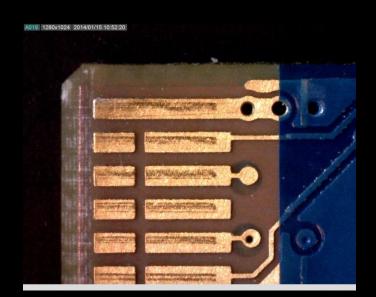
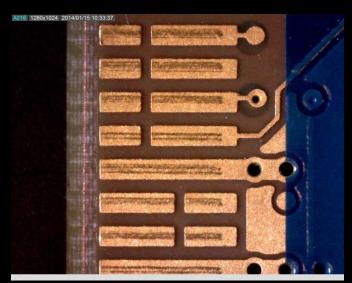
Schroff / Harting

Elma / Yamaichi
