## High Power test of T18\_VG2.4\_disk [2] at SLAC

- T18vg2.4\_disk [2] results to date
- HDX11\_electropolished\_big grains post mortem inspection

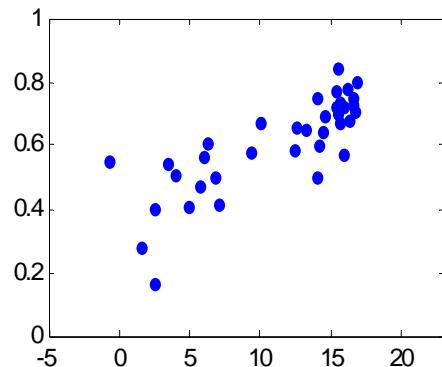
Missing Energy -vs- Breakdown Position (cell #)

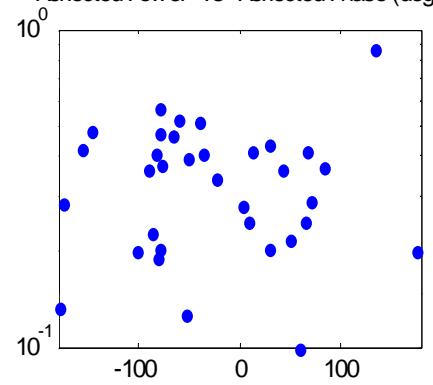
Reflected Power -vs- Reflected Phase (deg)

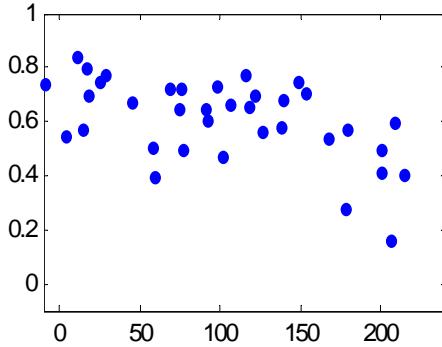
Missing Energy -vs- Time of Breakdown (ns)

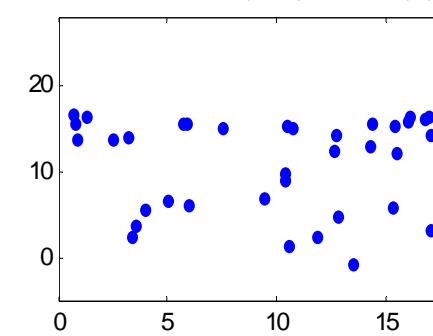
Breakdown Position (cell #) -vs- Time (hr)

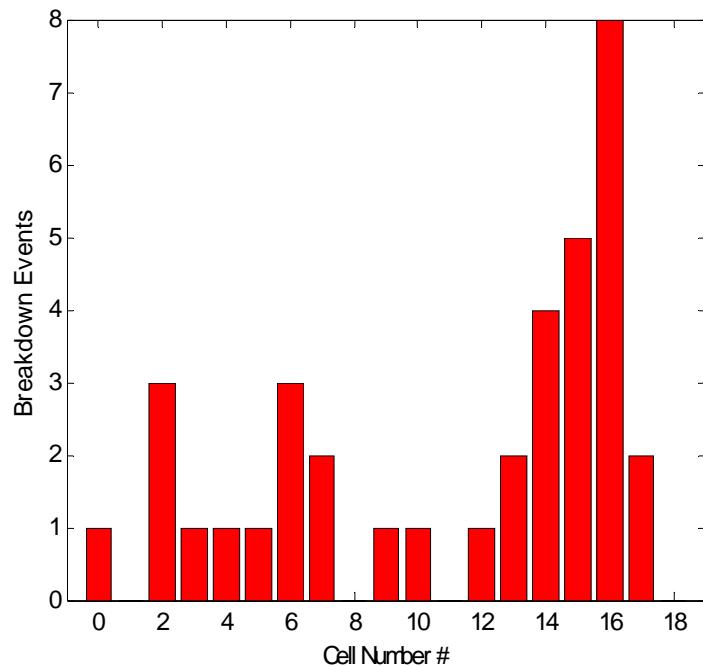
Breakdown Cell Distribution at 230ns

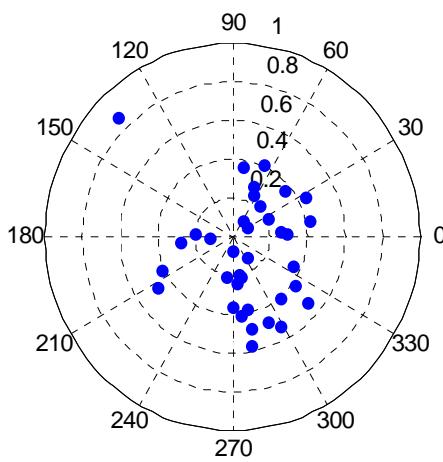
Reflected Power -vs- Reflected Phase

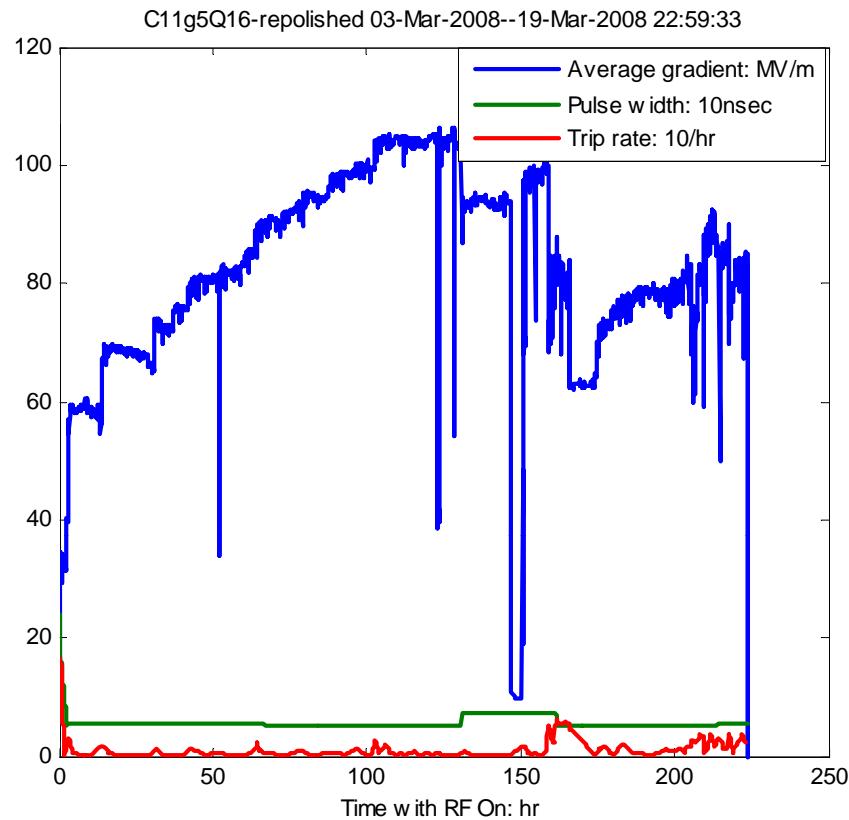
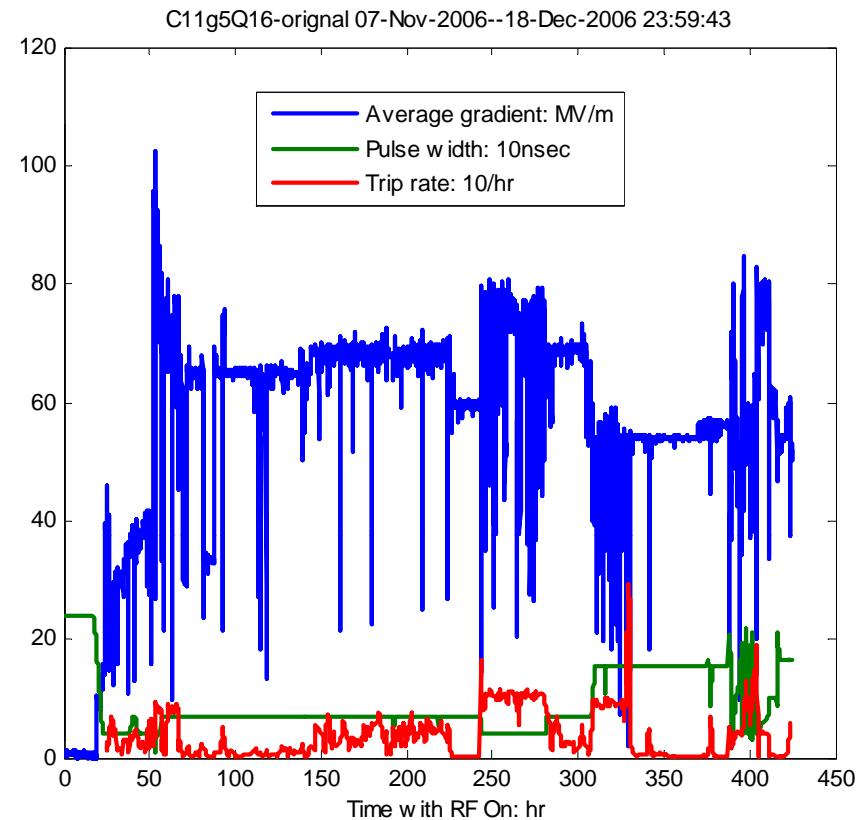
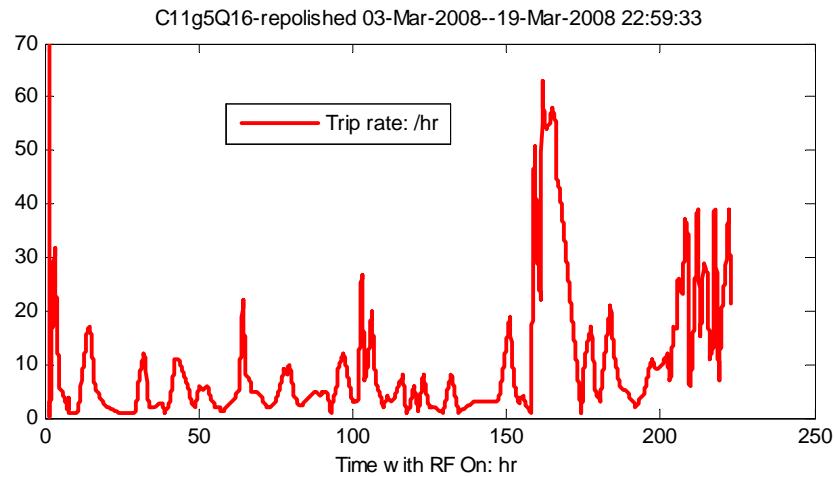
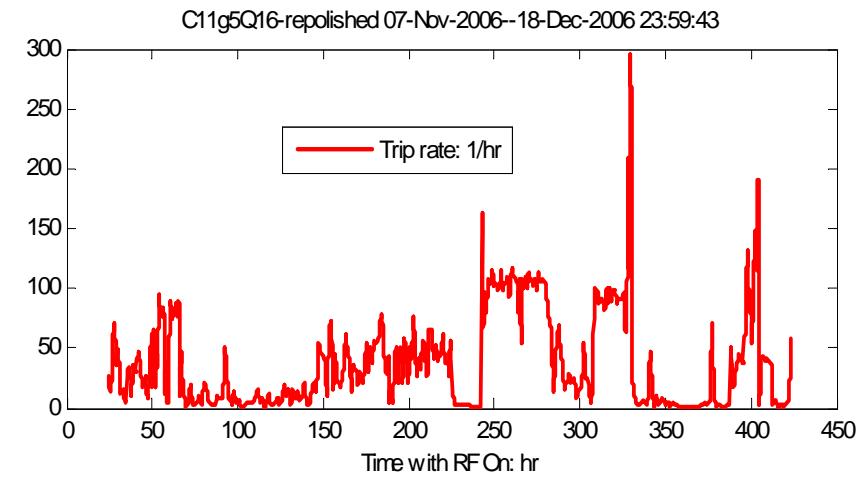
# HDX11 before and after electro polishing

- Quadrants were electro polished, and high temperature (1000 deg) hydrogen brazed, followed by 650 deg vacuum bake
- Structure was tested turned around and had similar results after a very promising start
- Post mortem analysis with SEM

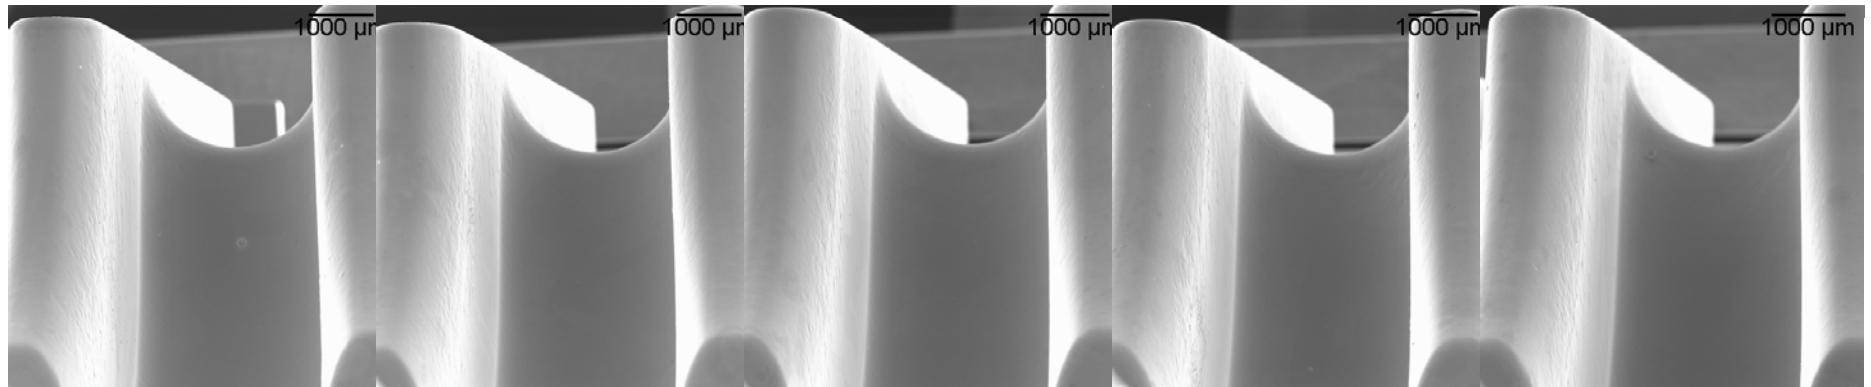
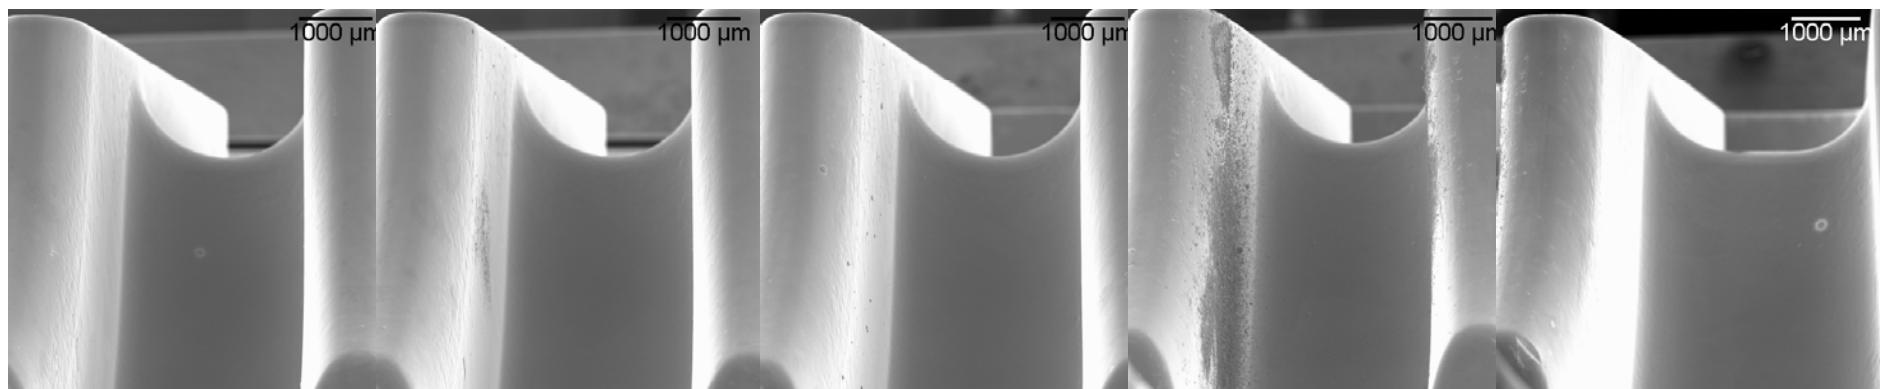
## SEM pictures

Mainly first regular cell damaged

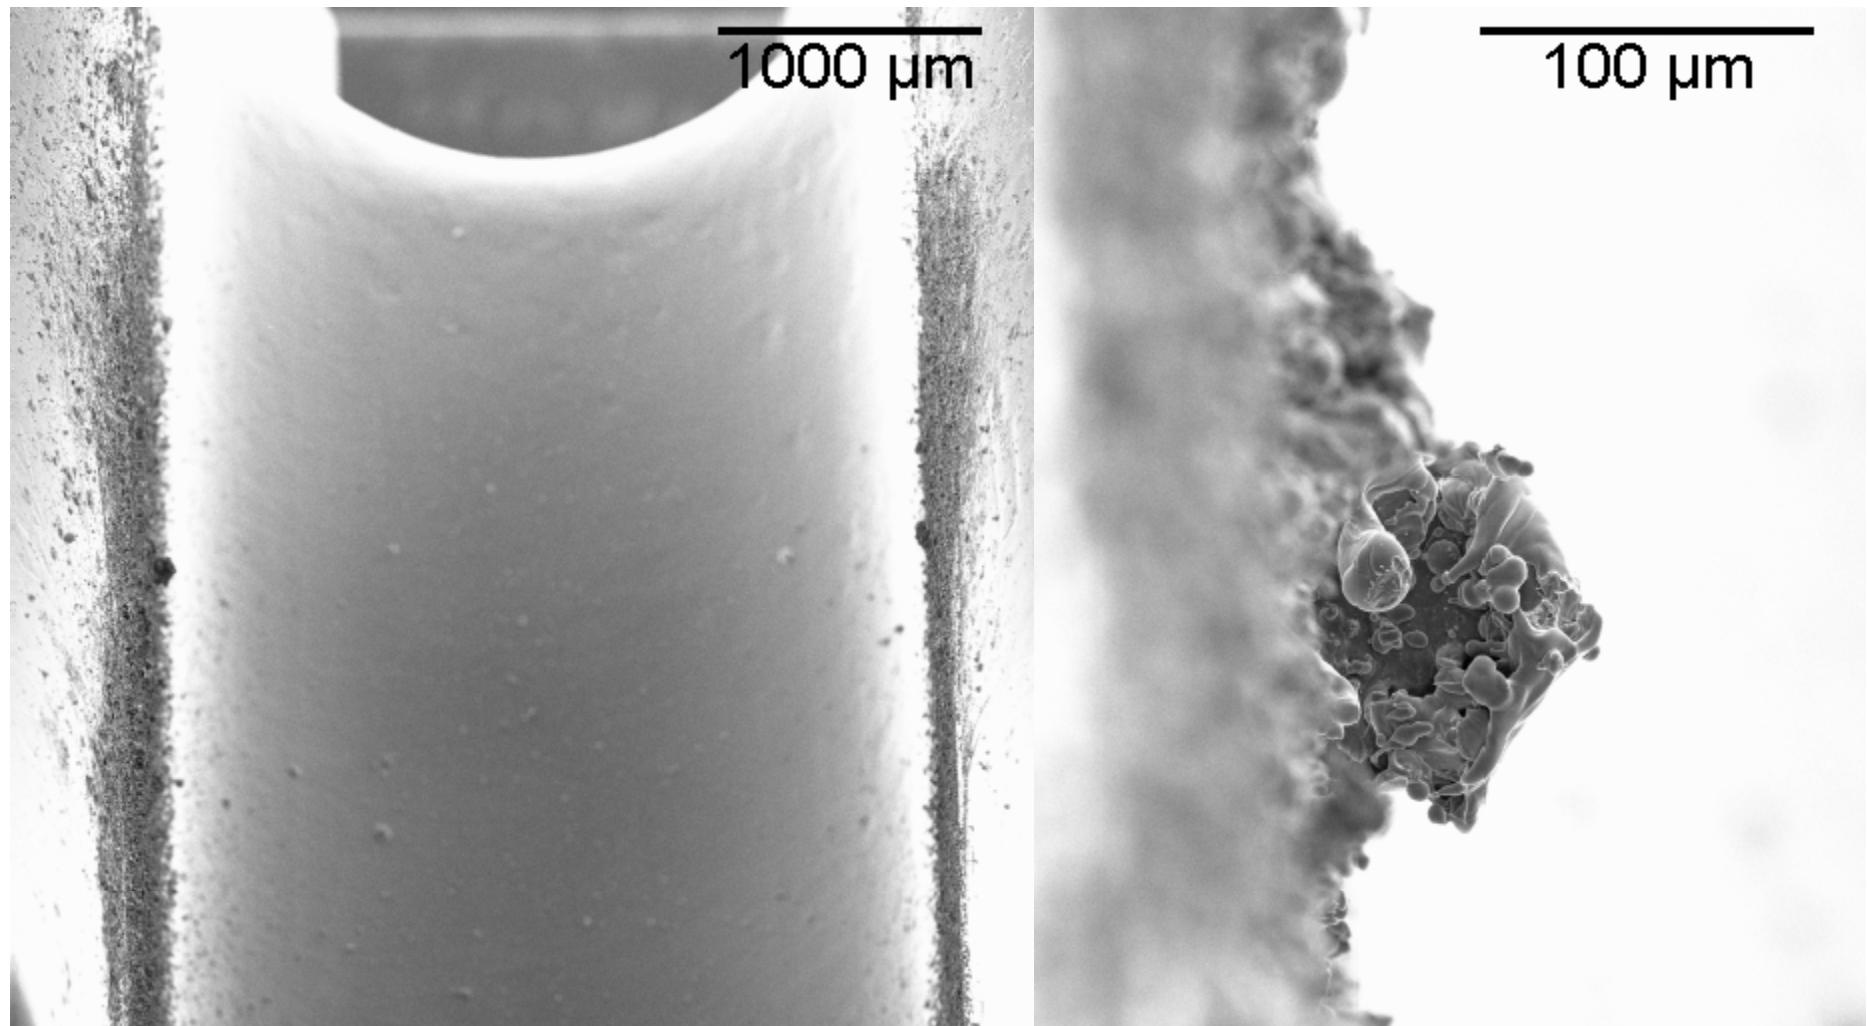
Cell No. 1 , growing tips  
are they connected ?

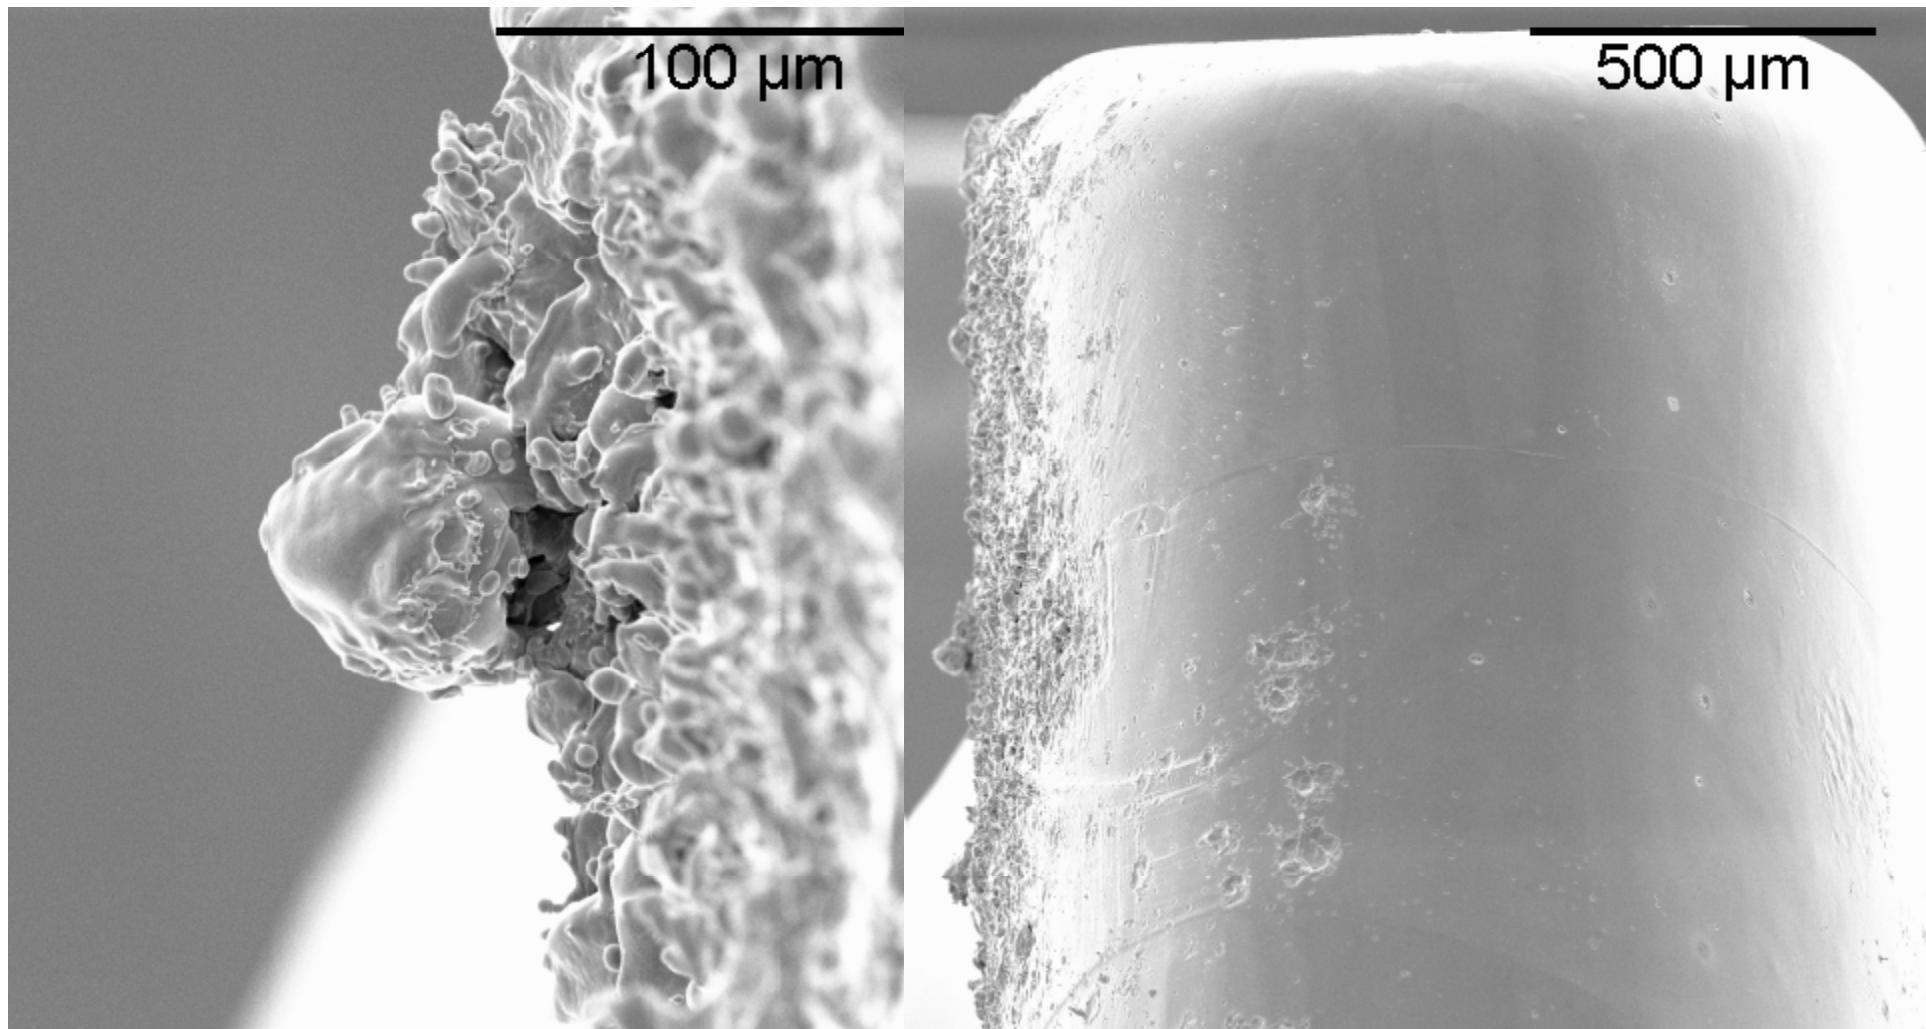
Cell No. 1 , growing tips

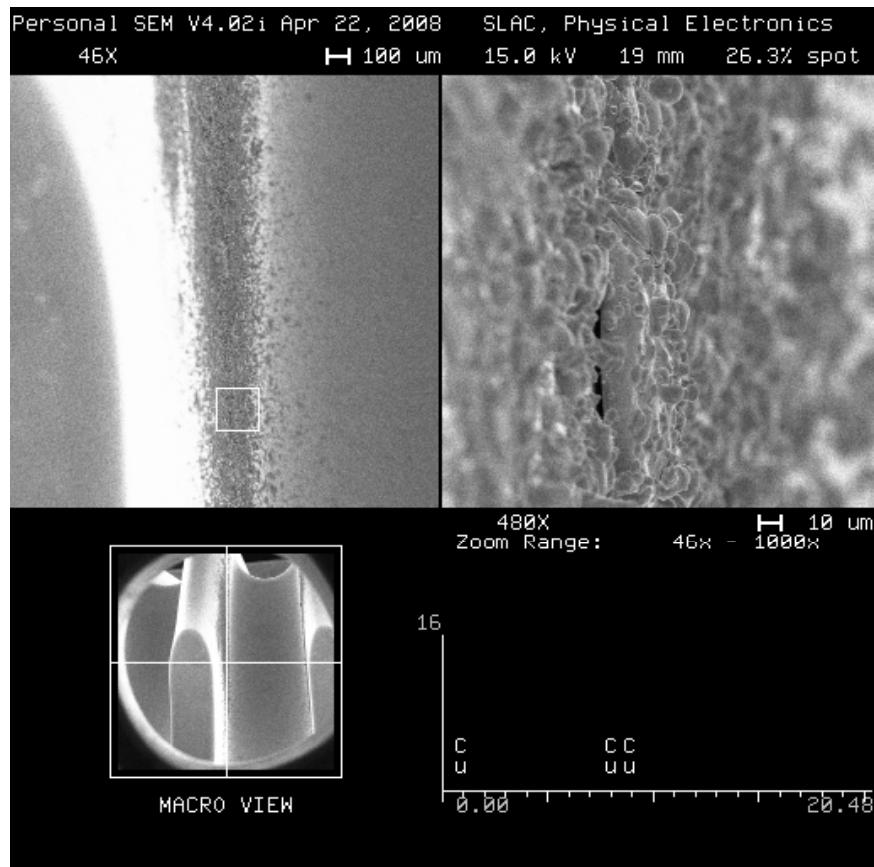
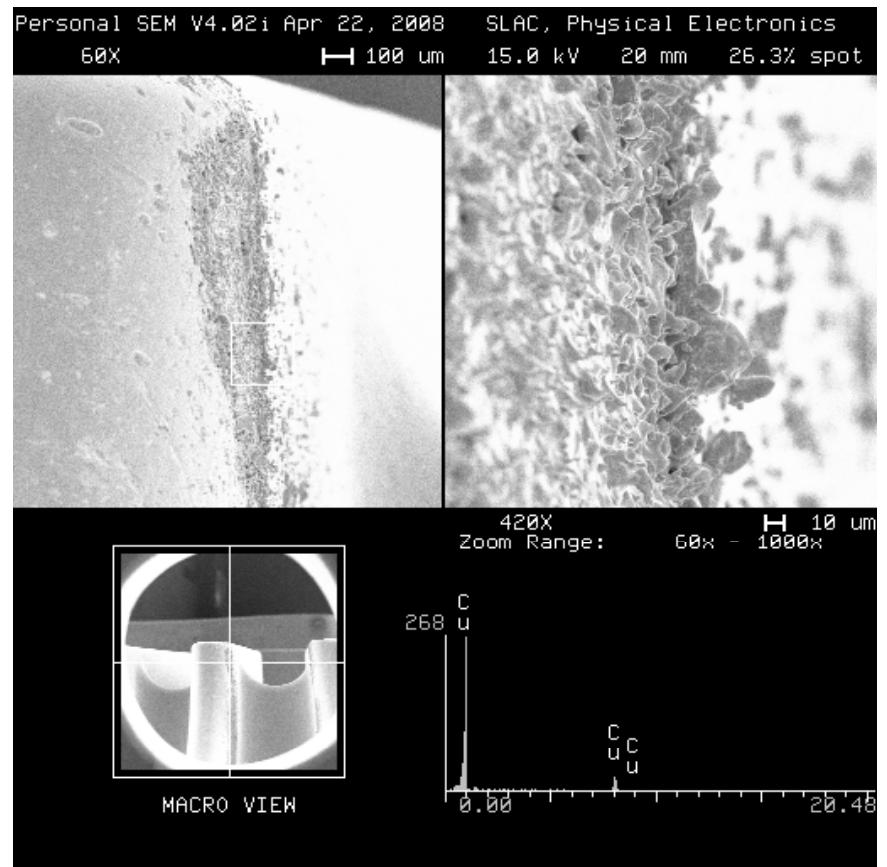
Cell No. 1 , voids and cracks ?

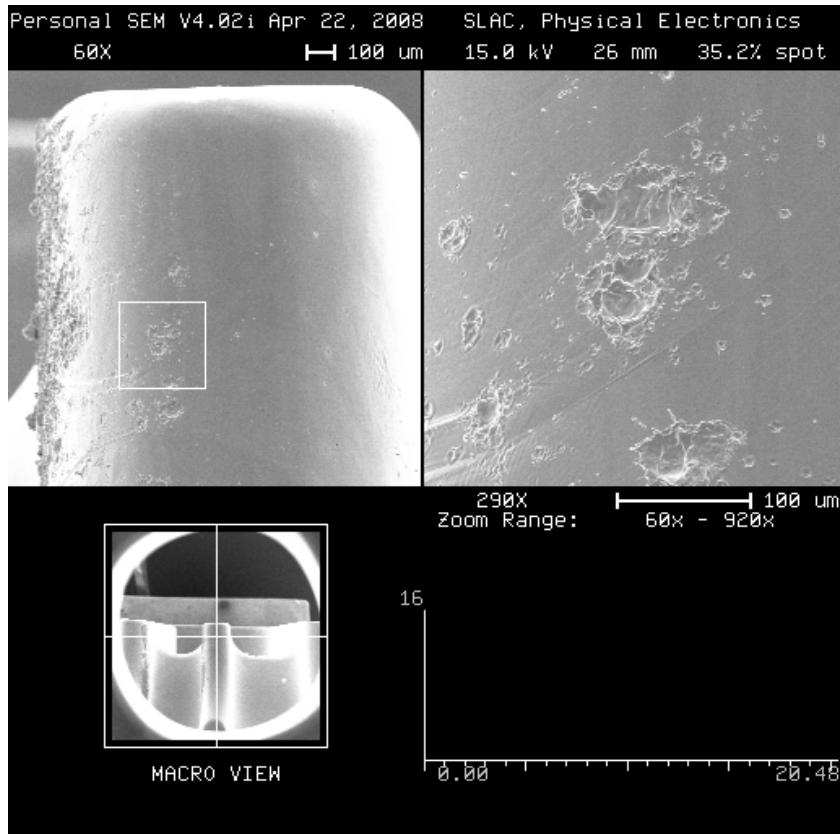
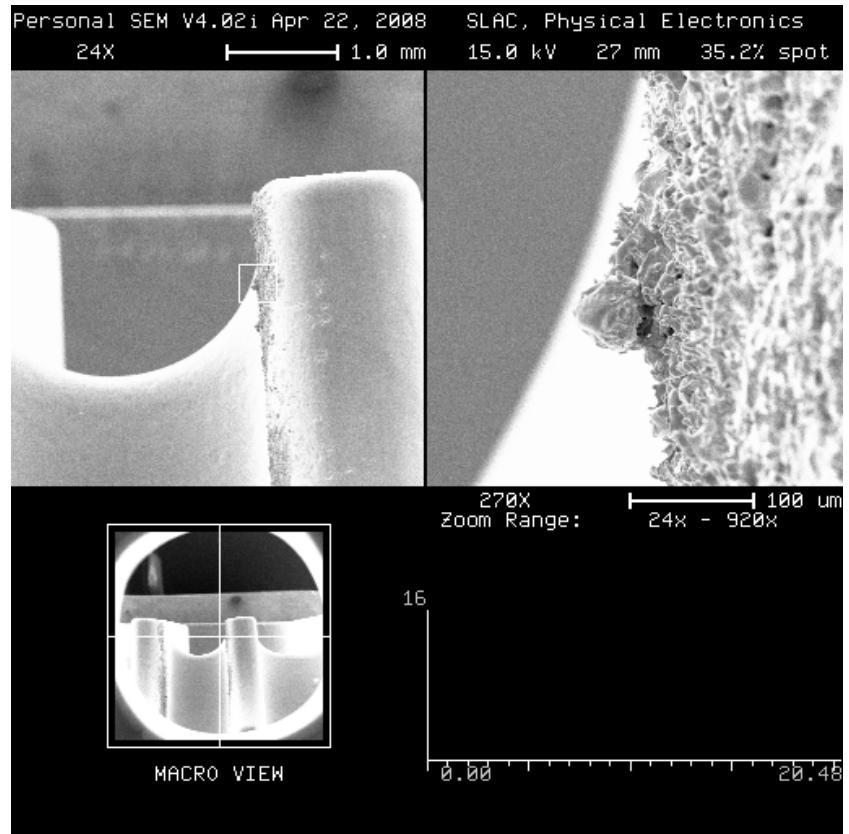
Cell No. 1 , damage  
craters vs lava field

Is this just more of the same  
or a new quality ?

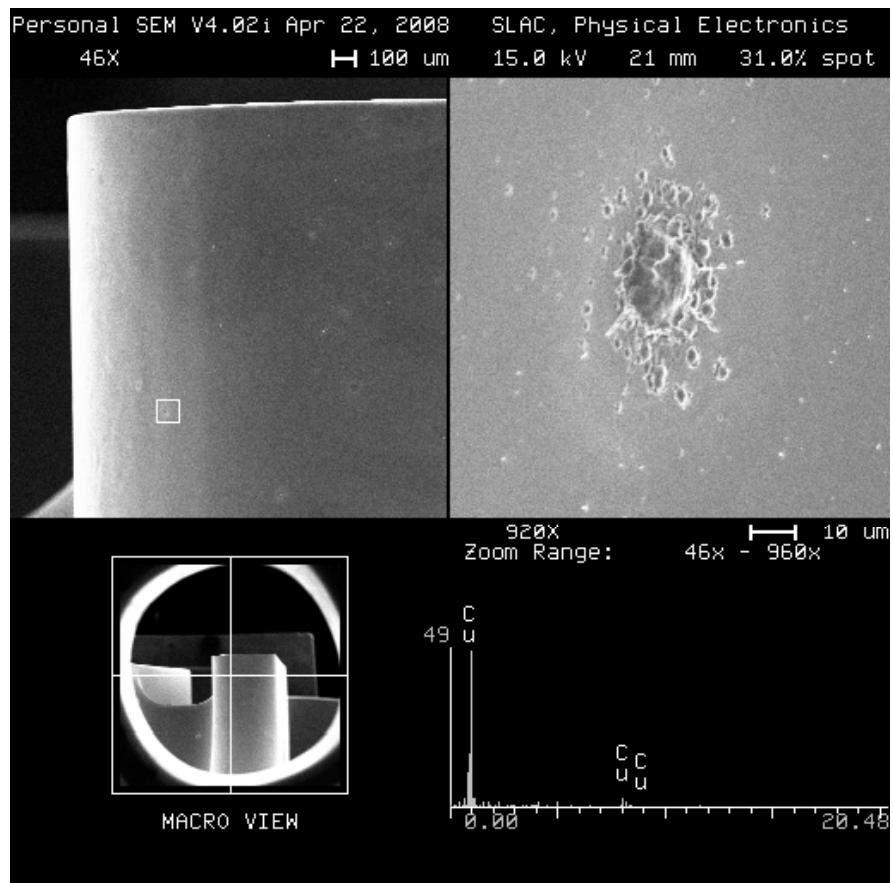
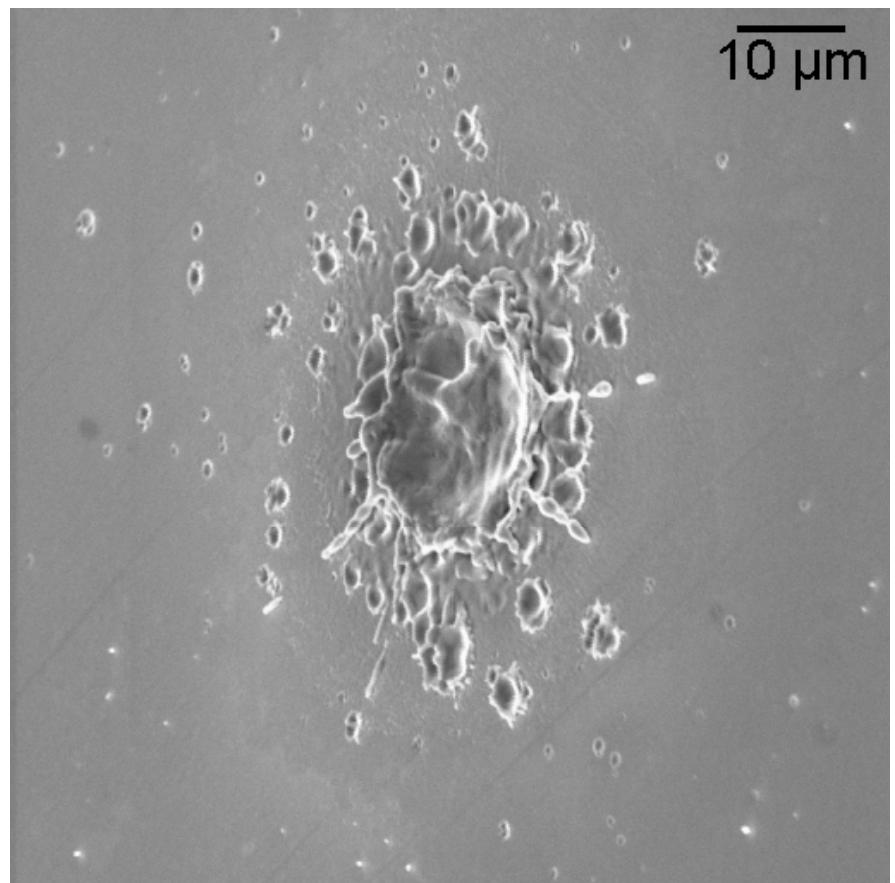
Splash, mechanism, where does it come from

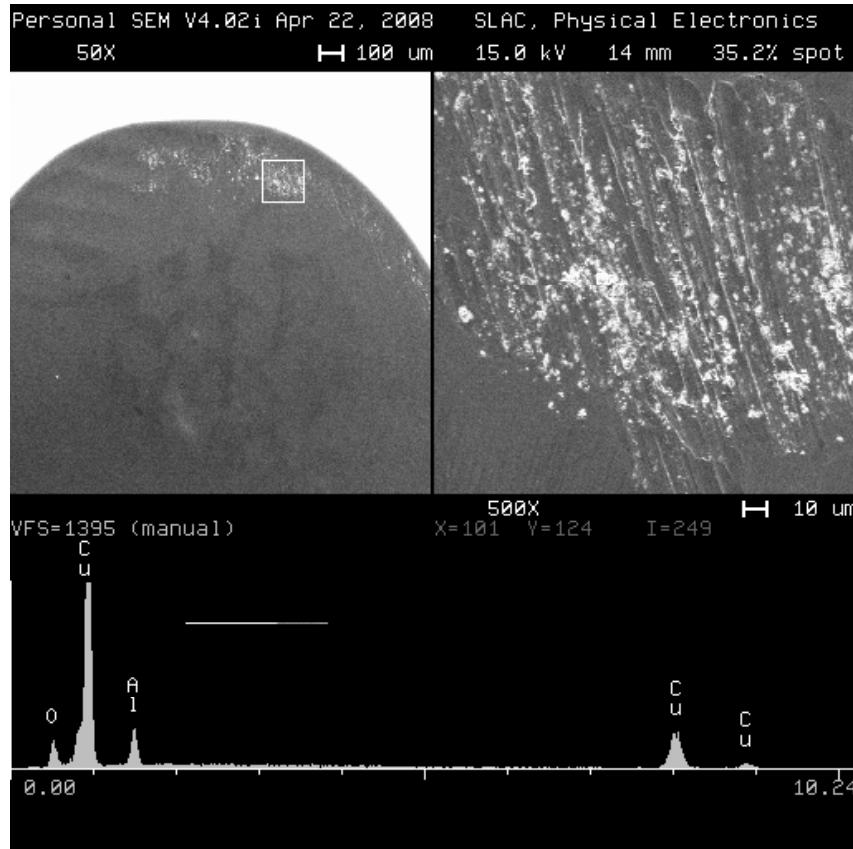
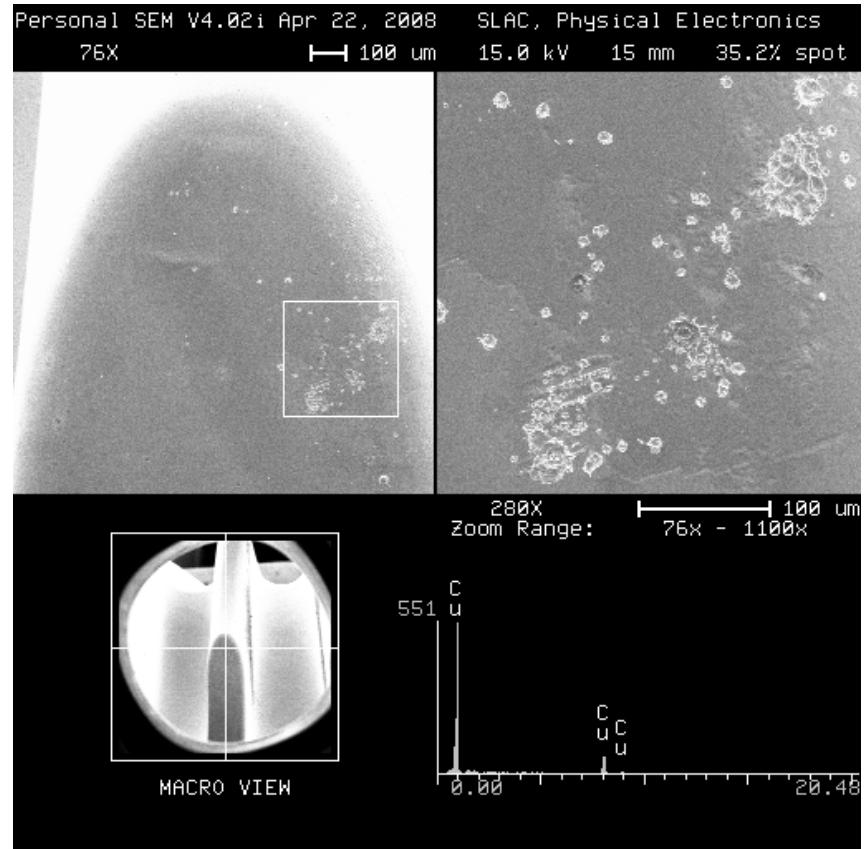
Slot activity, there are fields  
high enough to melt Copper

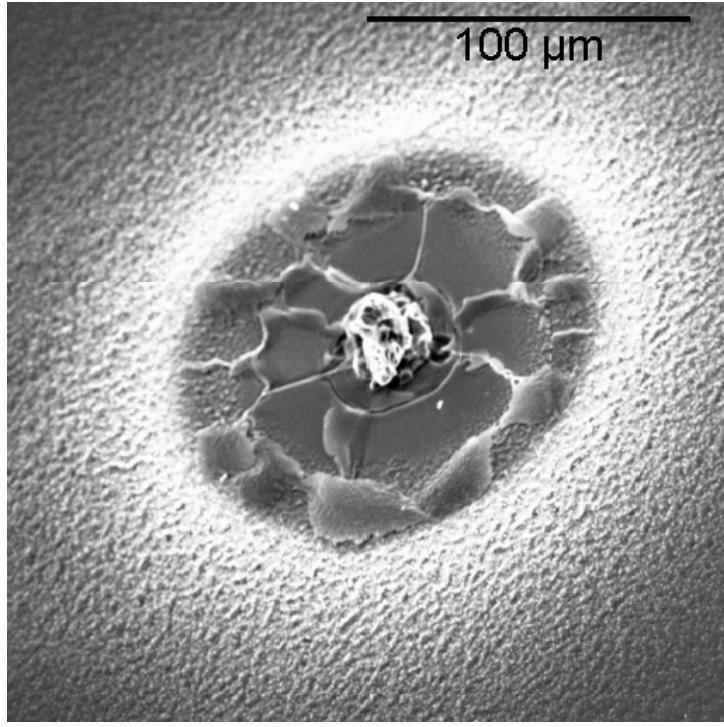
A nice particle, most likely  
before baking

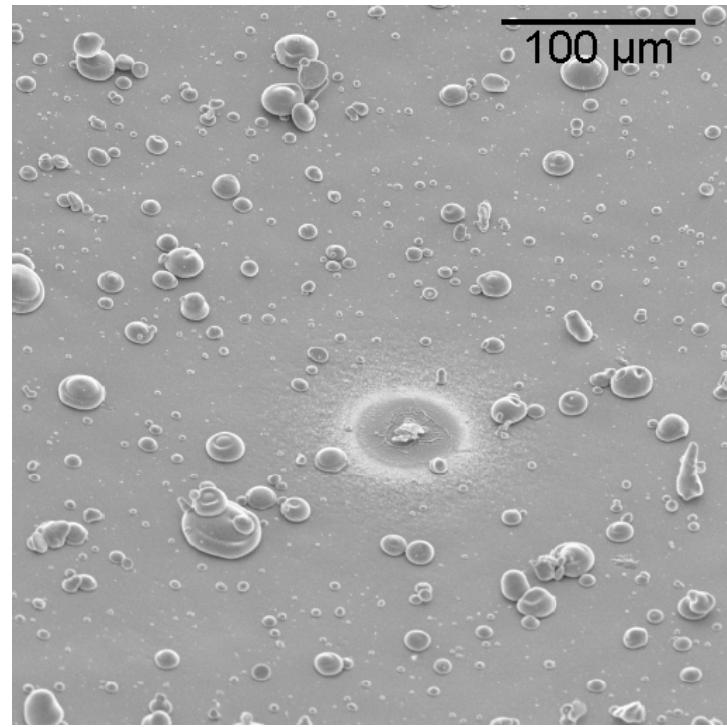
Droplets on the cell bottom
