# Structure Fabrication Status, SLAC

Juwen Wang

Stanford Linear Accelerator Center

CLIC08

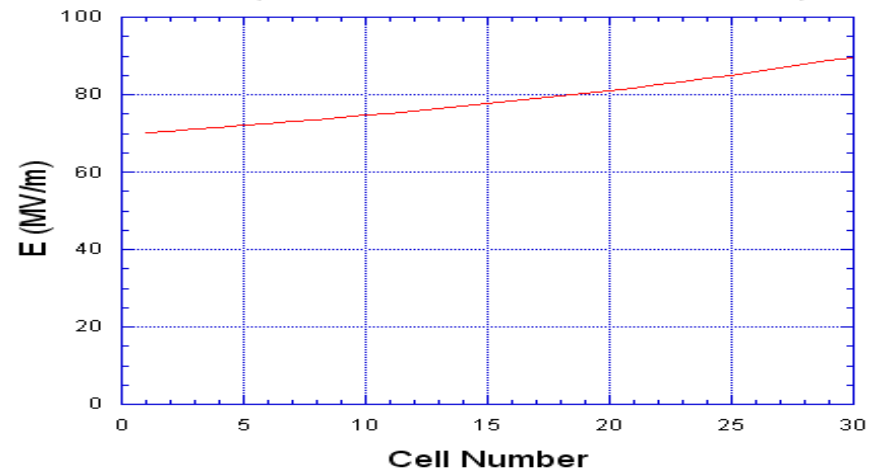
Accelerating Field with Input 50 MW  
T26 (Even or Odd Cells of T53VG3)

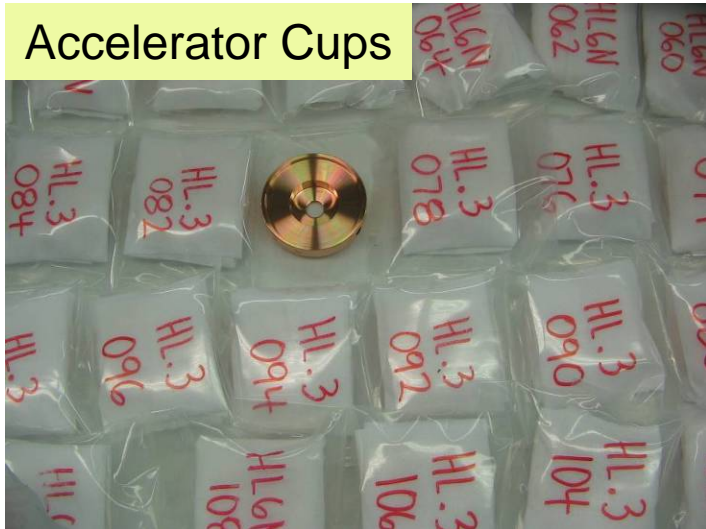
Accelerator Cups

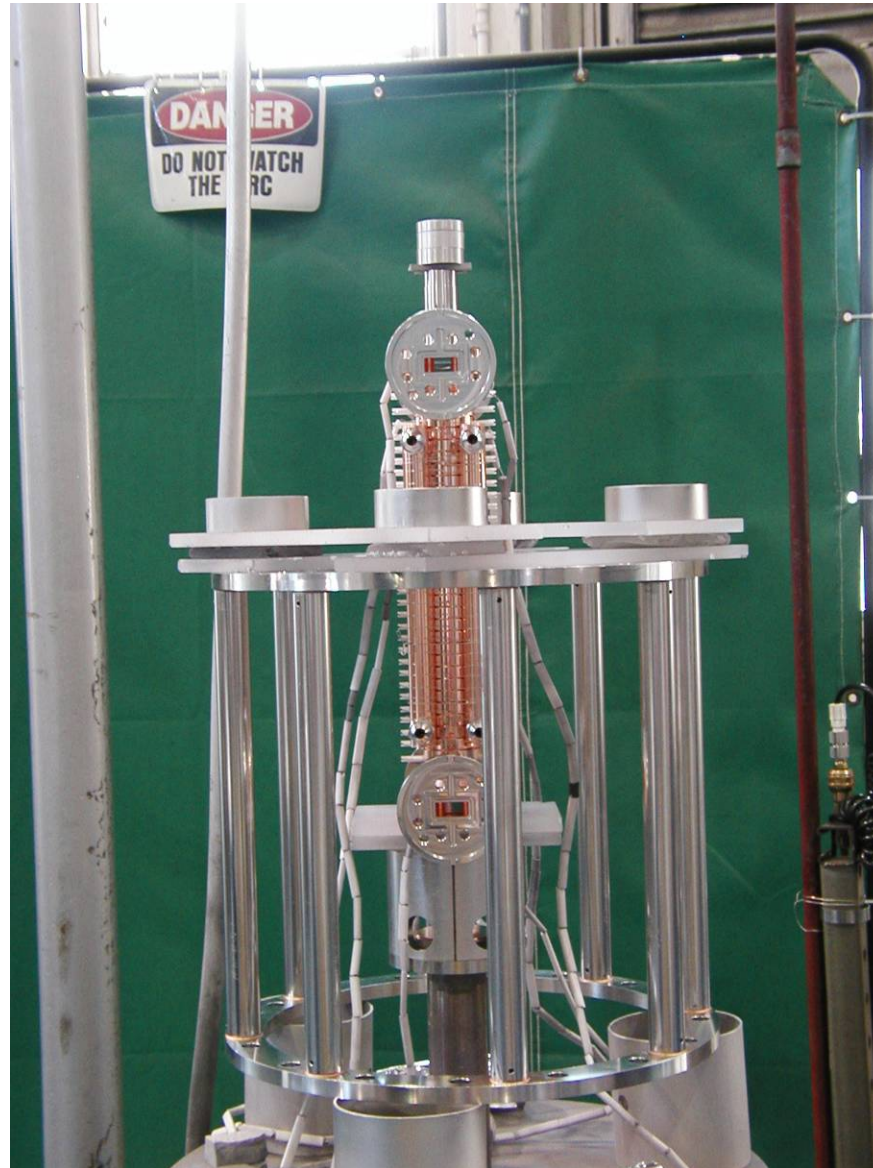
# Setting Up for Brazing of T28\_vg2.9 (T26) Structure

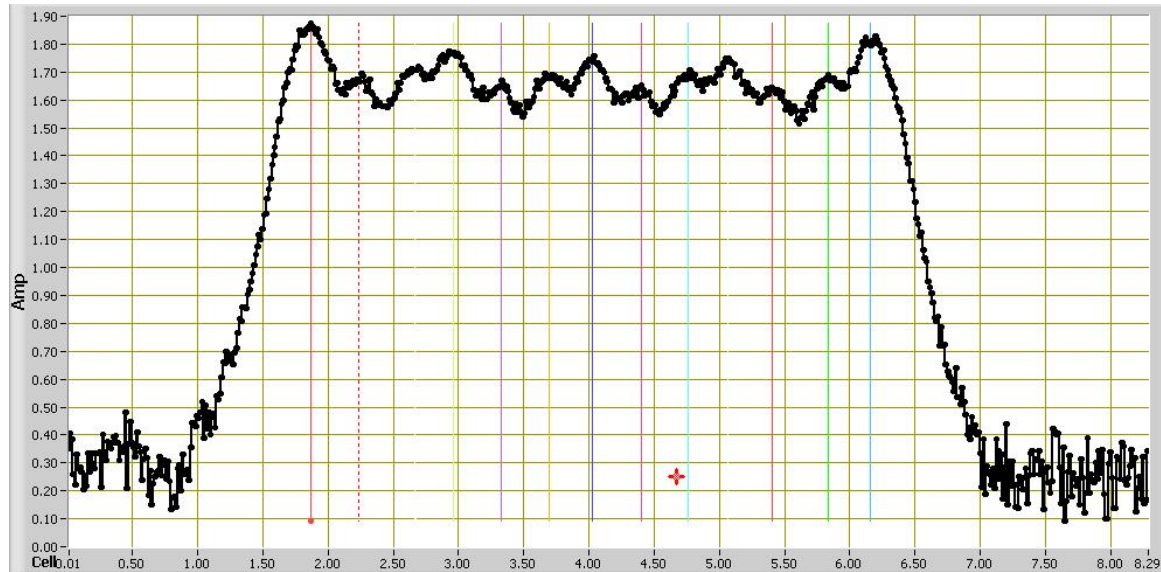
# HDX11 Cu Structure after Reassembly

Field  
Amplitude

- The field distributions based on the bead pulling studies were done for the frequency from 11405 MHz to 11430 MHz, the corresponding cumulated RF phase shift was ranging from 65 degrees to 28 degrees. the amplitude modulation gets worse when the phase shift reduces. When we do the high power tests, we have to consider the uniformity of the fields: the couple cells have higher field and every four cells have higher fields. As we know the trip rate could on order higher, when the gradient increase 10%.
- At this stage, it is hard to determine the exact impact to the frequency from the electrical polishing, because of lack of comparison with data before polishing.
- All S parameters of S11, S12, S22 were recorded. The filling time was measured to be ~ 4 ns.
