# Focus Coil

## Video Conference – 20/03/14

# Recap (up to CM38)

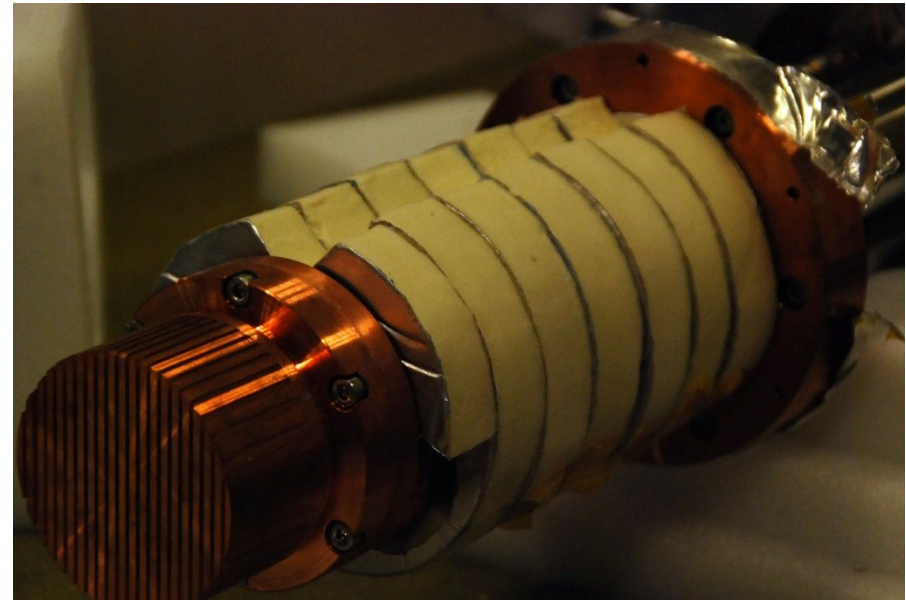
*Pre-cool down work*

- Insulation added between first and second stages on cryocoolers to reduce parasitic losses
- Support strap tension increased to intended level -  $\sim 100\text{kN}$  @ room temperature

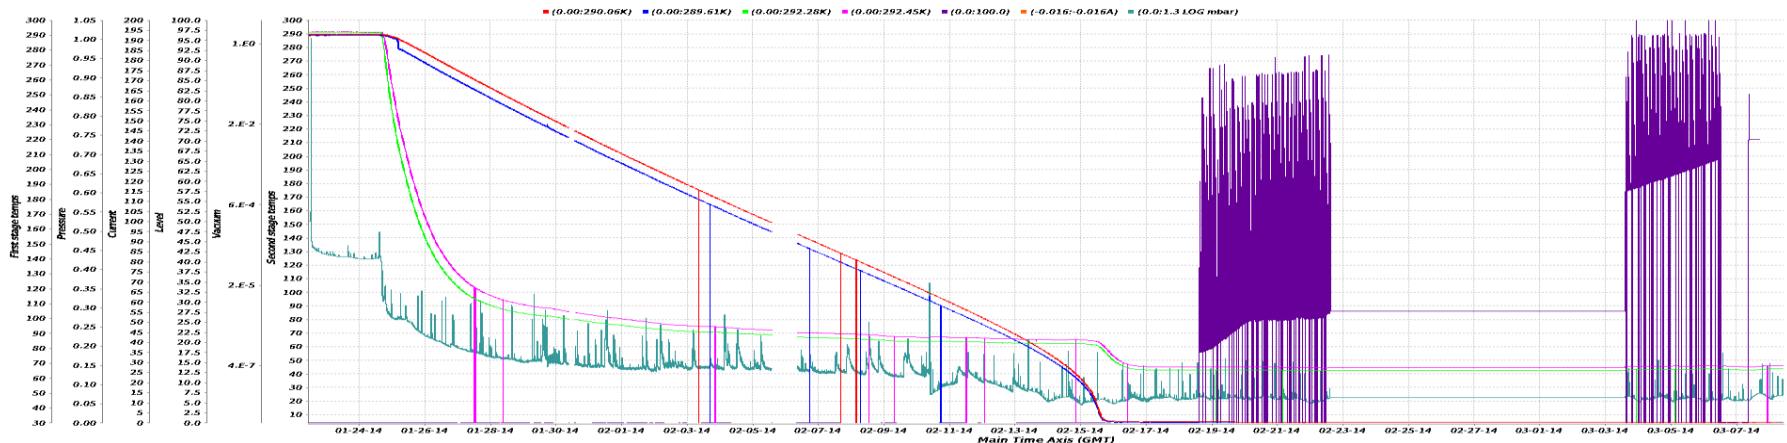
## Cooldown

- After experience with FC#2, similarly thorough leak checking discovered a 'previously unknown' leak rate of  $\sim 6.5 \times 10^{-7}$  mbar.l/s
- Doesn't change with cold mass temperature, so likely in a 'warm' location (first stage cryosock?)
- Otherwise, cooldown proceeded normally and completed in  $\sim 3$  weeks

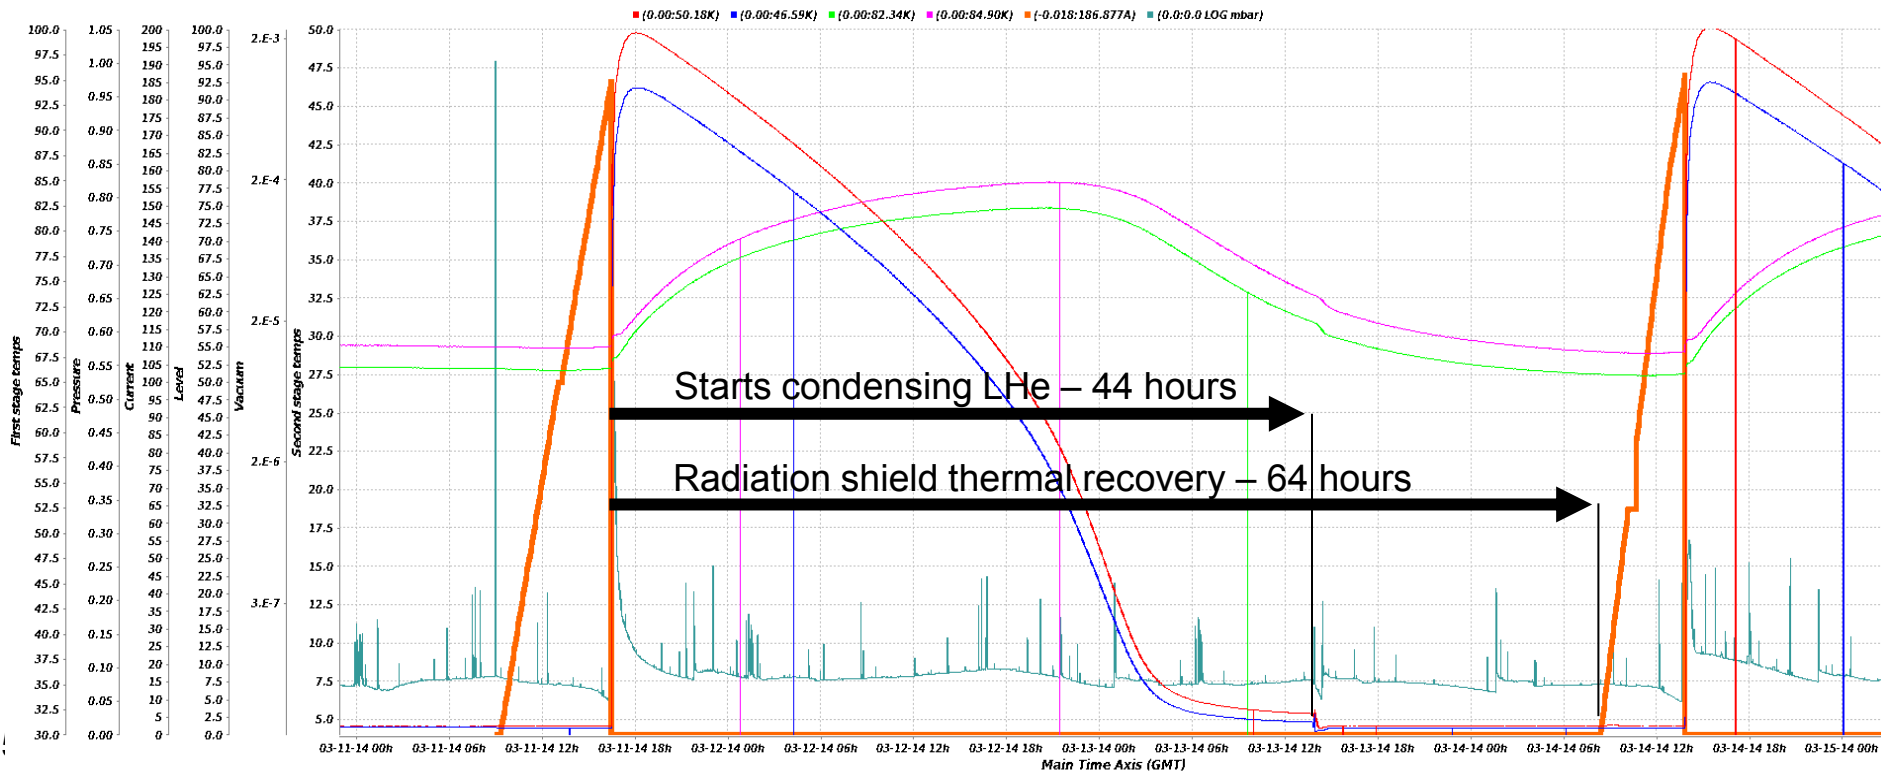
## Training

- First run reached 185.1A (Tuesday 11<sup>th</sup>)
- Module recovered in less than 48 hours
- Second run reached 187A (Friday 14<sup>th</sup>)

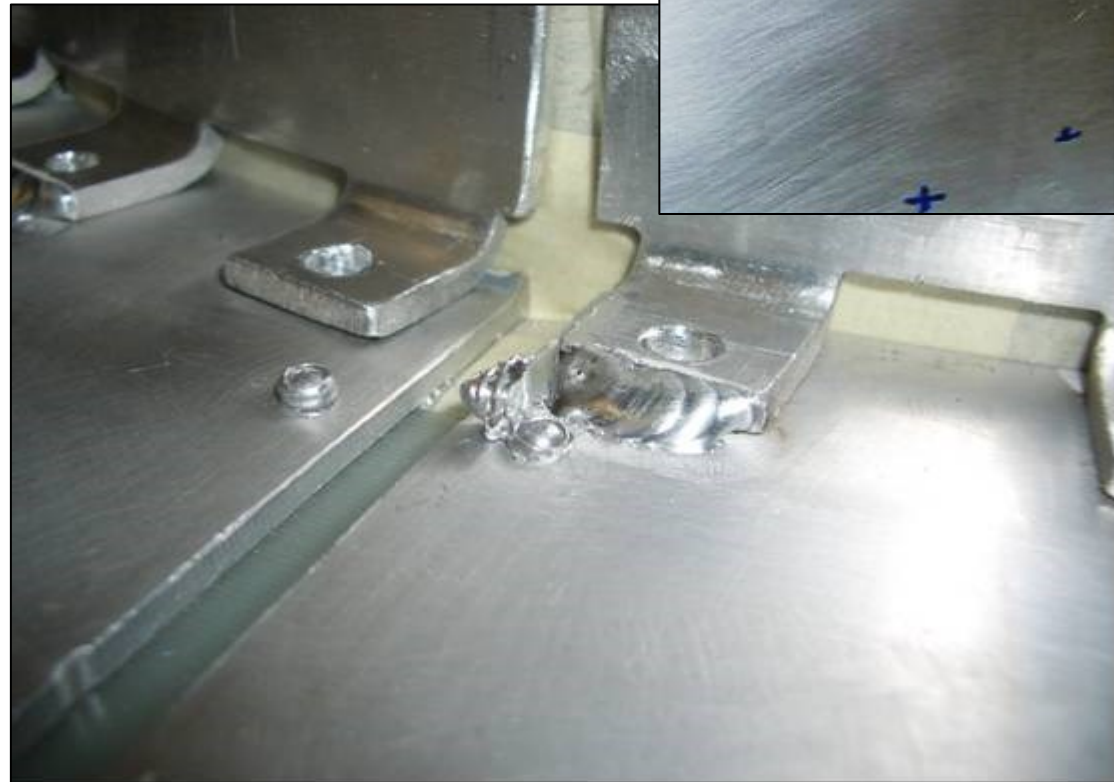
- Thermal short cause finally found – debris of an old pop-rivet on the radiation shield pressing into the cold mass
- Some evidence of bore misalignment
- Location of leak still unknown
- Sensor failure cause ambiguous

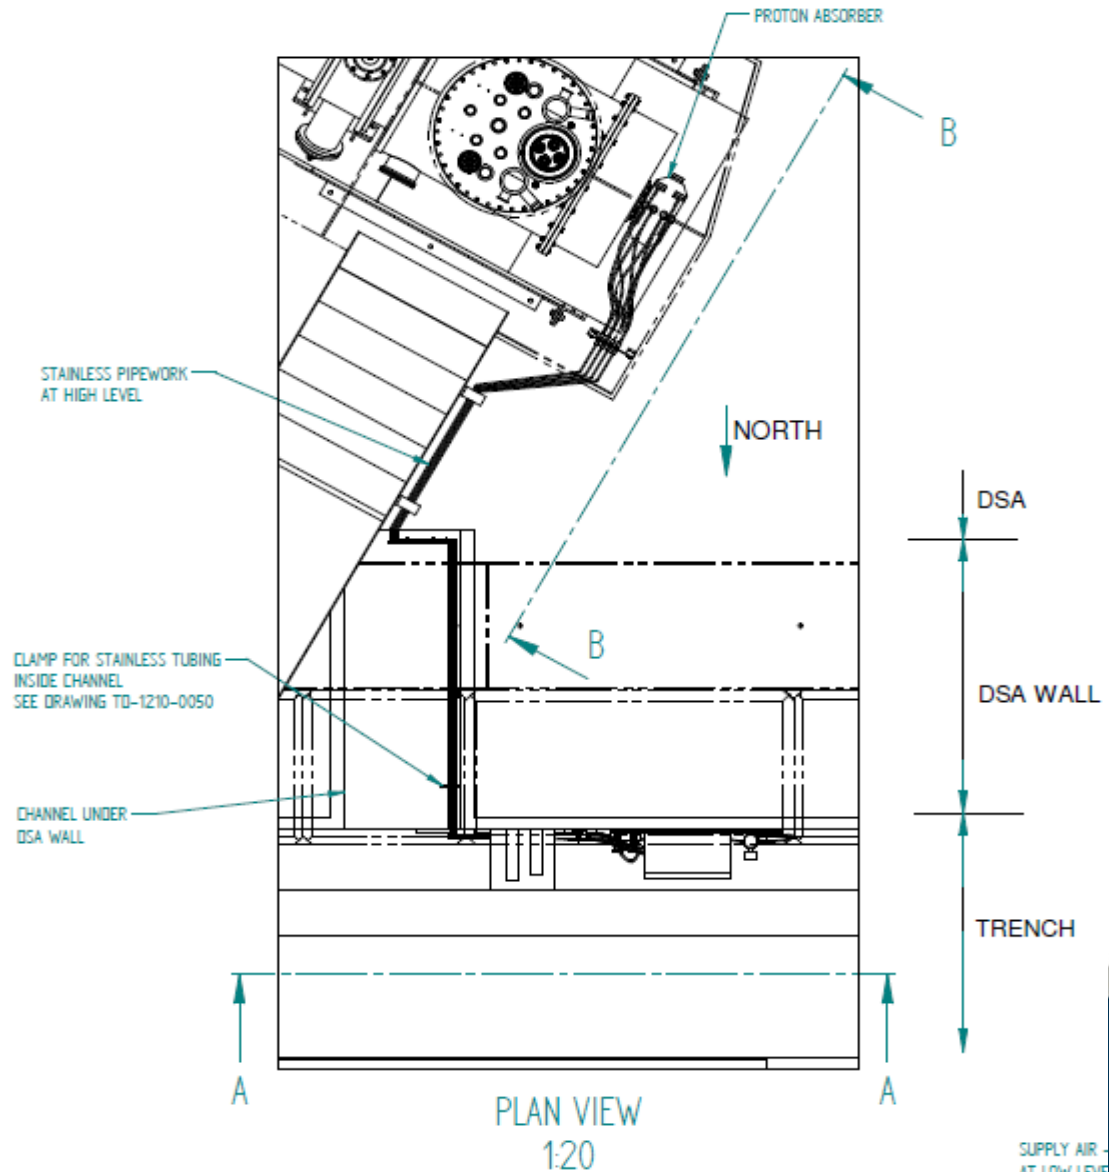
- To be installed and surveyed during Easter shutdown
- Will run off building air
- A 'soak' test will be carried out to identify any break-in failures
- A systematic test of the mechanism will implemented

- Pneumatic system designed and mounted on an aluminium plate
- Mechanism tested in R9 using N2 bottle supply
- Piping route from MICE Hall trench to DSA determined
- Operational procedure and risk assessments written
- Currently being measured in metrology (location of bore axis to 4 fiducial markers)
