# NLCTA Structure Tests Post NLC/GLC

C. Adolphsen, S. Döebert, G. Bowden,  
R. Fondos, L. Laurent, F. Wang, J. Wang

# NLCTA X/L-Band Structure Tests Post NLC/GLC

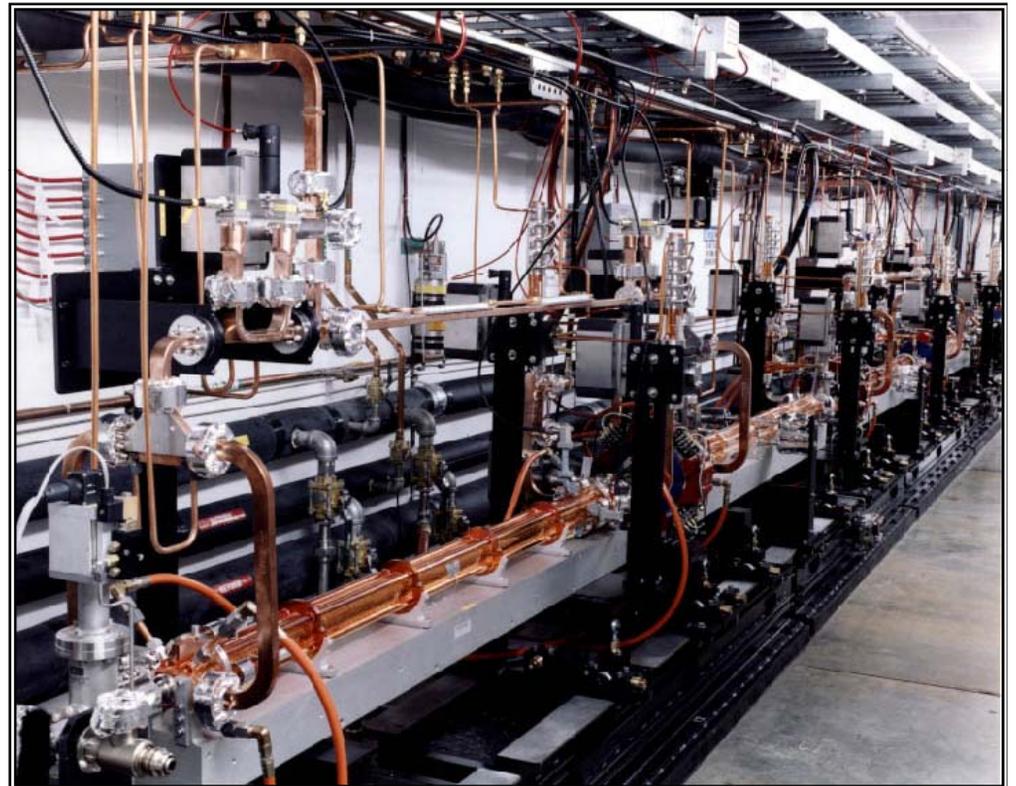
# X-Band Structure Stations at NLCTA in ESB

Station 1 and 2 each:

Are powered by two 50 MW Klystrons  
whose 1.5  $\mu$ s pulses are combined  
and compressed using SLED-II

Produce up to  $\sim 300$  MW at 240 ns  
 $\sim 150$  MW at 400 ns

Have two, 2.5 m slots for structures

Can run 24/7 using automatic controls

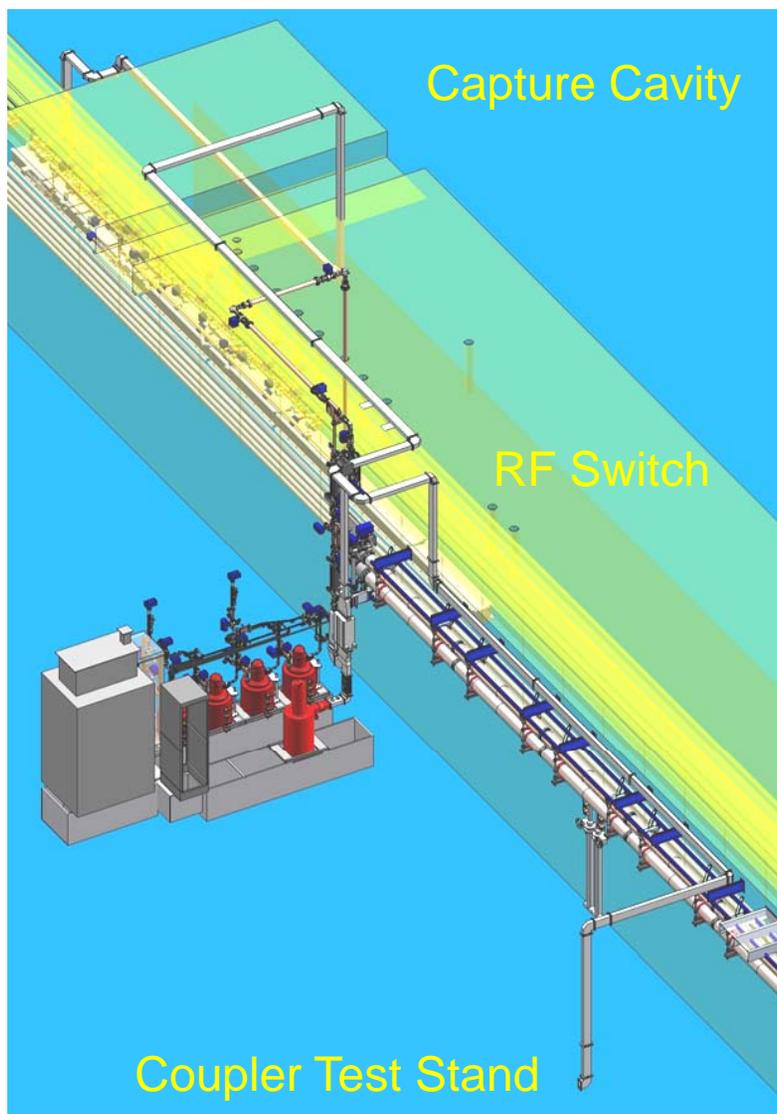
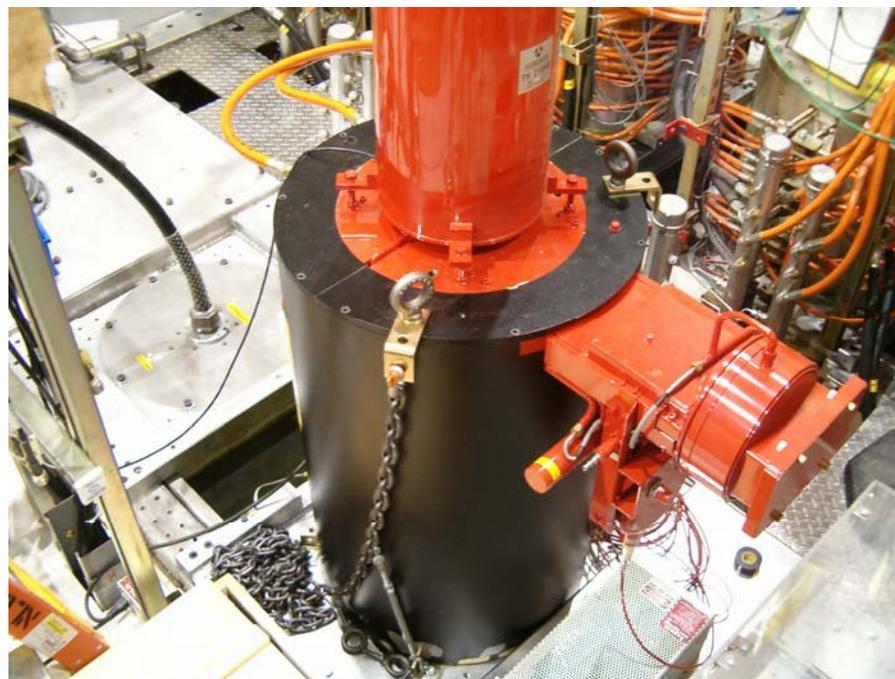
# L-Band (1.3 GHz) Test Stand at ESB

Produces 5 MW, 1.4 msec pulses at 5 Hz  
with a TH2104C klystron and a SNS-type  
modulator

Source powers a coupler test stand and a  
normal-conducting ILC e<sup>+</sup> capture cavity

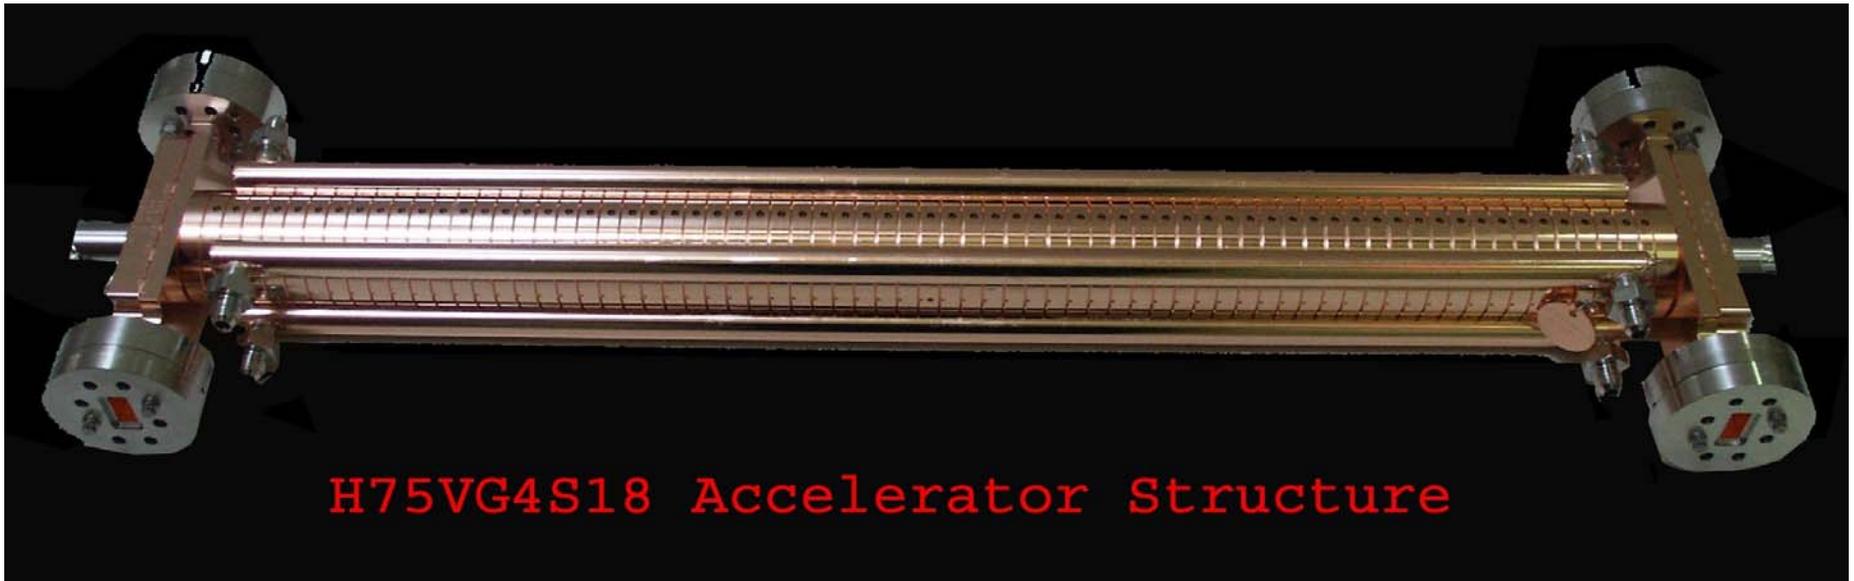
# Longer, Higher Group Velocity NLC/GLC Structure

75 cm long,  $a/\lambda = 18\%$ , initial  $vg = 4\%$ ,  
requires 173 MW for 100 MV/m operation

With 150 ns square pulses, breakdown  
rate =  $6e-6$  at 102 MV/m – same bkd  
rate/length as the T18\_VG2.4 structure  
( $a/\lambda = 13\%$ , 56 MW for 100 MV/m)

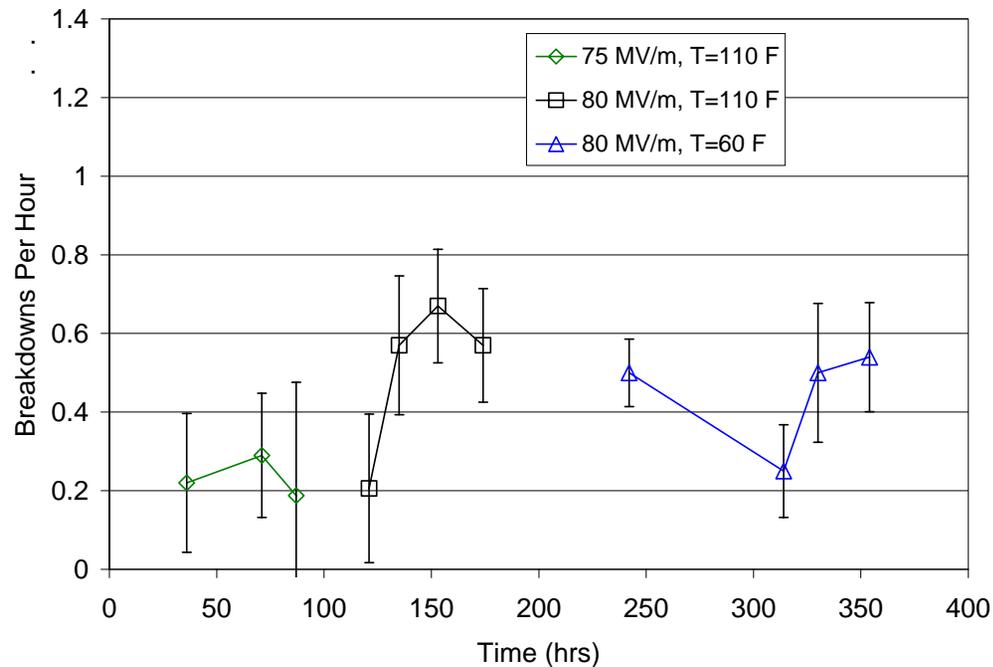
# H75VG4S18 Cool Down Test

- Operated structure at 60 Hz with 400 ns ramped pulses up to 80 MV/m.
- Lowered cooling temperature from 43 degC to 15 degC (and increased frequency by 5.4 MHz) – see little effect on bkd rate.

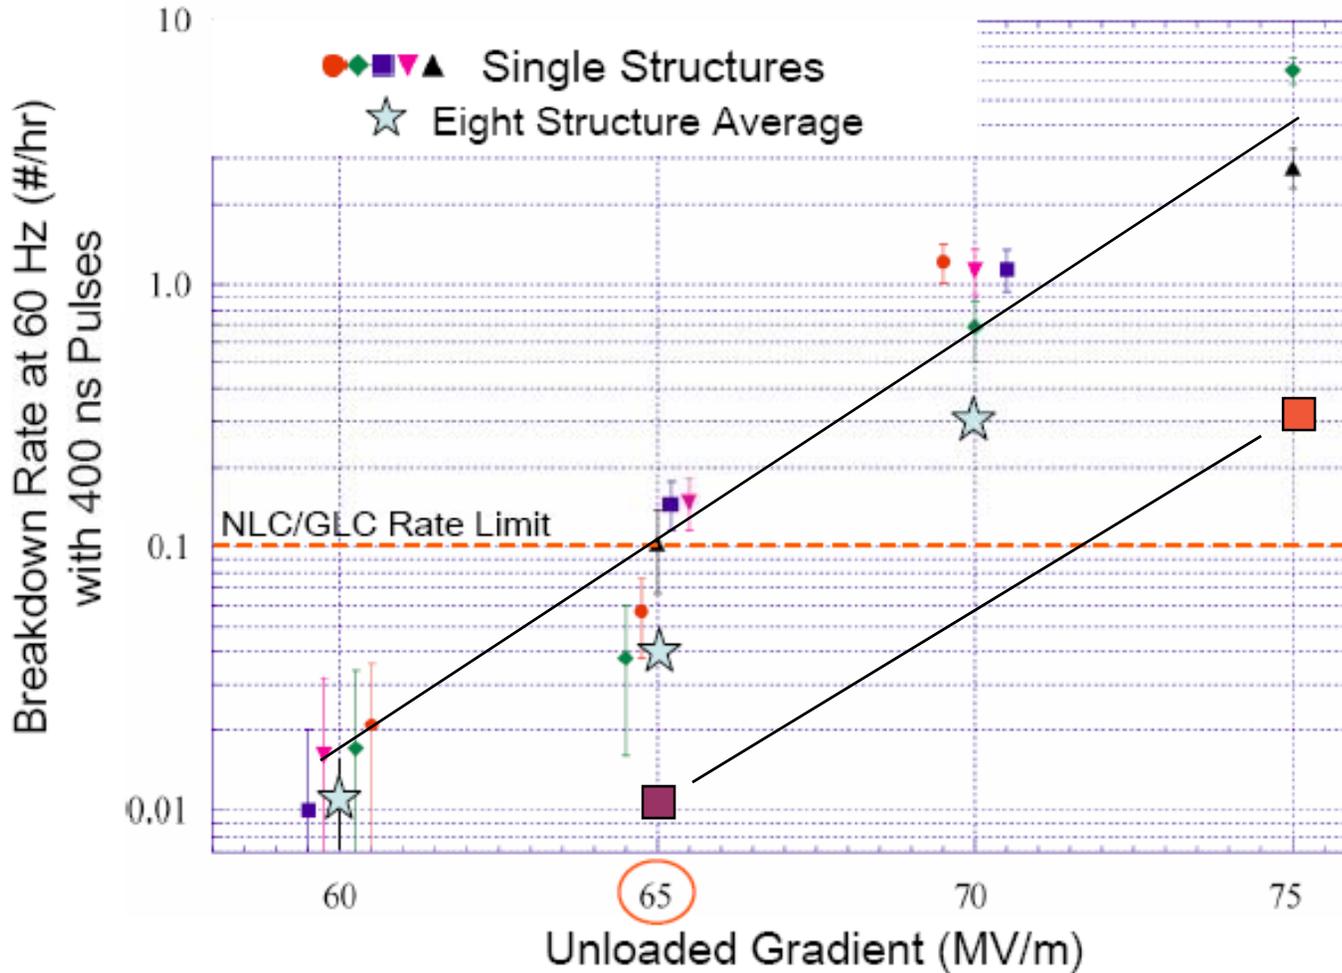
# High Gradient Performance

5 Structures after ~ 500 hr of Operation and  
8 Structure Average after > 1500 hr of Operation

■ FNAL FXB6 structure

■ KEK H75VG4S18 test in early 2006 with 400 ns pulses

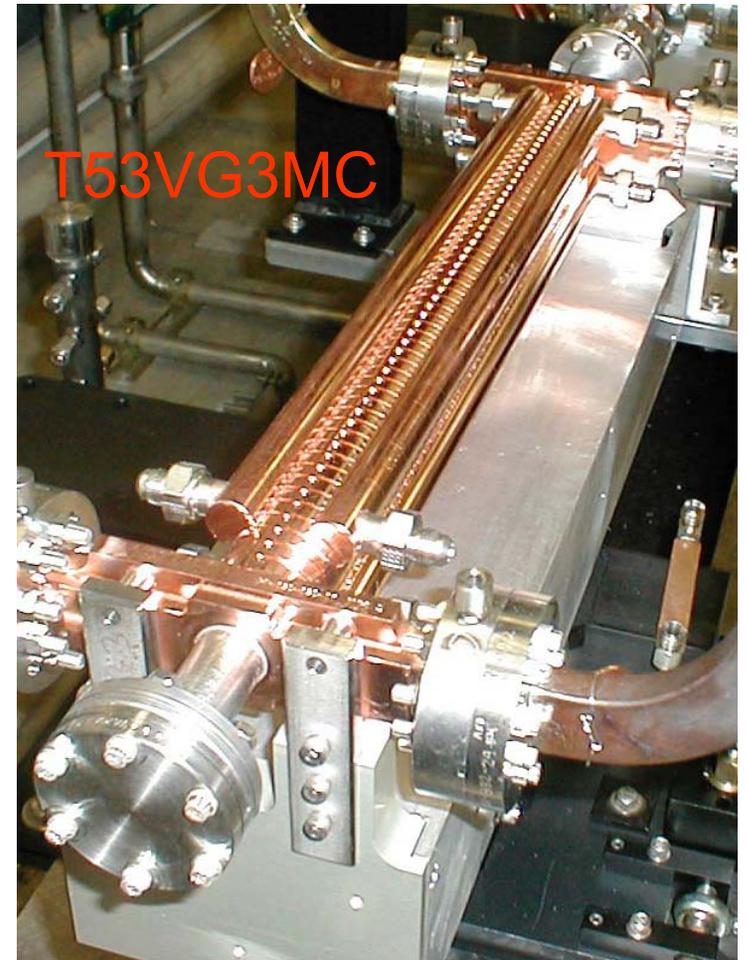
# Early NLC/GLC Low Vg Test Structure

First with Mode Converter input coupler – performed exceptionally well in 2002

- 53 cm long,  $a/\lambda = 13\%$ , initial  $v_g = 3.3\%$ , requires 98 MW for 100 MV/m operation
- In 2002, breakdown rate  $< 5e-7$  at 90 MV/m with 400 ns square pulses
- Reinstalled in 4/07 and have since run 2300 hours with shorter pulses (includes two vents to SLED system)
- In following plot, most points based on 60 Hz operation for more than 50 hours

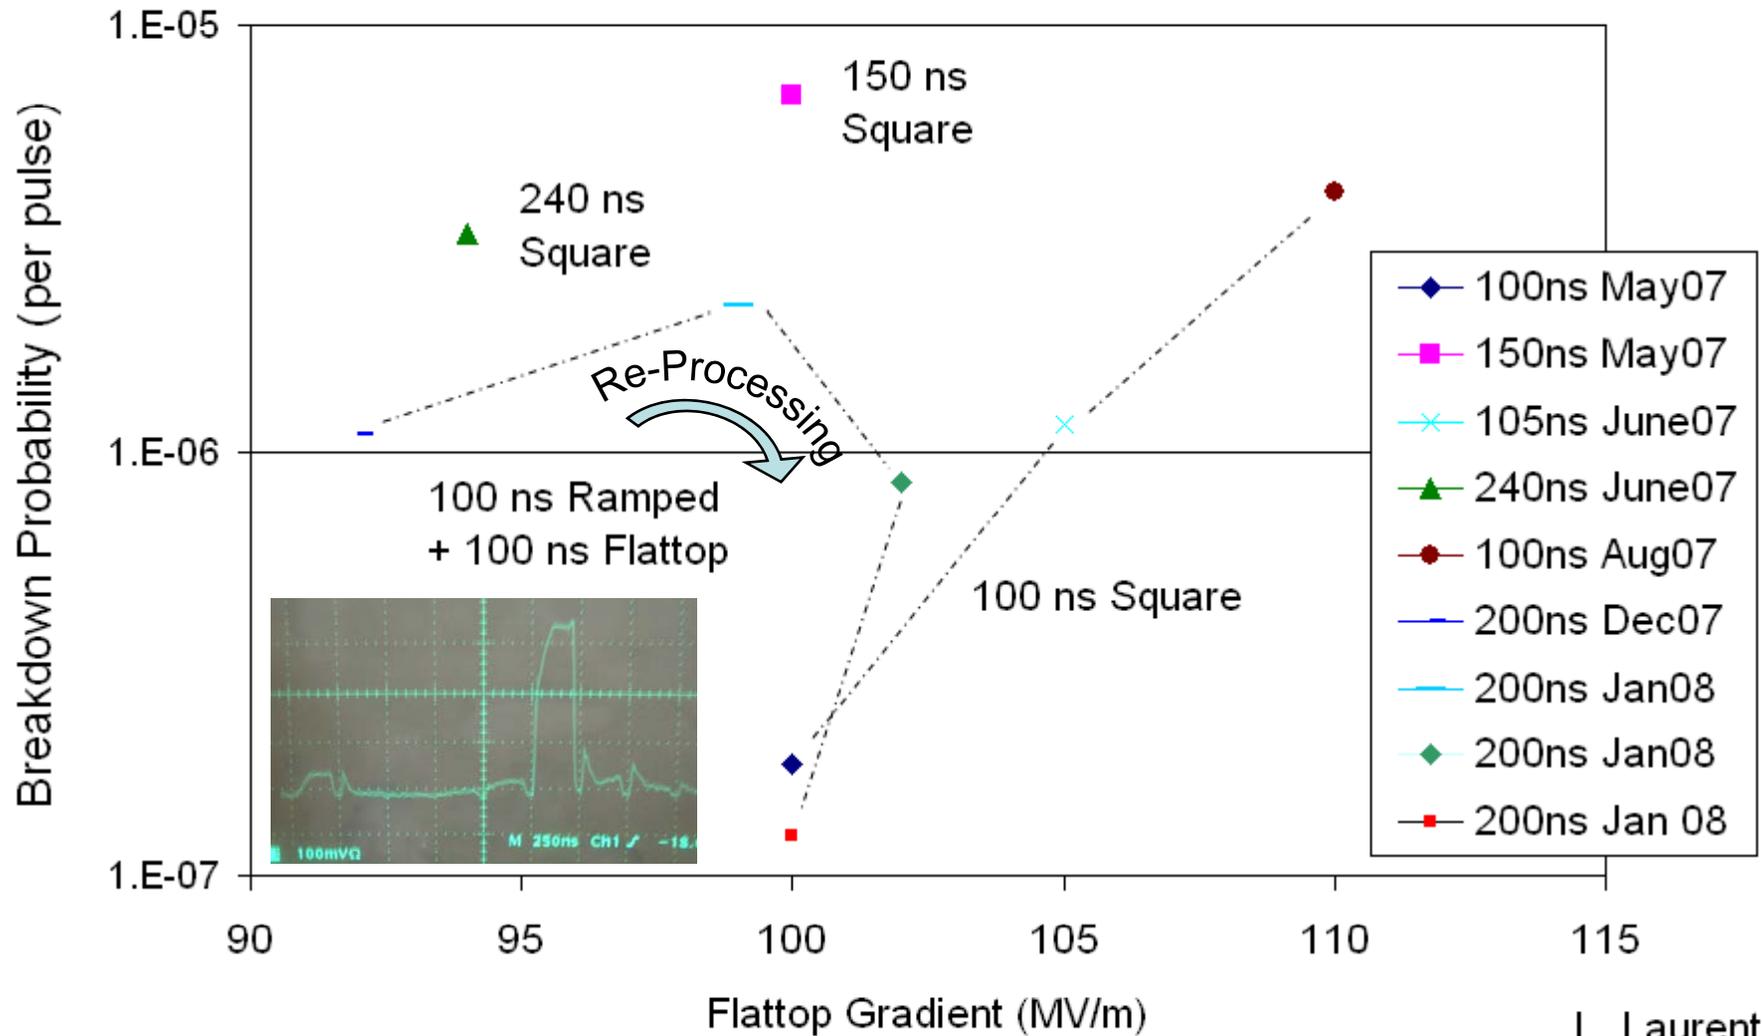
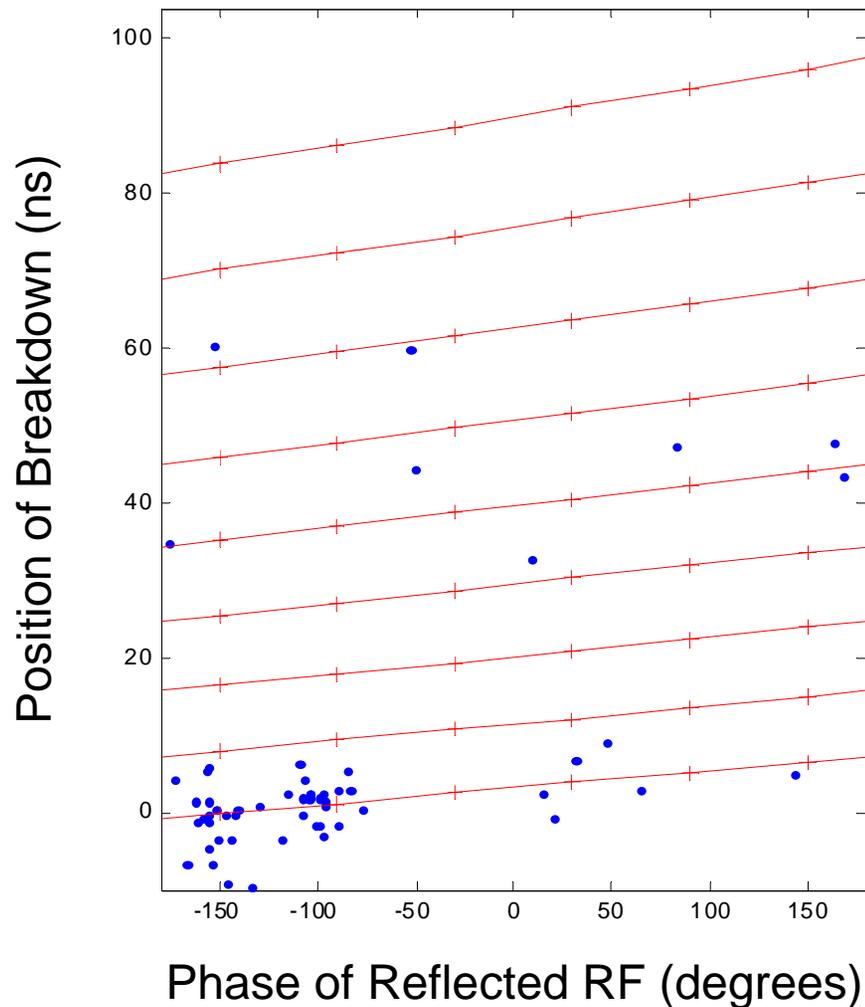
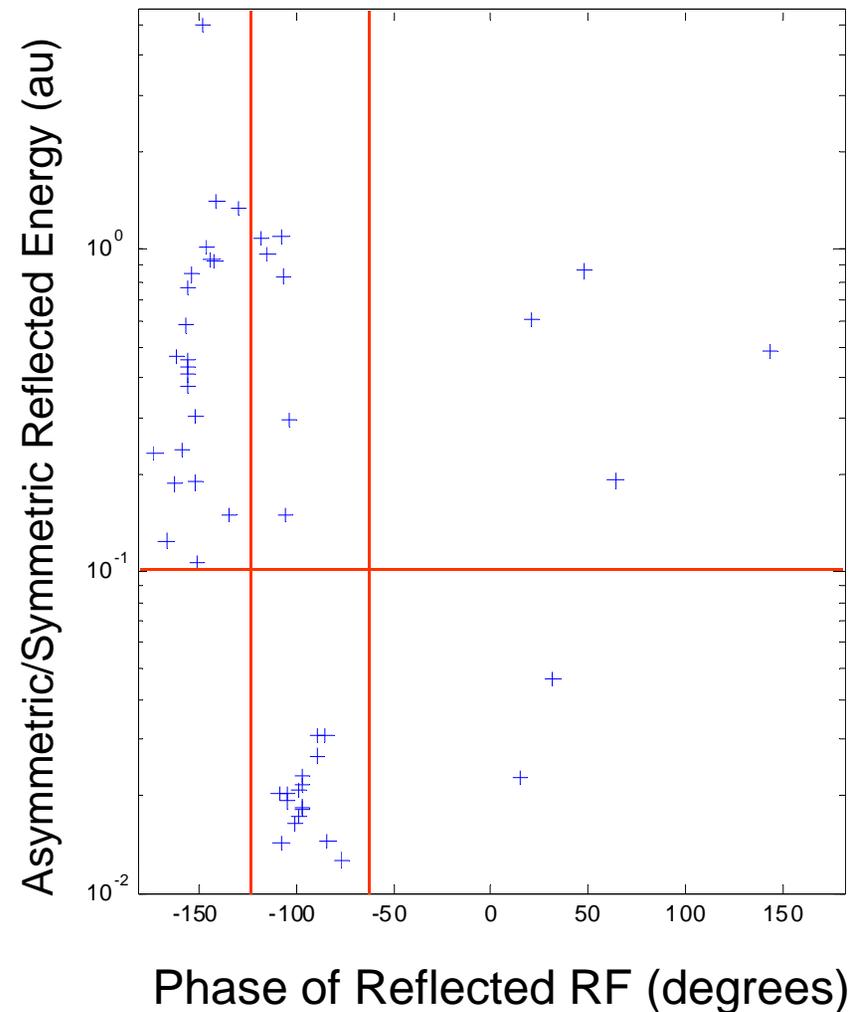
# Short Pulse Operation of T53VG3MC

Revisit earlier problem of structures with enhanced breakdown in first few cells – as an example, the first two cells of H60VG3S18 dominated breakdown rate at 65 MV/m with 400 ns pulses

All Events

Events in First 6 Cells

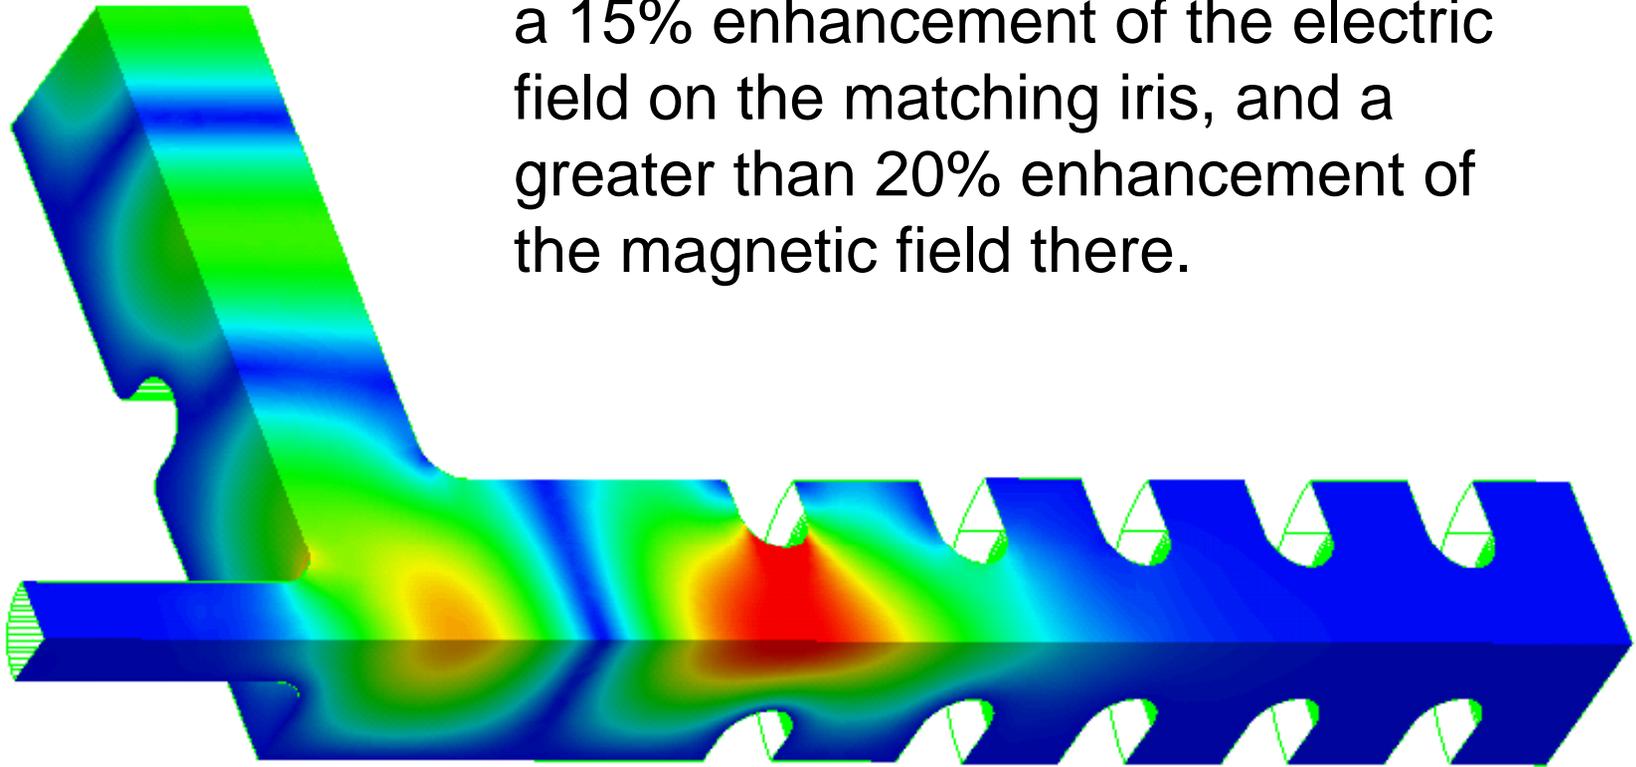
# Effect of H60VG3S18 WG Phase Mismatch

Depending on phase, produce up to a 15% enhancement of the electric field on the matching iris, and a greater than 20% enhancement of the magnetic field there.

Electric Field Pattern in Structure Excited Asymmetrically

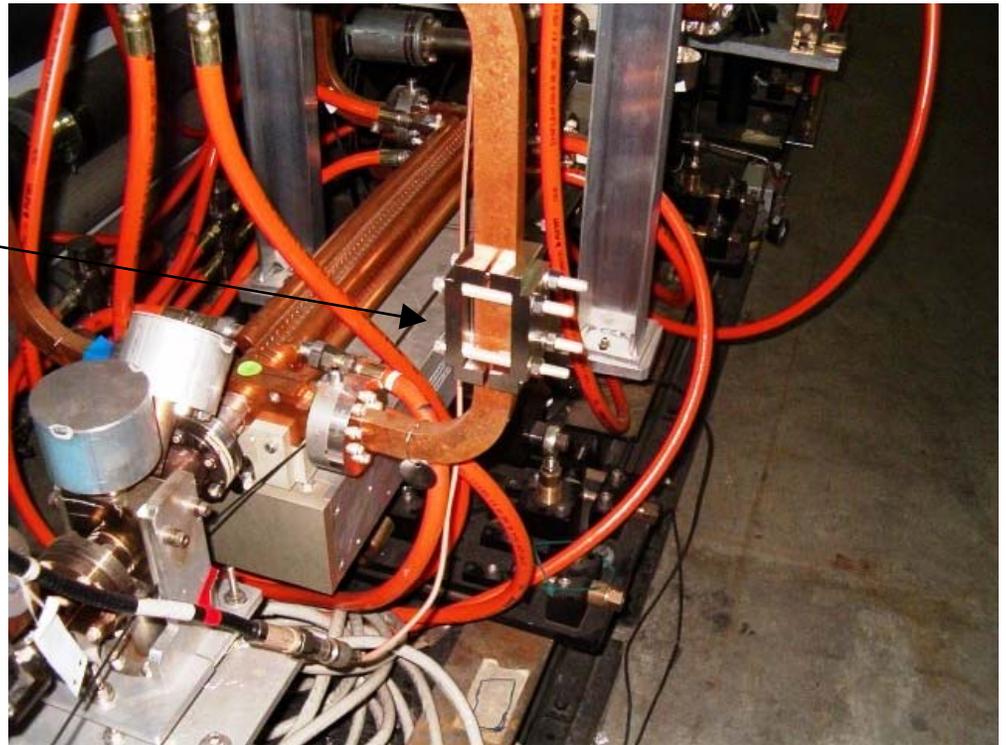
# Feed Arm Mismatch Test with T53VG3MC

Built device to squeeze one feed arm to produce  $\sim 20$  deg X-band phase shift

Measured 3.7% power in asymmetric port of magic tee that feeds power to the two arms (expected 3.0%, was  $< 0.1\%$  before squeeze)

Observed no change in breakdown rate

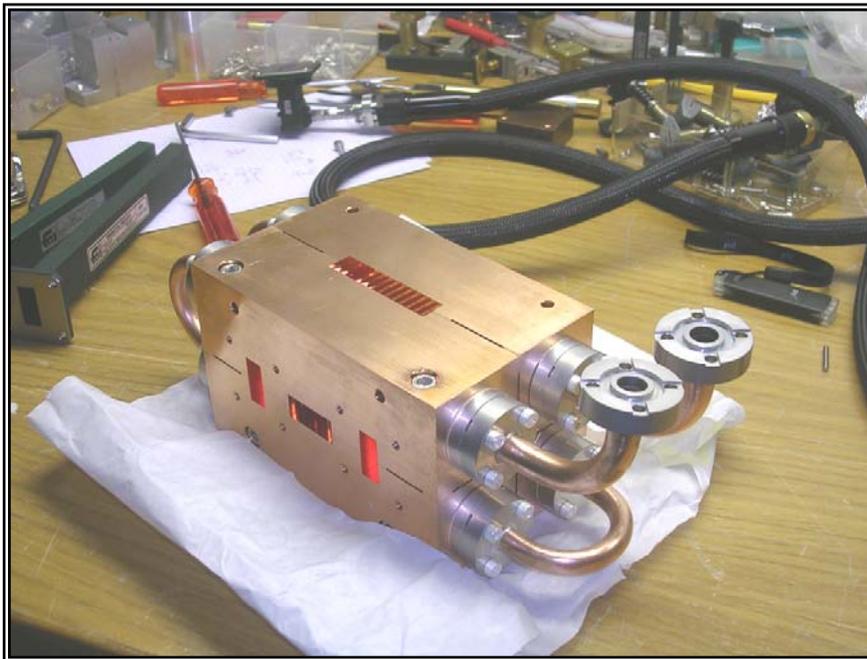
# HDX11 (C11vg5Q16) High Power Test Results at NLCTA

Scaled version of CERN 'HDS11 small'  
Parameters are the right-most  
in the table (set '2') – for 100 MV/m,  
input power = 164 MW

$f$ [GHz]	11.424
$a/\lambda$	0.19, 0.16
$\Delta\varphi$ [°], $l_c$ [mm]	60, 4.374
$a_{1,2}$ [mm]	4.987, 4.200
$d_{1,2}$ [mm]	1.445, 1.445
$Q_{1,2}$	3820, 3760
$r/Q_{1,2}$ [Linac $\Omega$ /m]	11000, 13000
$v_g/c_{1,2}$ [%]	8.0, 5.1
<b>for</b> $E_{acc}$ [MV/m]	150
$P_{1,2}$ [MW]	680, 370
$E_{s1,2}$ [MV/m]	270, 250
$\Delta T_{1,2}$ [K]	32, 28

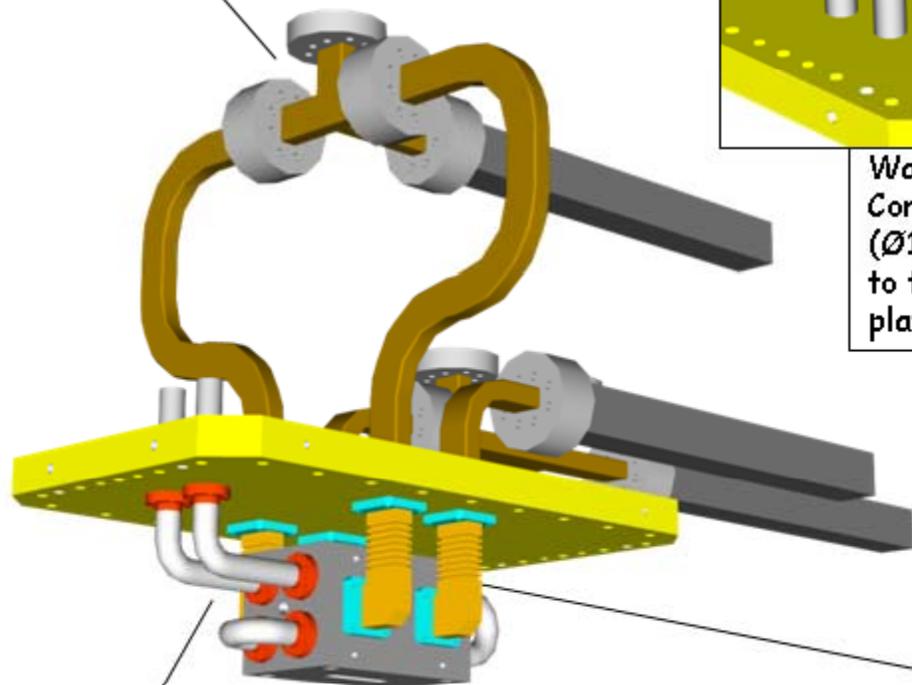
# HDX11, 11.424 GHz Structure for NLCTA

Input waveguide connection with SLAC Magic Tee

Waveguide terminations to Loads

Water-cooling Connections (Ø16mm) Brazed to the cover plate

Water connections inside the vacuum can with Helicoflex Joints

Structure based on HDS Technology

Waveguides in vacuum can with mitre bends

WR90 Waveguides Brazed to the cover plate

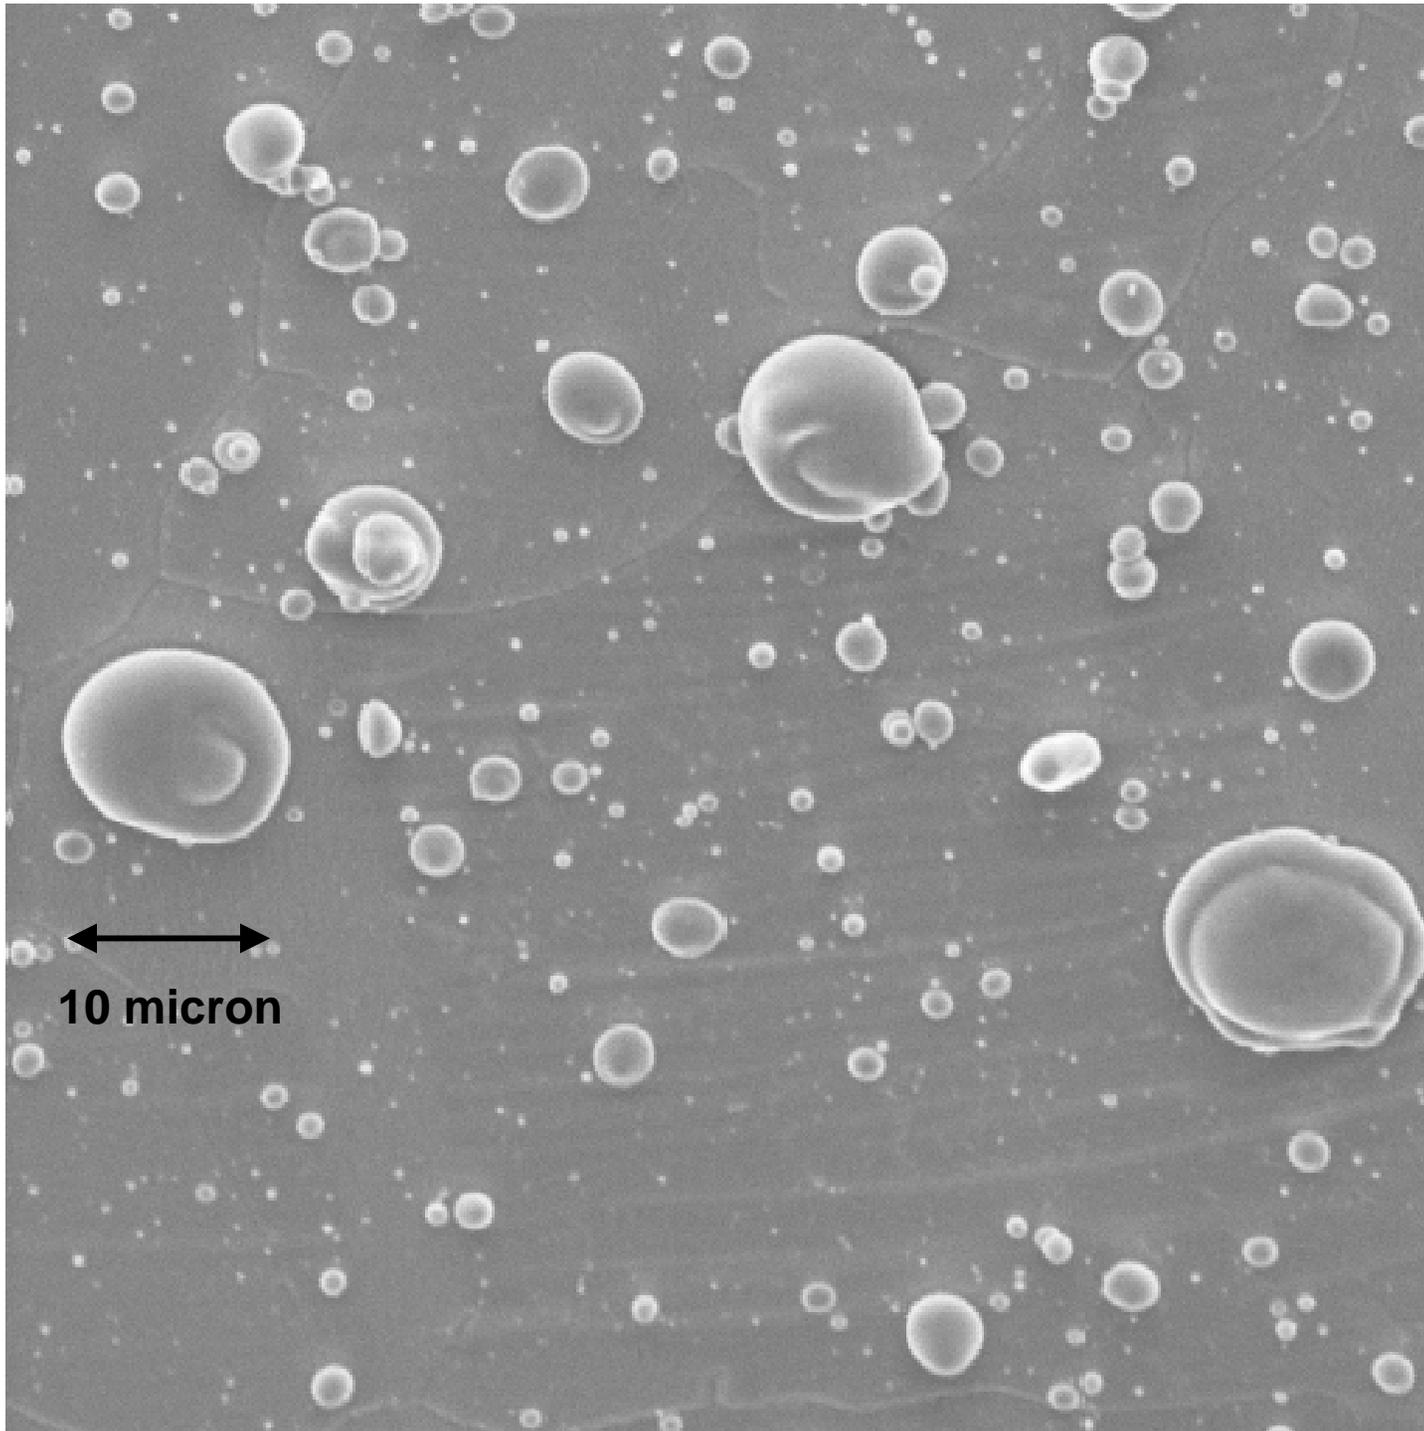
## Iris 1 (Top Right)

Not only were the ups irises heavily pitted, but 'whiskers' grew from the sides of most irises

Iris 2&3  
(Bottom  
Right)

Also, Cu  
splatter  
seen at  
bottom of  
the cells

Is this the  
origin of  
the  
whiskers  
on the side  
walls ?

- Electro-polish surface to smooth pits and whiskers
- Fire at 1050 degC (when brazing on water fittings) to grow large grains
- Attempt to better align quadrants
- Re-install in the can with the orientation reversed so the 'good' end now sees the input power.

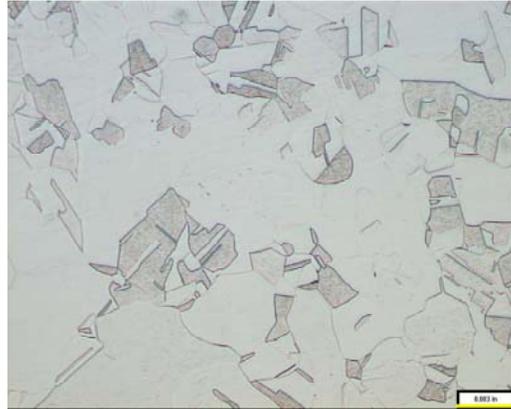
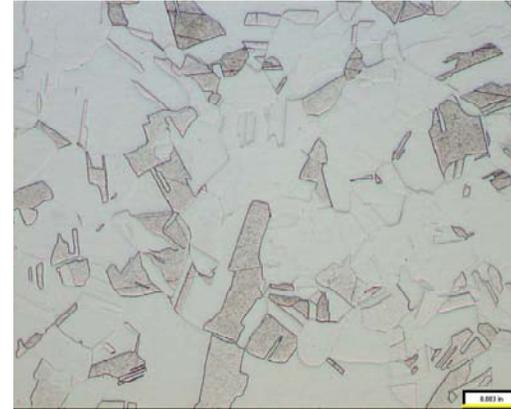
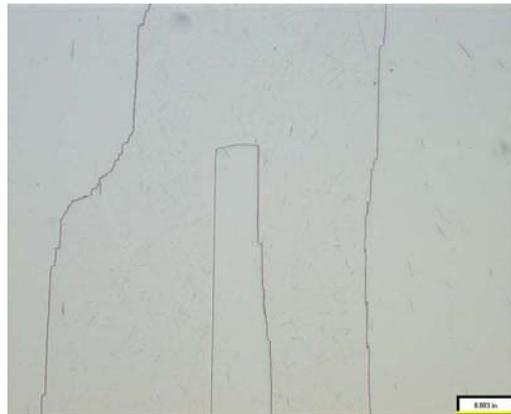
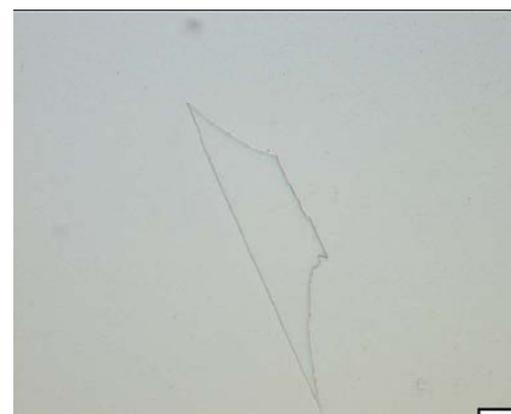
# Verified that Copper was of Good Quality

Metallography of CERN Copper before H<sub>2</sub> Fired (100x magnification) revealed an oxygen-free copper, cold worked with equiaxed, recrystallized grains that contained twinned regions. Very little contamination was observed.

Metallography of CERN Copper after H<sub>2</sub> Fired (100x magnification) revealed large, coarse, well-defined crystals consistent with grain growth due to high temperature annealing. Classification is ASTM F68 Class 1 for type A (cross grain), B (within grain), & C (grain boundary).

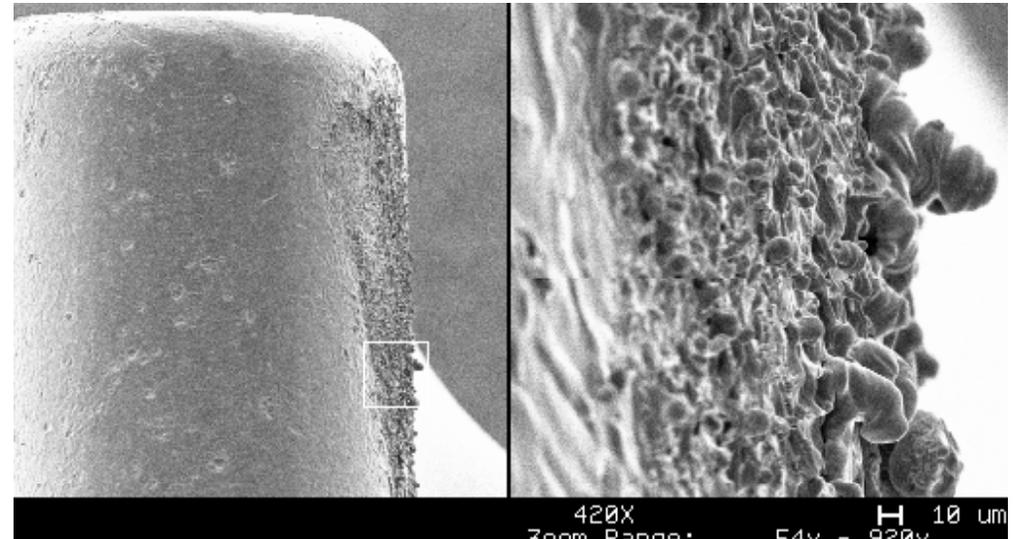
# Iris 7 Had a Pronounced 'Growth' and Was Hardest to Smooth

Before Electropolish

3-minute Electropolish

7-minute Electropolish

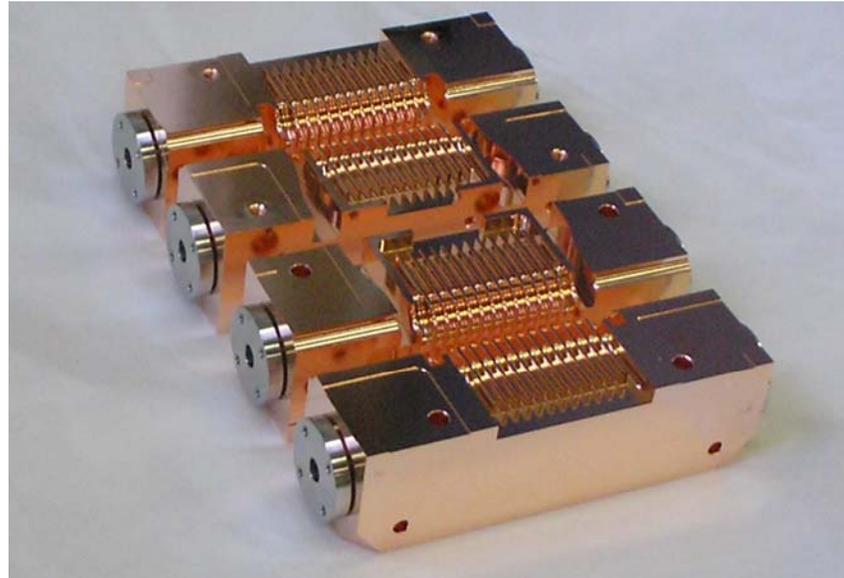
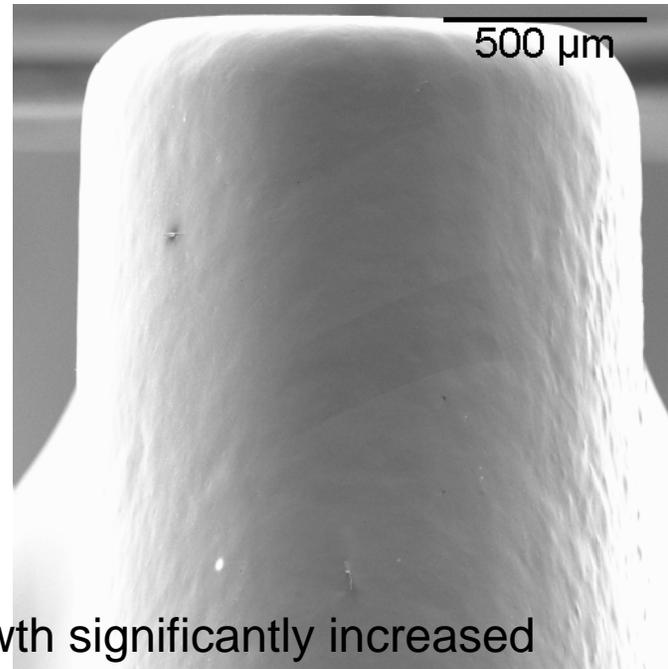
# After Brazing on New Water Fittings → Fittings

Before Braze

After Braze

Quad 7-8: Iris 1. Grain growth significantly increased

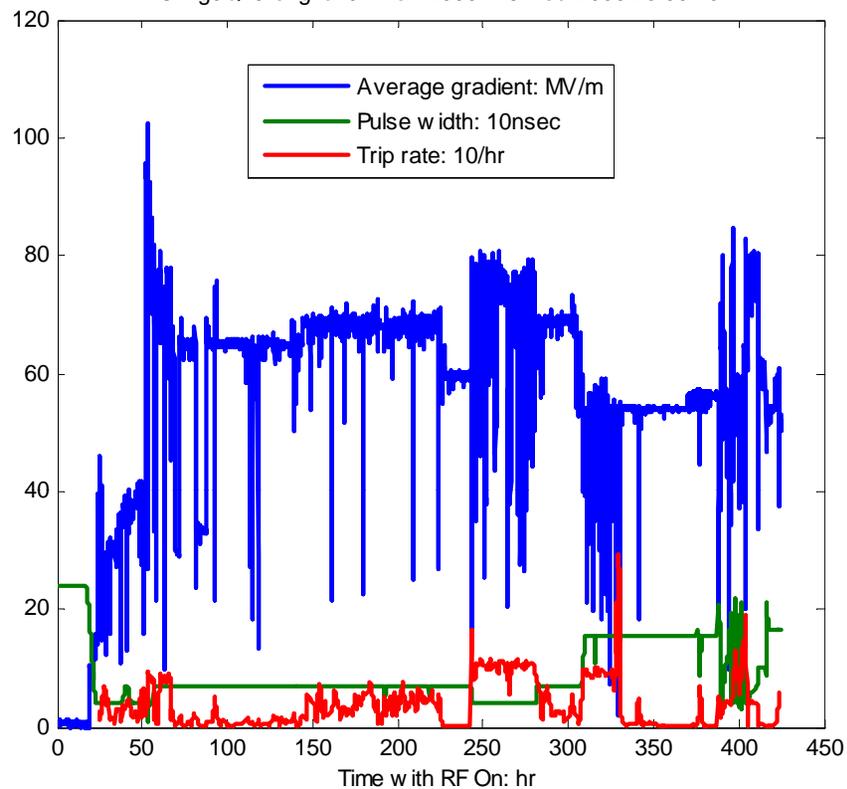
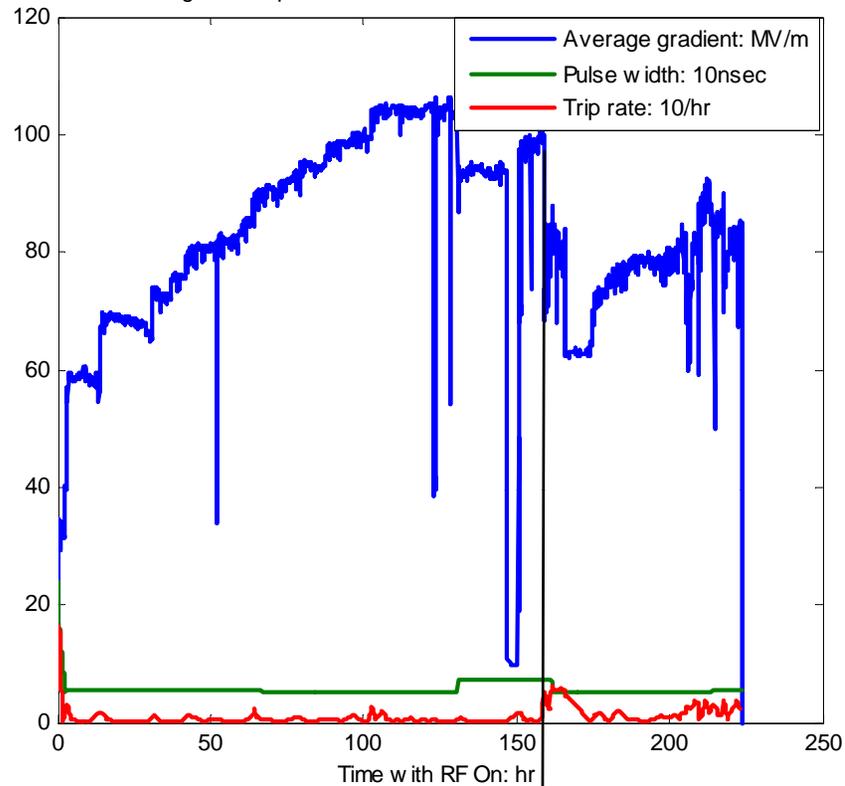
## First Run

C11g5Q16-original 07-Nov-2006--18-Dec-2006 23:59:43

C11g5Q16-repolished 03-Mar-2008--19-Mar-2008 22:59:33

Blue cross: the original structure running at 70ns@68MV/m

Red square: structure after e-polished at 50ns@80MV/m

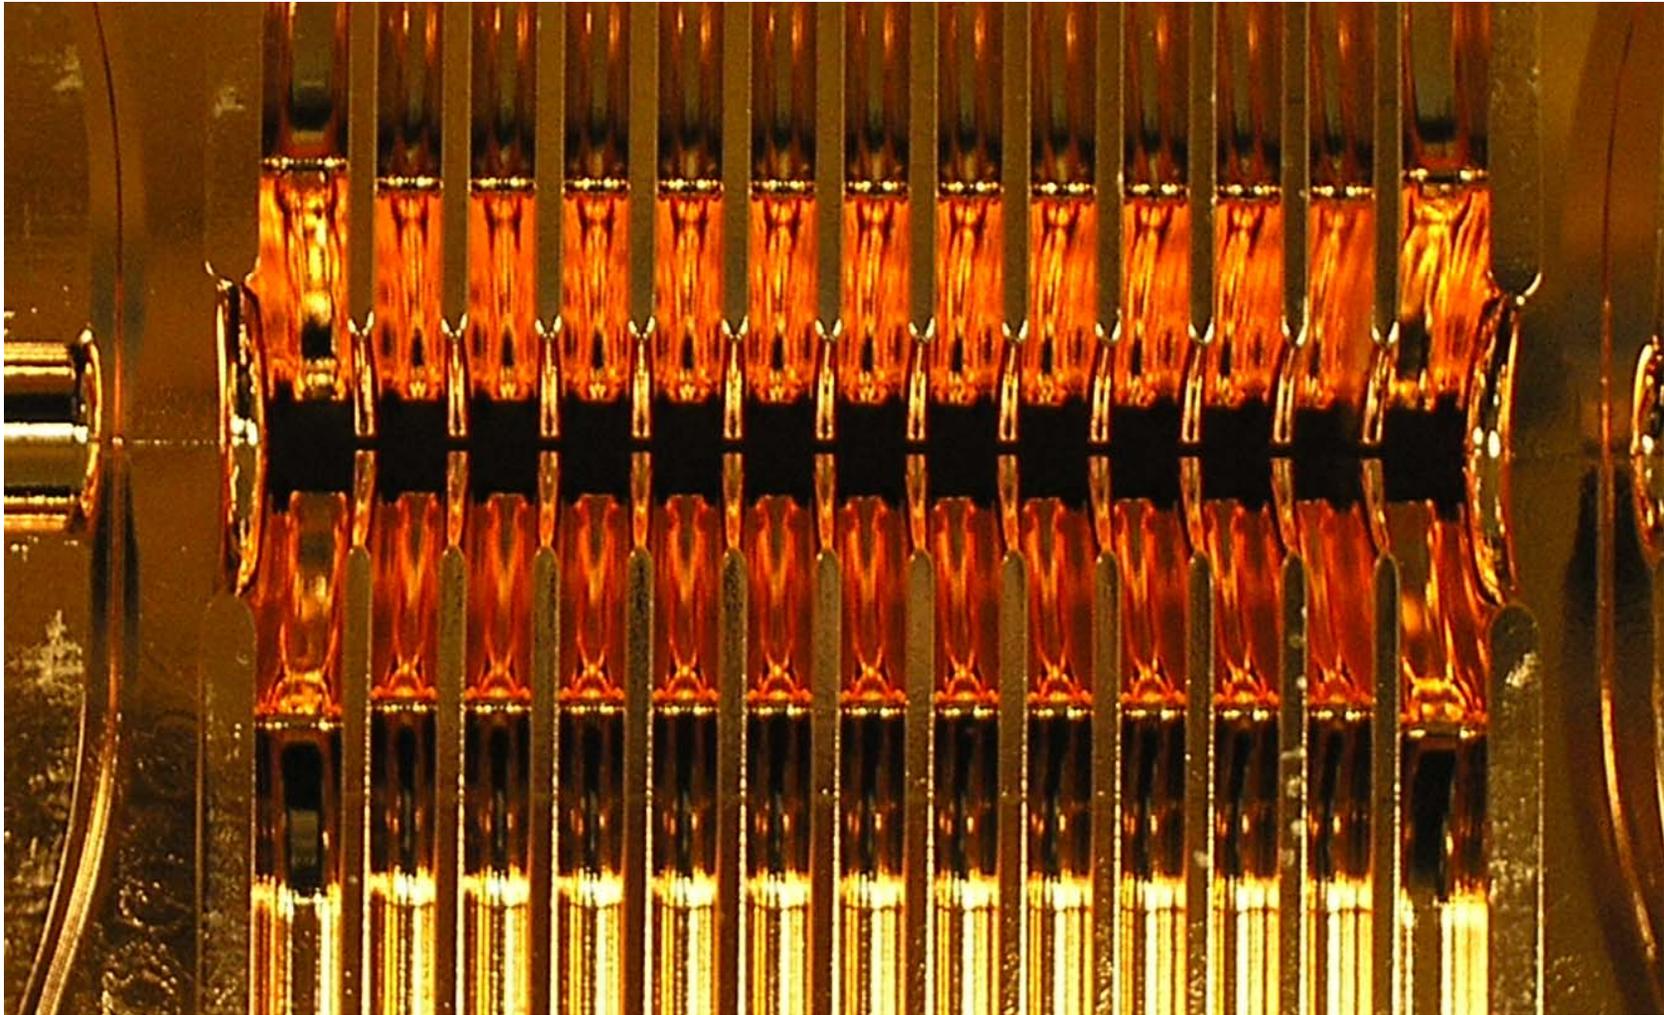
# Autopsy after Second Run

(Much less damage, better aligned)
