# NLCTA Structure Tests Post NLC/GLC

C. Adolphsen, S. Döebert, G. Bowden,  
R. Fondos, L. Laurent, F. Wang, J. Wang

# NLCTA X/L-Band Structure Tests Post NLC/GLC

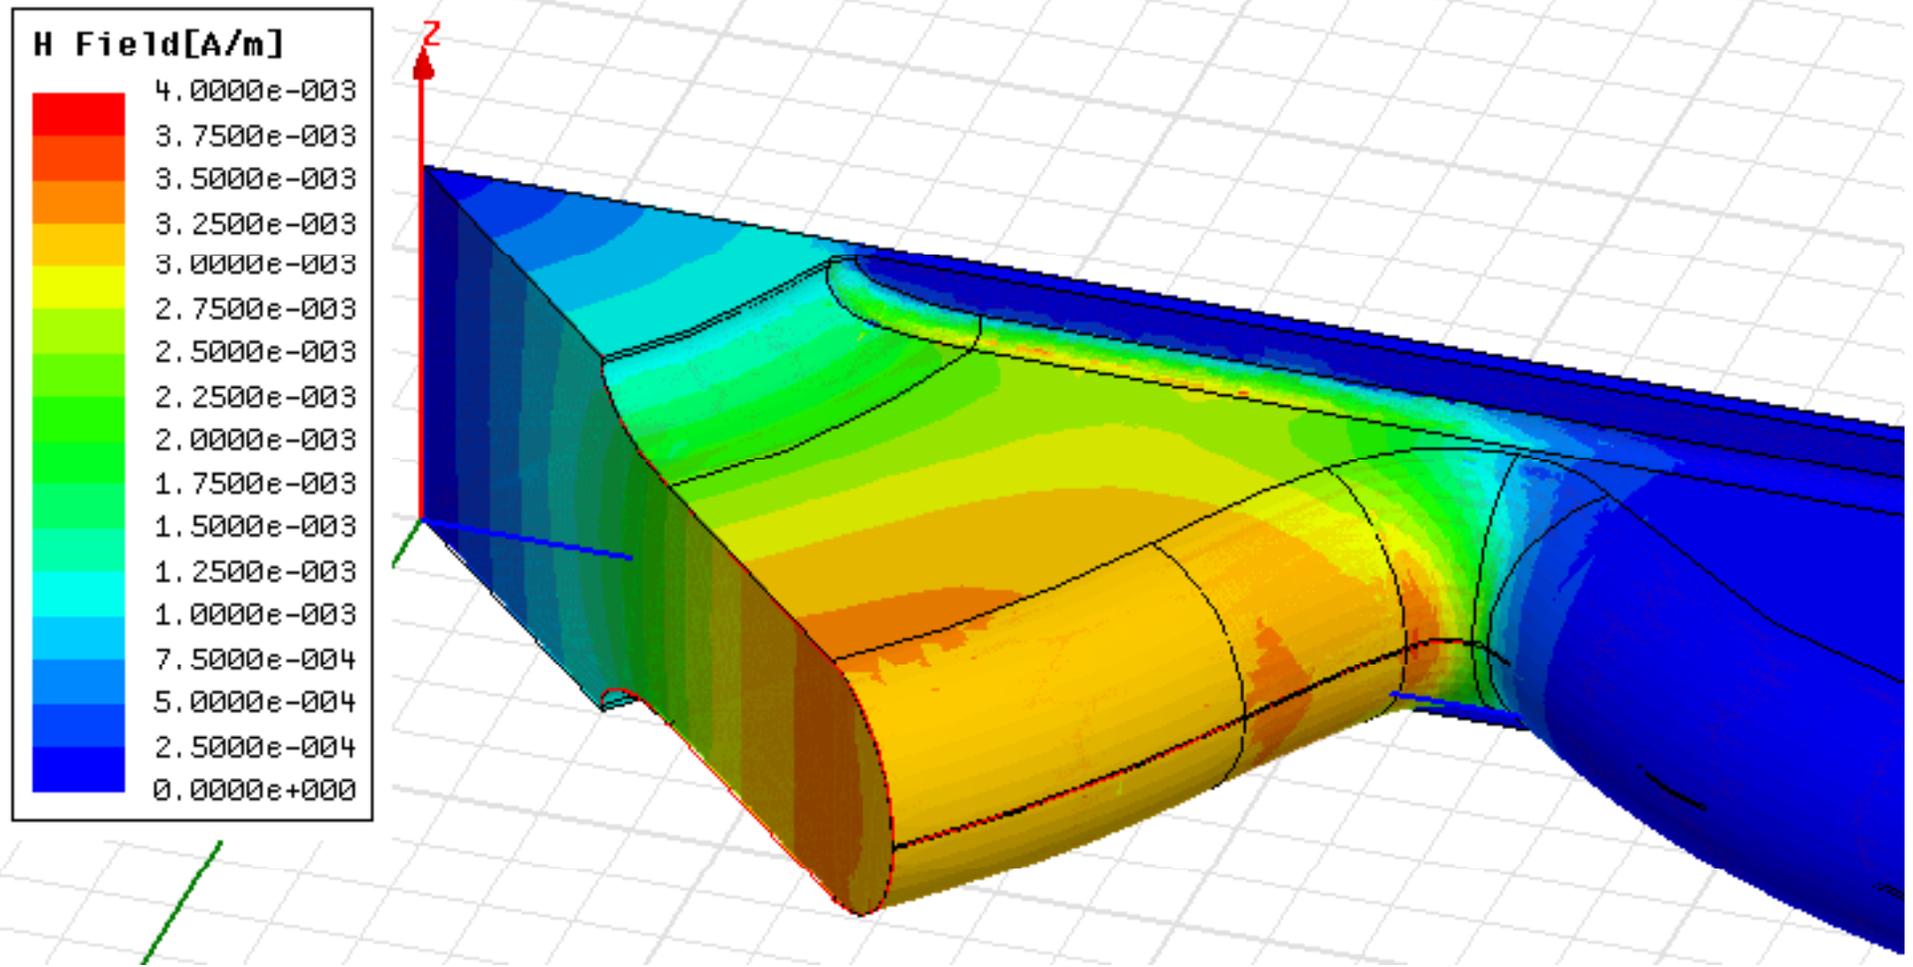
# HDX H Field

Surface magnetic field distribution in HDX11 for 1V/m accelerating gradient

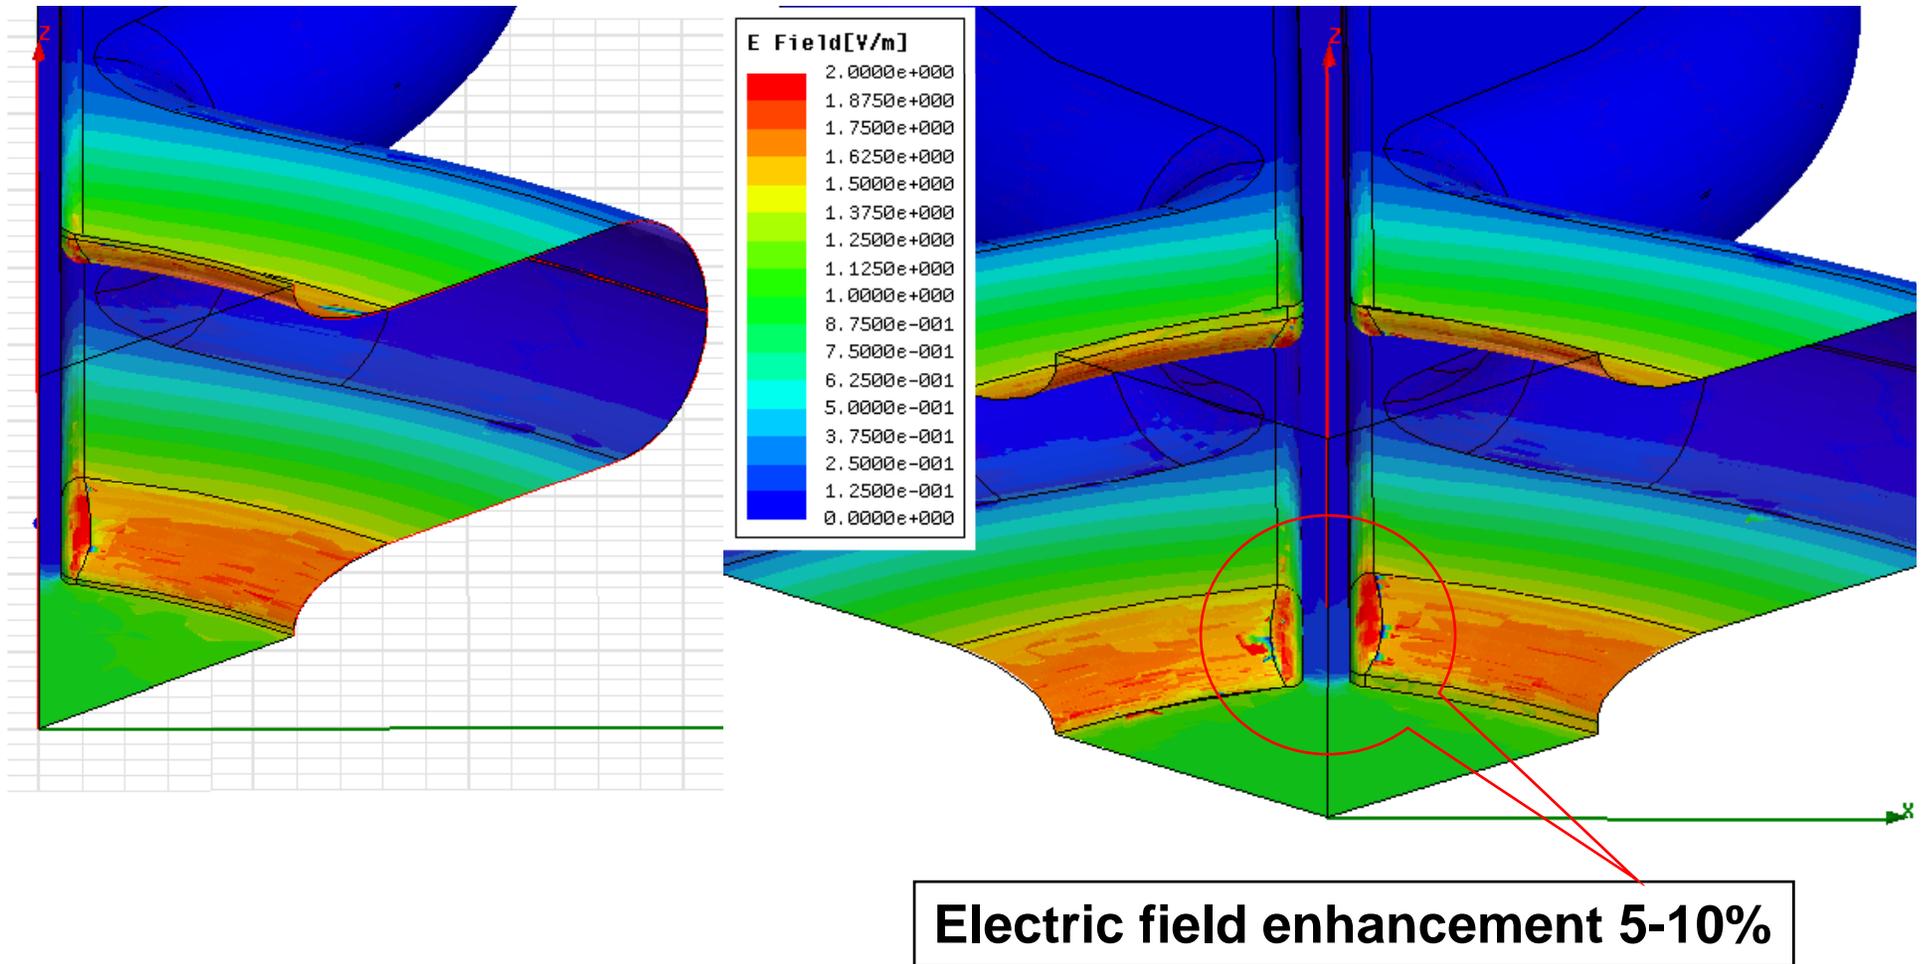
# Electric Field with Quadrant Misalignment

140 micron Longitudinal Misalignment

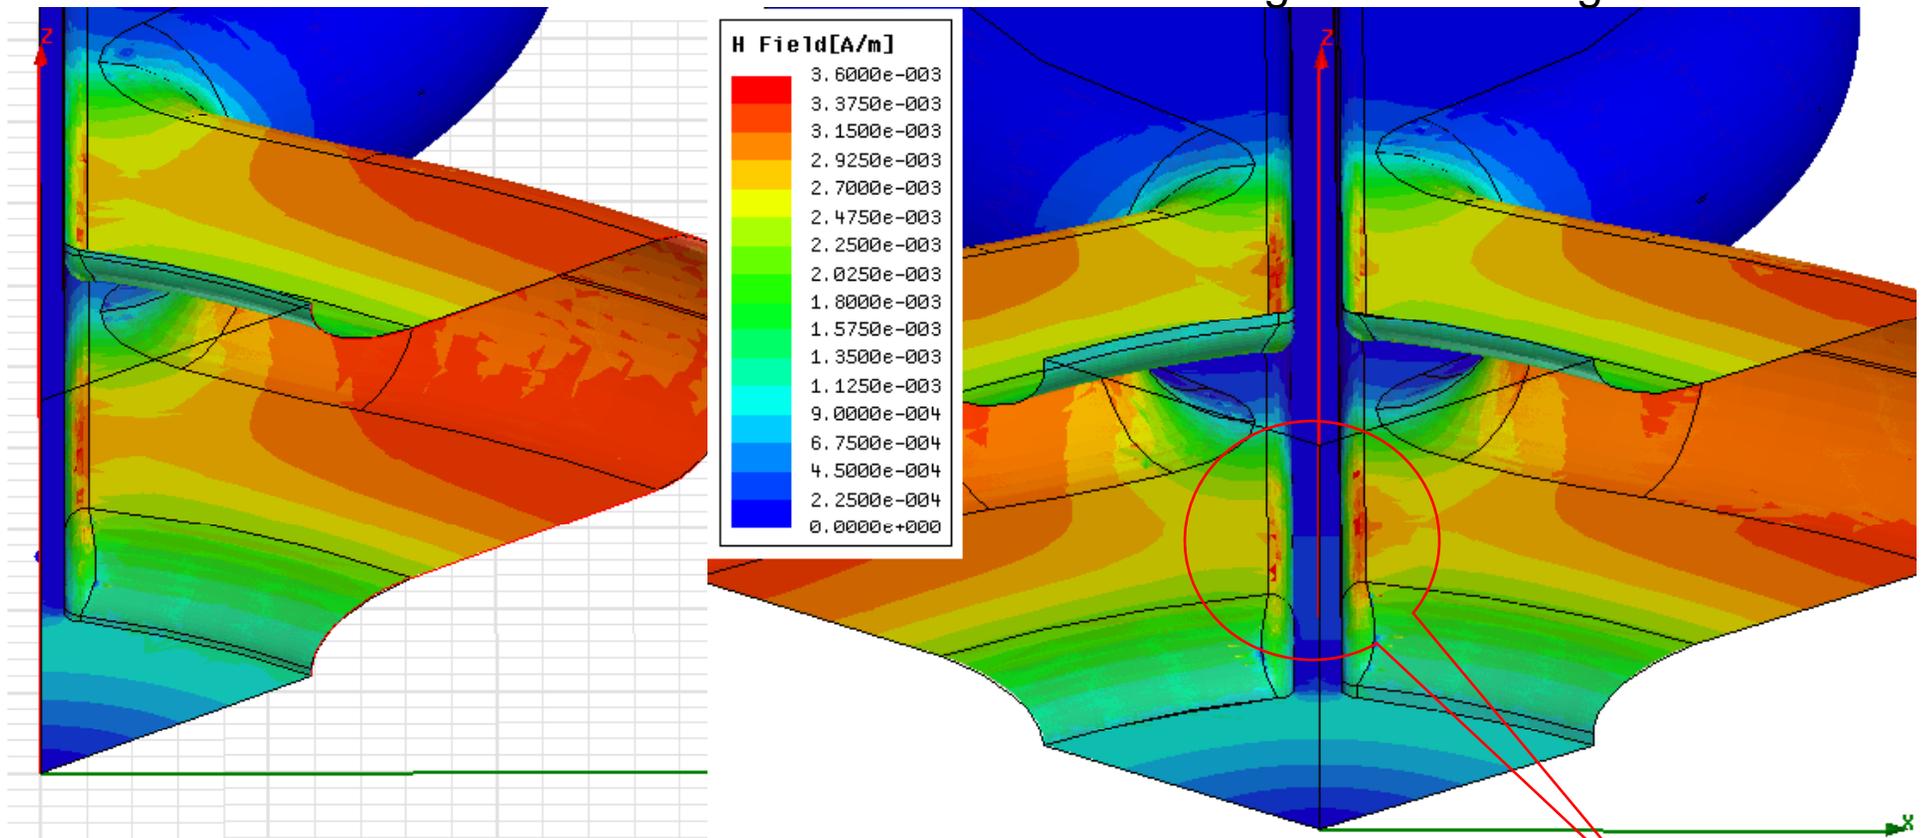
# Magnetic Field with Quadrant Misalignment

140 micron Longitudinal Misalignment

**Magnetic field enhancement 5-10%**

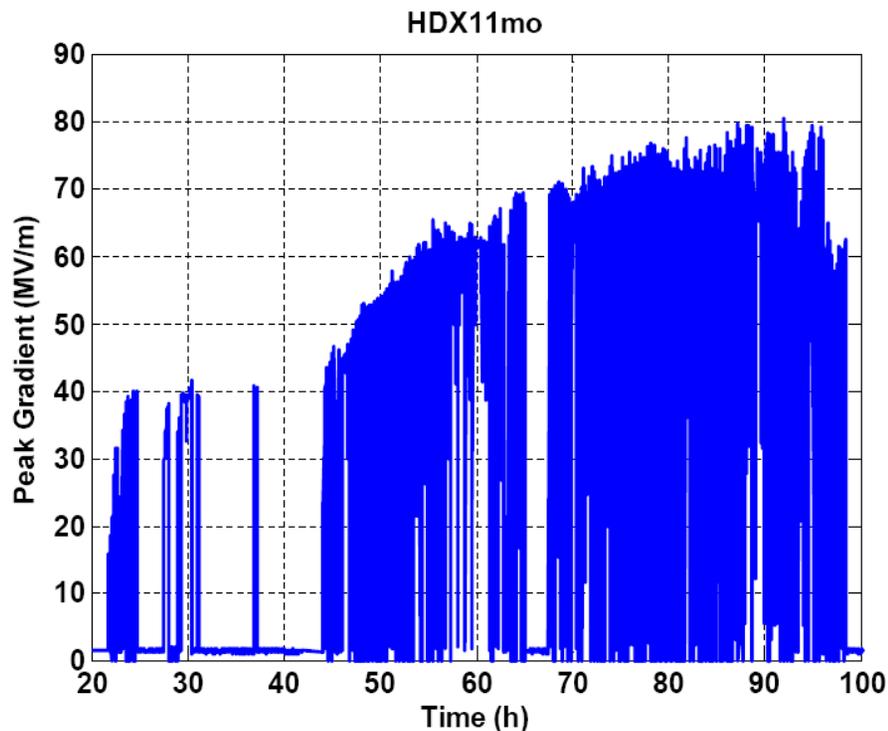
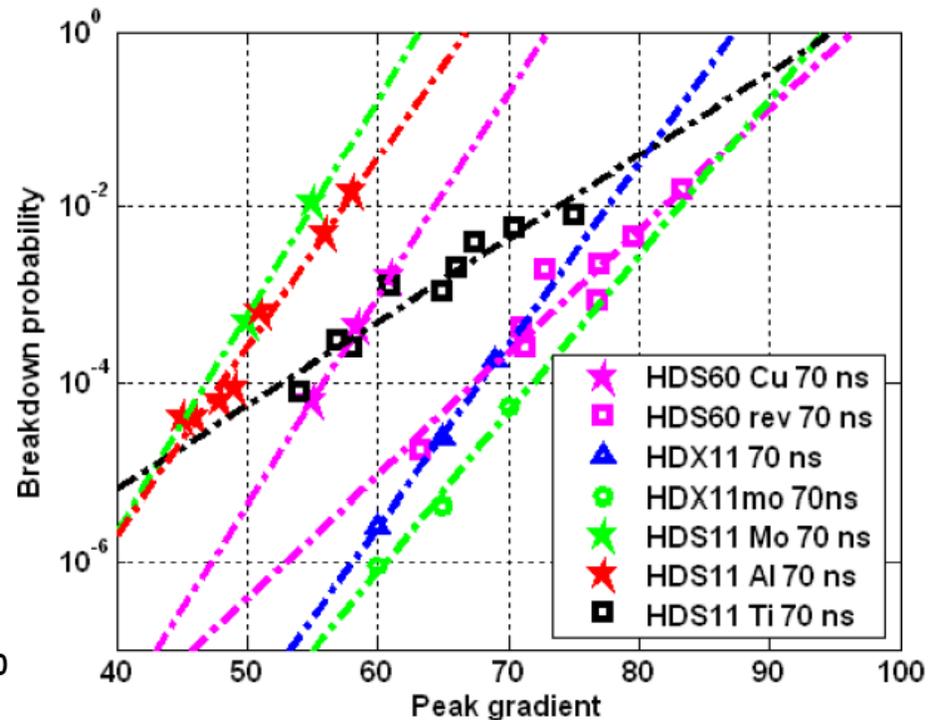
# Other Quadrant Structures

A Moly HDX structure was also tested at NLCTA – it performed poorly (see green curves) as did 30 GHz Cu, Mo, Al, and Ti versions at CERN. The Mo version tested at SLAC was never autopsied, although a Mo clamped structure was and showed surface cracking. A 120 deg, slotted Cu X-band version will be tested next.

Processing at 40 ns

All HDS-type structures tested so far

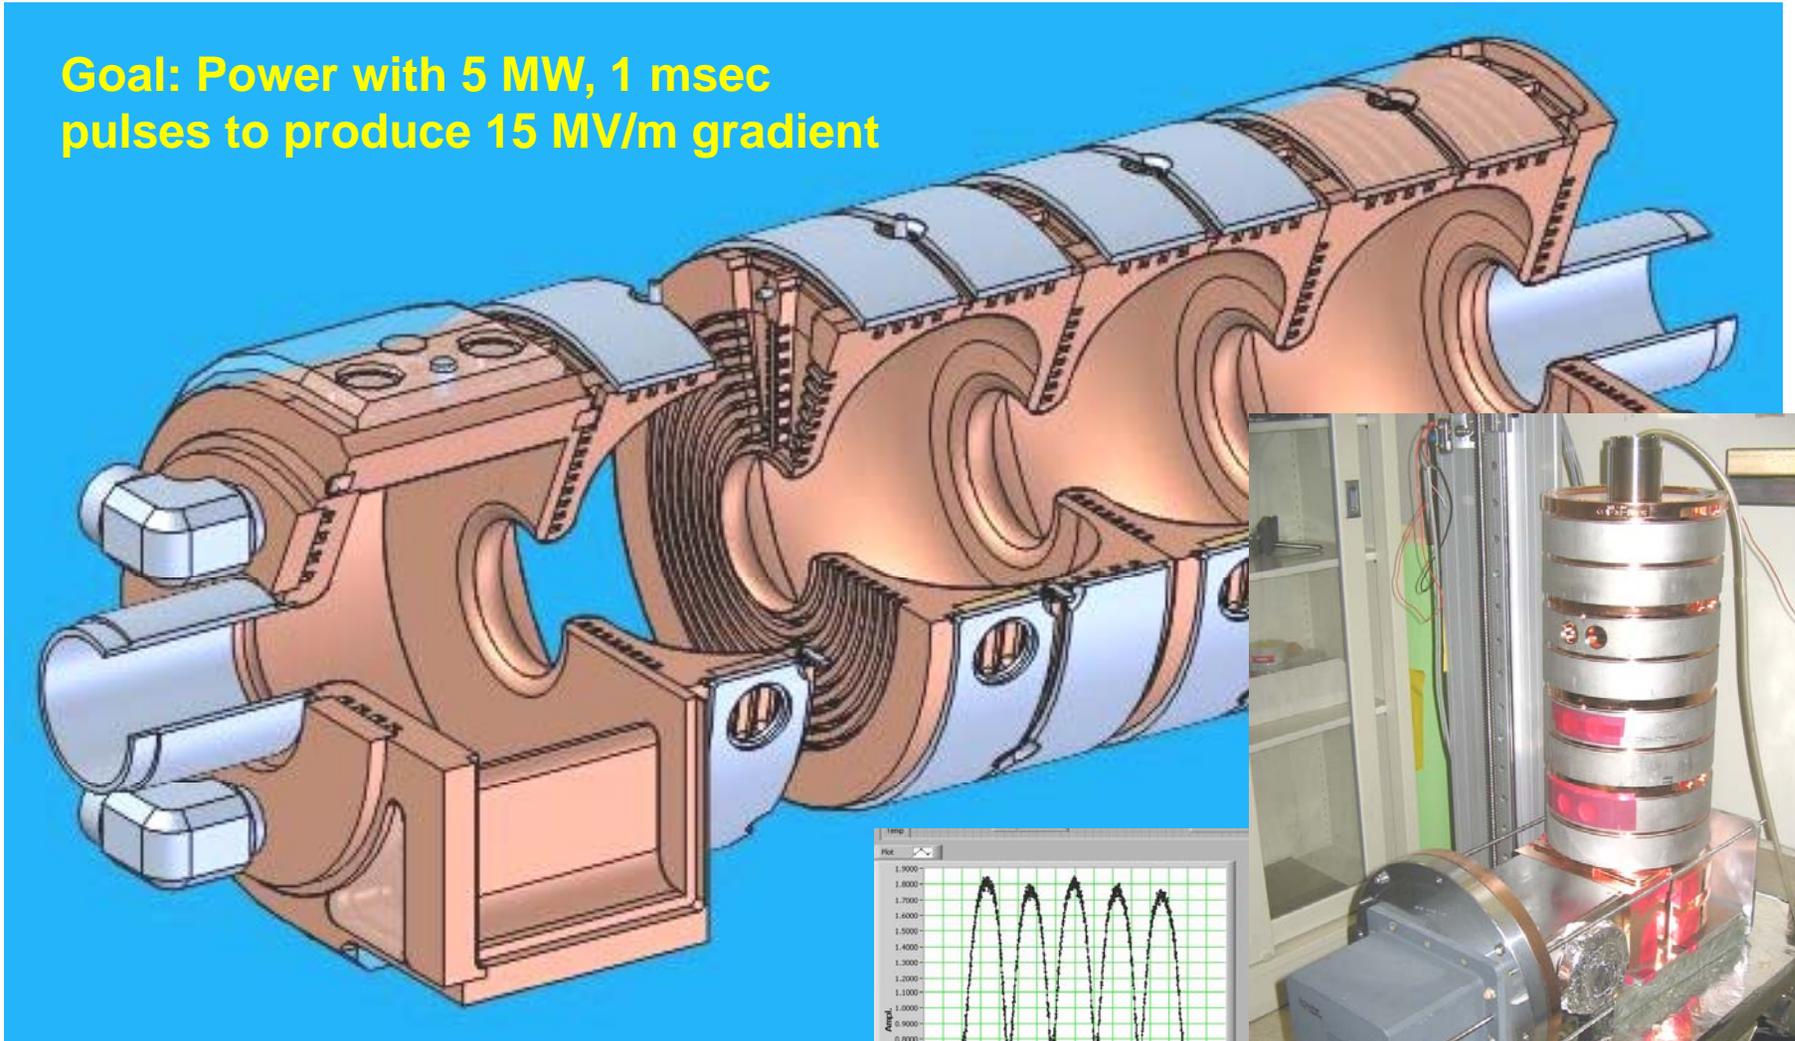
# ILC Positron Capture Cavity Prototype

Goal: Power with 5 MW, 1 msec pulses to produce 15 MV/m gradient

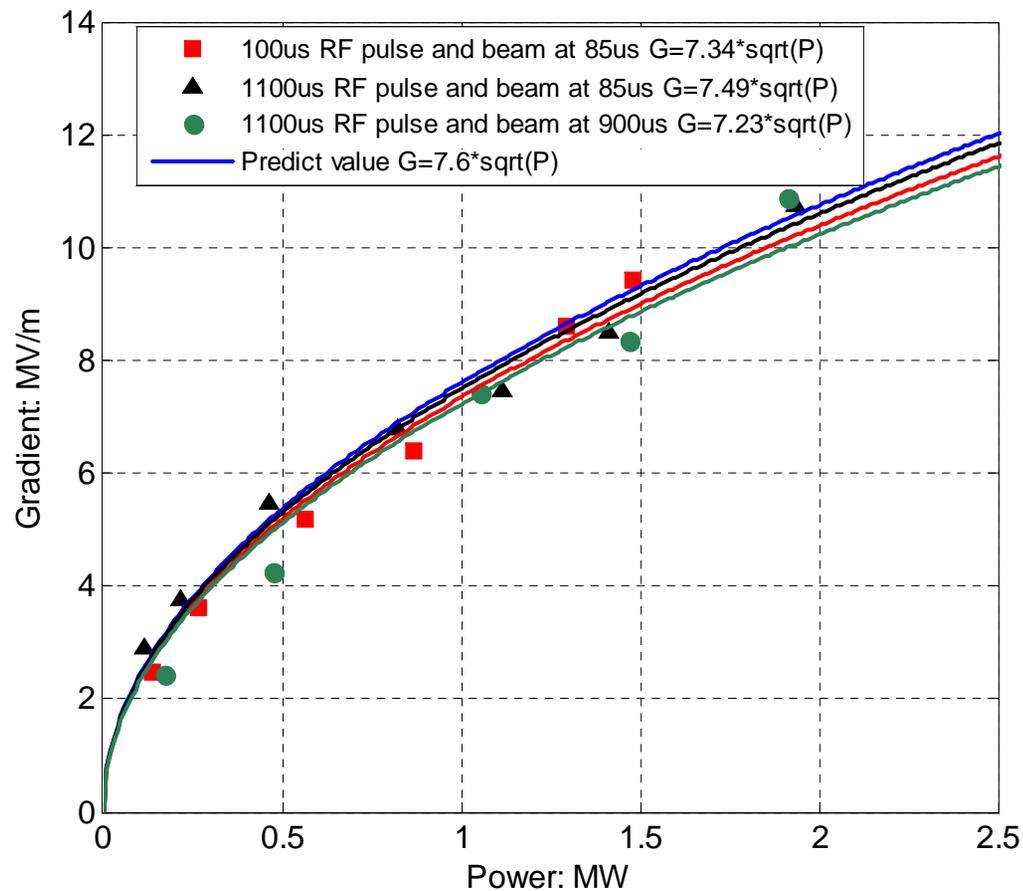
# Cavity Gradient Measurements with Beam

World's First L-Band (1.3 GHz) Cavity Operation in an X-band (11.4 GHz) Linac

### Power Limited Data

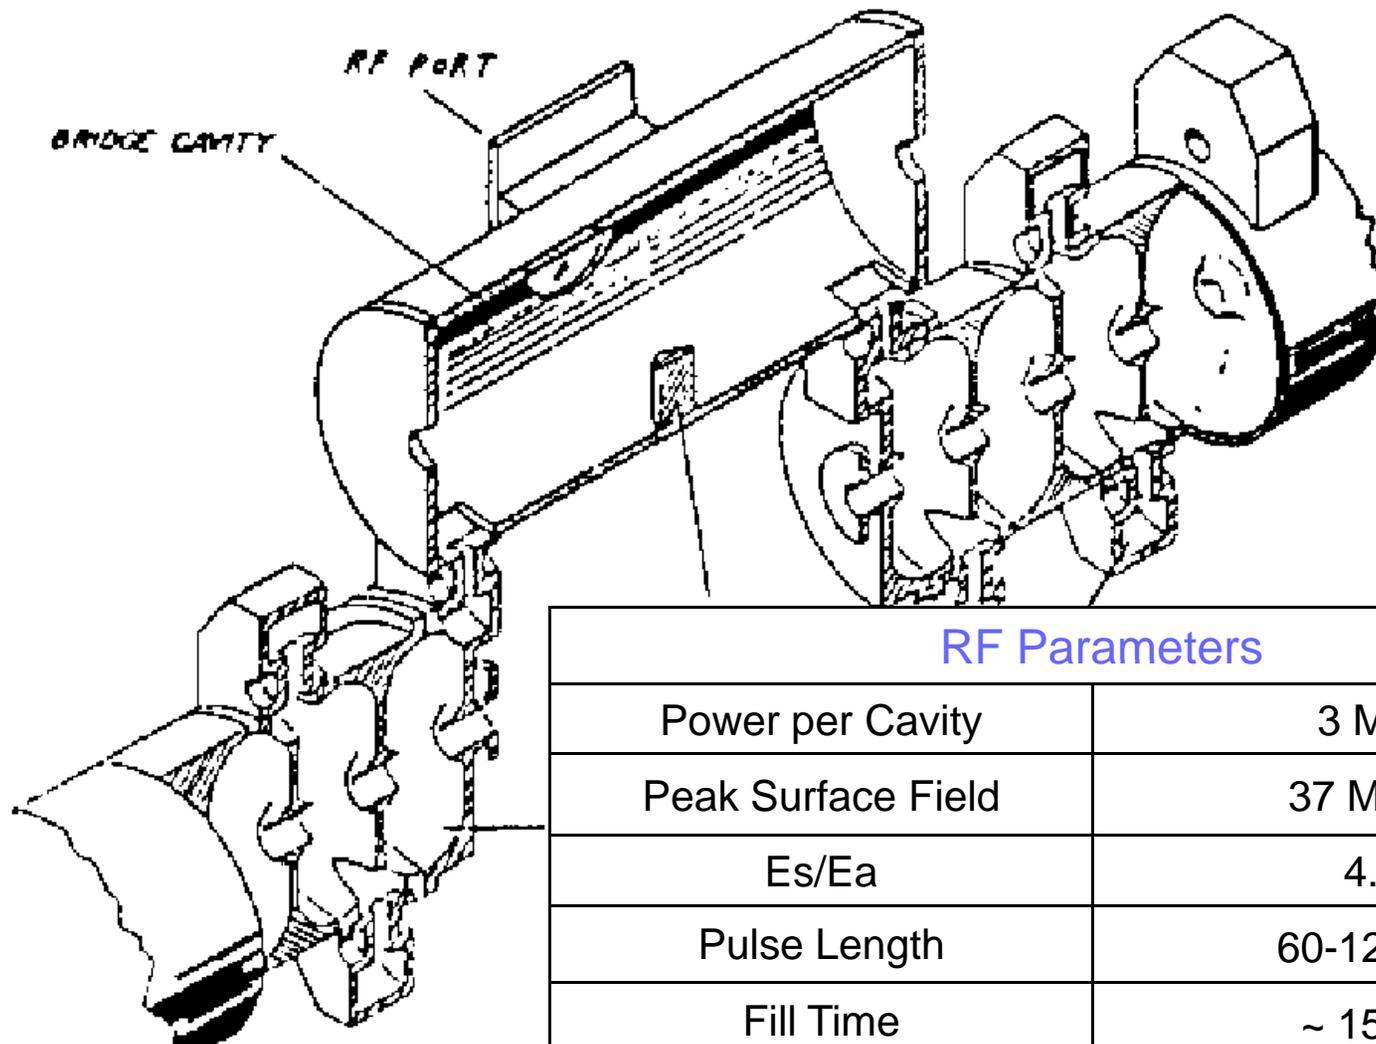
# FNAL 805 MHz Side-Coupled SW ( $\pi/2$ ) Cavities

RF Parameters	
Power per Cavity	3 MW
Peak Surface Field	37 MV/m
Es/Ea	4.5
Pulse Length	60-120 $\mu$ s
Fill Time	$\sim$ 15 $\mu$ s

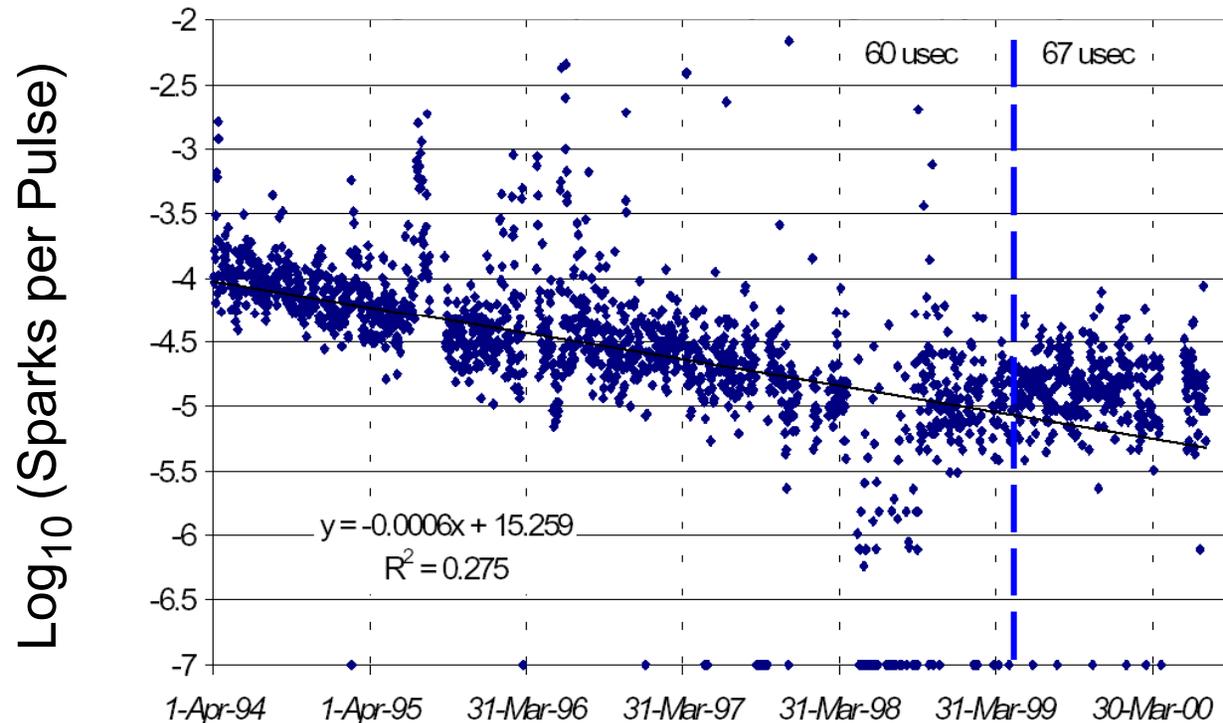
# Module 3 (64 Cells) Spark Rate Over ~ 5 Years at 1.3 Million Pulses/day

Rate  $\sim (E/E_0)^{19.5}$  for 33-60 MV/m surface fields ( $\sim (E/E_0)^{19}$  at X-band).

Rate  $\sim \text{Pulse Length}^4$  ( $\sim \text{Length}^{3.3}$  at X-band).

Recover after vent to air in a few minutes to hours (same as X-band)
