Focus Coil Update

Oversight Committee meeting

24th April 2014

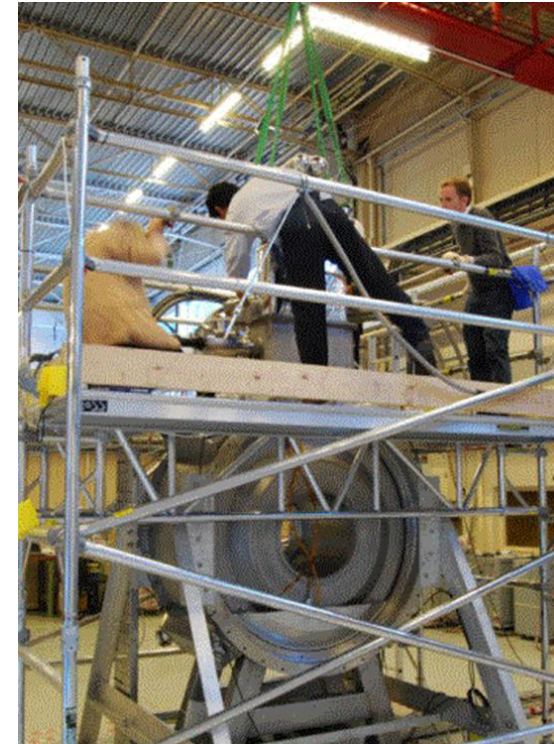
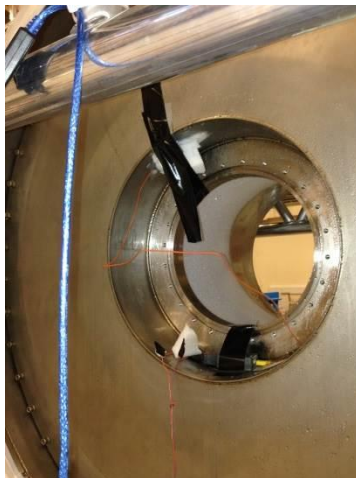
Focus Coil 2 - Findings

- Arrived at the end of October 13 and was pumped on while FC#1 was removed from the test setup.
- Cooling with the cryo-coolers started a few weeks after.
- During the cool down the cold mass bore temp sensor developed a fault.
 - 4 wire sensor, one leg connected to earth
 - Resistances could be used to ascertain a temperature but the lakeshore unit would not read
- Leak in the He system was found
 - Leak rate increased as the temperature dropped
 - The hypothesis is that the leak in on the cold mass, a weld perhaps.
- The temperature of the radiation shield stalled at ~120K
 - Target temp ~60K
 - Condensation on the warm bore was seen in one specific spot
 - Obvious a thermal short – around 90W excess heat load on the 1st stage

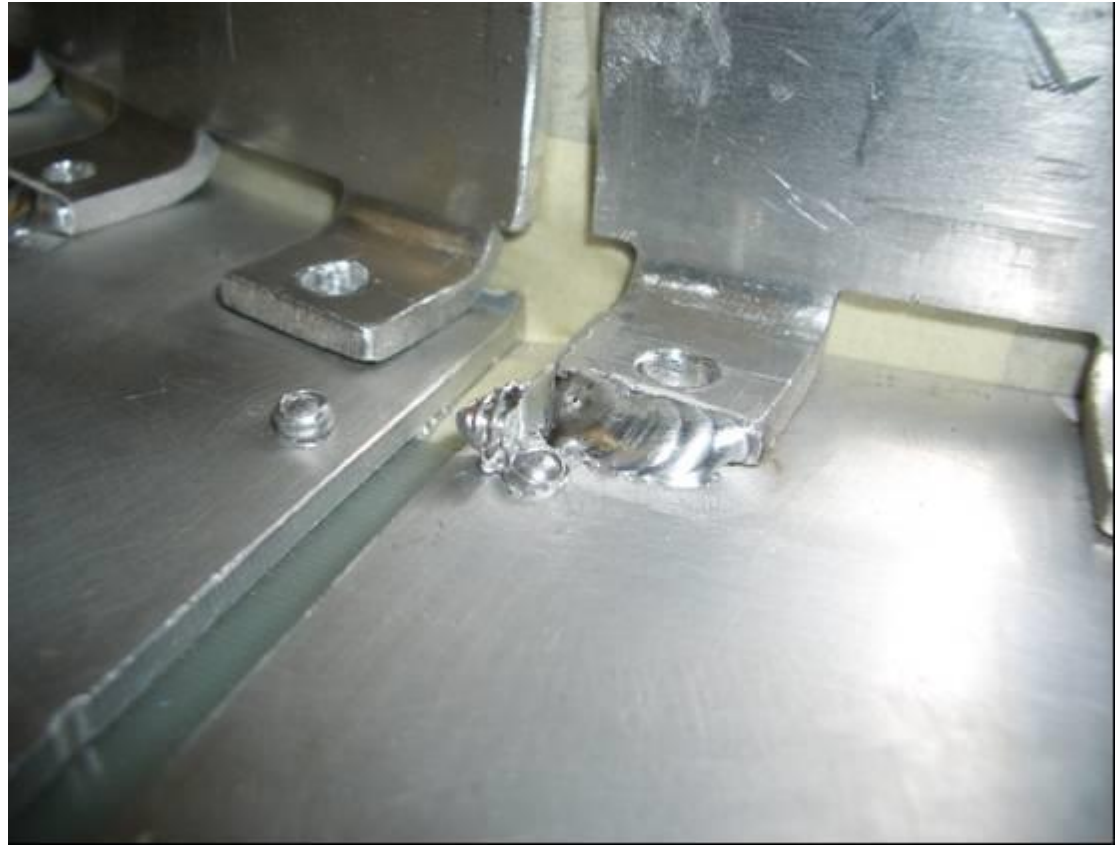
Focus Coil 2 - Findings

- Focus Coil #2 shipped back to Tesla for investigation work
- Warm bore removed - some damage to the MLI found but not enough to cause such a large heat leak.
- Warm bore / Cold mass bore not concentric – around 3mm off of centre – Still only a portion of the hot load
- Reason found to be the waste material from a pop rivet pressing the MLI to a thermal short.
- No evidence of why the sensor stopped working below a certain temperature.

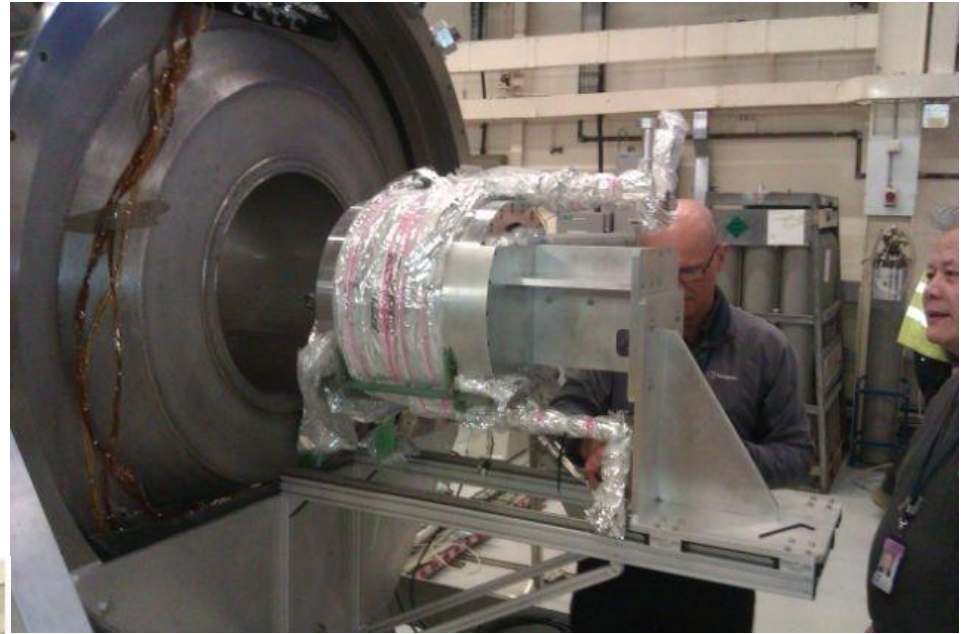
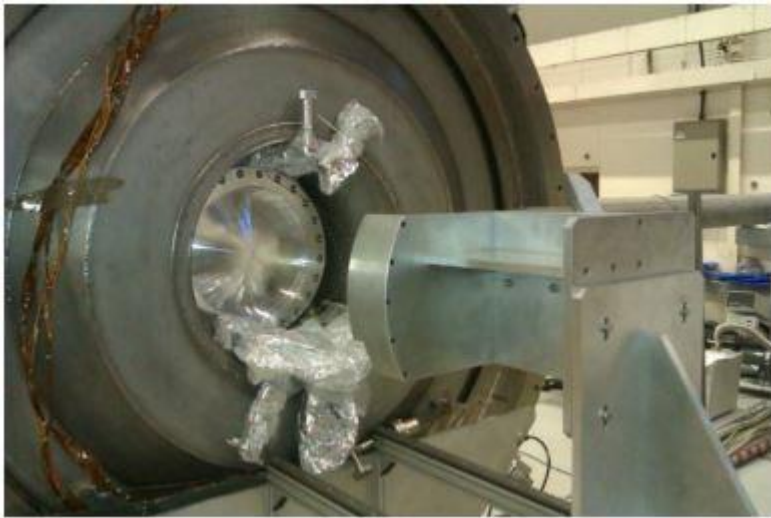
Absorber fit check

- Insertion tooling manufactured
- Some adjustment of the Turret / Absorber lines
