# Evaluation of a potential explosive Front-End

Cern DGS<sup>1</sup>, Cern EN-STI<sup>2</sup>, Cern PH-DT<sup>3</sup>

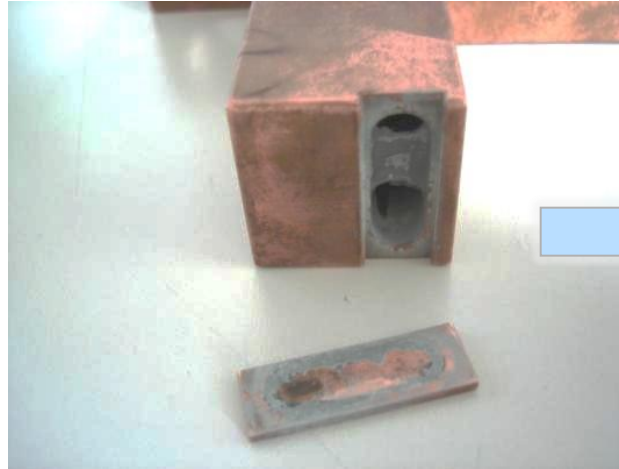
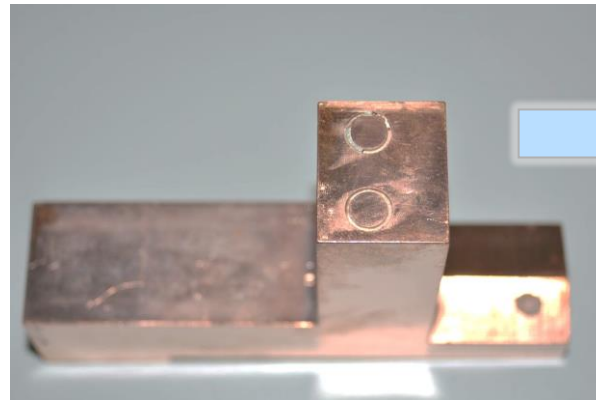
Leaking points

Electron beam welding technique used for new cold gas line + control quality → No water leak since 1990

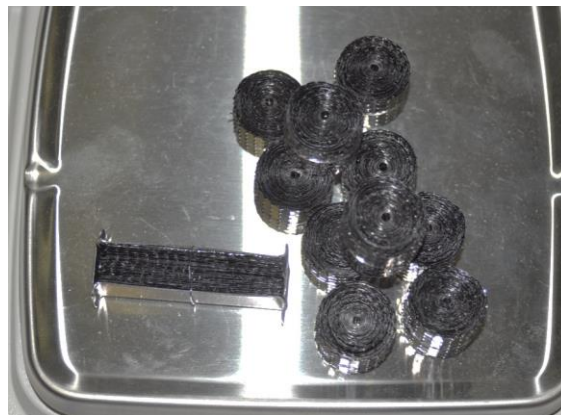
2 types of material were inserted inside container:

- Tantalum bar (Reduced surface)
- Tantalum rolls (Larger surface)
- Pills or powder material were not tested

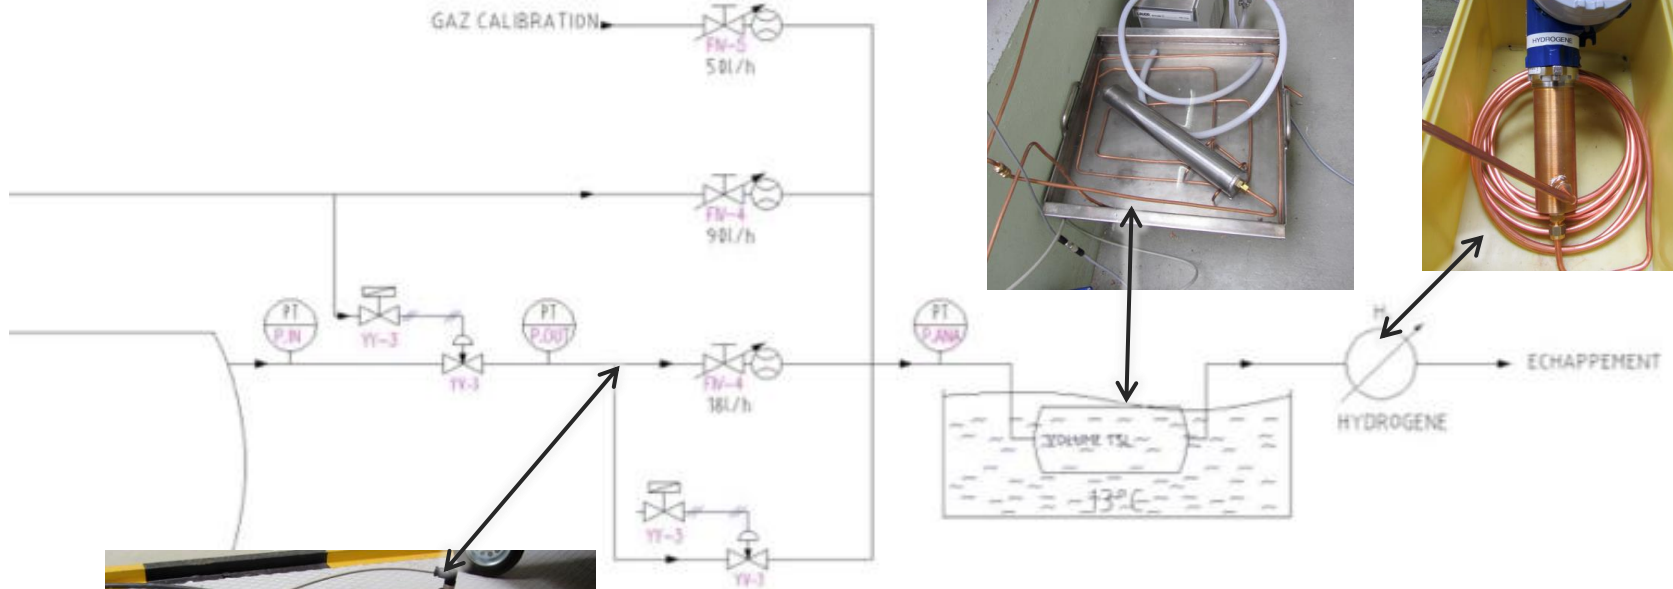
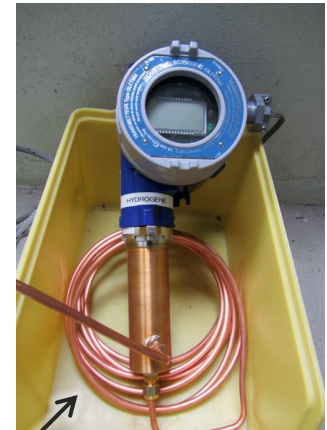
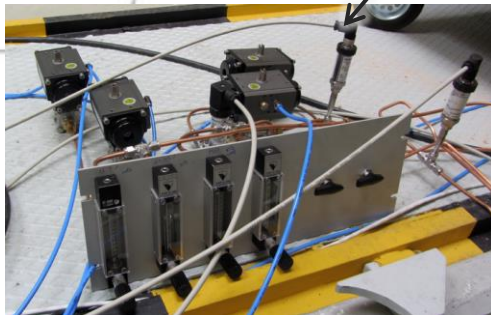
Hydrogen Monitoring

- Pressure and Hydrogen monitoring was done from outside the bunker
- Purge mode with Argon (3 flushings of the volume before access)

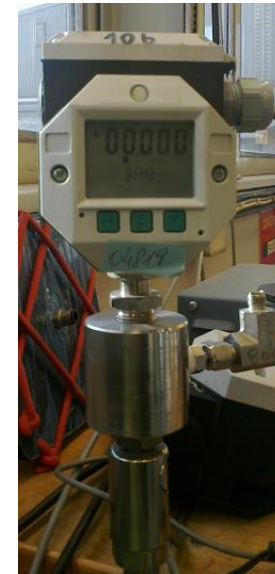
Only **pressure was monitored** → Started with vacuum  $10^{-5}$  - Expected pressure after water leak was **6 bars**

Capteur : Digibar 0 -10 bars and local pressure gauge (recorded by video)

Tantalum bar	
Mass (g)	489.9
Specific surface area (m <sup>2</sup> 1)	2.51
Energy (KJ)	136.4
Water leak (ml/s)	10
Time of leak (mn)	5

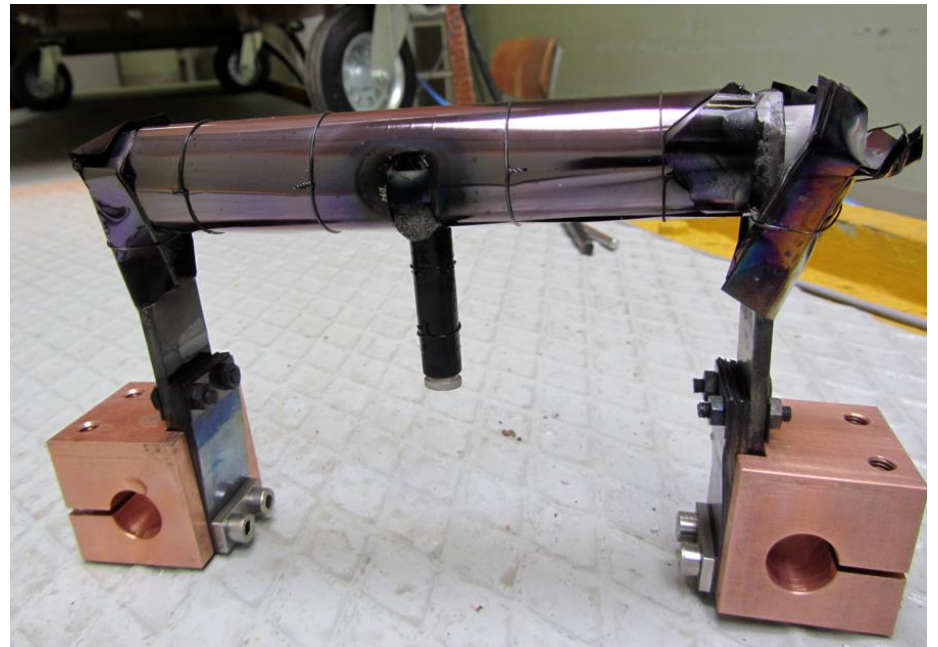
Pressure increase was negligible

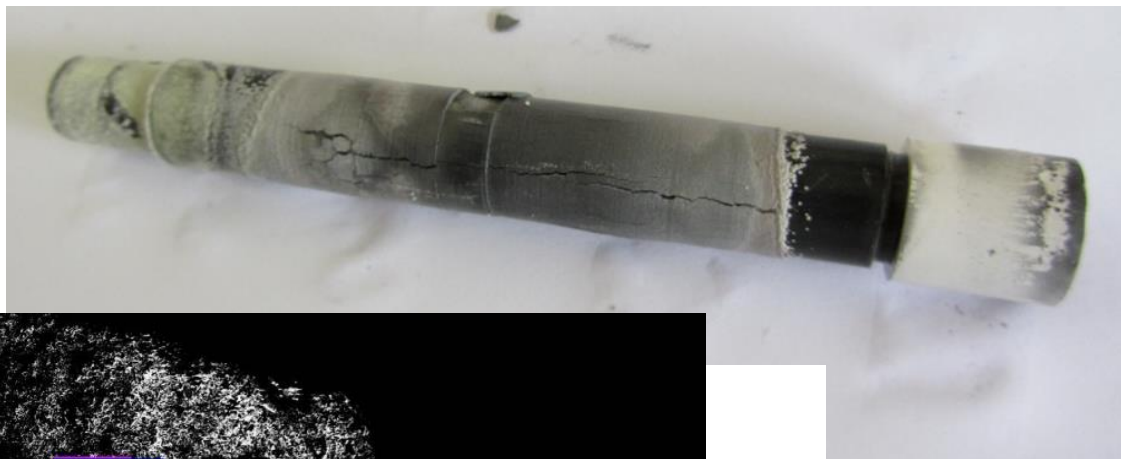
Oxidation process occurred and Hydrogen was produced (under vacuum)

SEM and EDS analysis of the white deposit confirmed the production of tantalum oxide

Mass calculation:  
2 to 3 liters of H<sub>2</sub> were produced

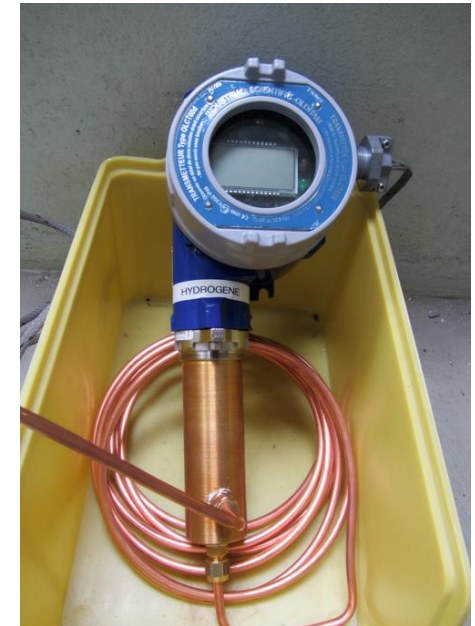
Focus on Hydrogen production and pressure monitoring

Pressure sensors were added on the purge setting (previous sensors not adapted)

Tantalum rolls	2	8
Mass (g)	20.3	162.4
Specific surface area (m <sup>-1</sup> )	800	6400
Energy (KJ)	5.7	45.2
Water leak (ml/s)	10	2
Time of leak (mn)	1	2

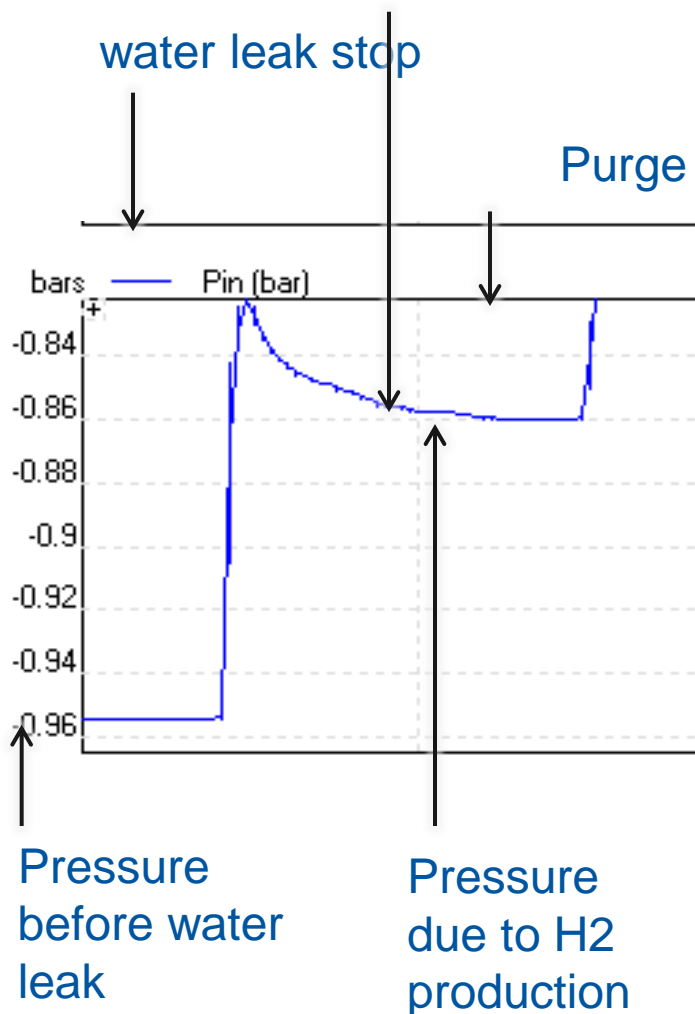
water condensation

Tantalum rolls	2	8
Initial pressure (mbars)	- 955	-955
Final pressure (mbars)	- 860	-585
Pressure variation	95	370
H2 (via pressure data) (l)	5	24
H2 (via H2 sensor data) (l)	4	-

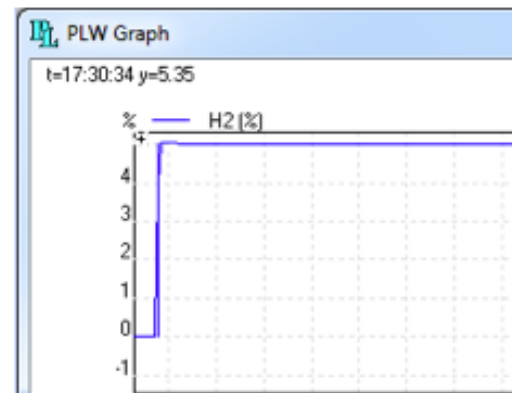
Sensor saturation
