OUTLINE

FC 1 HISTORY

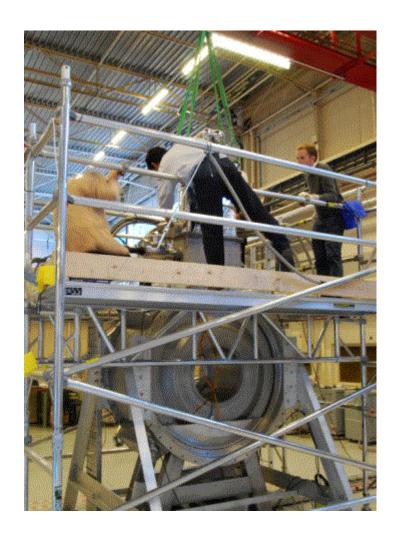
ENTER – AND EXIT – FC 2

- FC 2 arrived end October 2013
 - Connected
 - Pumped down
 - Started to cool with cryocoolers
- Three faults:
 - Faulty temp. sensor
 - He leak
 - Worse when cold
 - Thermal shorts
 - Couldn't cool cold mass...
- Returned to manufacturer

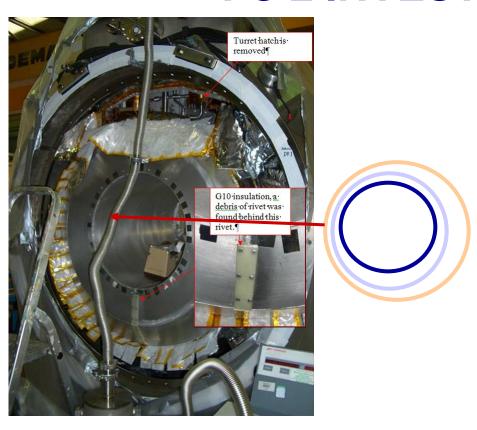
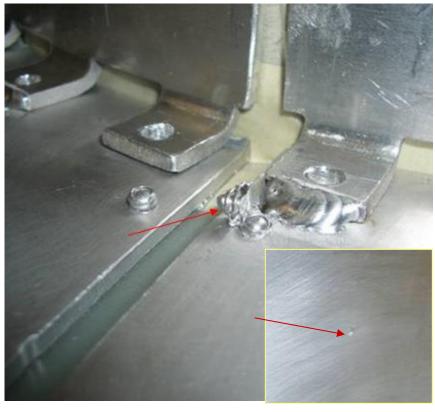
FC 2 INVESTIGATIONS

- Forensic disassembly established source of thermal shorts:
 - 1. Cold mass / rad. shield / warm bore tube not concentric 6mm clearance reduced to 3mm → compressed MLI
 - 2. Debris of pop-rivet on radiation shield impinging on cold mass
- Calculations agree with observed thermal loads

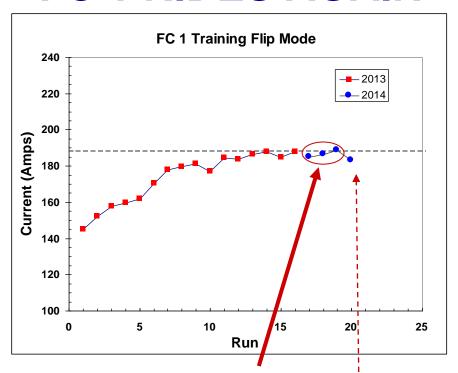
FC 1 RIDES AGAIN

- Three training runs after warm-up
 - It remembered its training!
- First estimate of stable operating current in R9 was 185 Amps
 - Two stable 4-hour runs at 185 Amps
 - Quenched at 183 Amps on third attempt
- Stable at 180 Amps for two 24 hour runs

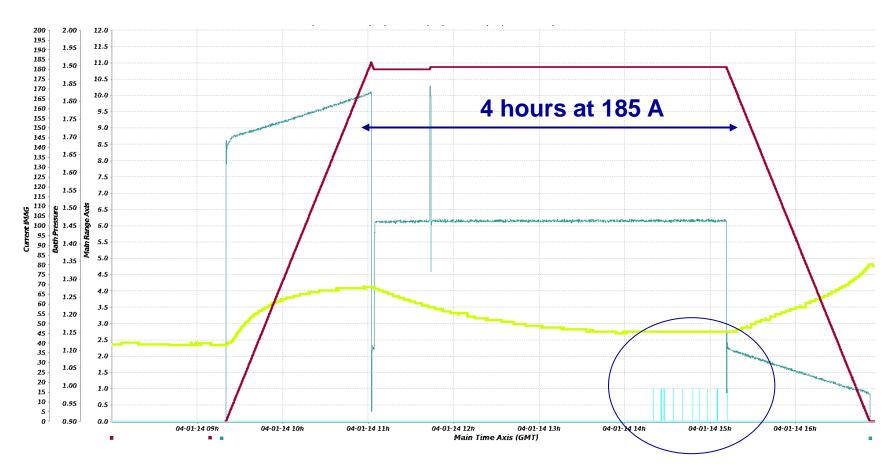
CRYOCOOLER PERFORMANCE

He bath heater activating at full current → excess cooling capacity

But marginal

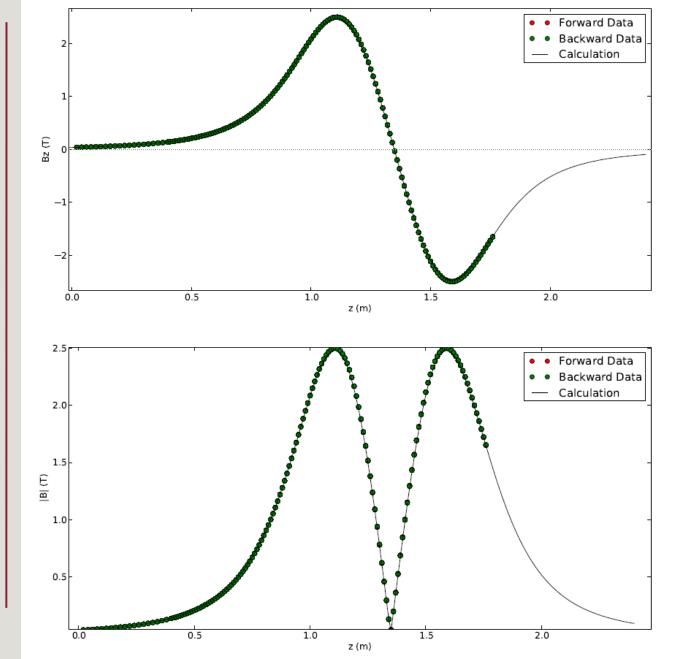
Comparison to calculation

- Flip mode
- 150A
- Mapper takes data in both directions of travel – requires some correction (see later)
- Top: B_z from mapper
- Bottom: |B| from mapper – avoids the question of Hall probe alignment w.r.t. the field
- Negligible difference between B_z and |B|

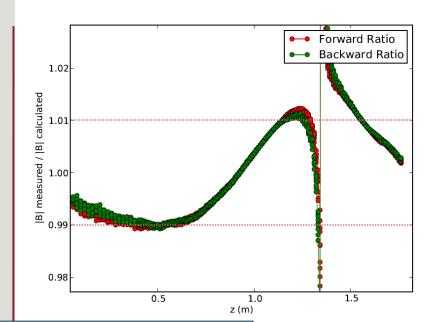
Comparison to calculation

- Solenoid mode
- 100A
- Mapper takes data in both directions of travel – requires some correction (see later)

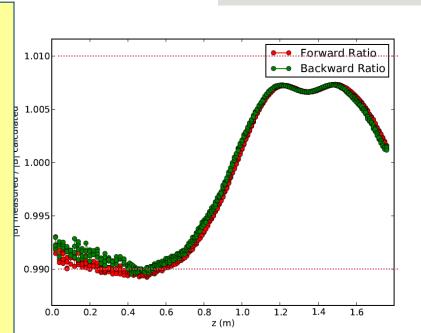
Ratio of measured to calculated field in Flip Mode at 150A

Also seen with 'probe on a stick'

Surprisingly large \rightarrow Δ thickness \sim -5 mm

Need to check nominal dimensions of coils with manufacturers

Idea is to fit (4 parameters) coil dimensions

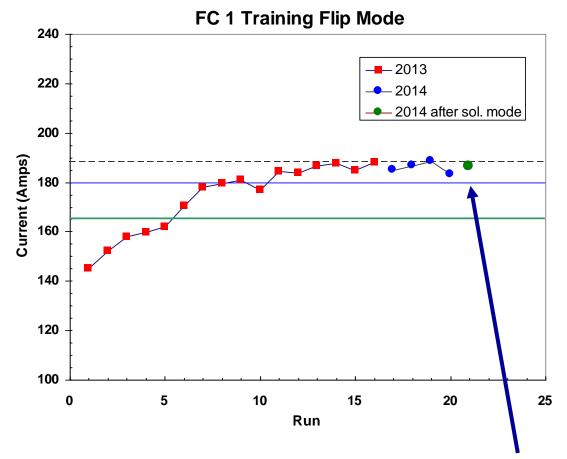
FC 1 AFTER SOLENOID MODE

It went straight to 186.5 Amps before quenching

→ Still remembers its training

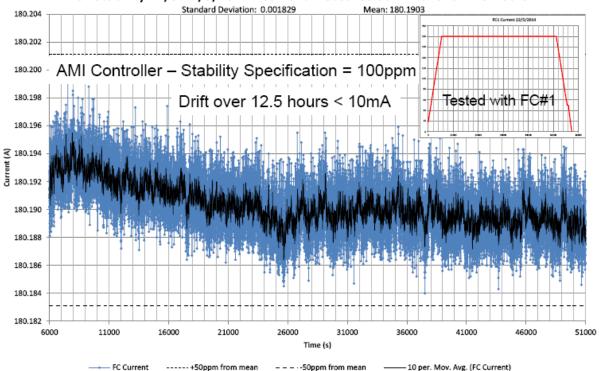
PSU STABILITY

Checked by DL team

Better than 60 ppm in 12 hours

Absolute calibrations agree to ~ 1.1 parts / 1000 (0.11 %)
