Long Shutdown (LS1) in the LHC

G. Schneider

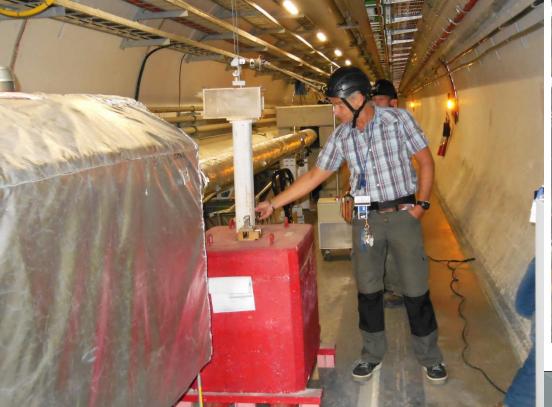
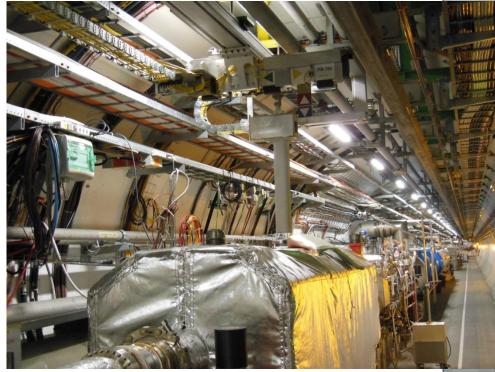
BRAN:

Beam Rate Neutral Particles, Luminosity measurement on either side of collision points = 8 total

- Remove and re-install instruments for bakeout
- New BRAN C in Point 8 for higher radiation resistance
- New installation tooling and procedure
- Pressure tests of installation

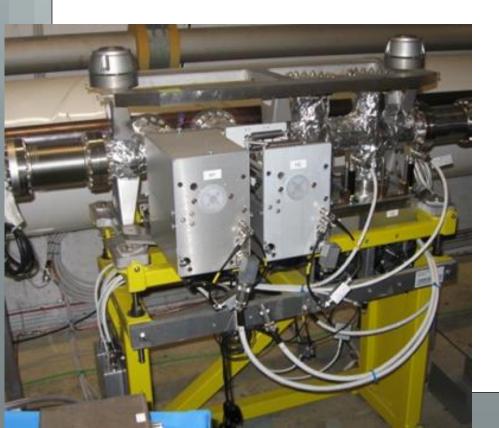
BWS: Wire Scanners

Instrument to measure the beam profile 2 for each horizontal and vertical for each beam = 8 total

Leaks on bellows (more than 10000 cycles) Wire refurbishment

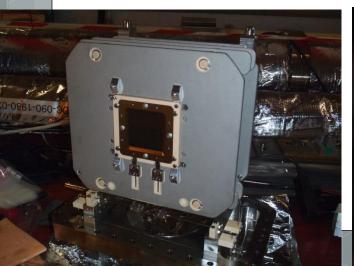
Damaged Phosphor Screen

- Leak tightness: Surface roughness and profile defined; Seal type changed and grooves in spacer added
- Leaks opened after bakeout. Why?
- Instrument refurbishment:
 - Exchange of MCP (Multi Channel Plate) and Phosphor Screen
 - Cameras more radiation hard
 - Installation of thermometers in vacuum

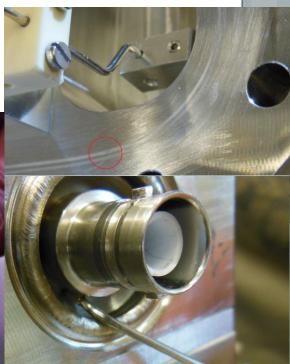
Courtesy: M. Sapinski

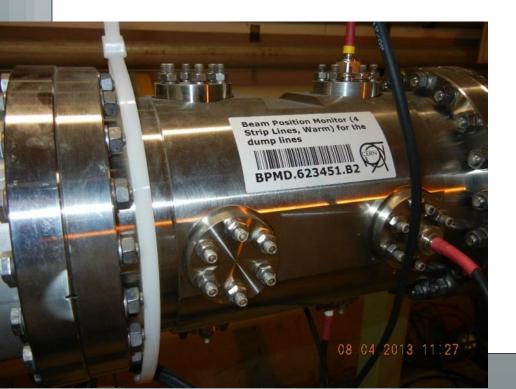
BPM:

Beam Position Monitor Total 1145 Monitors installed in the machine

- Engineering Change Requests (ECR) to move, add and change BPMs
- BPM cables to be removed for each bakeout

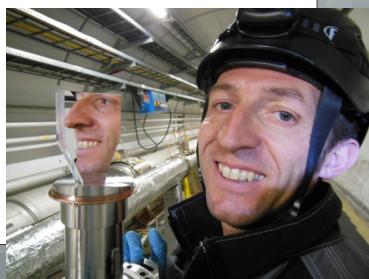
BSRT:

Synchrotron Radiation Telescope to measure the beam profile

- Instrument overheated due to RF-coupling in Run1
- New design proposed, made and tested
- New mirror now made with fused silica instead of silicon
- Optical table refurbishment
 - focusing lenses in the near UltraViolet (UV, ~250nm) for imaging @
 6.5-7TeV minimizing diffraction
 - minor changes in optical filters layout and control
 - New interferometer line, for alternative (to imaging) beam size measurements, in principle diffraction-free (ongoing)

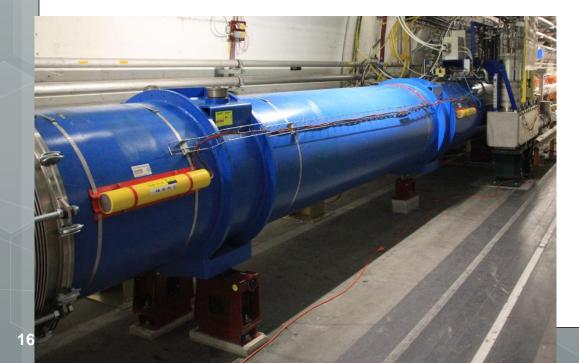
Beam Loss Monitor (BLM): Outside beam vacuum

Remove and reinstall BLMs in order to have access to the interconnects

- □ all BLMs in ARCS (total ~2500 of which 816 were re-located)
- □ about 70% of LSS BLMs (total ~1000)
