55th Cryogenic Engineering Conference, Tucson, Arizona
June 28 – July 2, 2015

In-Flight Performance of the OCO-2 (Orbiting Carbon Observatory-2) Cryocooler

*Arthur Na-Nakornpanom, Bret J. Naylor and Richard A.M. Lee
Jet Propulsion Laboratory, California Institute of Technology*

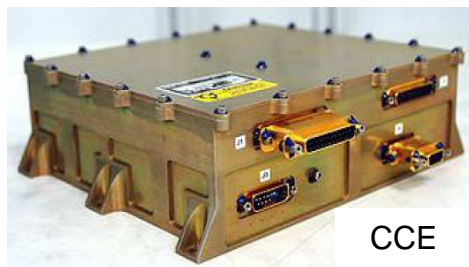
OCO-2 Cryo/Thermal System

- Thermal Mechanical Unit (TMU)
 - NGAS High Efficiency Cryocooler (HEC)
 - Single stage linear pulse tube cooler maintains cold head temperature at ~ 110 K
 - Cryocooler maximum drive limit is set to 50% (~ 48 W compressor power) due to spacecraft power limitations
- Cryocooler Control Electronics (CCE)
 - NGAS Advanced Cryocooler Electronics (ACE)
- Cryogenic Subsystem (CSS)
 - Developed by Utah State University Space Dynamics Laboratory (SDL)
 - Interface between the three focal plane arrays (FPAs) and the TMU
 - Thermal isolates each FPA from instrument optical bench
 - Flexible aluminum foil thermal link connects each FPA to the TMU
 - Cryocooler BOM heat load is ~ 3 W at 110 K
 - With TMU cold block controlled to ~ 110 K, the CSS maintains the three FPAs at ~ 120 K

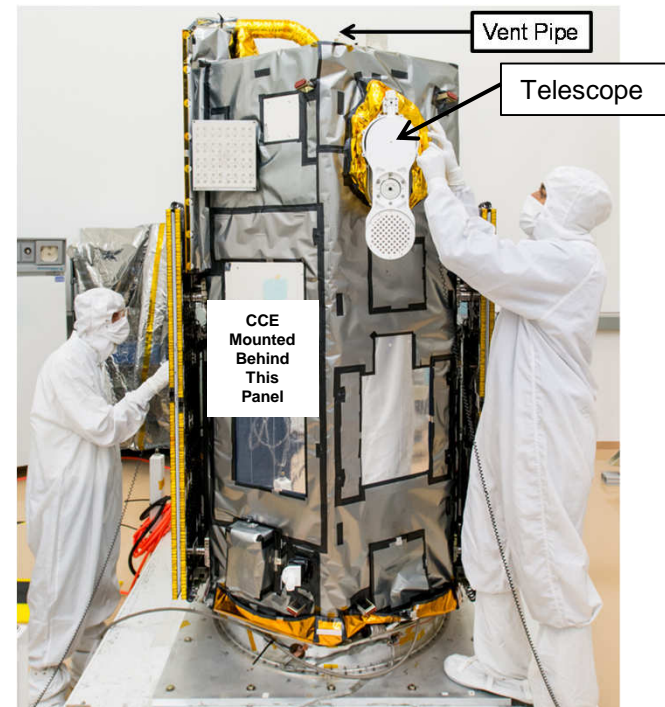
OCO-2 Instrument Heat Rejection System

- Cryocooler Heat Rejection System (HRS) uses variable conductance heat pipes (VCHPs) to transport waste heat from the cryocooler to a space-viewing radiator
- CCE is directly mounted to a spacecraft radiator viewing Earth
