# Measurement and characterization of LumiCal sensors in the TAU lab

FCAL Meeting, CERN, March 24 2015

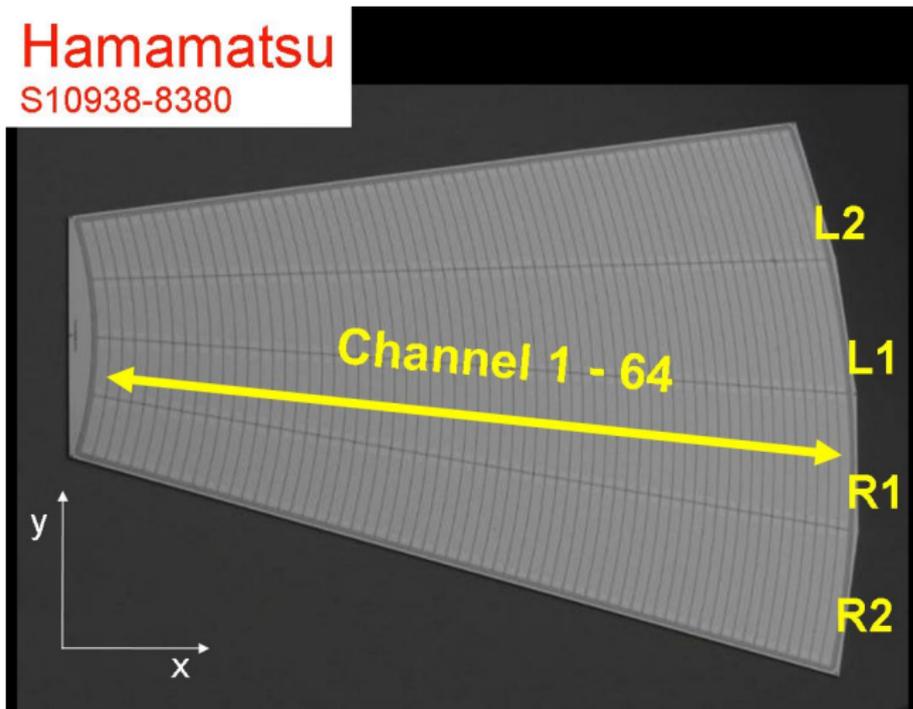
# Sensor Layout

**Hamamatsu**  
S10938-8380

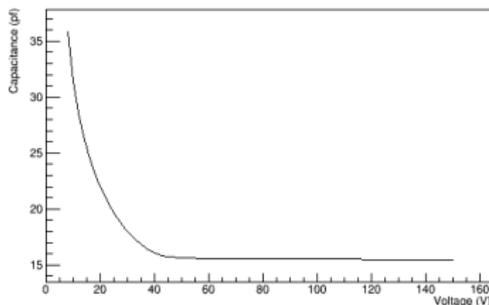
(a) C vs V plot

Expected two behaviors in two voltage regions:

1. For  $V < V_d$        $C(V) \sim V^{-0.5}$
2. For  $V > V_d$        $C(V) \sim \text{const}$

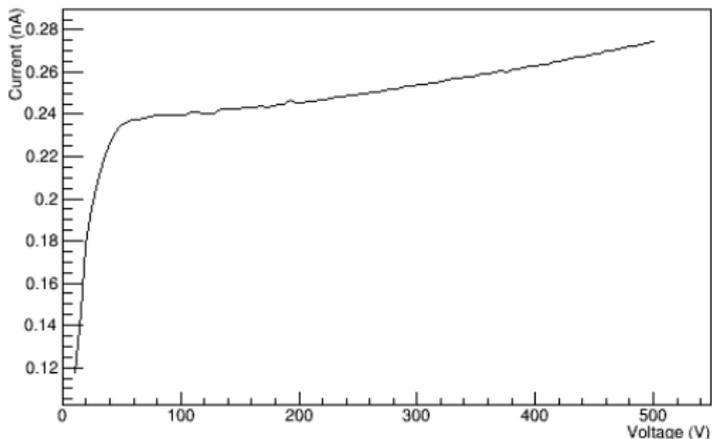
Expected two behaviors in two voltage regions:

1. For  $V < V_d$        $I(V) \sim \sqrt{V}$
2. For  $V > V_d$        $I(V) \sim \text{linear}$

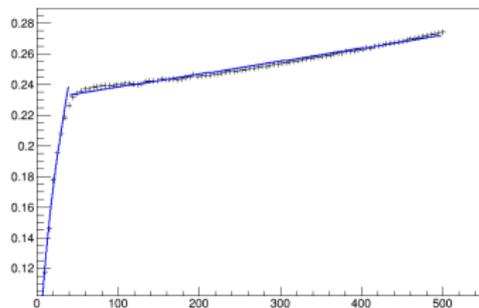
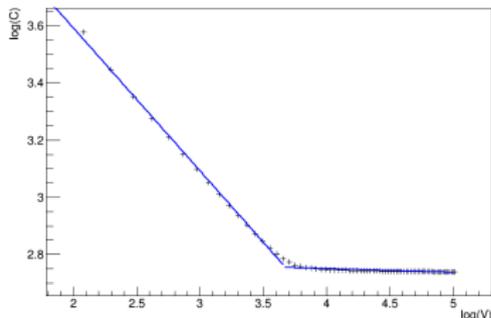
One can fit the  $C(V)$  logarithmic curve and find the depletion voltage and the constant capacitance in the high voltage region. Similarly, one can find the average level of current for the linear part of the  $I(V)$  curve.

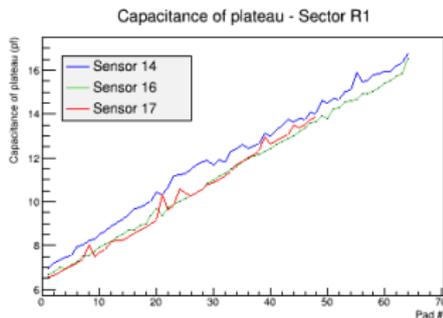
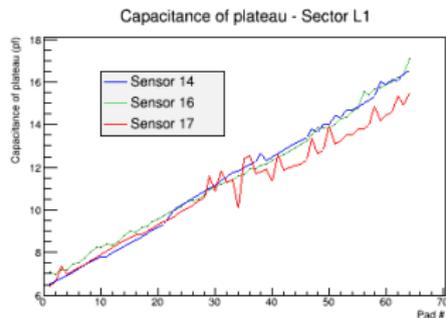
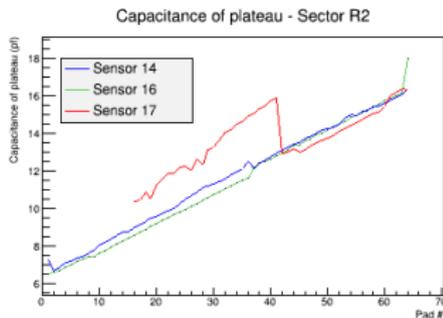
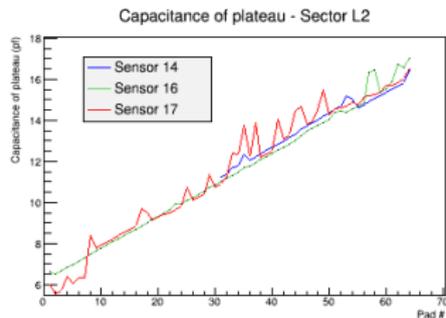
Capacitance is linearly dependant of pad number (i.e. pad size)  
and is independent of the sector or of the specific sensor  
(geometrical quality)

- Electrical measurements of sensors are ongoing in the TAU lab
- Data collected from three different sensors suggests that behavior is rather uniform among the different sensors
- Depletion voltage of all pads is in the 40V-55V range
- Broken sensor is (obviously...) damaged, but some pads still show almost normal behavior

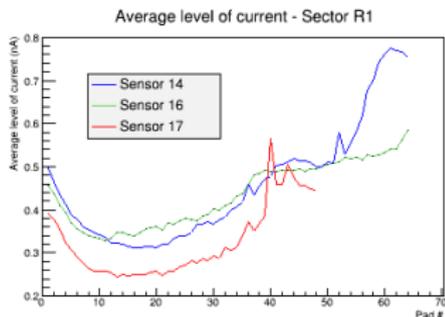
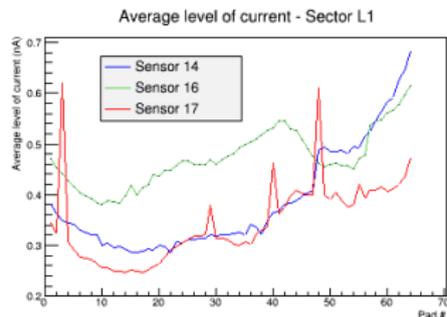
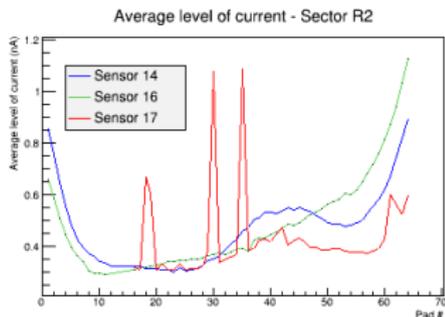
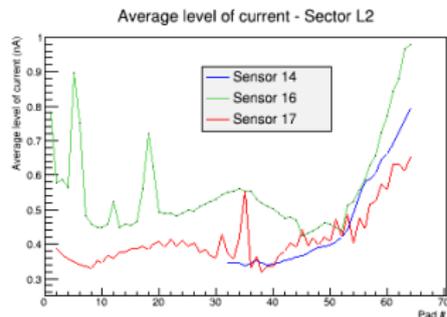
Current values display (roughly) the same dependance on pad number in different sensors, for a given sector

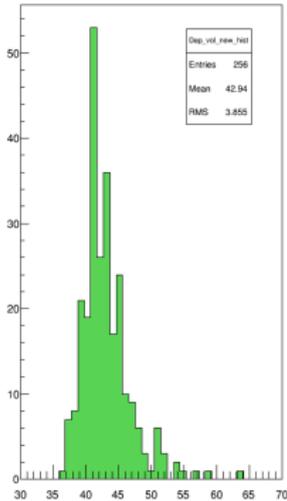
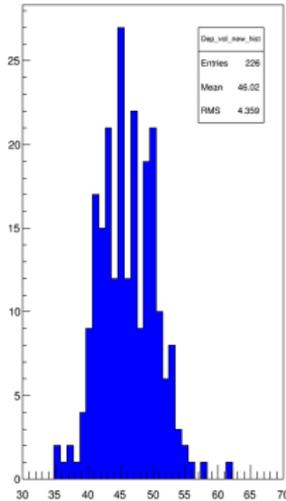
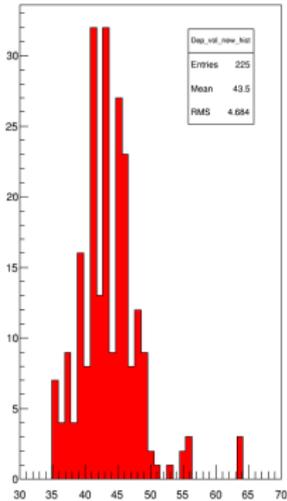
Depletion voltage of all pads lies in a rather small range of values, regardless of the specific sensor/sector/pad

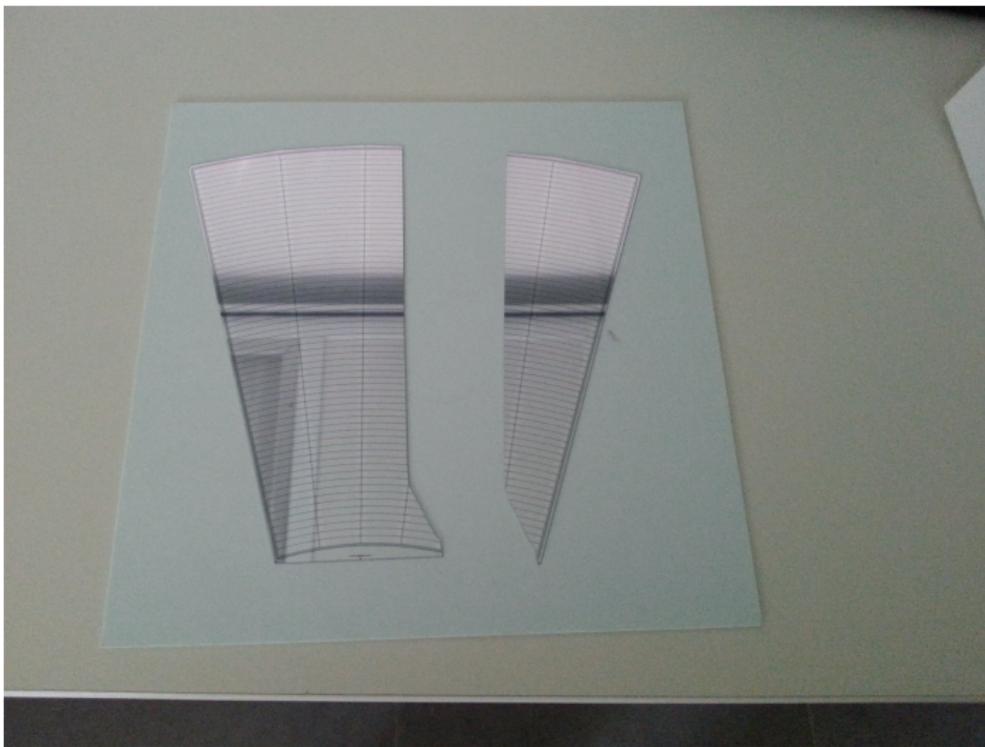
## The broken sensor

Selected intact pads were measured from both parts of the sensor

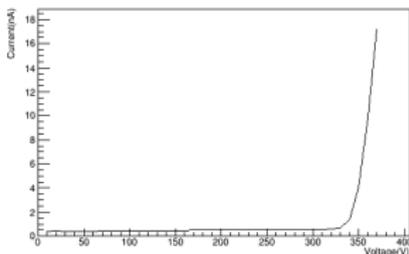
Many of the pads are breached and show a very large increase of current:

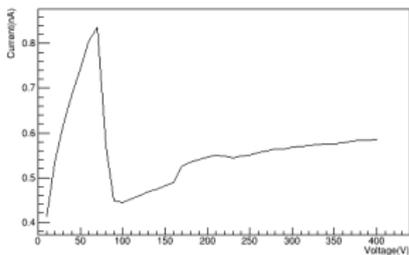
Some of the pads display normal behavior with an addition of a "spike" at low voltage:
