## Pulsed surface heating: Ultrasonic and Laser fatigue experiments

- **CLIC Fatigue issues**
- **Materials & Preparation**
- **Pulsed laser fatigue testing** (Sergio Calatroni & Holger Neupert)
- **Ultrasonic fatigue testing**
- **Up-to-date results**
- **Conclusions & Future plans**

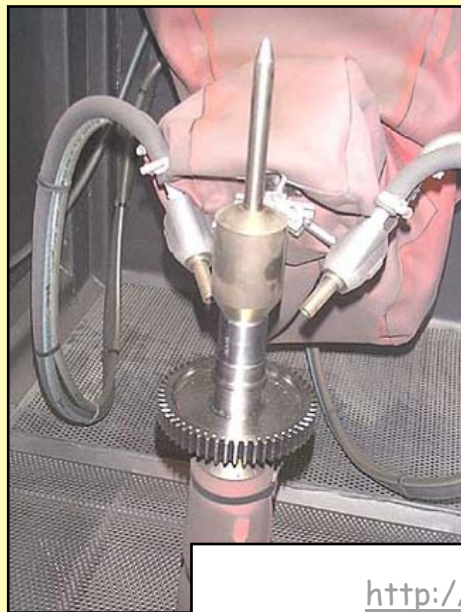
## "Classical" Shot Peening

- Blasting of metal or glass balls against materials surface
- Hardens the surface and introduces a compressive residual stress
- Long history of improving fatigue strength of parts of machines
- Applicable to complex geometries
- Increases the surface roughness

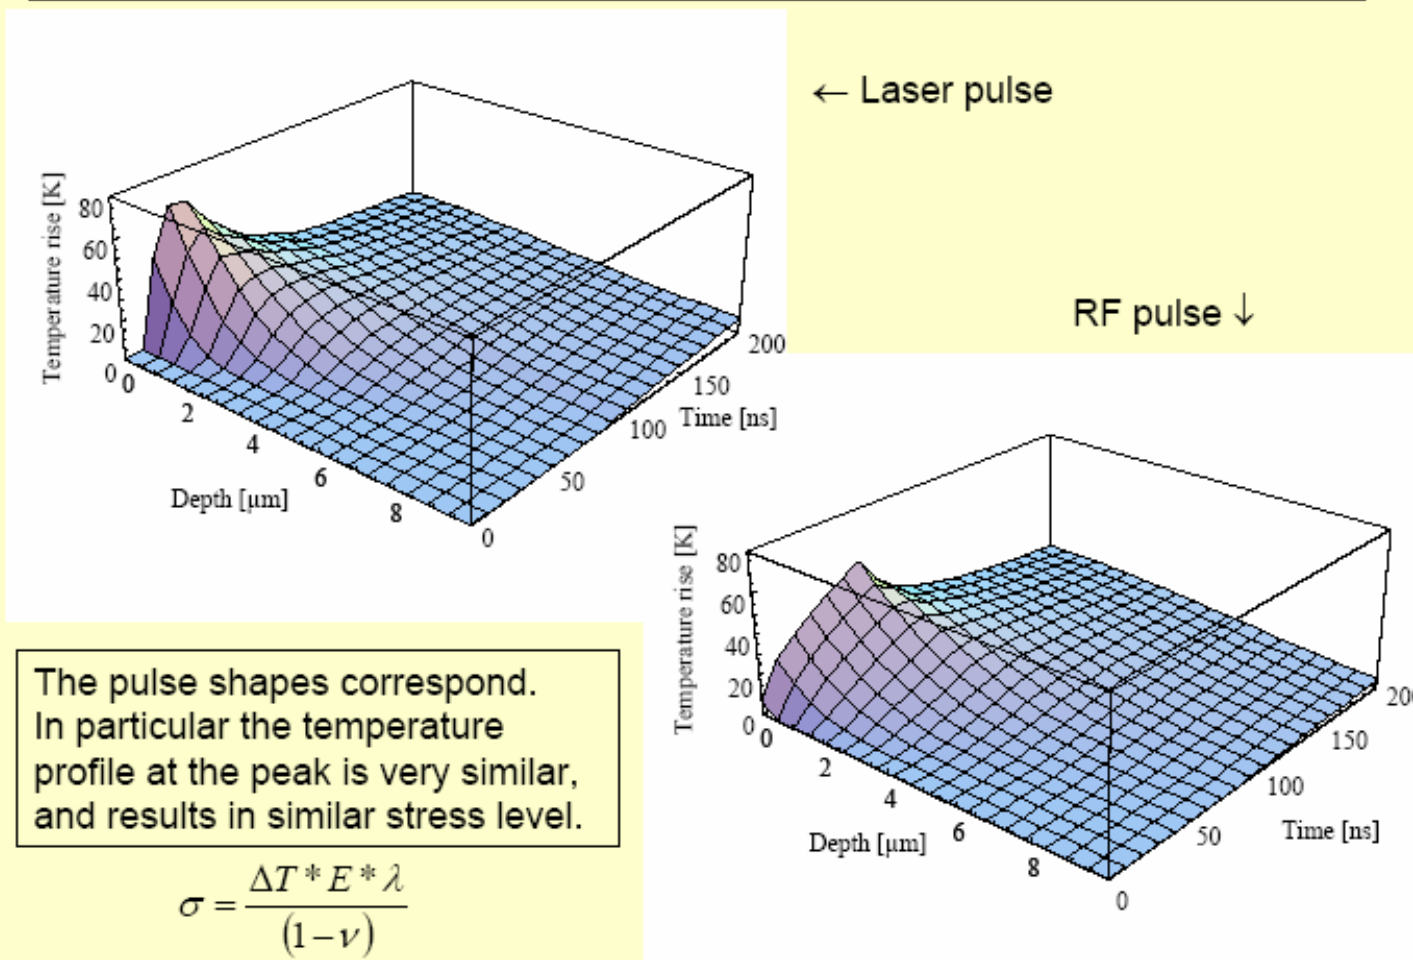
Comparison of heating profiles

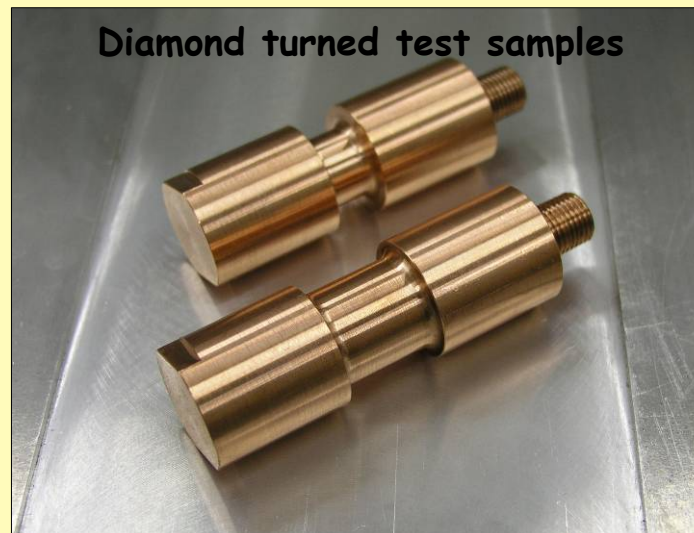
- Cyclic mechanical stressing of material at frequency of 24 kHz.
- High cycle fatigue data within a reasonable testing time. CLIC lifetime  $7 \times 10^{10}$  cycles in 30 days.
- Will be used to extend the laser fatigue data up to high cycle region.

Amplitude measurement system

Fatigue test specimen

Air Cooling

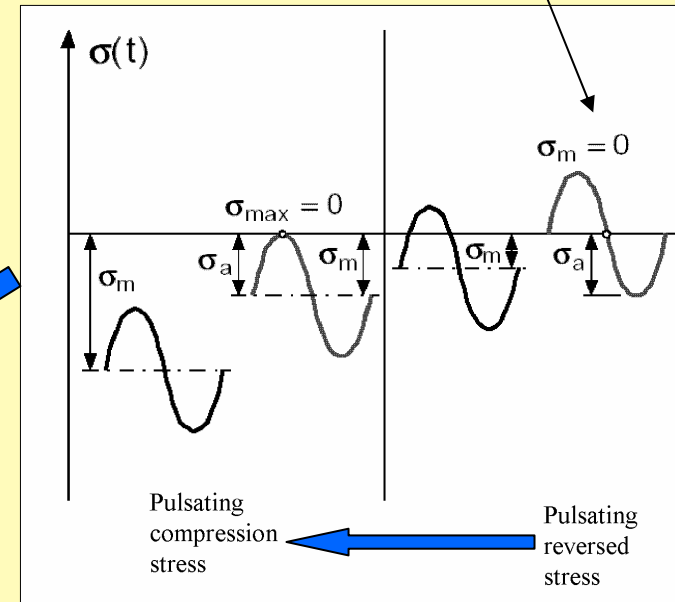
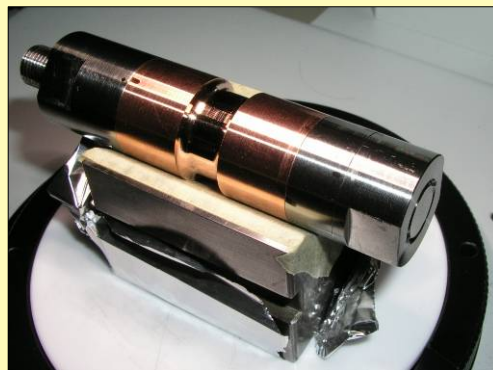
Varying the stress condition by a special pre-stressed specimen

Default ultrasound stress condition

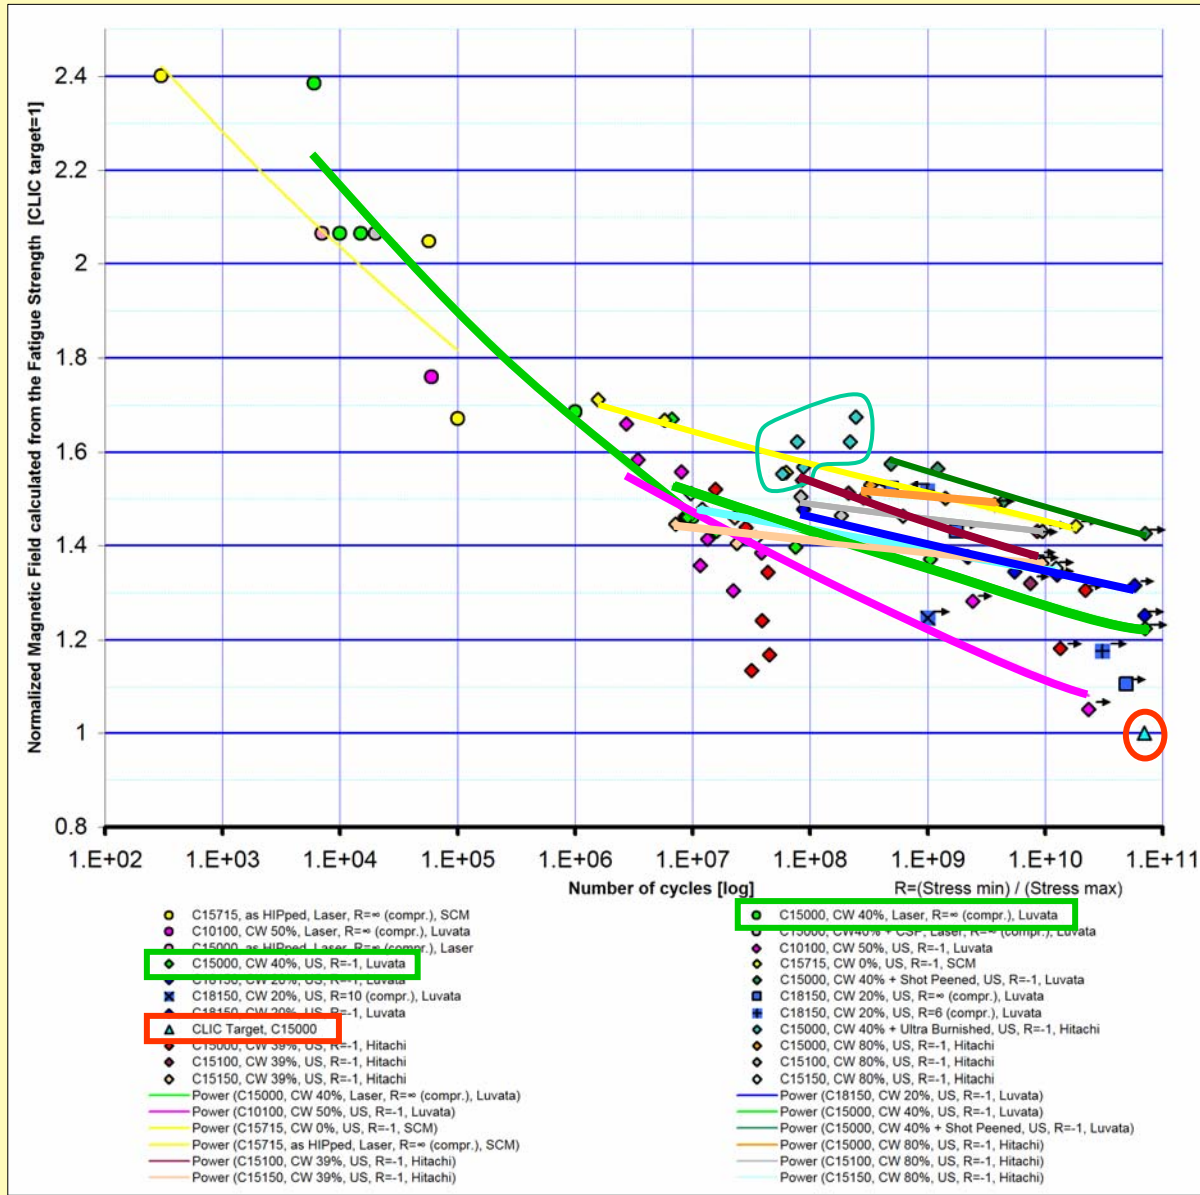
- ◇ Ultrasound
- Ultrasound pre-stressed
- Laser
- △ CLIC Target
- Run-out

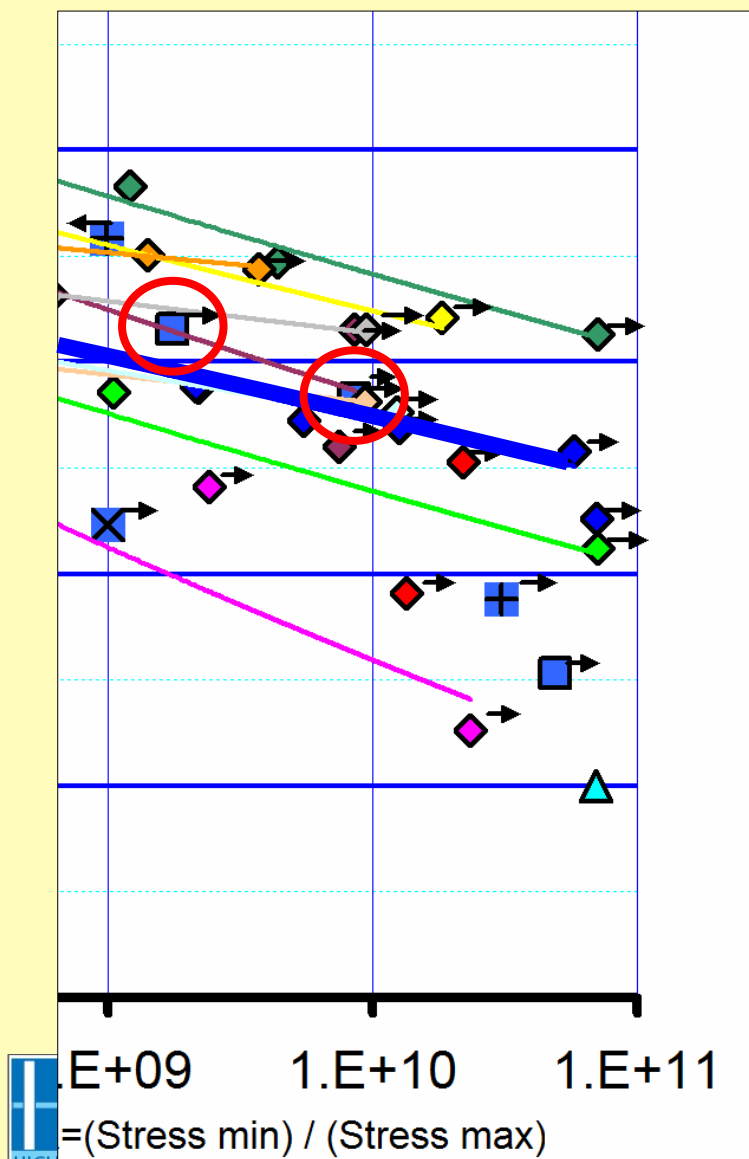
C18150 fully reversed conditions  $R=-1$

C18150 fully compressive conditions  $R=\infty$

Based on the few experiments with pre-stressed C18150 specimens it looks like that the compressive mean stress does not change the fatigue strength from the fully reversed conditions (at least when the absolute maximum stress value does not exceed the yield strength).
