Microstructural features of pre- and post-BD RF- tested samples: facts and questions

Inna Popov, Ayelet Yashar, Yinon Ashkenazy

CLIC, CERN

MeVARC-5, Lapland

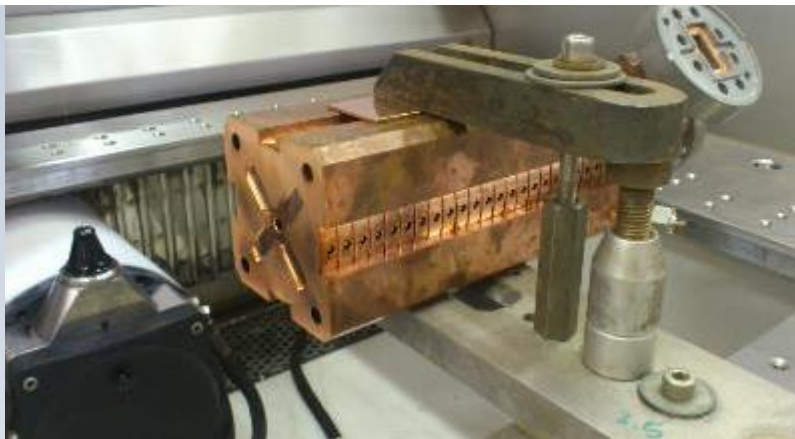
EDM wire cutting machine at CERN workshop:

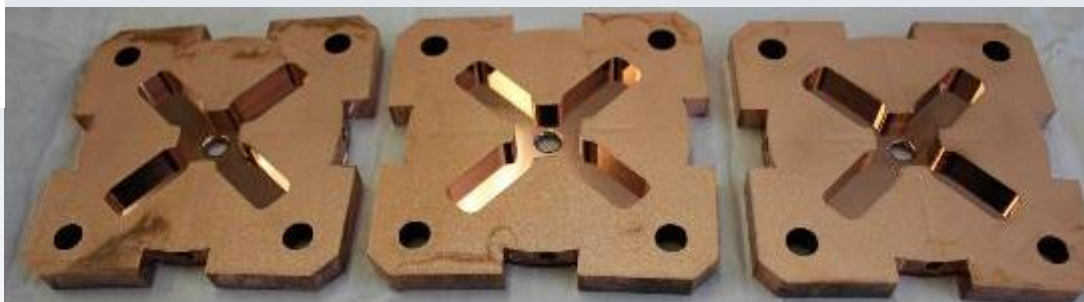
Structure ready for SEM after degreasing:

US of the cells:

Iris #4

Iris #5

Iris #6

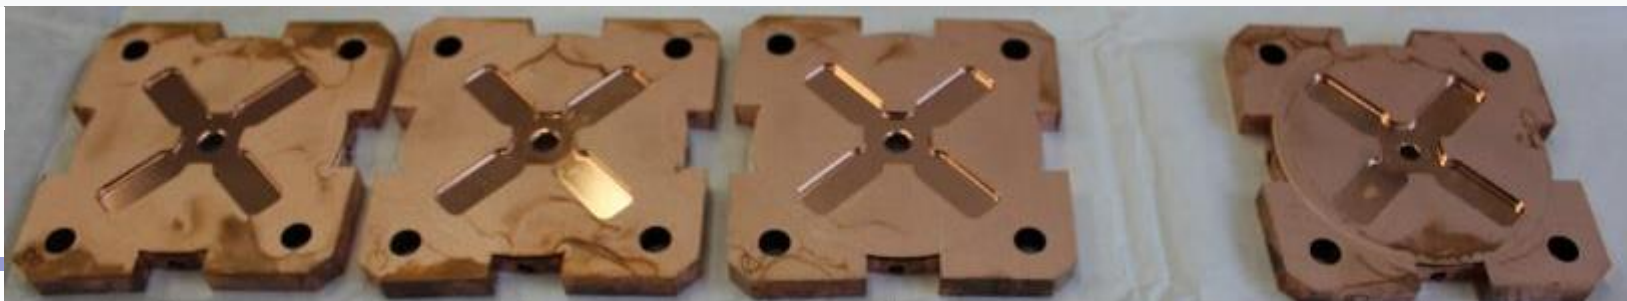
DS of the cells:

Iris #4

Iris #5

Iris #6

Iris #23

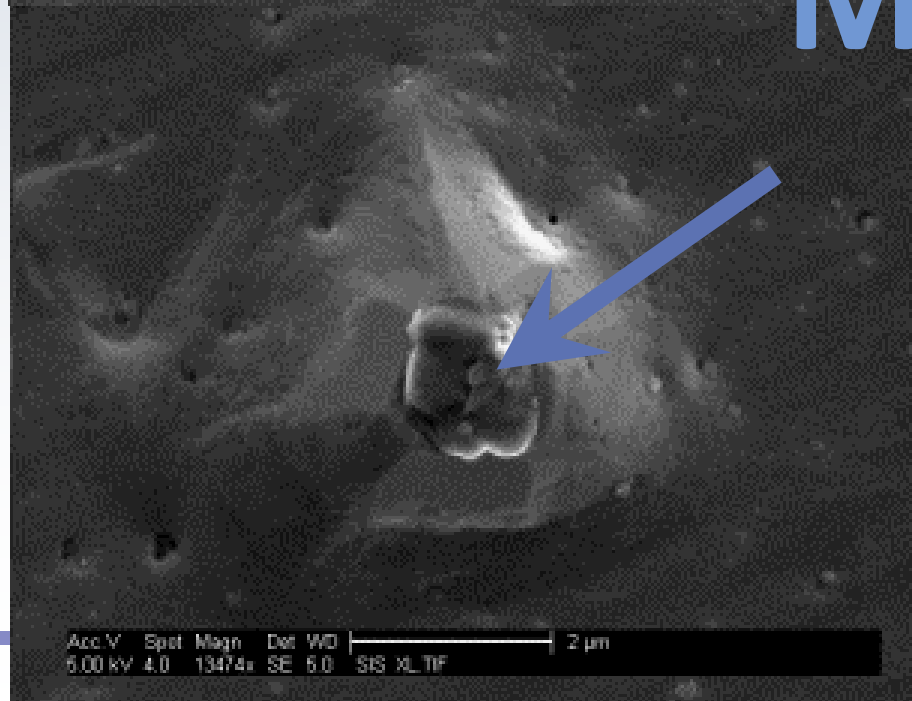
I. A Reference Sample

- fine non-conductive particles - oxides

Cu

Mn, S

- ✓ A reference sample was not suitable to answer the task questions
- ✓ If not occasional, this is a problem of raw OFE Cu quality or uniformity

**! After-production - Cu is extremely soft =
= almost fully relaxed closed to equilibrium
microstructure = low density of dislocations**

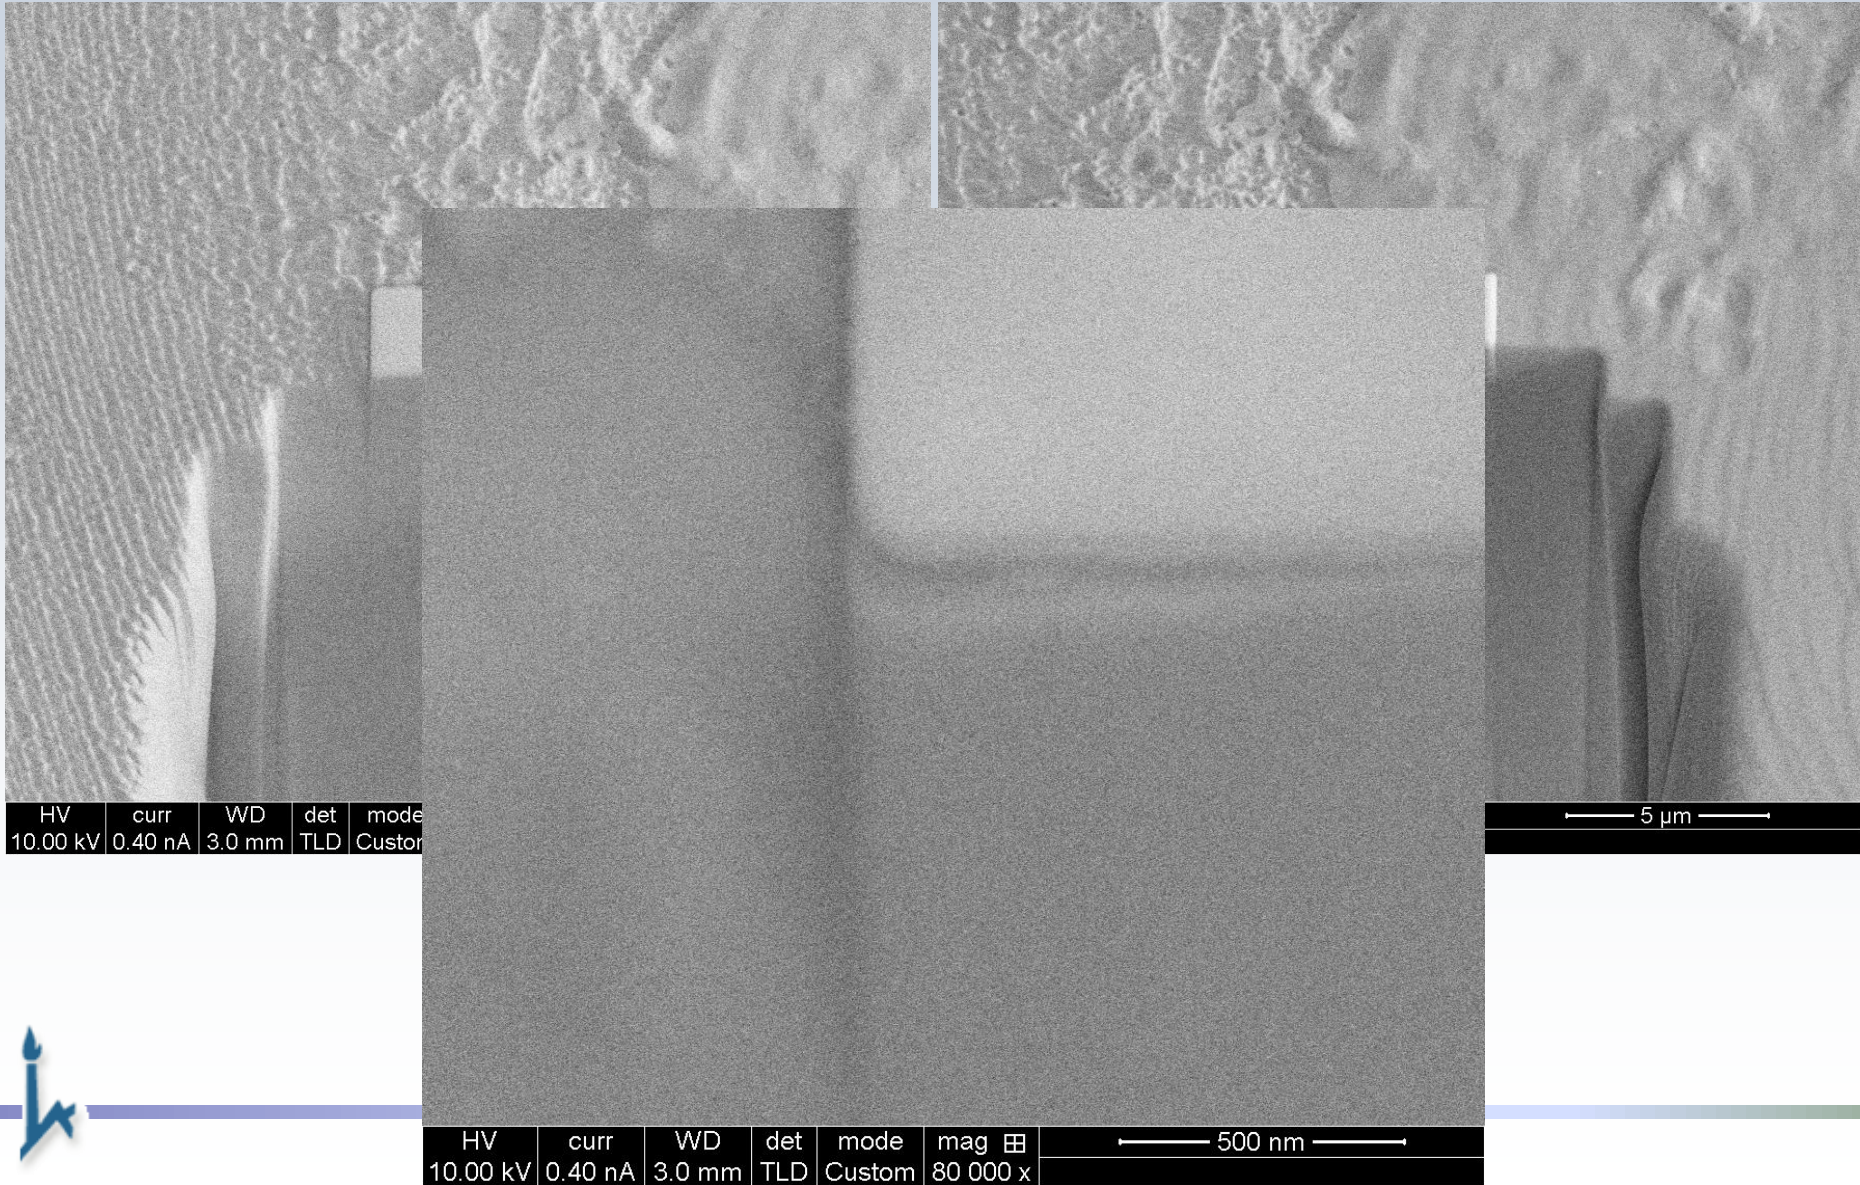
Our preliminary results on ECCI of FIB XS with BSE mode of TLD
