Status of parasitic FE from metallic surfaces and potential destruction of emitters by μ -discharges and ion beam impact

P. Serbun, S. Lagotzky, G. Müller
FB C Department of Physics
University of Wuppertal

5th International Workshop on Mechanisms of Vacuum Arcs, 1-5 September 2015

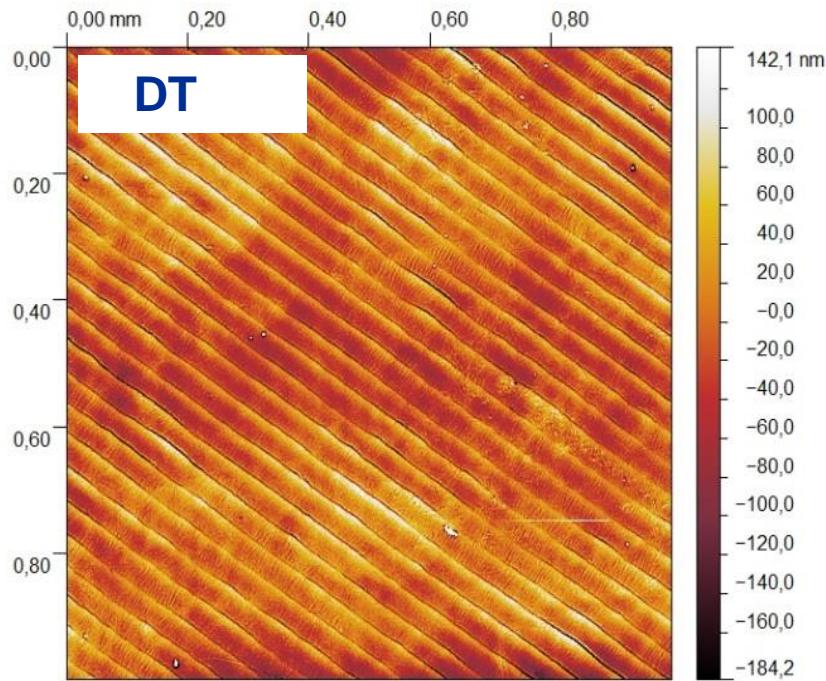
Samples measured with optical profilometer (OP) in the area relevant for FESM

- Slightly wavy surface ($\lambda \sim 0,5 - 1$ mm)
- Many ridges from DT
- Damage layer?
- Average roughness: $R_a/R_q = 126/145$ nm
- Sample surface now very flat ($\pm 0,5$ μm)
- Many pits ($N < 18$ mm⁻²) due to etching
- Grain size: 1300 μm² - 5.3 mm²
- $R_a/R_q = 150/230$ nm slightly increased

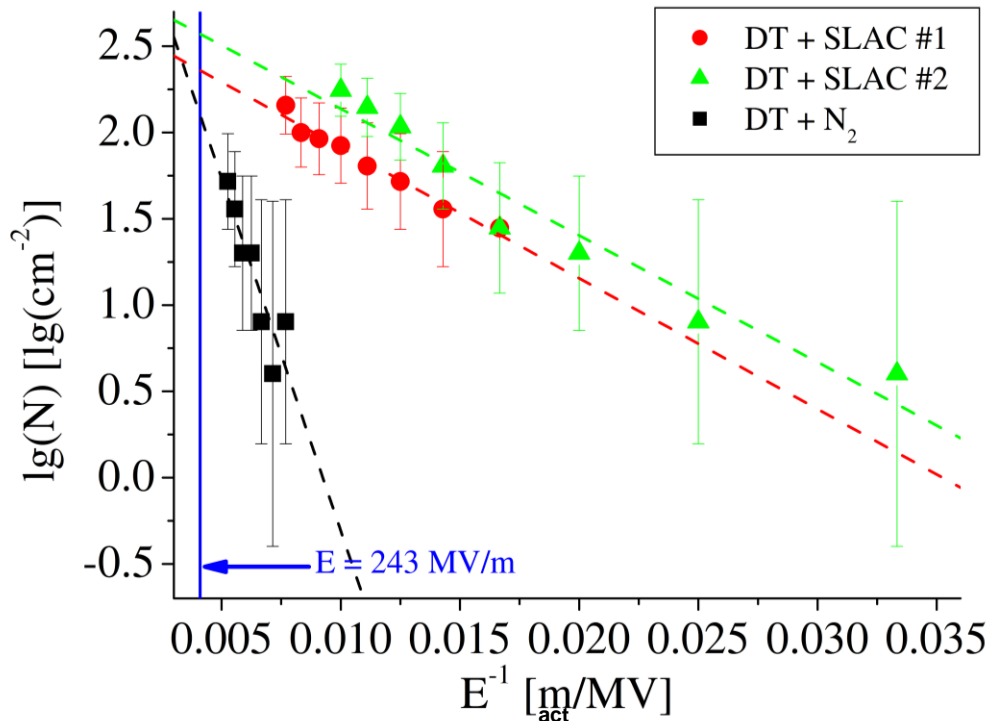
FE activation statistics without/with N₂ cleaning

for two types of samples

- Emission from surfaces **without** any **cleaning** starts at **30 MV/m**
- **Cleaning** with N₂ shows FE starting at **130 MV/m**
- N @ $E_{\text{peak}} = 243 \text{ MV}/\text{m}$ reduces from **229/372** cm^{-2} to **124** cm^{-2}
- N increases exponentially [3]:
$$N \sim \exp(1/E_{\text{act}})$$

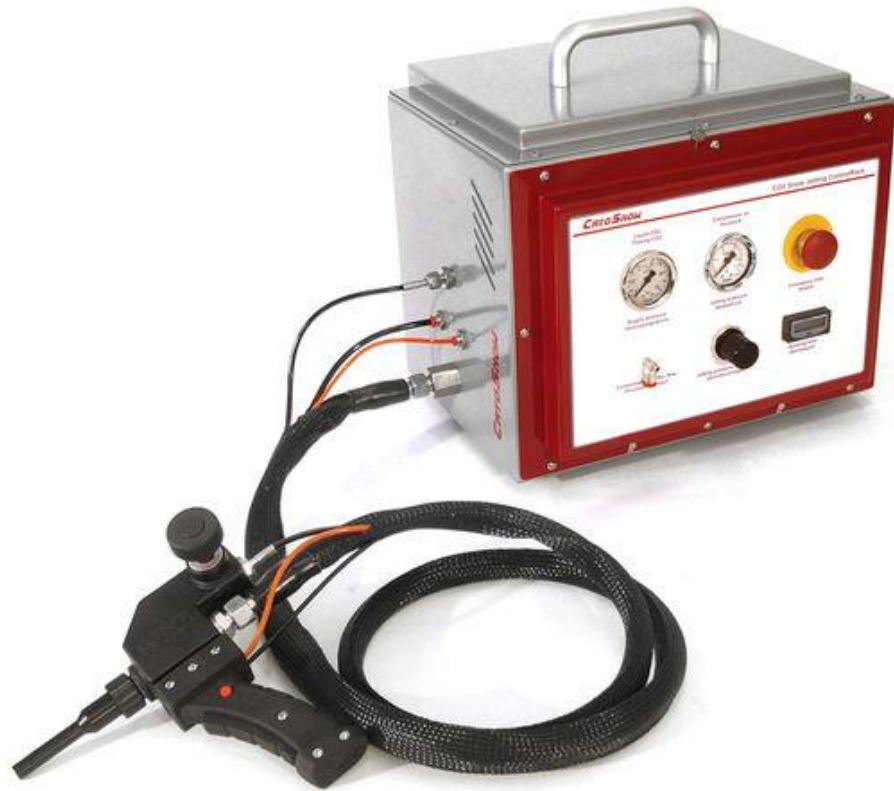
Dry ice cleaning (DIC) system

- Commercial DIC system (SJ-10, CryoSnow) installed in cleanroom (class iso 5)
- Non-abrasive blasting where dry ice is accelerated in a pressurized air stream and directed at the surface
- Samples/caps cleaned for 2.5 min under 90° /45° and 3 x rotated in 90° steps
- Most particulates (> 100 nm) are removed

- Cleaning of (grounded) samples with handgun (d ~ 5 cm) typically for 5 min
- Liquid CO₂ (10 bar) and N₂ (8 - 10 bar, propellant gas)
→ Flat (12x3 mm) or round (Ø = 5 - 10 mm) jet of CO₂ snow particles
- Samples are treated 2.5 min under 90° / 45° and 3 x rotated in 90° steps
- Teflon protection caps are cleaned as well

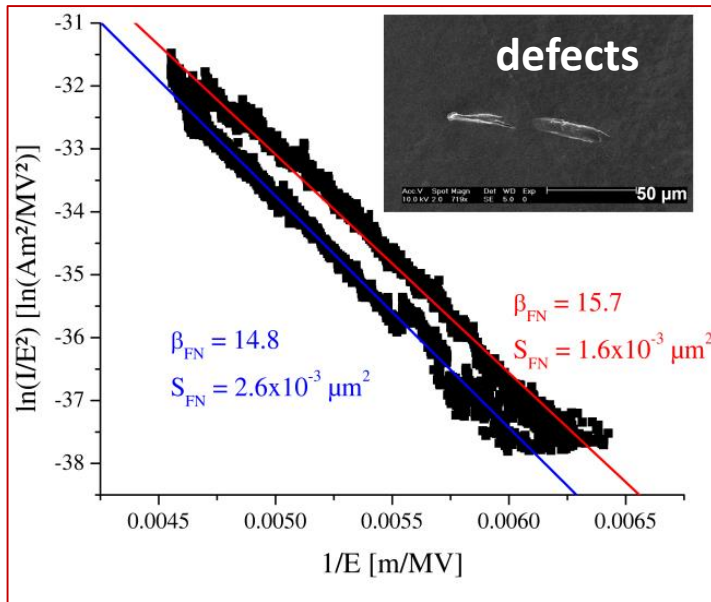
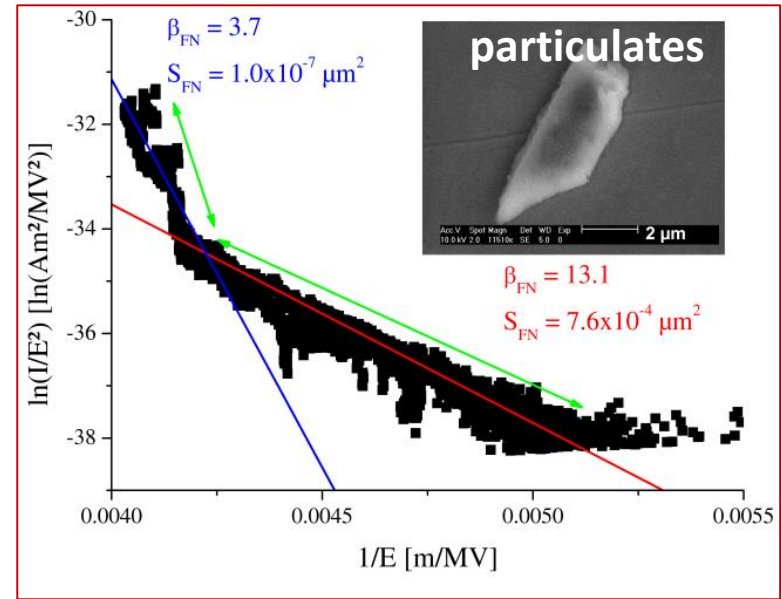
Single emitter characteristics on DIC-cleaned samples

SEM/EDX : 57% surface defects; 12% particulates (Al, Si, W); 31% unidentified;

- Rather stable FE
- Slight jumps probably due to melting of micro-tips
- More unstable FE
- Changed slope at high fields due to bad electrical contact to bulk

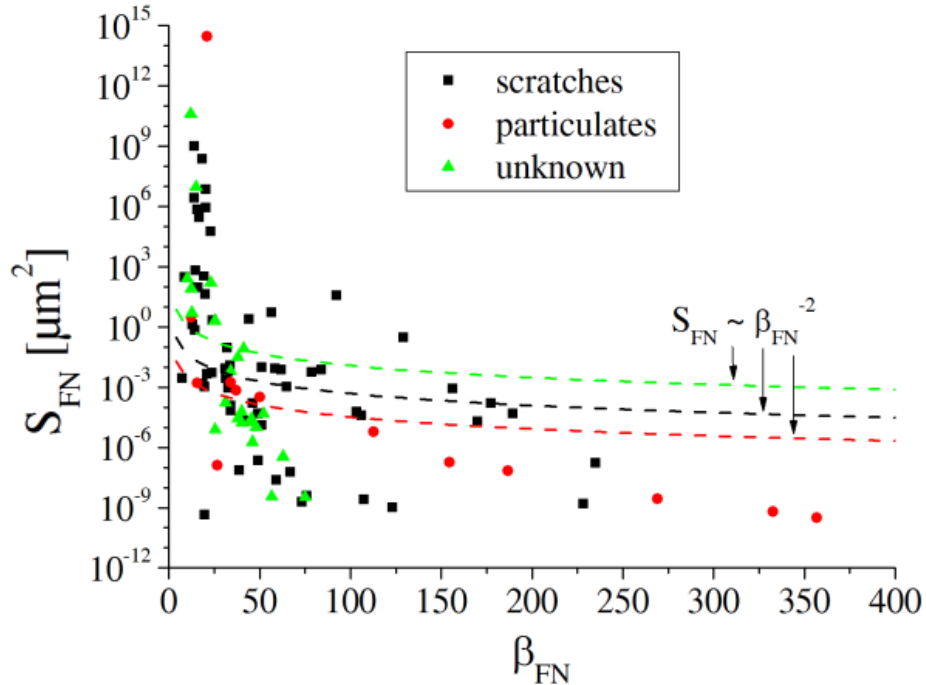
Correlation between S_{FN} and β_{FN}

- Highest β_{FN} are caused by particulates
- Most S_{FN} and β_{FN} are in a reasonable range for all types of emitters
- Most data are correlated: $S_{FN} \sim \beta_{FN}^{-2}$
- No correlation at low β_{FN} : high S_{FN} values with respect to the anode size hint at other FE mechanisms like MIV- and MIM-emission [4]

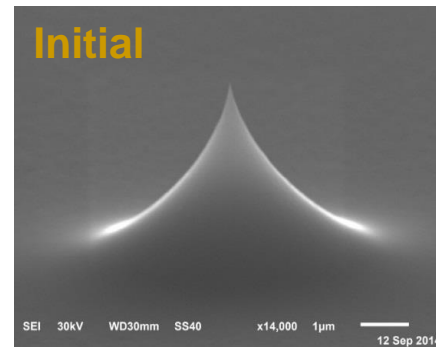
SEM images of different emitters before/after

Discharges lead to

- morphological changes (significantly shortened, partially/completely removed emitters)
- create craters;

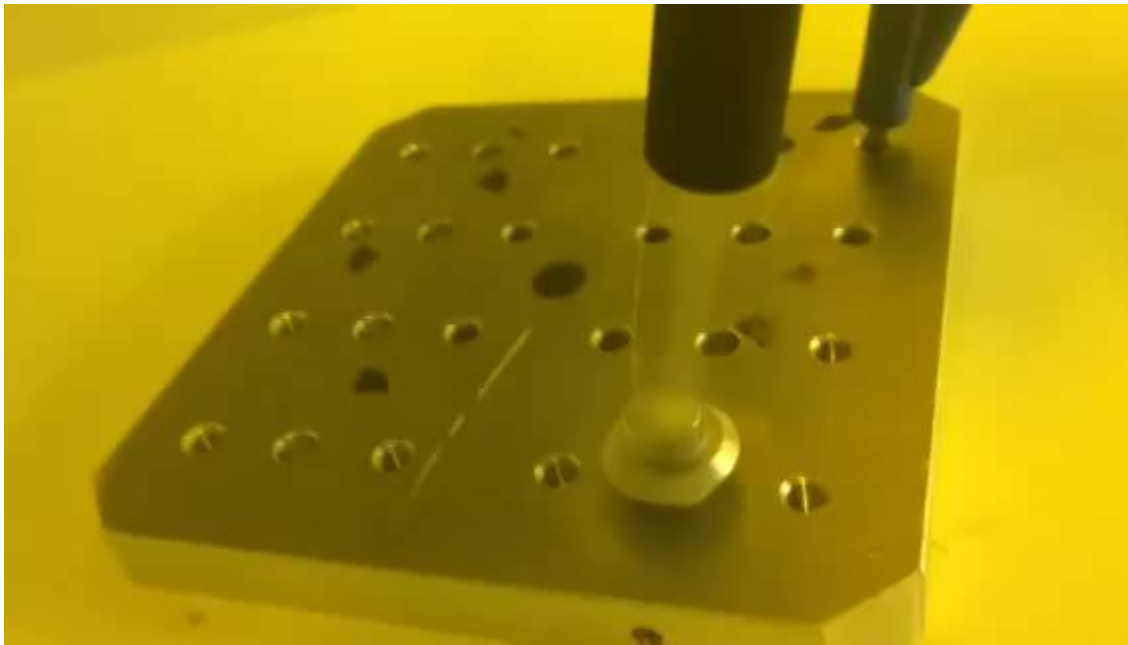
Cleaning process
