Debriefing MBHSP101

Mechanical behaviour

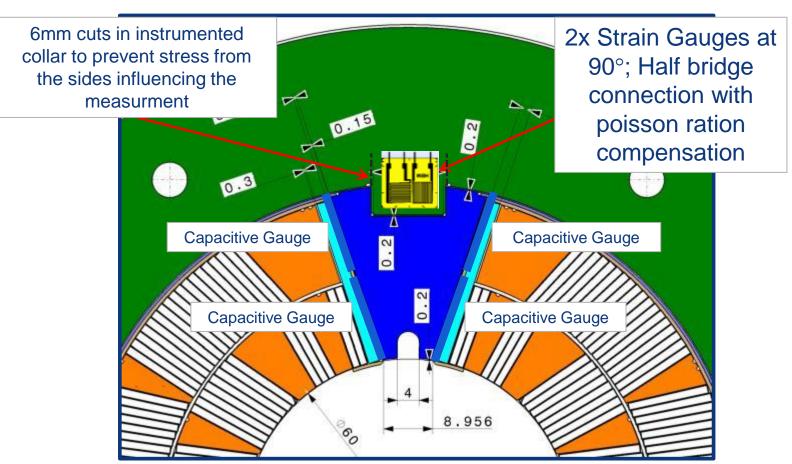
Instrumentation - mechanical

Instrumentation design, assuming only bending and compression on the collar nose

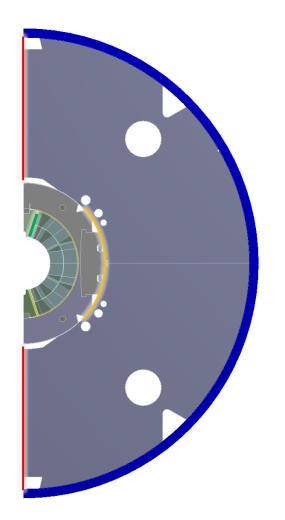
New parameters

- Yoke midplane +20µm
- Collar outer radius -40µm
- Friction between loading pole and coil -> μ=0.3
- Friction between collared coil
 and yoke -> µ=0.3

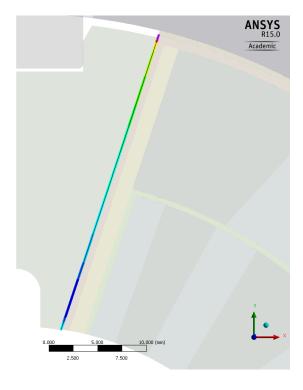
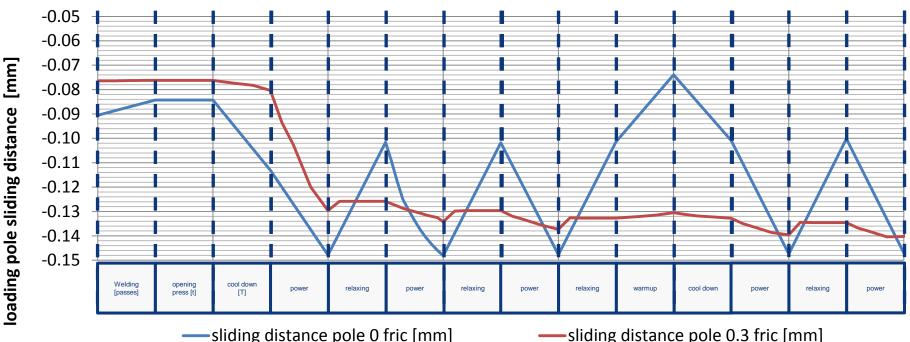
- Pole movement during cool down depence on friction
- Sliding distance → negative closer to the center (for top pole)

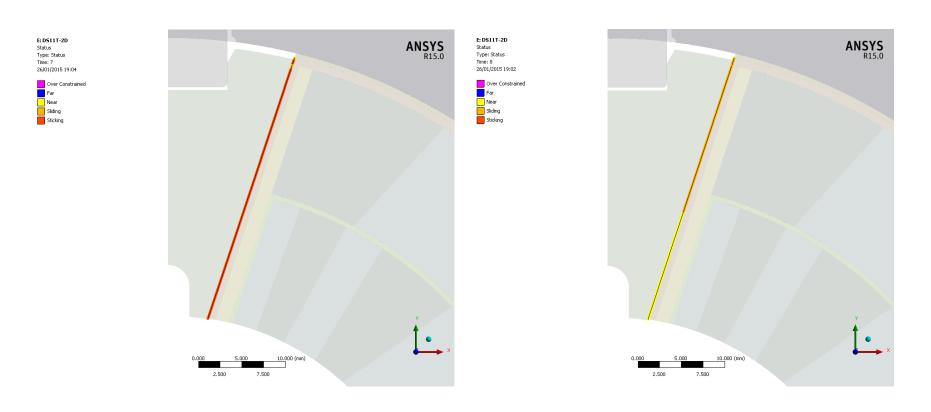
- During cool down the pole gets stuck
- Due to redcution of the friction force during powering it moves closer to the center

After first cool down – 0 powerings

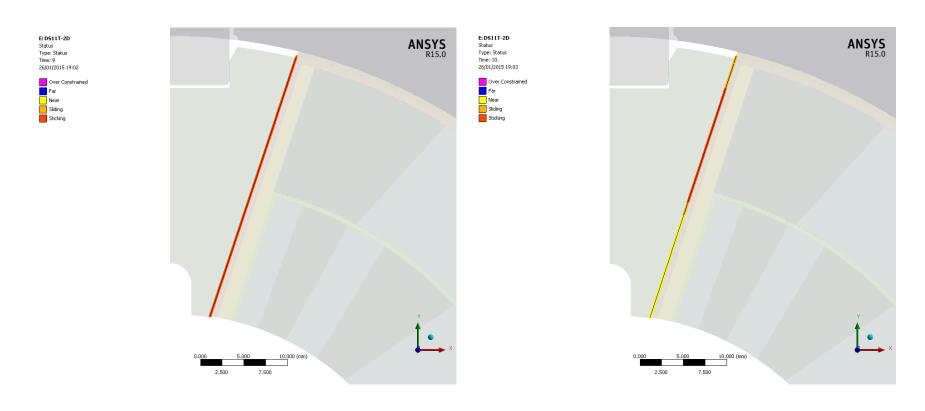
First powering

After first powering

2nd powering

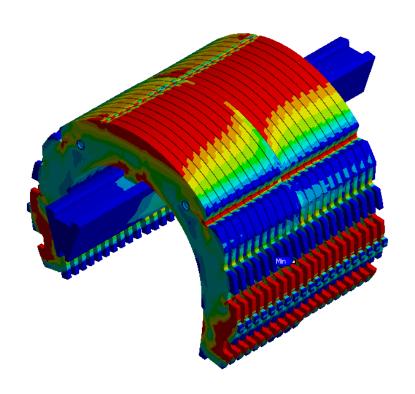
Pole + collar pack

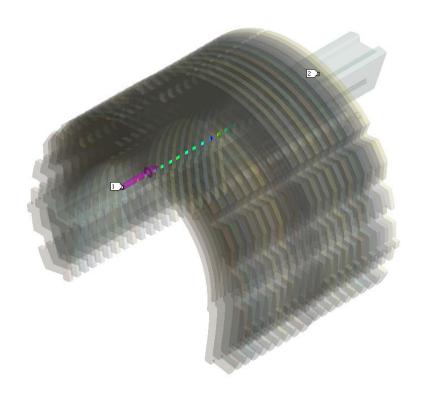
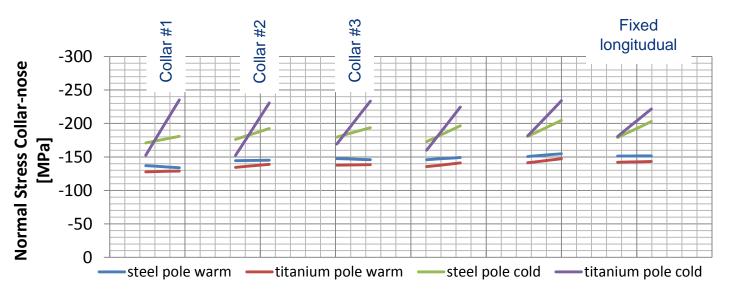
Measured instrumentation region

the different thermal contraction between pole and collar might bend the collar noses during cool down.

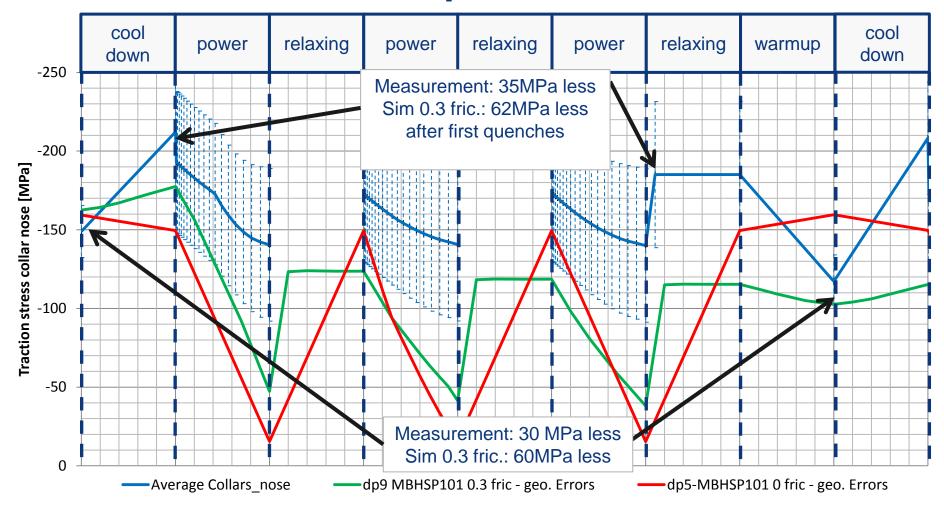
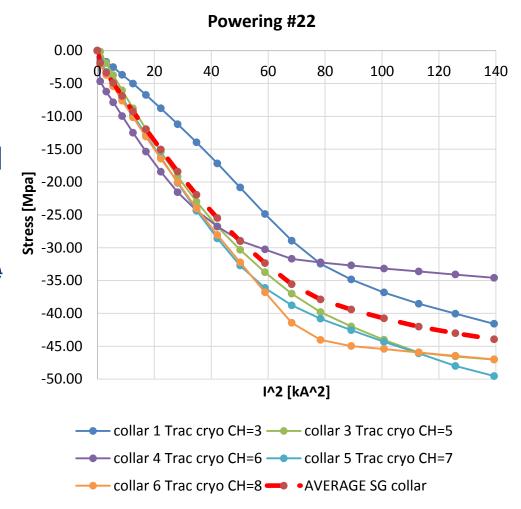
Collar-nose experimental data

- Normalized over spread from cool down
- Pre-stress decreased by ~44MPa
- According to the FE
 the stress in the nose
 should decrease by
 ~100MPa
- Behaviour is not linear compared to I^2

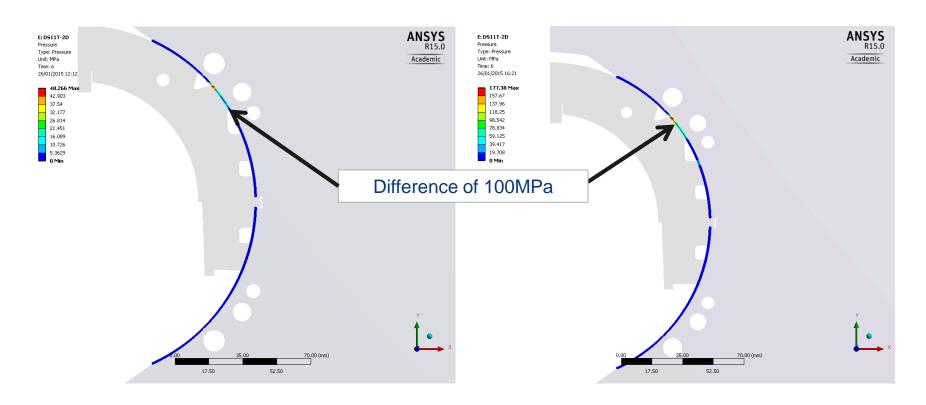
Welding – MBHSP101

Welding - norm

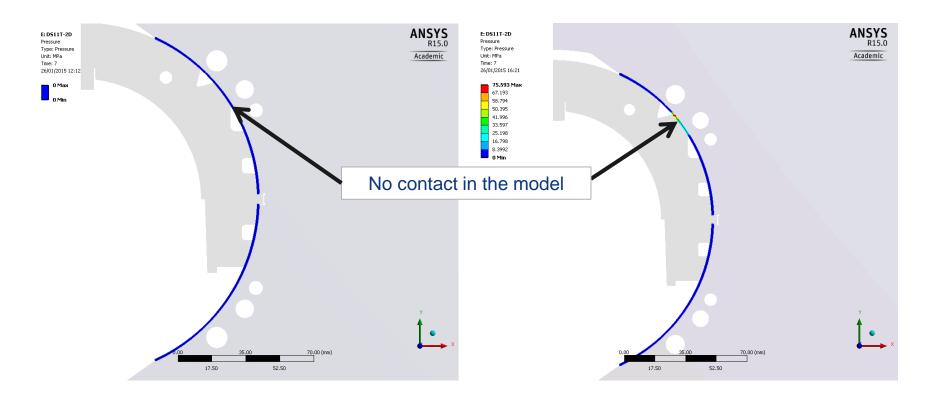
1.9K - MBHSP101

1.9K - norm

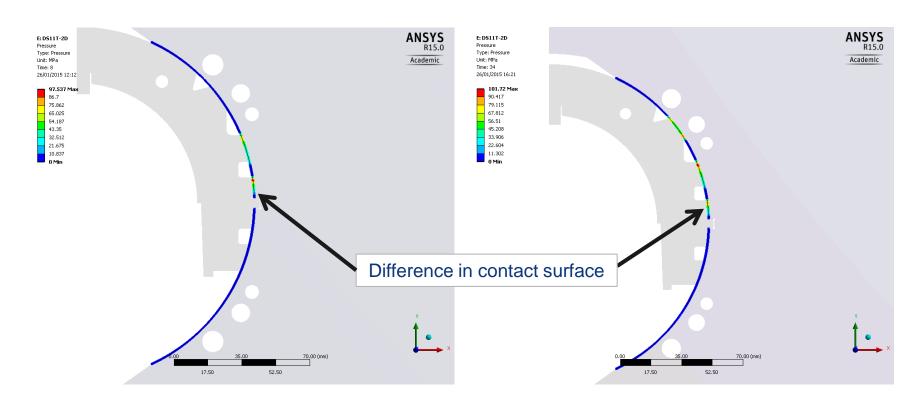
Powering – MBHSP101

Powering – norm

- Normalized at 0kA
- Powering #22
- Not linear behaviour depence on friction and geo. errors

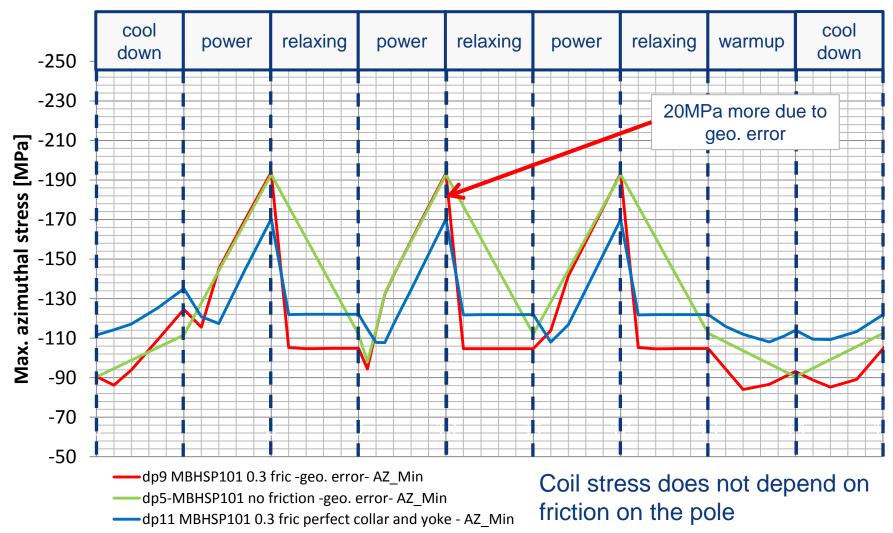
Mechanical stress-during powering

Perfect collar-yoke contact

Collar-yoke conctact with error (MBHSP101)

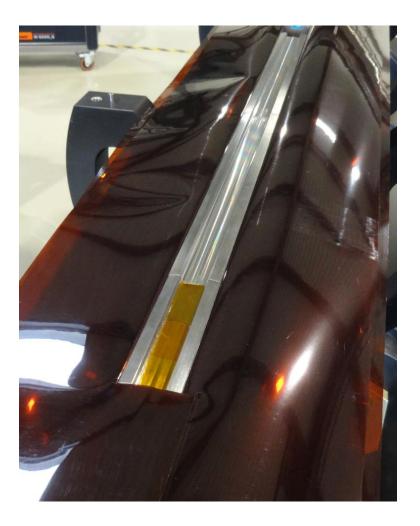
Behaviour in the transition region

- Reduced topshimming by 0.14mm
- Staircaise shimming to gradually reduce the loading
- Possible creeping of kapton

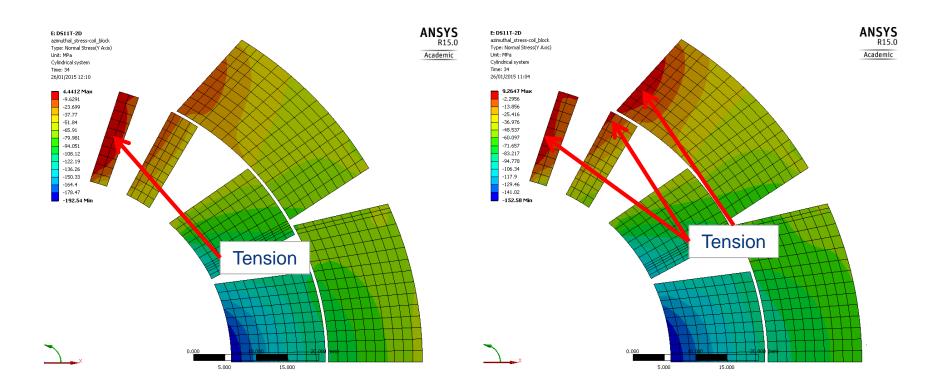
Behaviour in the transition region

Centre of magnet + geo. errors

Transition Region – smaller midplane + reduced shimming + geo. errors

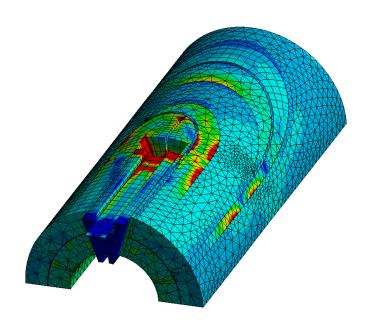
Behaviour in the transition region

Work is in progress for a 3d-model of the transition region

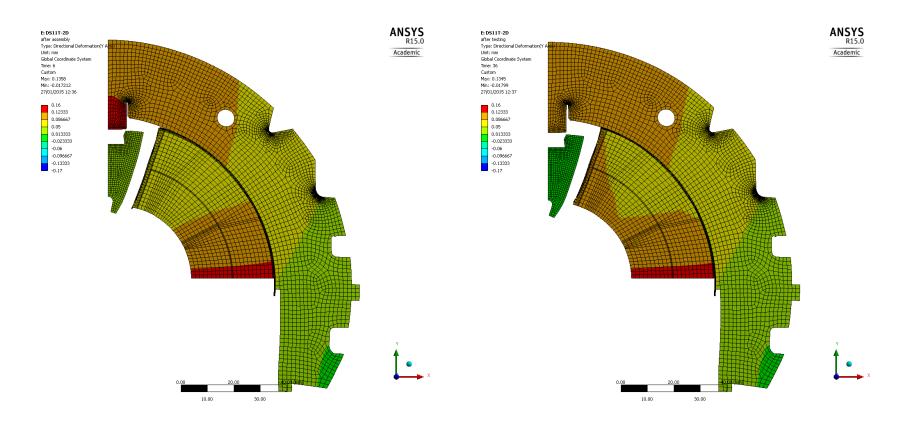
Deformation in Y before and after testing

After assembly

After testing
