CMS Inner Detector

The Run 1 to Run 2 transition, and
first experience of Run 2

Clemens Lange (UZH)
on behalf of the CMS collaboration
VERTEX 2015
Santa Fe, New Mexico, USA
1st June 2015

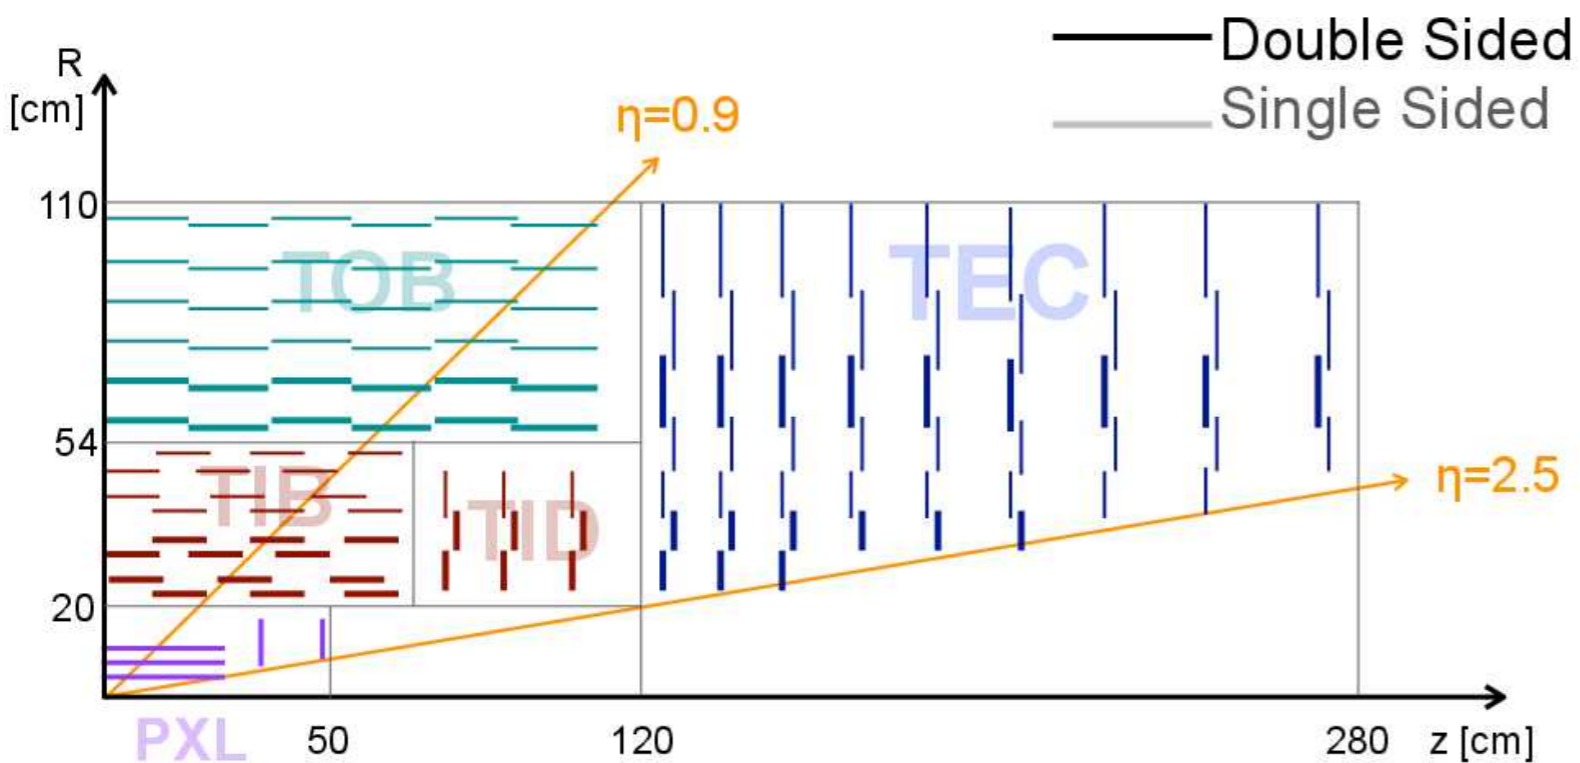
CMS Silicon Strip Tracker

basic properties:

- > 10 layers in barrel region
 - 4 Inner Barrel (TIB), 6 Outer Barrel (TOB)
- > 9+3 discs in the inner disks (TID) and endcaps (TEC)
- > active area 200 m²
- > ~9.6 million electronic channels

- > p⁺-in-n silicon sensors
- > 320 μm and 500 μm thick
- > 512-768 strips
- > strip pitch 83-205 μm

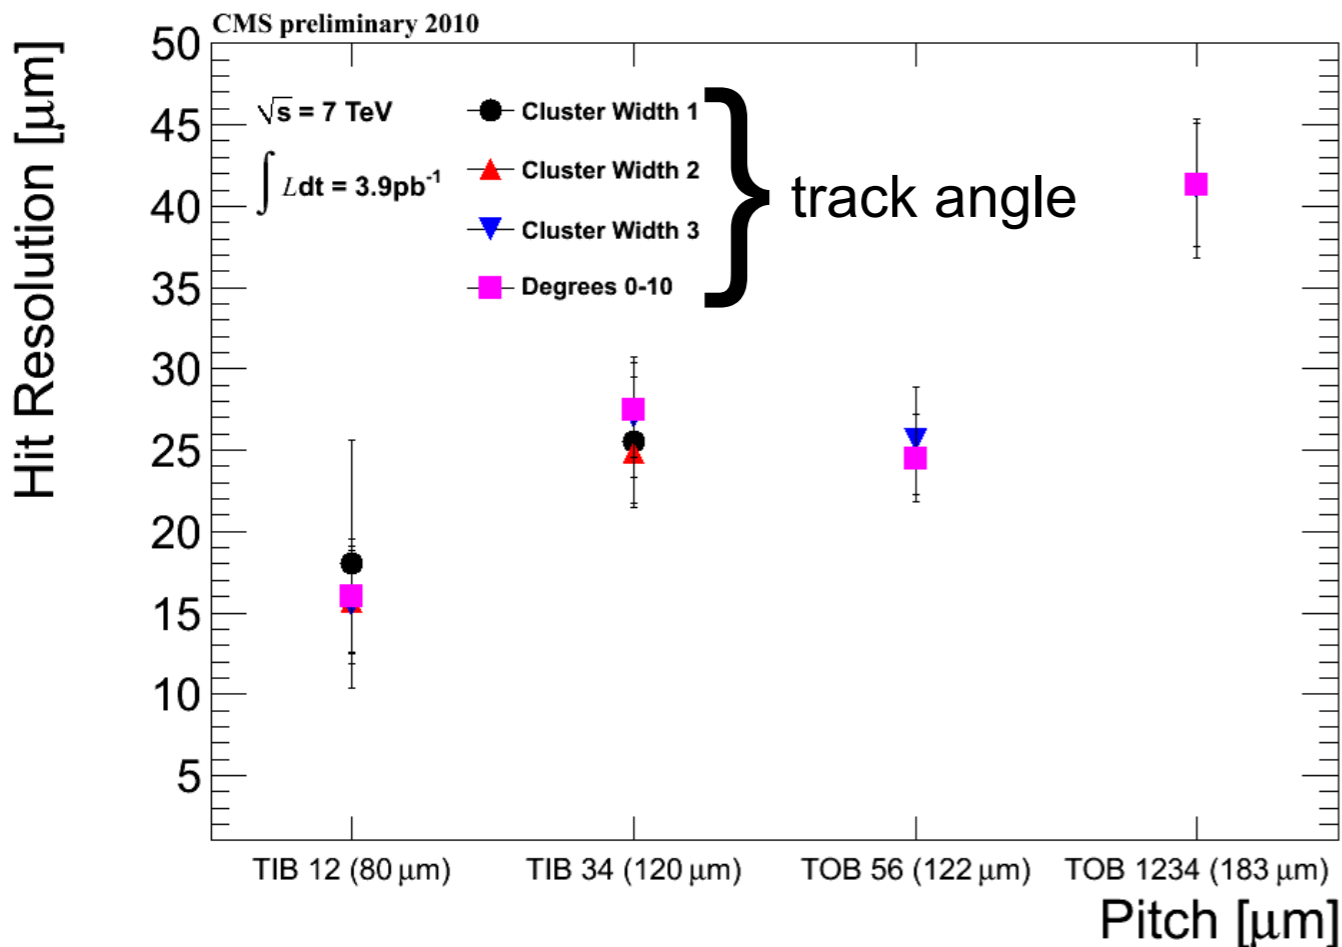
Performance of the Strips Tracker in Run 1

- > hit efficiency considering all modules: variations down to 92%
- > for good modules: > 99%

- > hit resolution: 16-42 μm depending on pitch

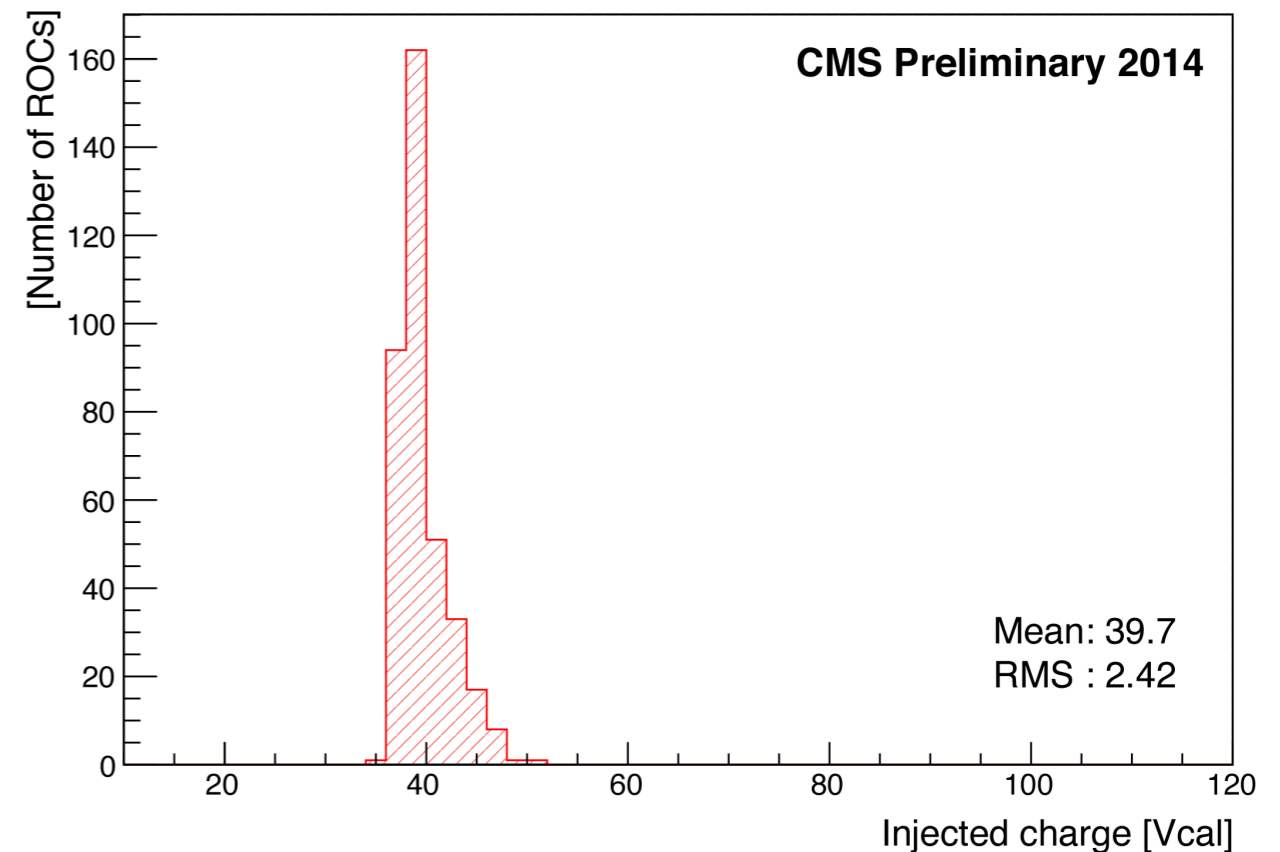
Mean Threshold of all the ROCs in one BPix sector (T=-15°C)

Vcal: digital-to-analog amplitude unit corresponding to about 65.5 electrons (offset -414 electrons)

- > pixel detector was re-commissioned in January 2015 within ~2 weeks
 - exercised and improved during LS1
 - basic set of calibrations
 - analog voltage for ROC (Vana) calibration
 - pixel comparator threshold calibration
 - pulse height optimisation
 - gain calibration
- > switch to new trigger and timing control system
- > tracker bulkheads closed on 29th January
- > BPix: ~1% disabled channels
- > FPix: 0.04% dead channels

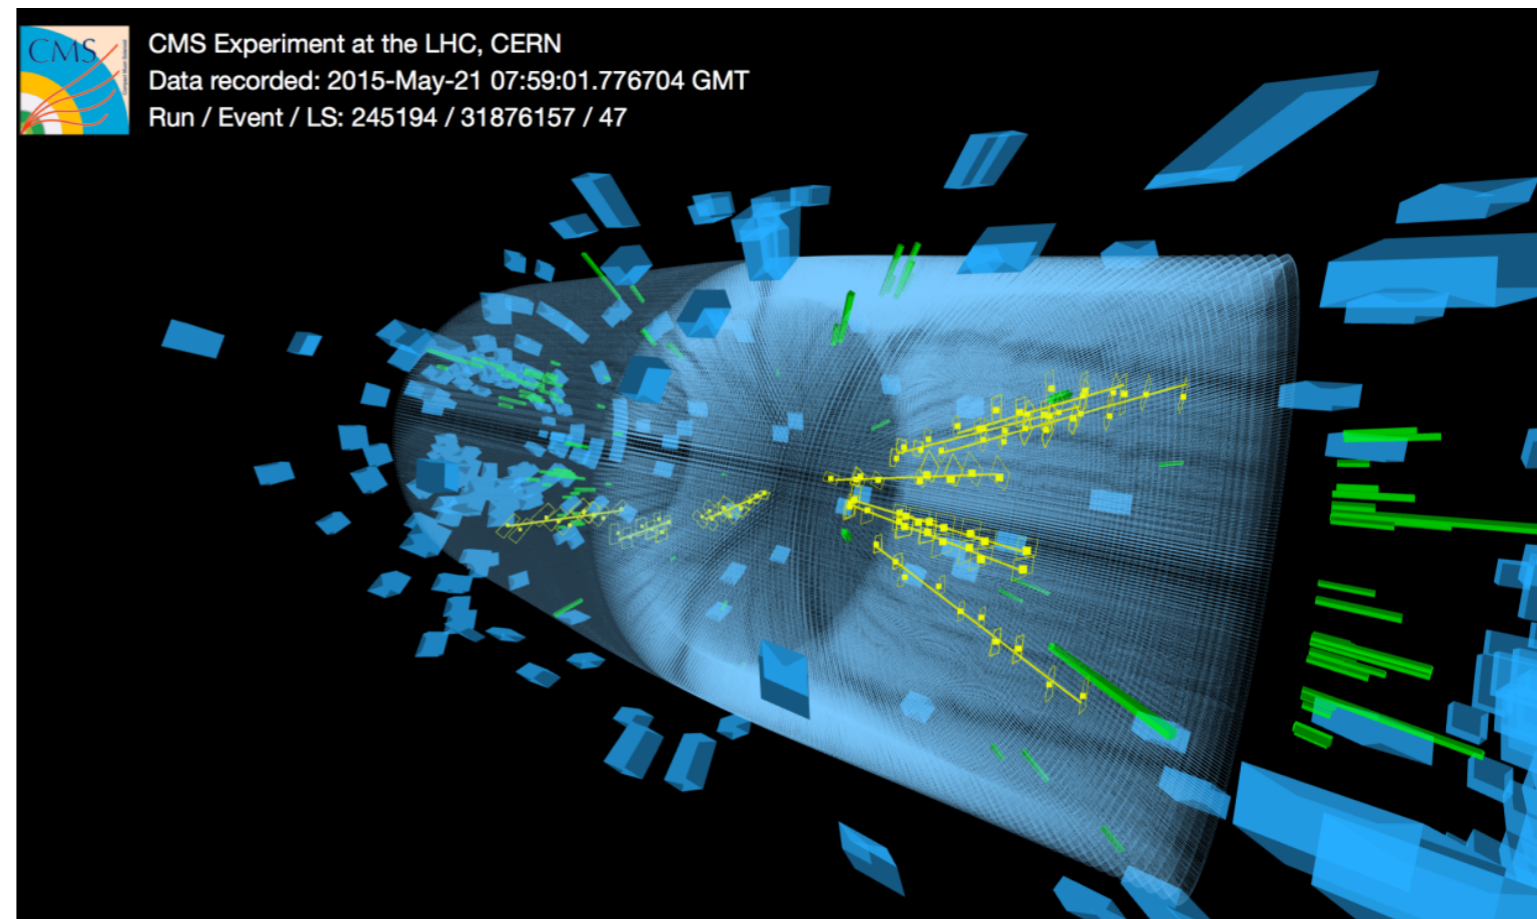
> CRUZET (Cosmic RUn at ZERo Tesla) started on 10th February

- timing scans (internal and with respect to global)
- noisy pixels masked (< 0.1%)
- 420 hours of cosmics recorded

> CRAFT (Cosmic Run At Four Tesla) started on 19th March

- recorded 3 million cosmics events (1.8 million tracks)

> 20th May: first LHC test collisions at 13 TeV centre-of-mass energy

- pixel detector off since beams not declared as stable
- strips tracker taking data

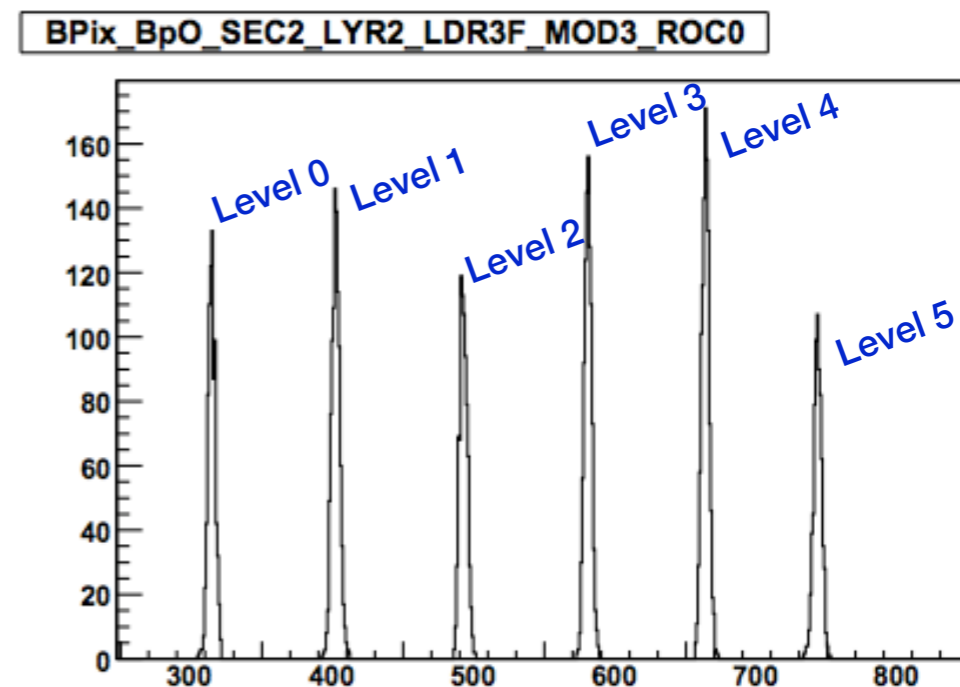
pixel address level distribution

- > Pixel Detector functioning depends on readout chain settings
- > optimal settings for readout system parameters must be used
- > majority of settings unchanged until:
 - detector temperature changes
 - significant amount of radiation is accumulated
- > for parameters more sensitive to environmental changes, recalibration performed on regular basis:
 - Front-End Driver(FED) opto-receiver offset adjustment (weekly)
 - set the signal baseline in the middle of ADC range
- > address level calibration (monthly):
 - ensure good decoding of pixel address by FED
