Investigation of Cherenkov light scattering and refraction on aerogel surface

A.Yu.Barnyakov^{a,c}, M.Yu.Barnyakov^{a,c}, V.S.Bobrovnikov^{a,c},
A.R.Buzykaev^{a,c}, A.F.Danilyuk^{b,c}, A.A. Katcin^a, P.S. Kirilenko^{a,c},
S.A.Kononov^{a,c}, D.V.Korda^a, E.A.Kravchenko^{a,c}, V.N.Kudryavtsev^a,
I.A.Kuyanov^{a,c}, A.P.Onuchin^{a,c}, I.V.Ovtin^{a,c}, N.A.Podgornov^a,
A.Yu. Predein^b, V.G.Prisekin^a, R.S. Protsenko^b, L.I.Shekhtman^a

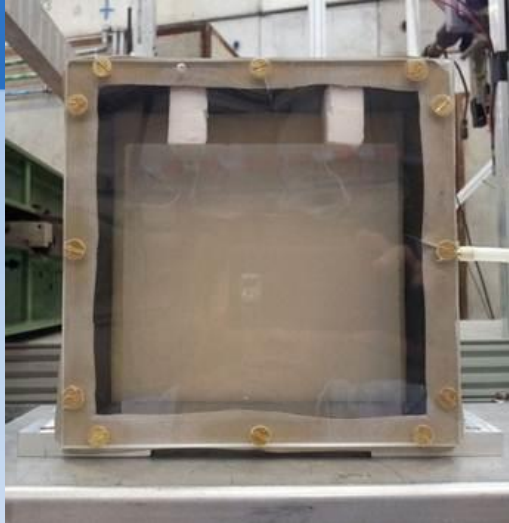
Beam test with PDPC FARICH prototype at CERN (2012)

- 4-layer aerogel
- $n_{\max} = 1.046$
- thickness 37.5 mm
- focal distance 200 mm
- hermetic box with acrylic glass window was used to prevent moisture condensation on aerogel tile

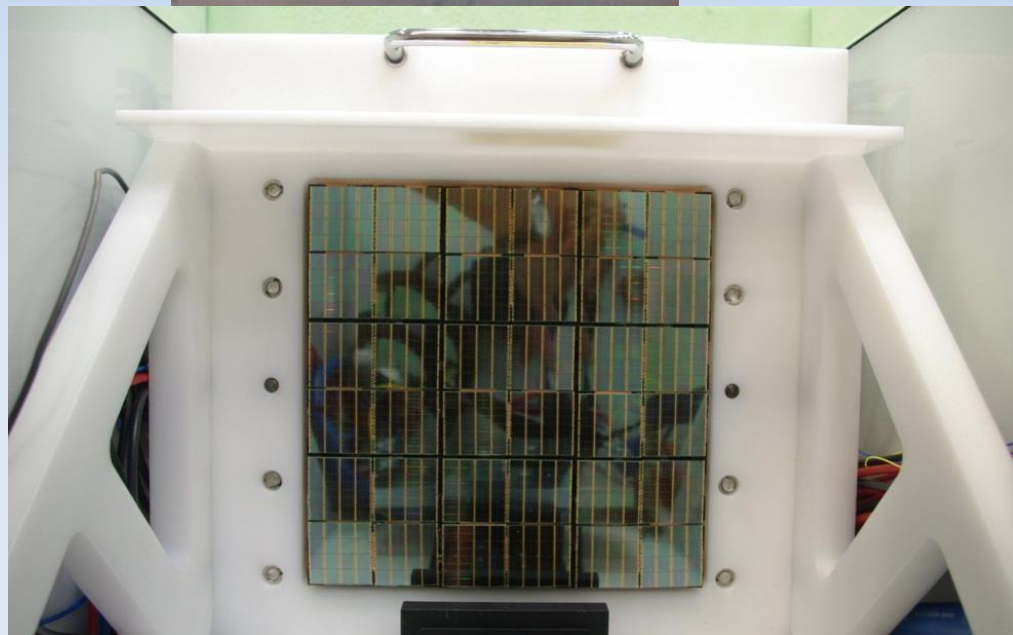
Photon matrix $20 \times 20 \text{ cm}^2$

- Sensors DPC3200-22
- 3200 micro-cells in pixel,
- 3x3 modules = 6x6 tiles = 24x24 dies = 48x48 pixels
- 576 time channels
- 2304 amplitude (position) channels
- Pixel dimension $3.2 \times 3.9 \text{ mm}^2$
- to detect single photons detector was cooled to $-40^\circ \text{ Celsius}$

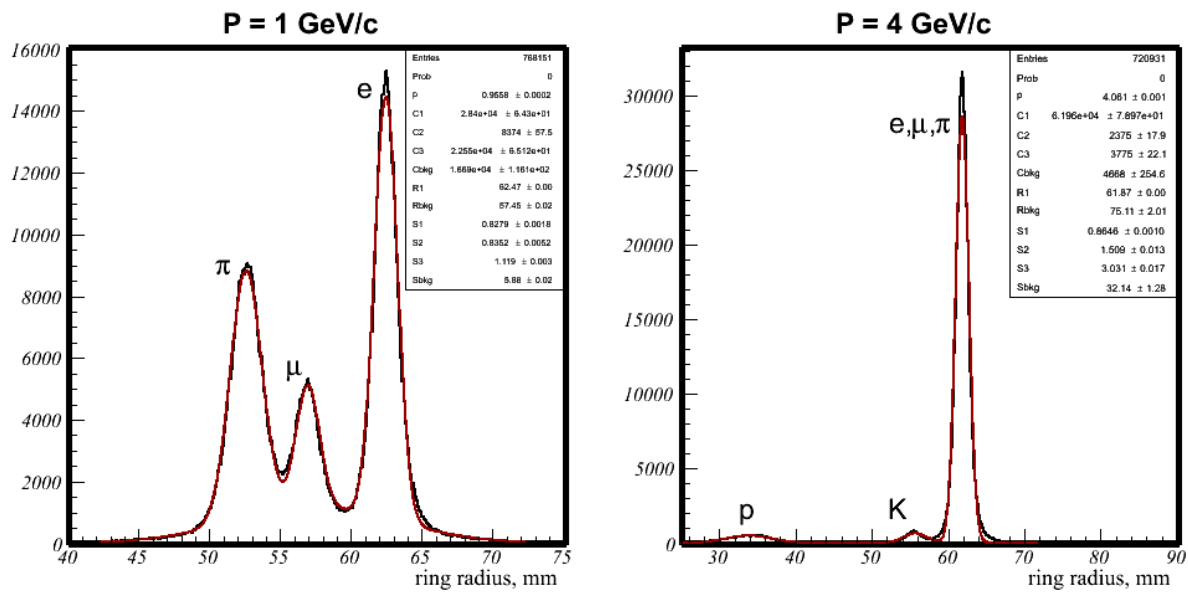
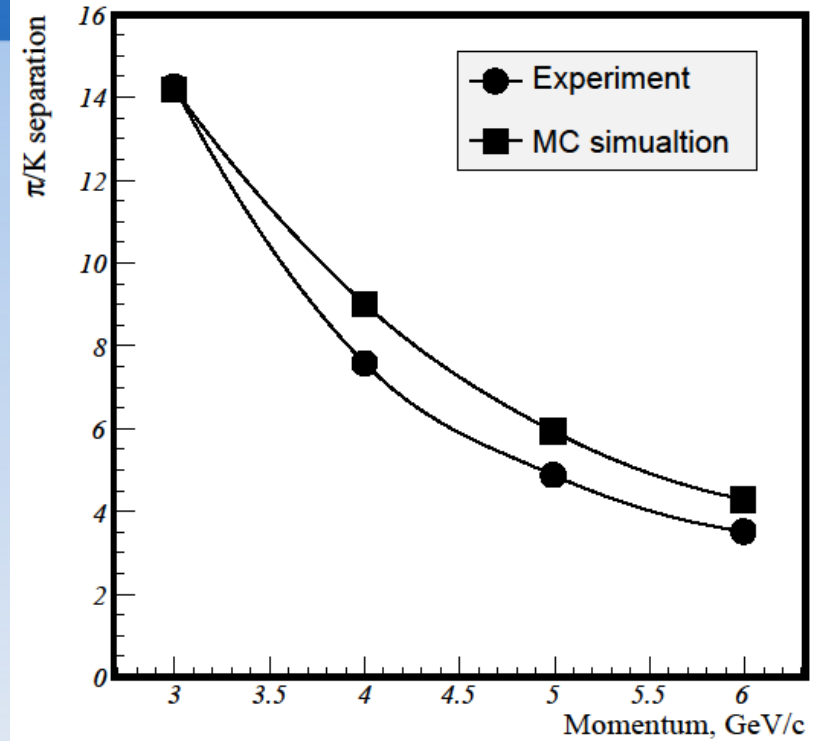
Cherenkov rings radius distribution

μ/π : **5.3 σ** @ 1 GeV/c
 π/K : **7.6 σ** @ 4 GeV/c
 π/K : **3.5 σ** @ 6 GeV/c

▣ **2.6 times less than in initial MC simulation**

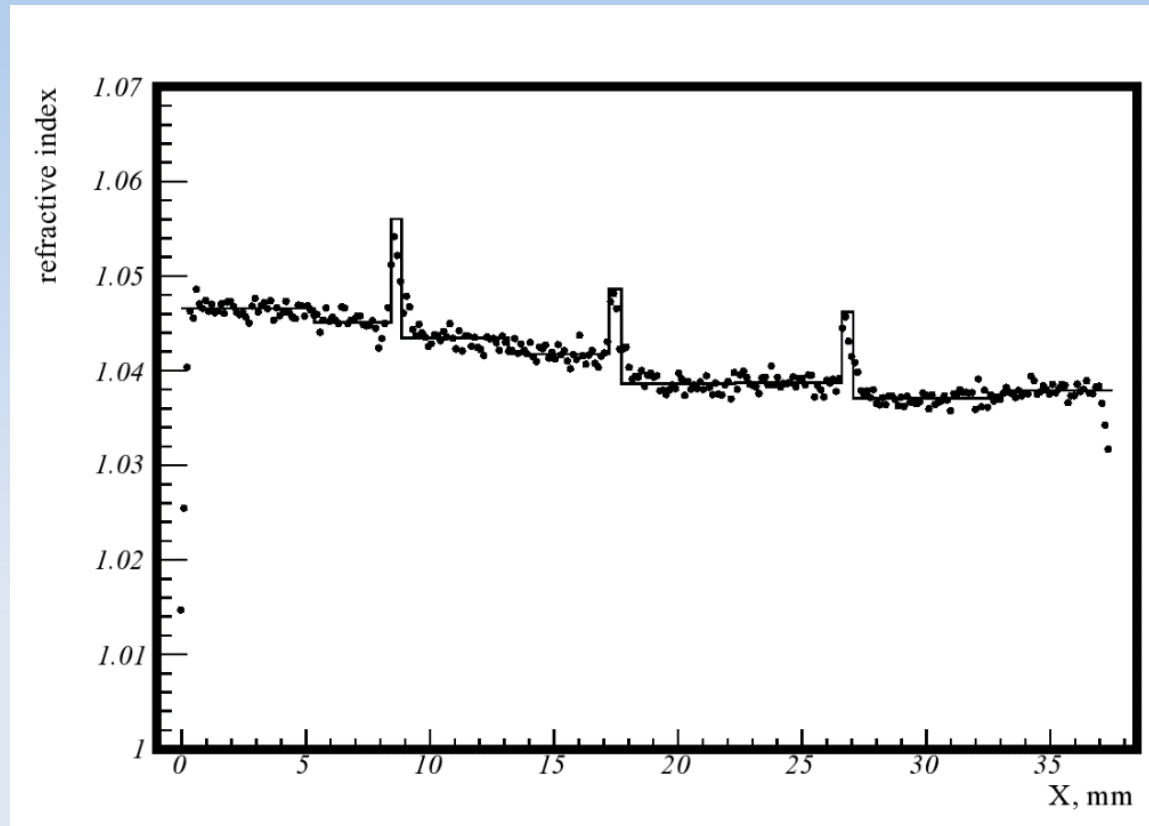
X-ray scan of the density within thickness of the tile

- N_{pe} was 1.6 times less than expected
- Strong effect of uncontrolled refractive index variations

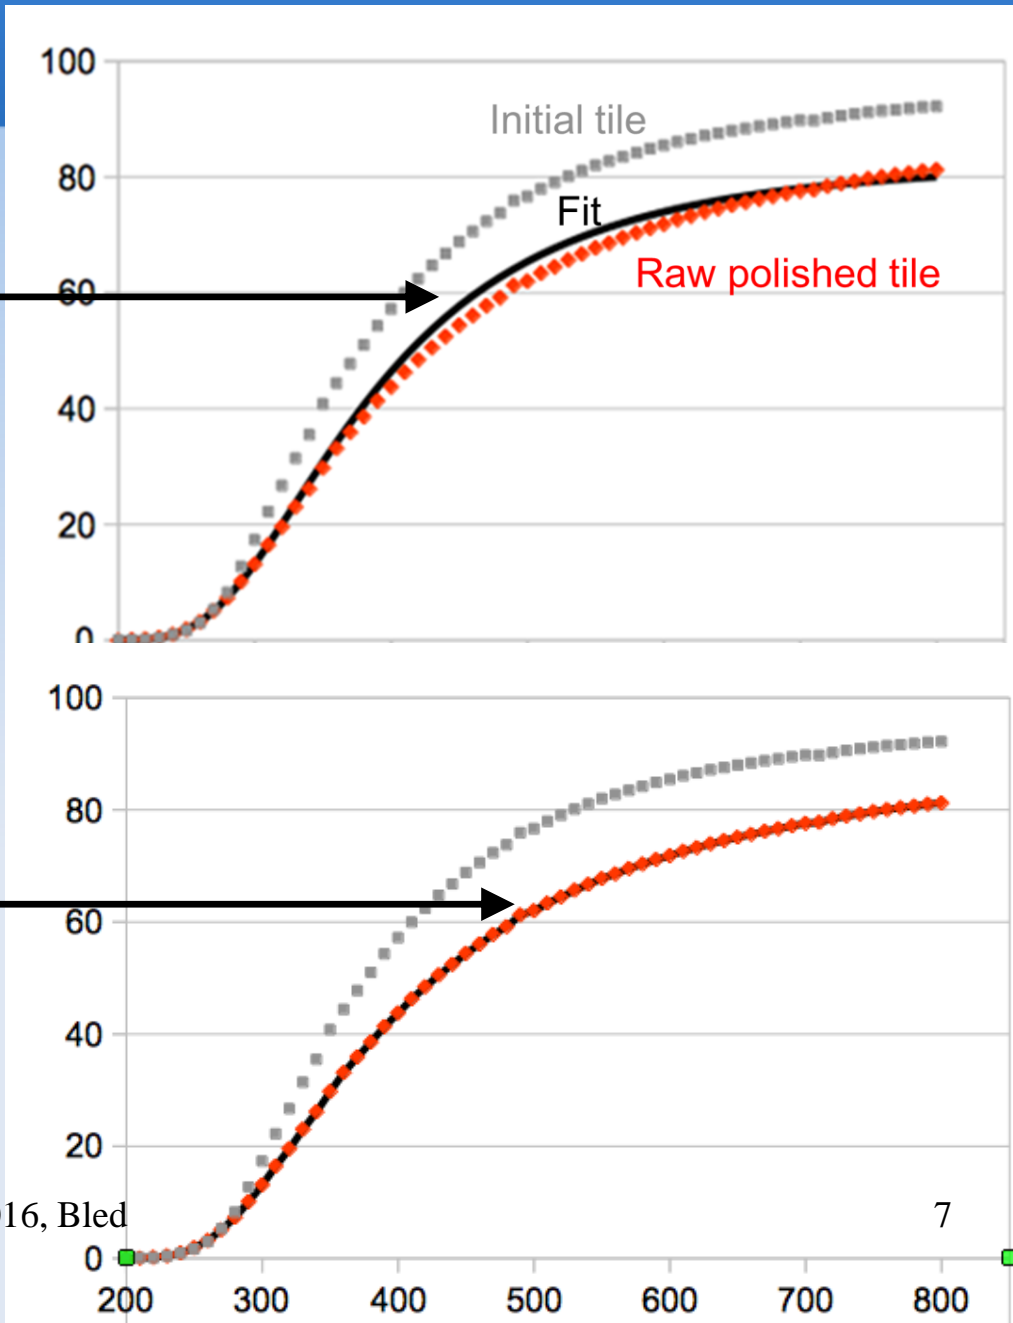
Light scattering on the polished aerogel surface (1)

$$\frac{I}{I_0} = A \cdot \exp\left(-\left(\frac{t}{L_{sc}} \left(\frac{\lambda}{400}\right)^4\right)\right)$$

A, %	Lsc, mm
Initial tile	94.85±0.4	51.3±1.5
Raw polished tile	91.15±0.9	56.8±1.7

$$\frac{I}{I_0} = A \cdot \exp\left(-\left(\frac{t}{L_{sc}} \left(\frac{\lambda}{400}\right)^4\right) - \frac{M}{\left(\frac{\lambda}{400}\right)^2}\right)$$

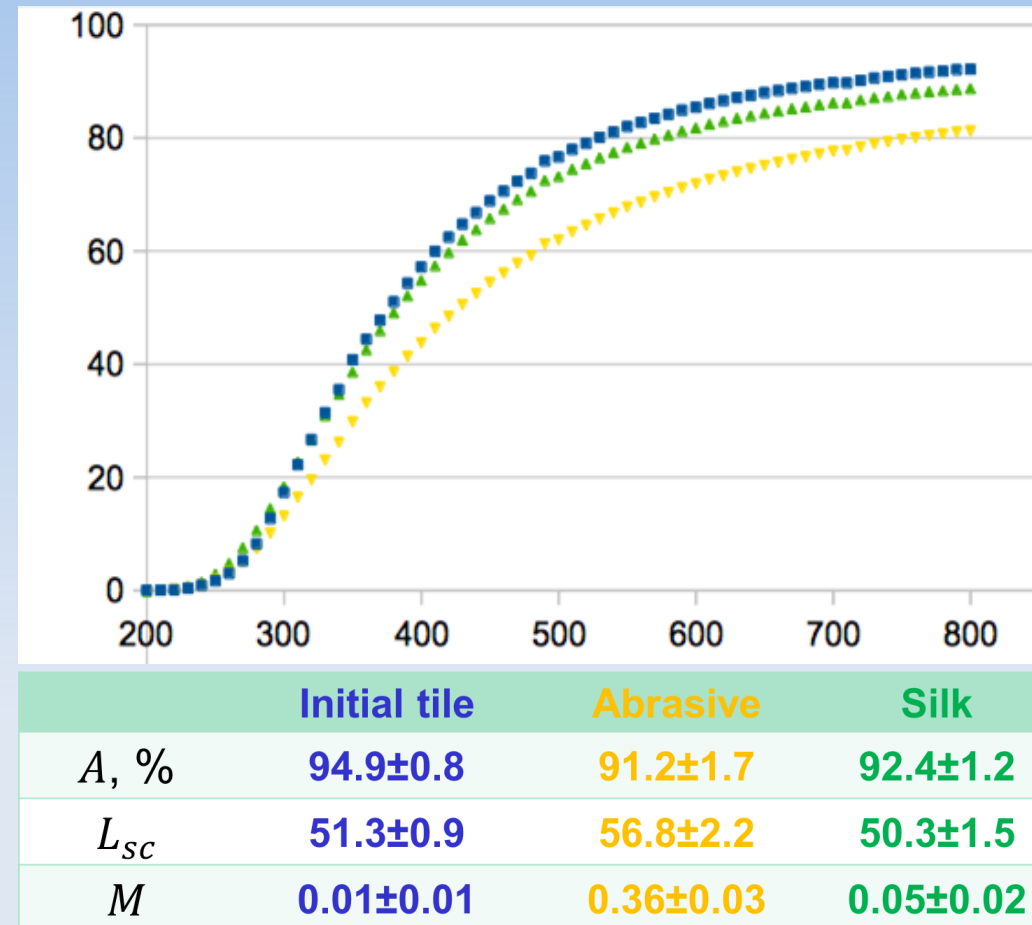
Light scattering on the polished aerogel surface (2)

- Best result we got using natural silk for polishing
 - Almost optical quality
- Only ~5% loss of light

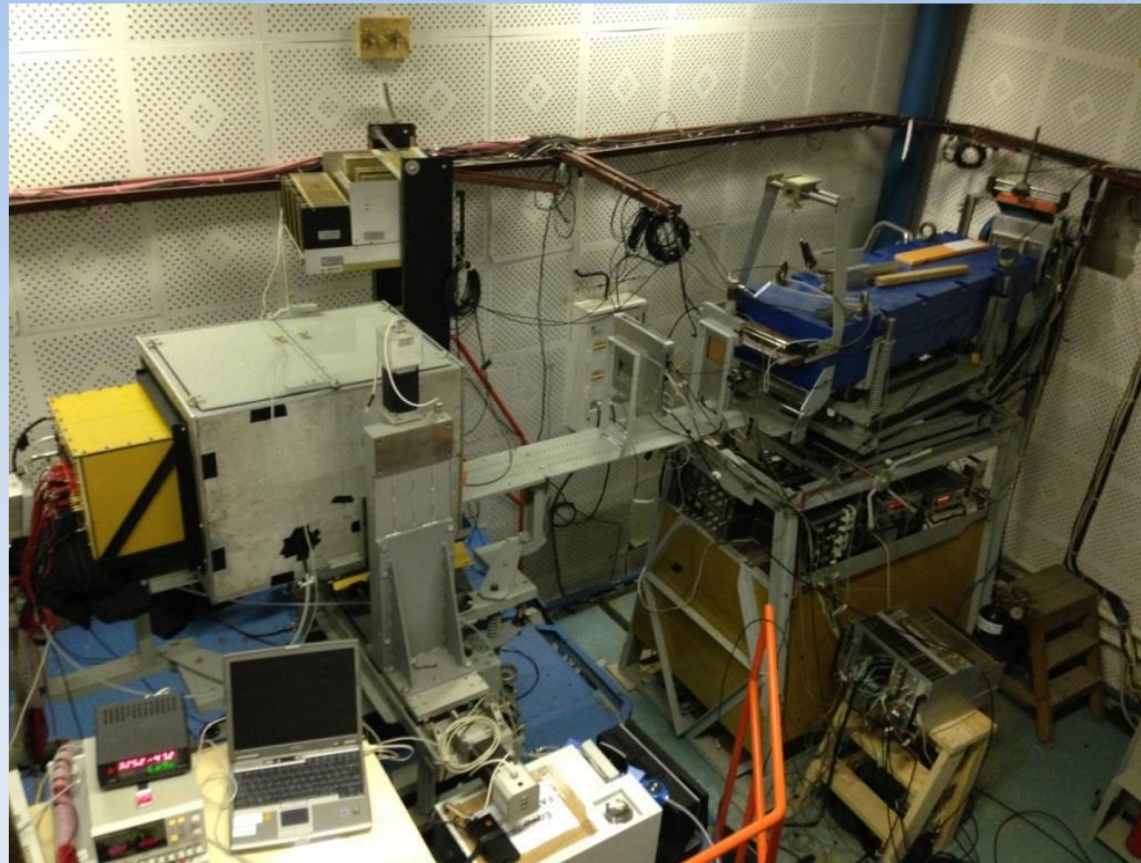
Test beam measurements with polished tile(1)

- Electron beam with 3 GeV/c momentum at VEPP-4M
- Sensors DPC3200-22
- 3200 micro-cells in pixel,
- 20x20 cm = 3x3 modules = 6x6 tiles = 24x24 dies = 48x48 pixels
 - = 576 time channels
 - = 2304 amplitude (position) channels
 - = Pixel dimension 3.2x3.9 mm²
- to detect single photons detector was cooled to -40° Celsius

R,mm	σR ,mm	Npe
clean	69.33±0.05	1.18±0.03	13.3±0.1
silk	69.01±0.05	1.83±0.06 +55%	12.7±0.1
clean	69.78±0.05	1.22±0.03	12.6±0.1
abrasive	68.01±0.05	2.67±0.09 +119%	12.0±0.1
clean	70.95±0.05	1.08±0.04	13.3±0.1
bottom	71.27±0.05	1.39±0.06 +29%	13.3±0.1

We see strong degradation of Cherenkov angle resolution due to small angle scattering at polished surface

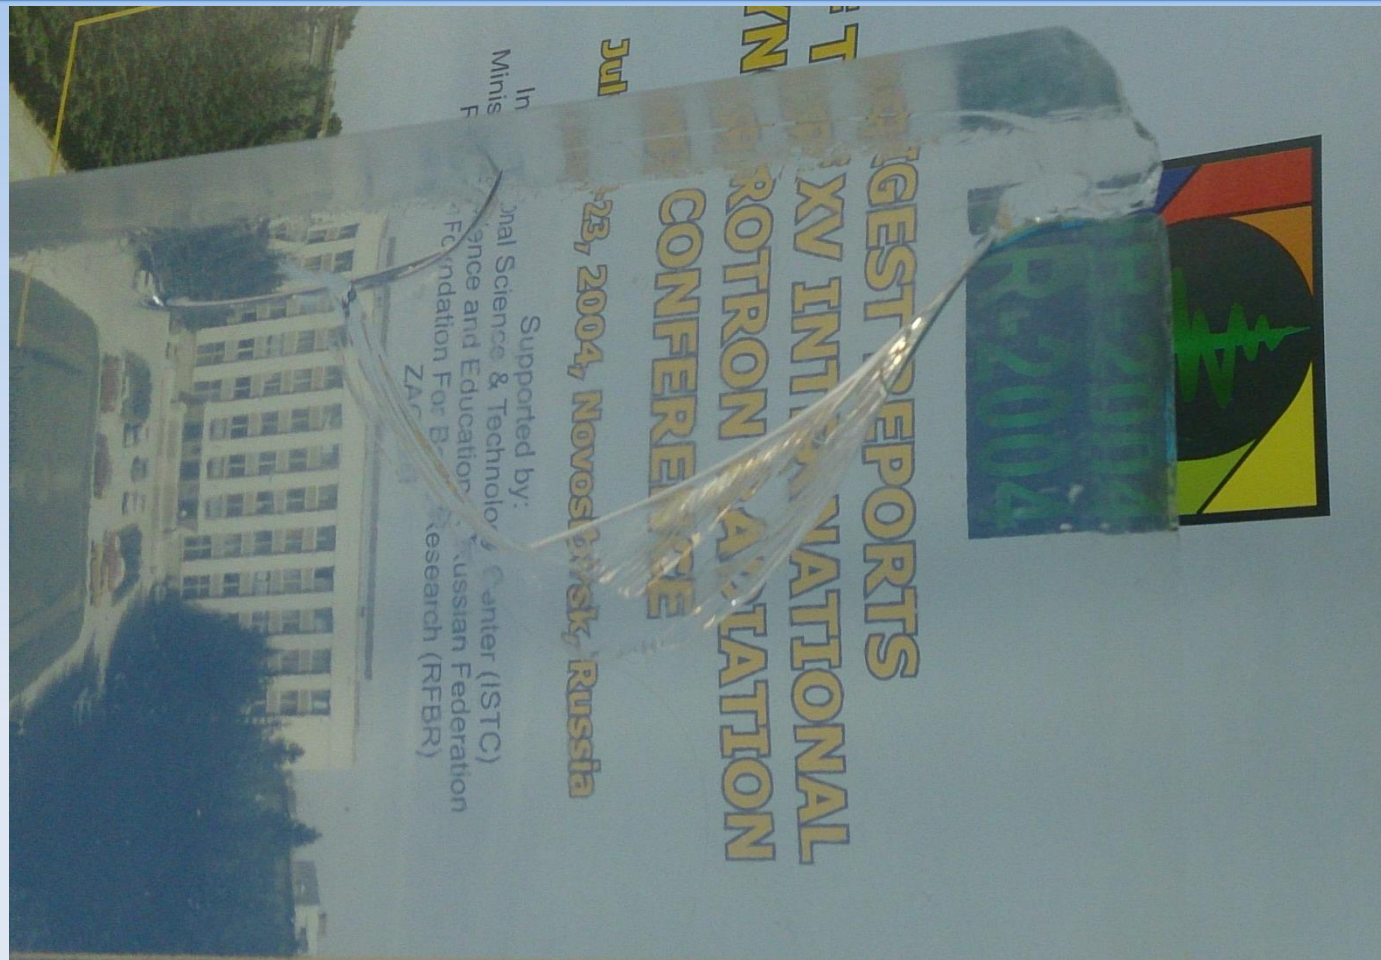
Impact of cracks in aerogel on the Cherenkov angle resolution(1)

What will happen when a crack appears inside of aerogel tile?

- Crack is a **thin** air gap inside aerogel.
 - Radius of curvature of the crack is much-much larger than gap.
 - We can assume that this is a parallel gap.
- In addition $\sin(\Theta_{agl}) * 1.05 = \sin(\Theta_{air})$
 - Light deviation from the initial direction after the crack should be very small.

- Fresnel reflection at normal incidence is $(n-1)^2/(n+1)^2 \sim 0.0025/4 \sim 0.0006$
 - Loss of photons on the crack is negligible
- The angle of total internal reflection is large. $\Theta_{tir} = 72^\circ$
 - Probability of total internal reflection is small.

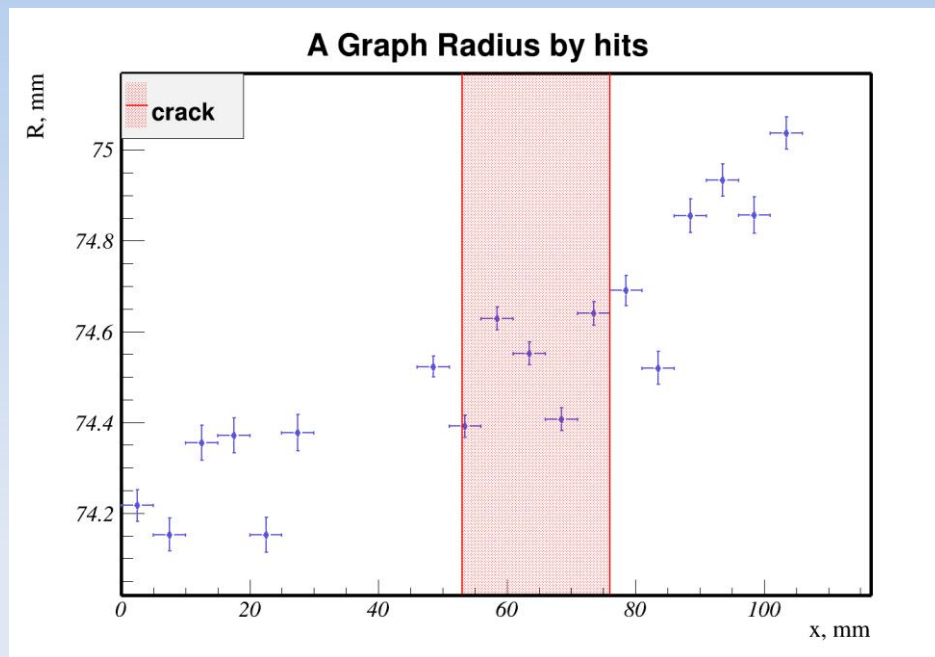
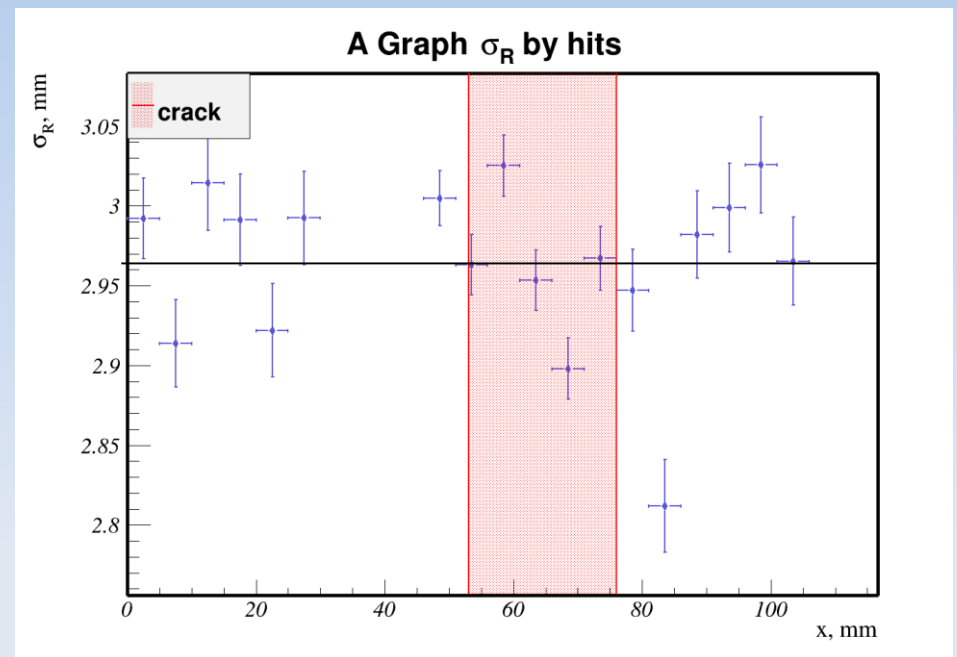
Test beam experiment with cracked aerogel tile(2)

Preliminary results

We do not see Cherenkov angle resolution degradation in the crack area of the tile

- **Previously found method of aerogel polishing with silk can not be used. We see a strong effect of small angle scattering at polished surface.**
- **Non destroying crack in aerogel tile does not influence on the accuracy of Cherenkov angle measurement at that area.**
