# Measurements on 8” Novati Wafer

## **USCMS Outer Tracker Workshop**

Brown University, Providence, RI, USA

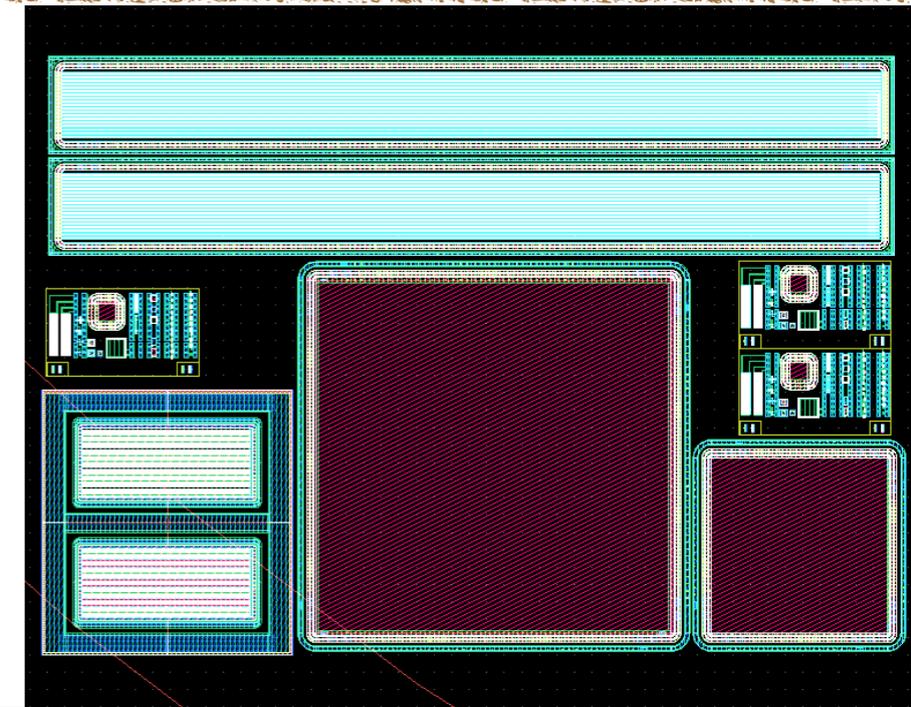
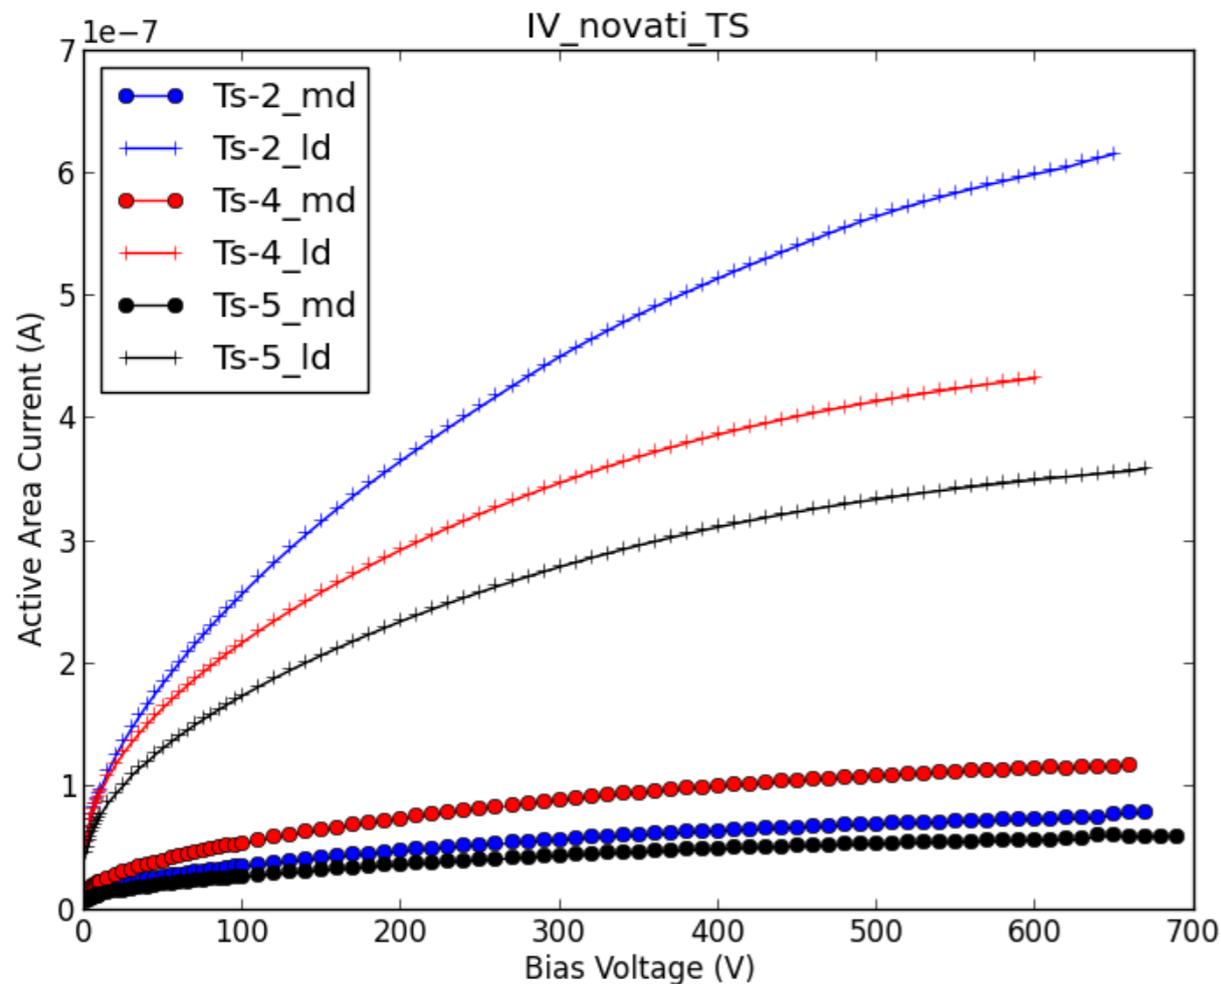
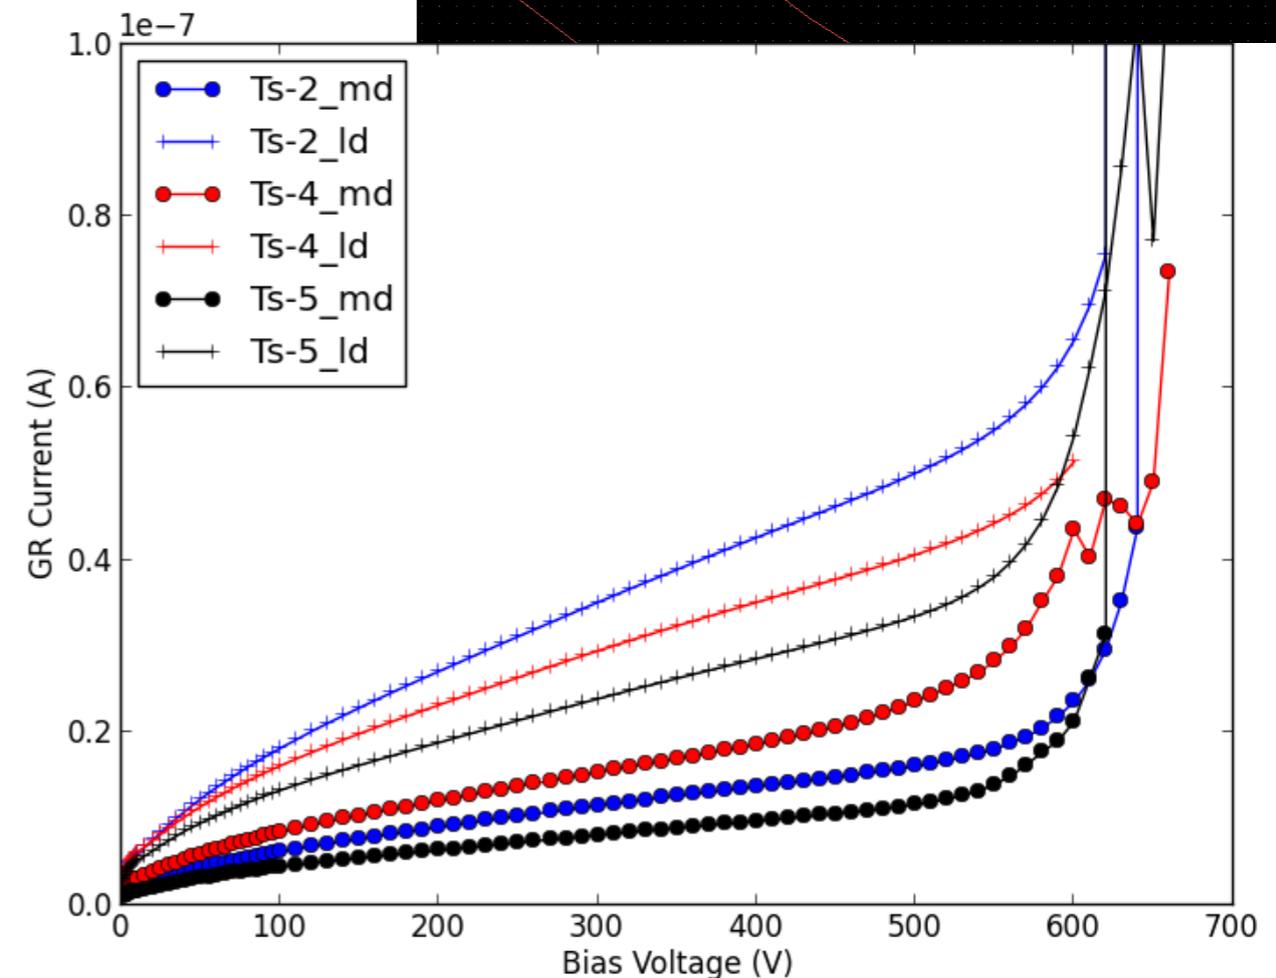
# Diode IV Characteristics

- Measurements on LD and MD in different TS structures
- Comparison of results from very first measurements
- GR breaks down around 600V
- Uniform across different structures

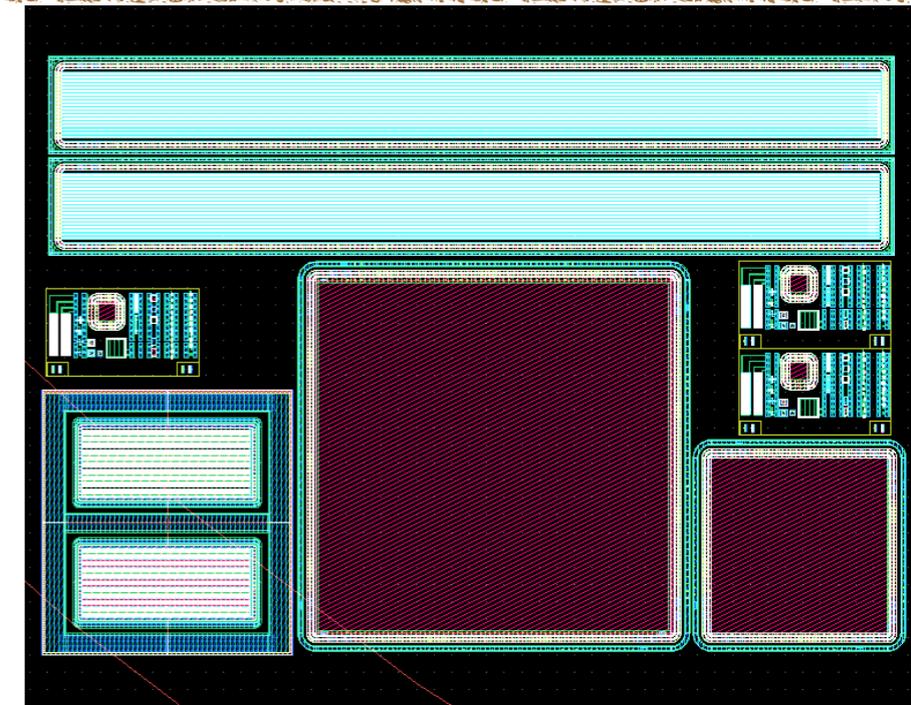
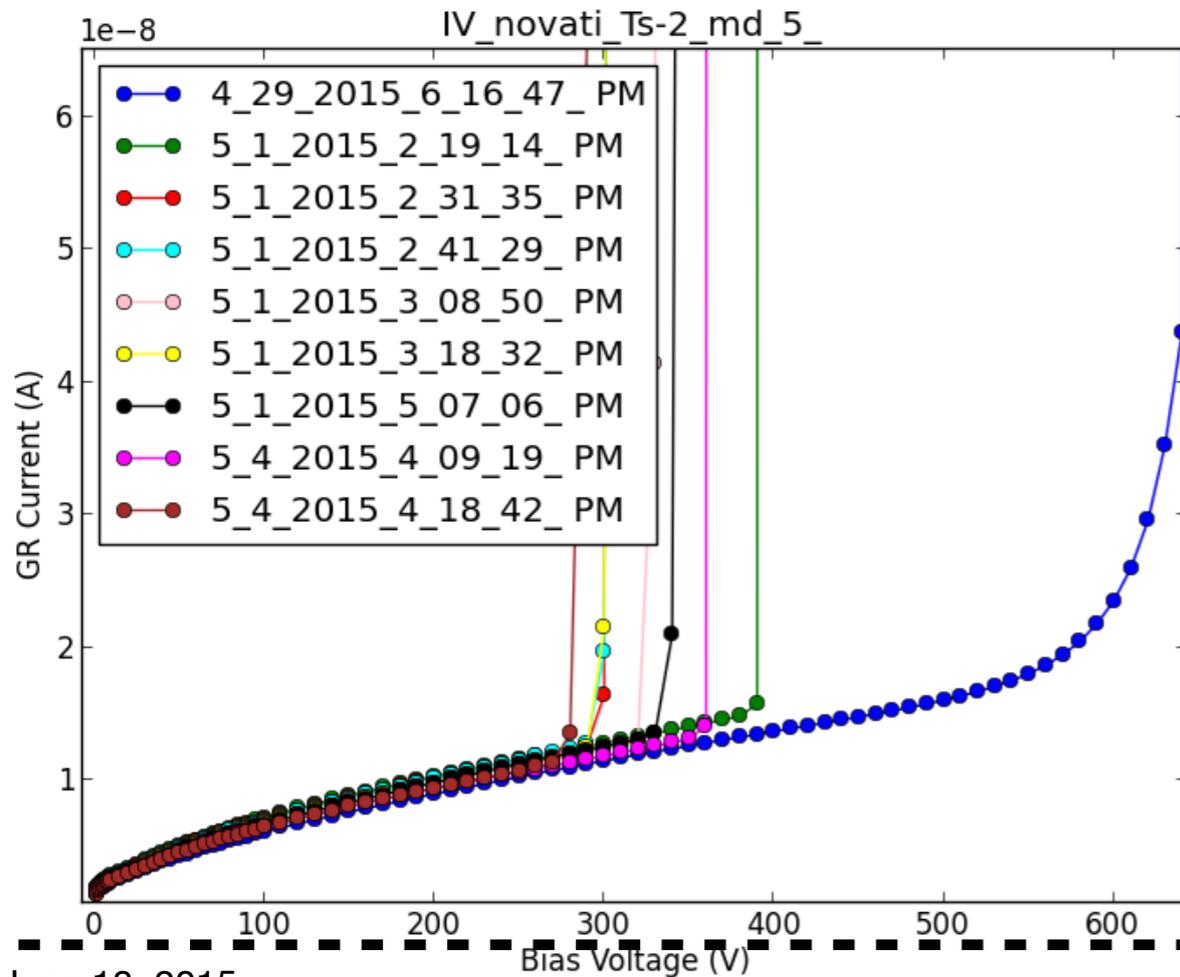
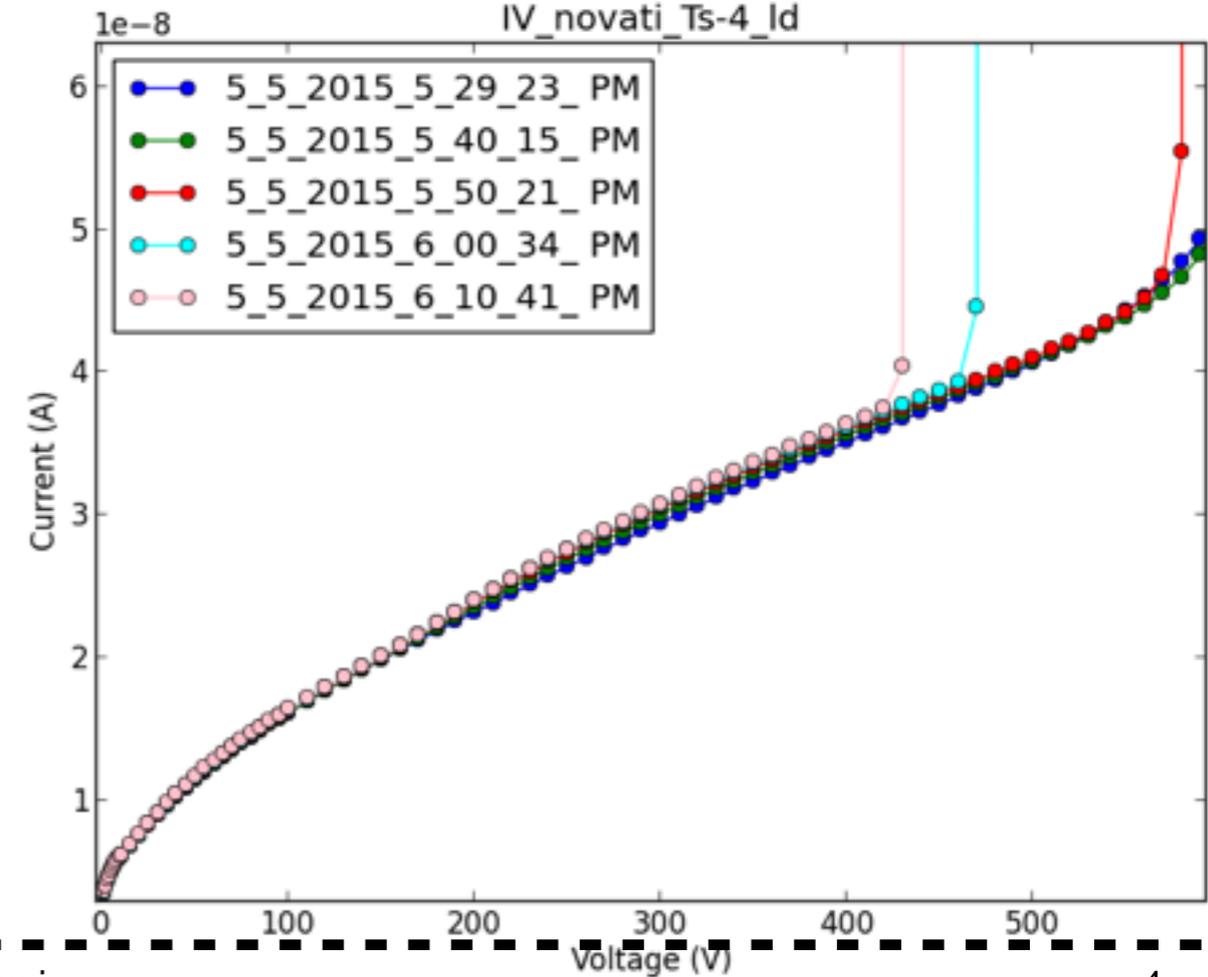
# Diode IV Characteristics

- Repeating the same measurements results in lower break down voltages
- How much the b-d voltage drops seems to depend on how high the current gets in the previous measurement

- Studied several structures on Novati wafer; SS, TS, PS, CL, SL, HGC
- Diodes work well for the first measurement— depletion achieved with thinned sensors to 500  $\mu\text{m}$
- Lowering of b-d voltage as the measurements repeated
  - Break-down happens very suddenly, resulting in very high current
  - Drop in b-d voltage is dependent on high current in previous measurements
- Strips break-down very early:  $\sim 100\text{V}$  —depletion won't be possible even after thinning
- Strips behave approximately the same across different structures
- Inter-strip capacitance is within acceptable range  $\sim 1\text{ pF}$

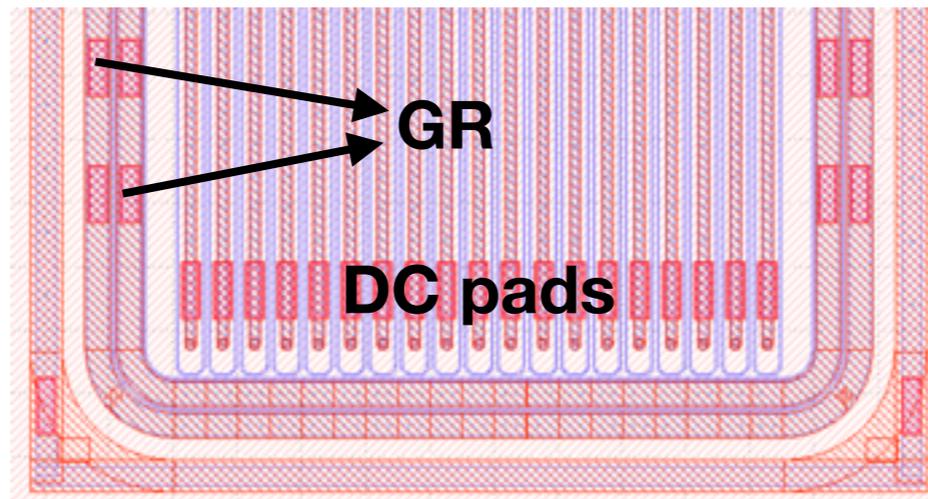
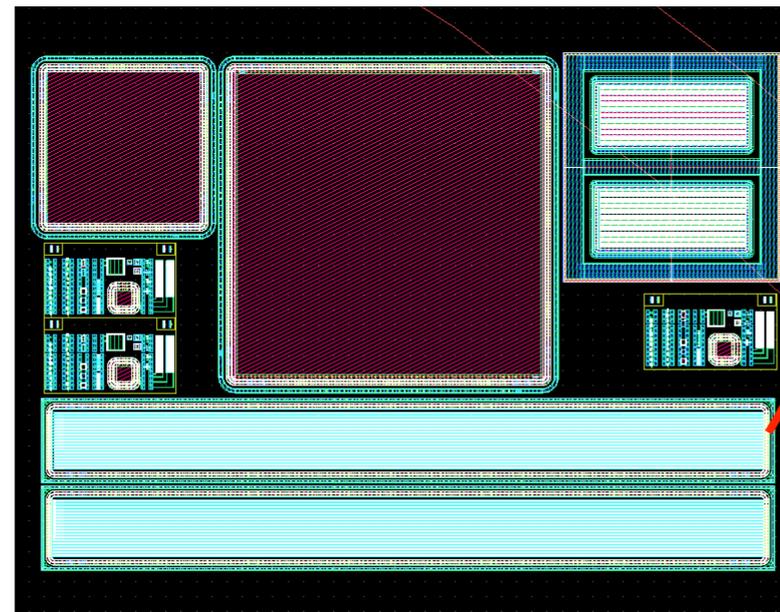
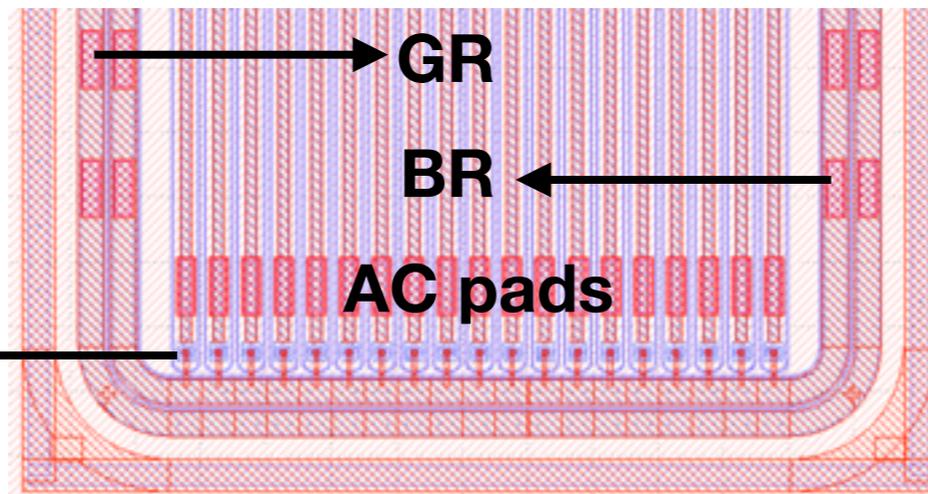
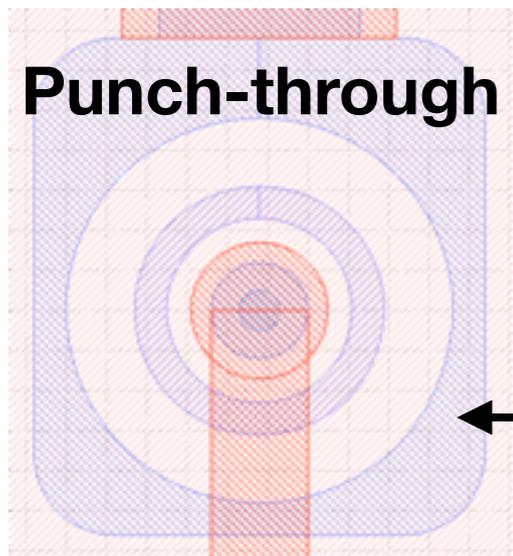
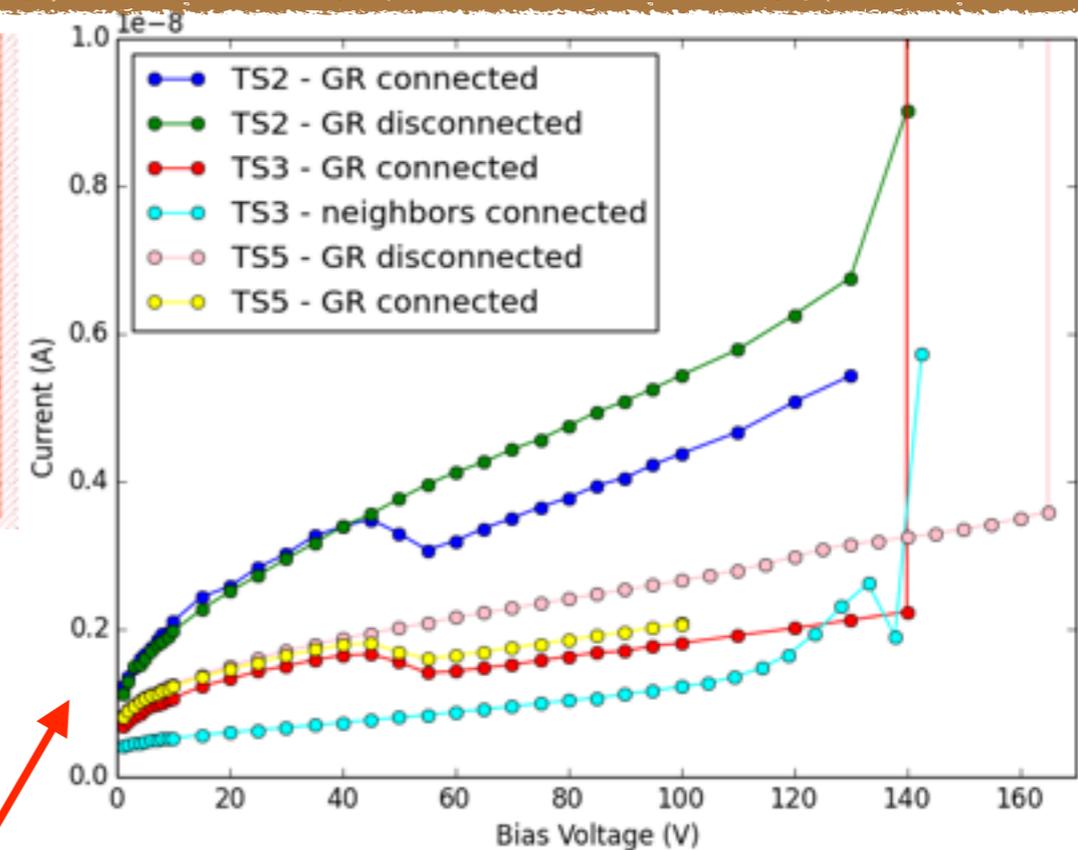
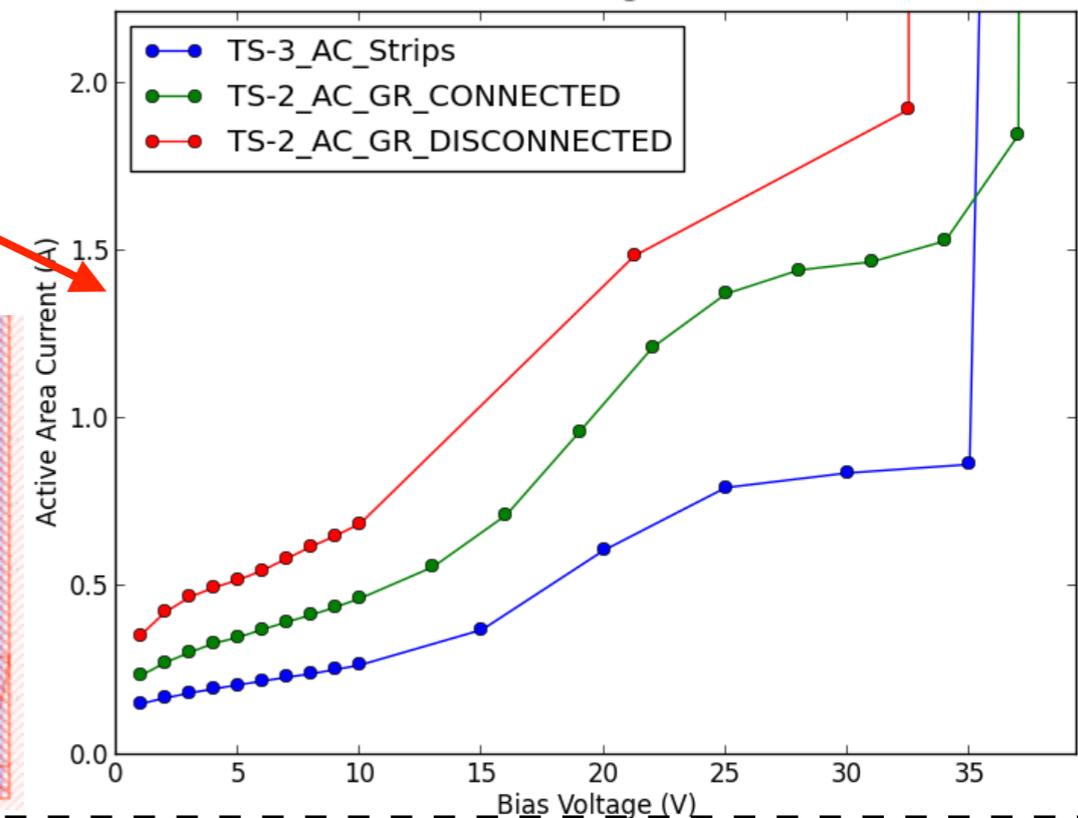
# Twenty Strips in Test Structure

- Single strip leakage current from DC coupled twenty strips
- AC coupled strips measured from bias ring
- Significantly lower B-D compared to diodes
- Lower b-d for AC coupled strips

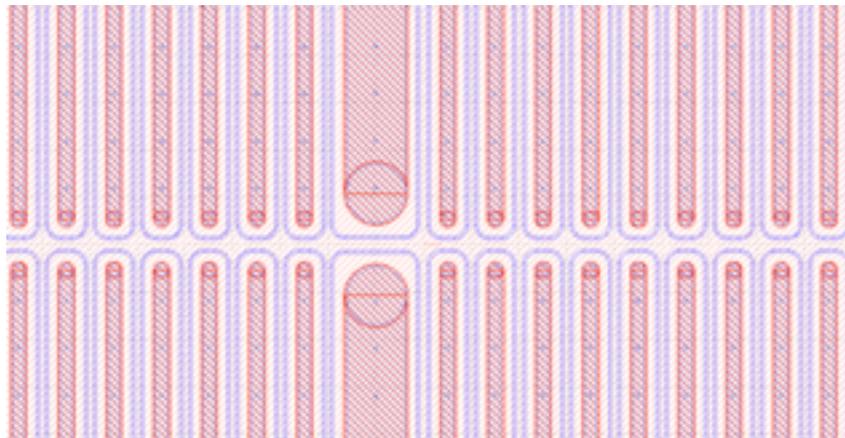
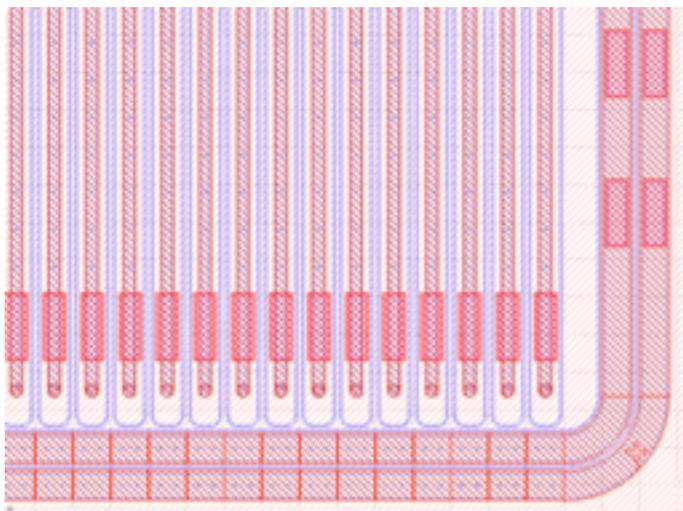
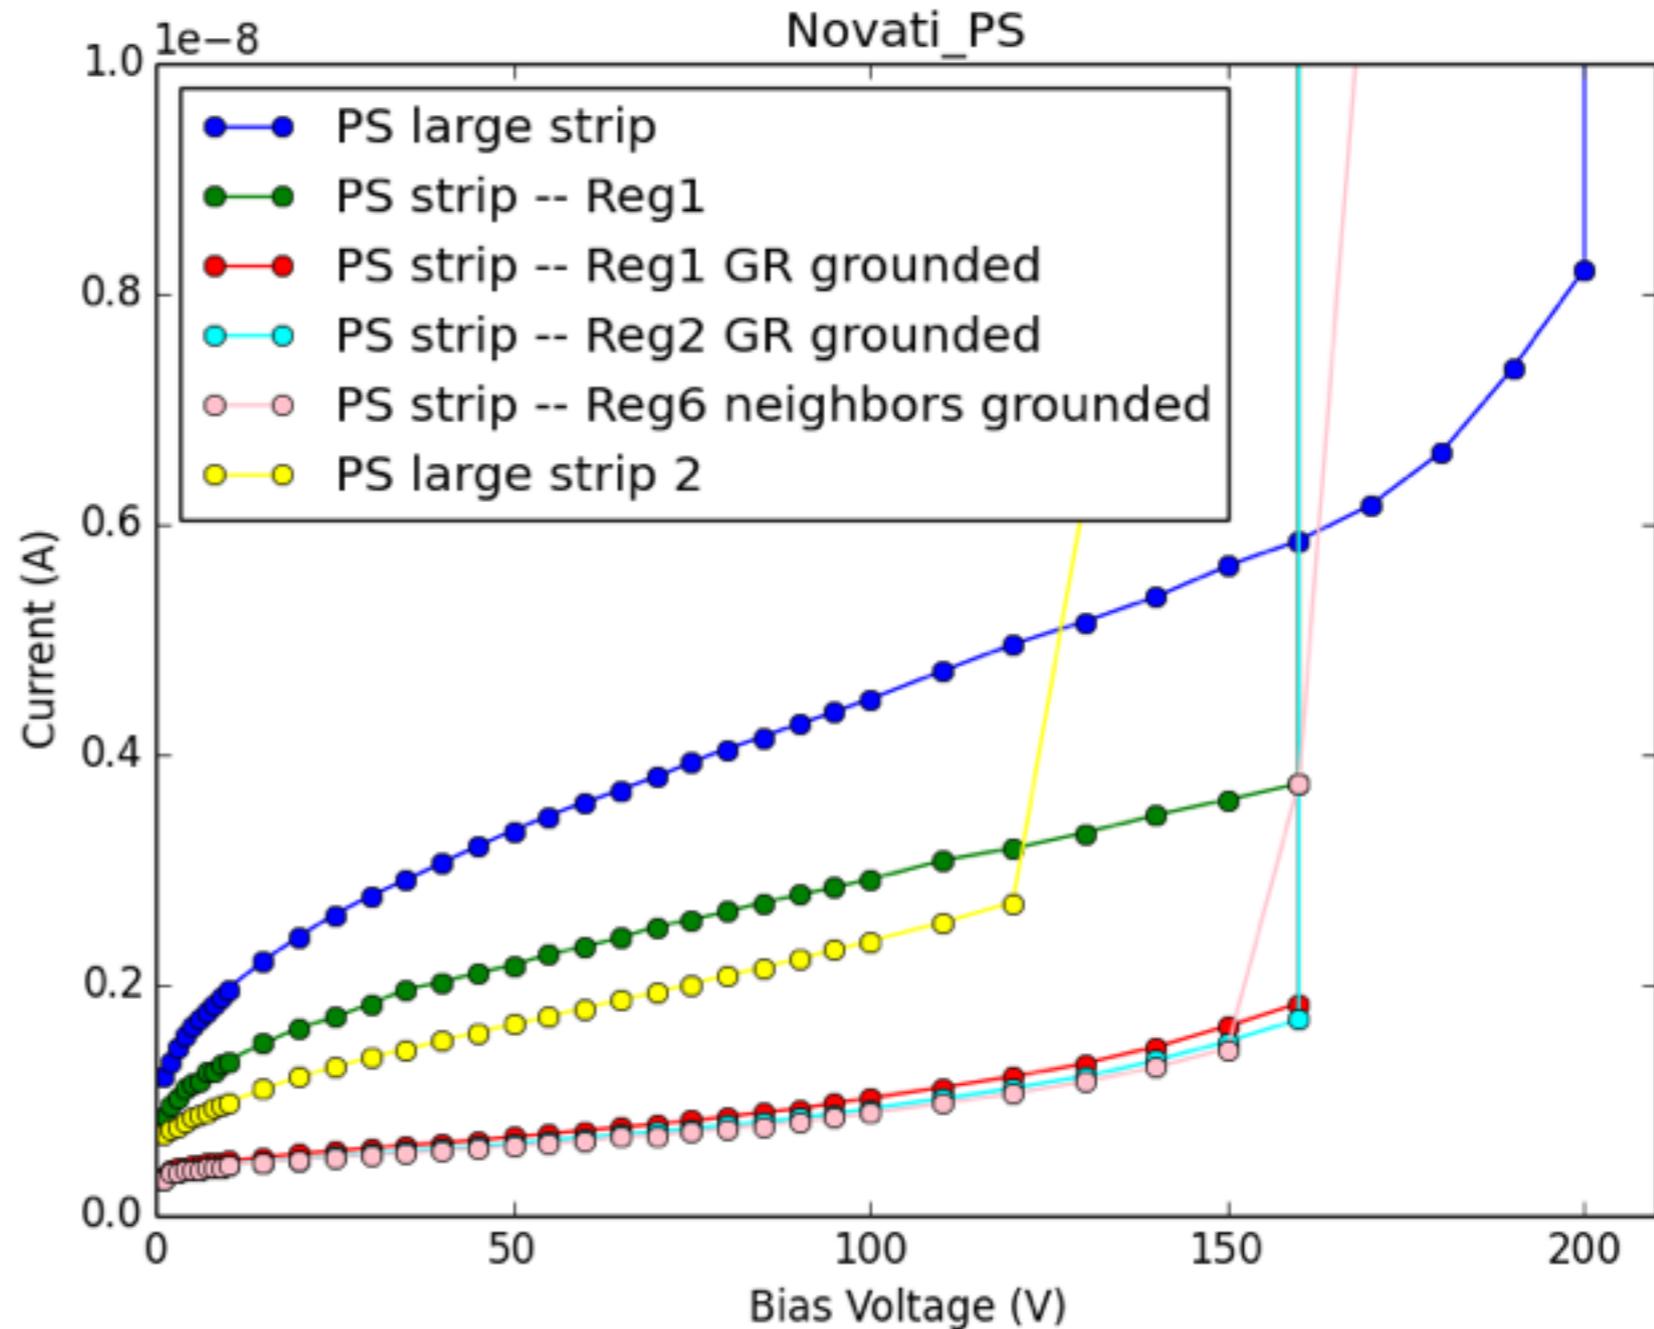
# PS Sensor Measurements

- First measurements compared
- B-D voltage drops 20-50V in the next measurements
- Uniform across different strips

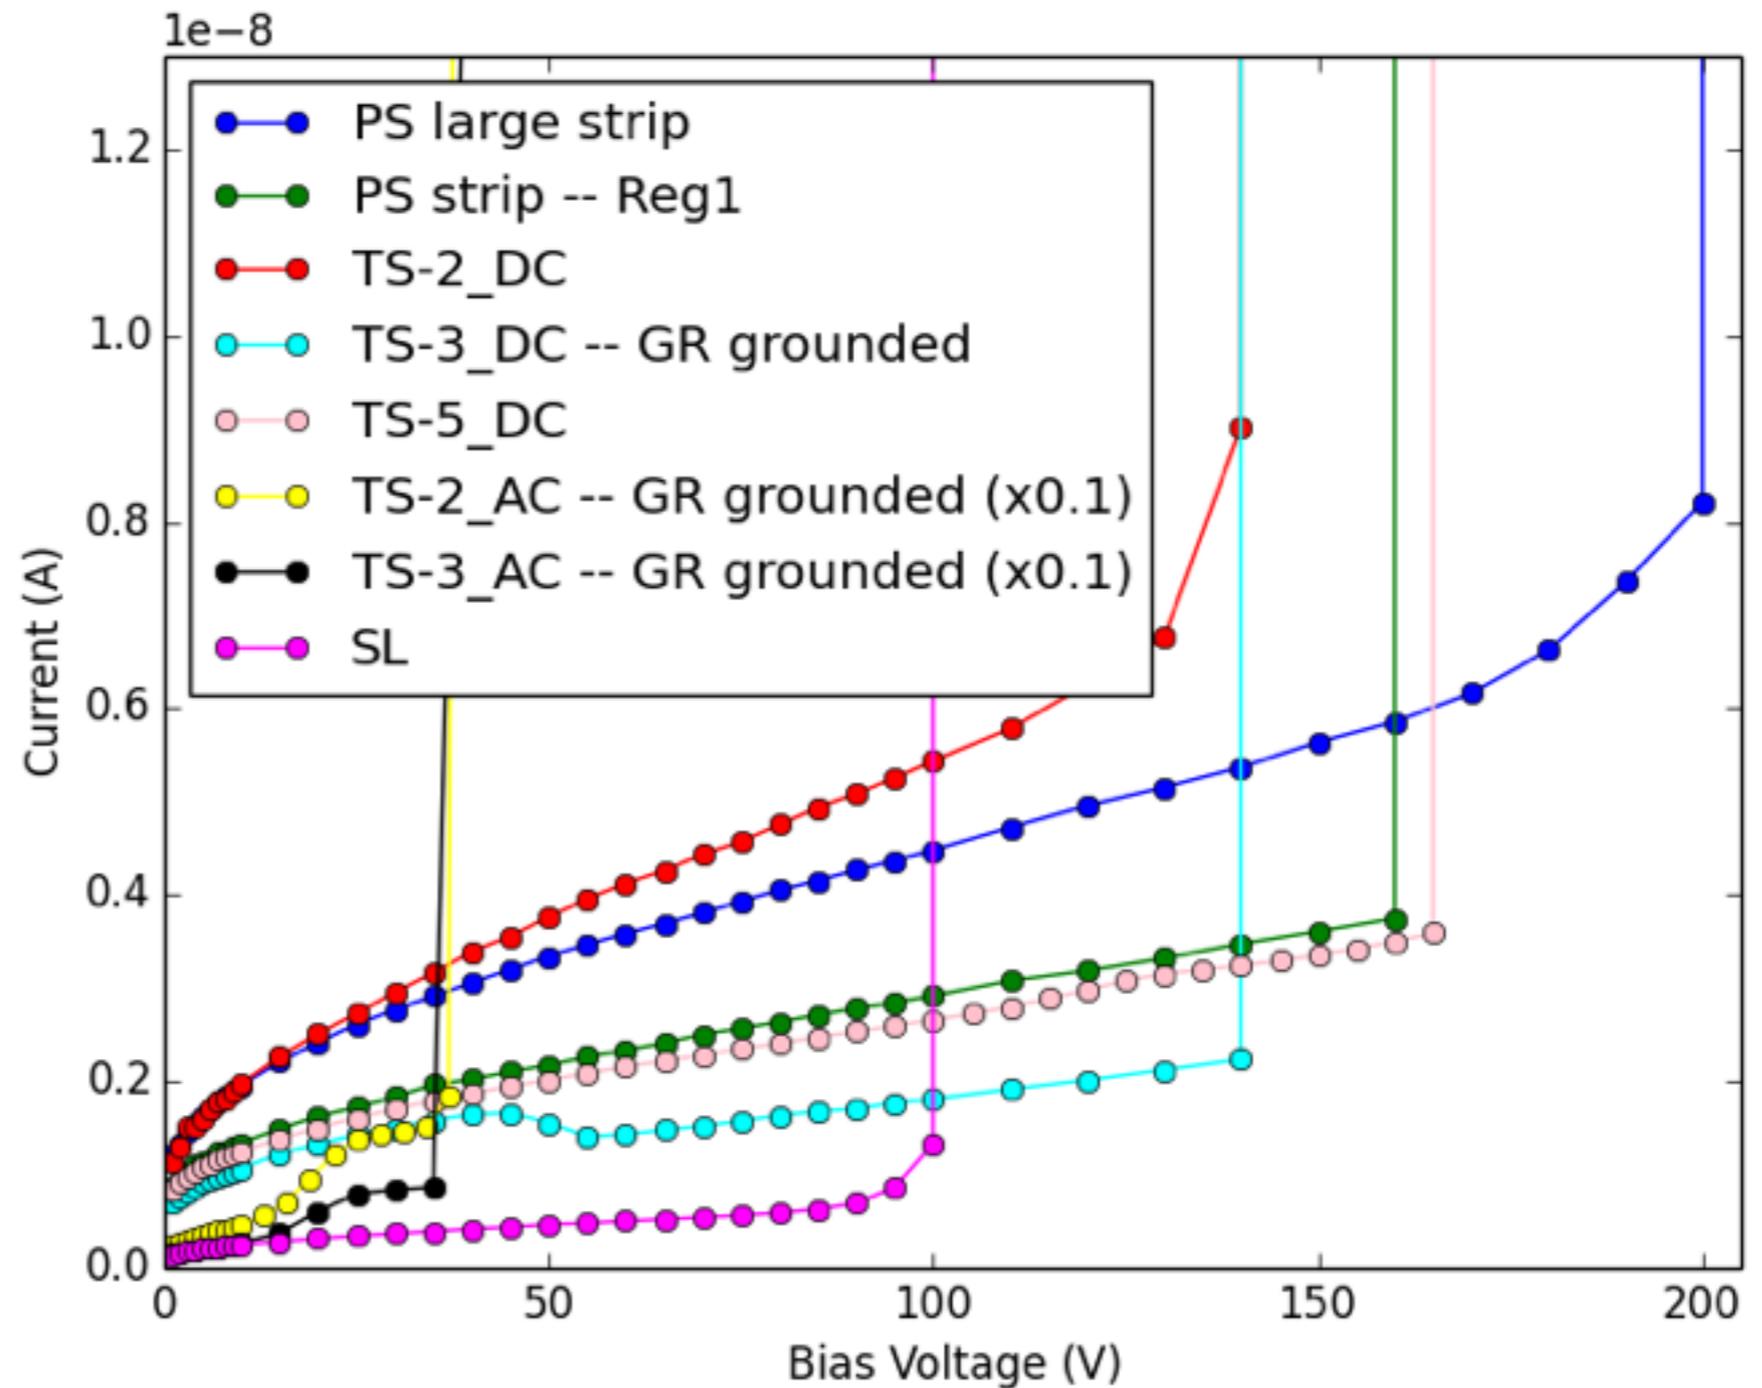
# Comparison of Strip Leakage Current Measurements

- Compare measurements from different structures with strips
- Sensor behavior is approximately uniform across different structures

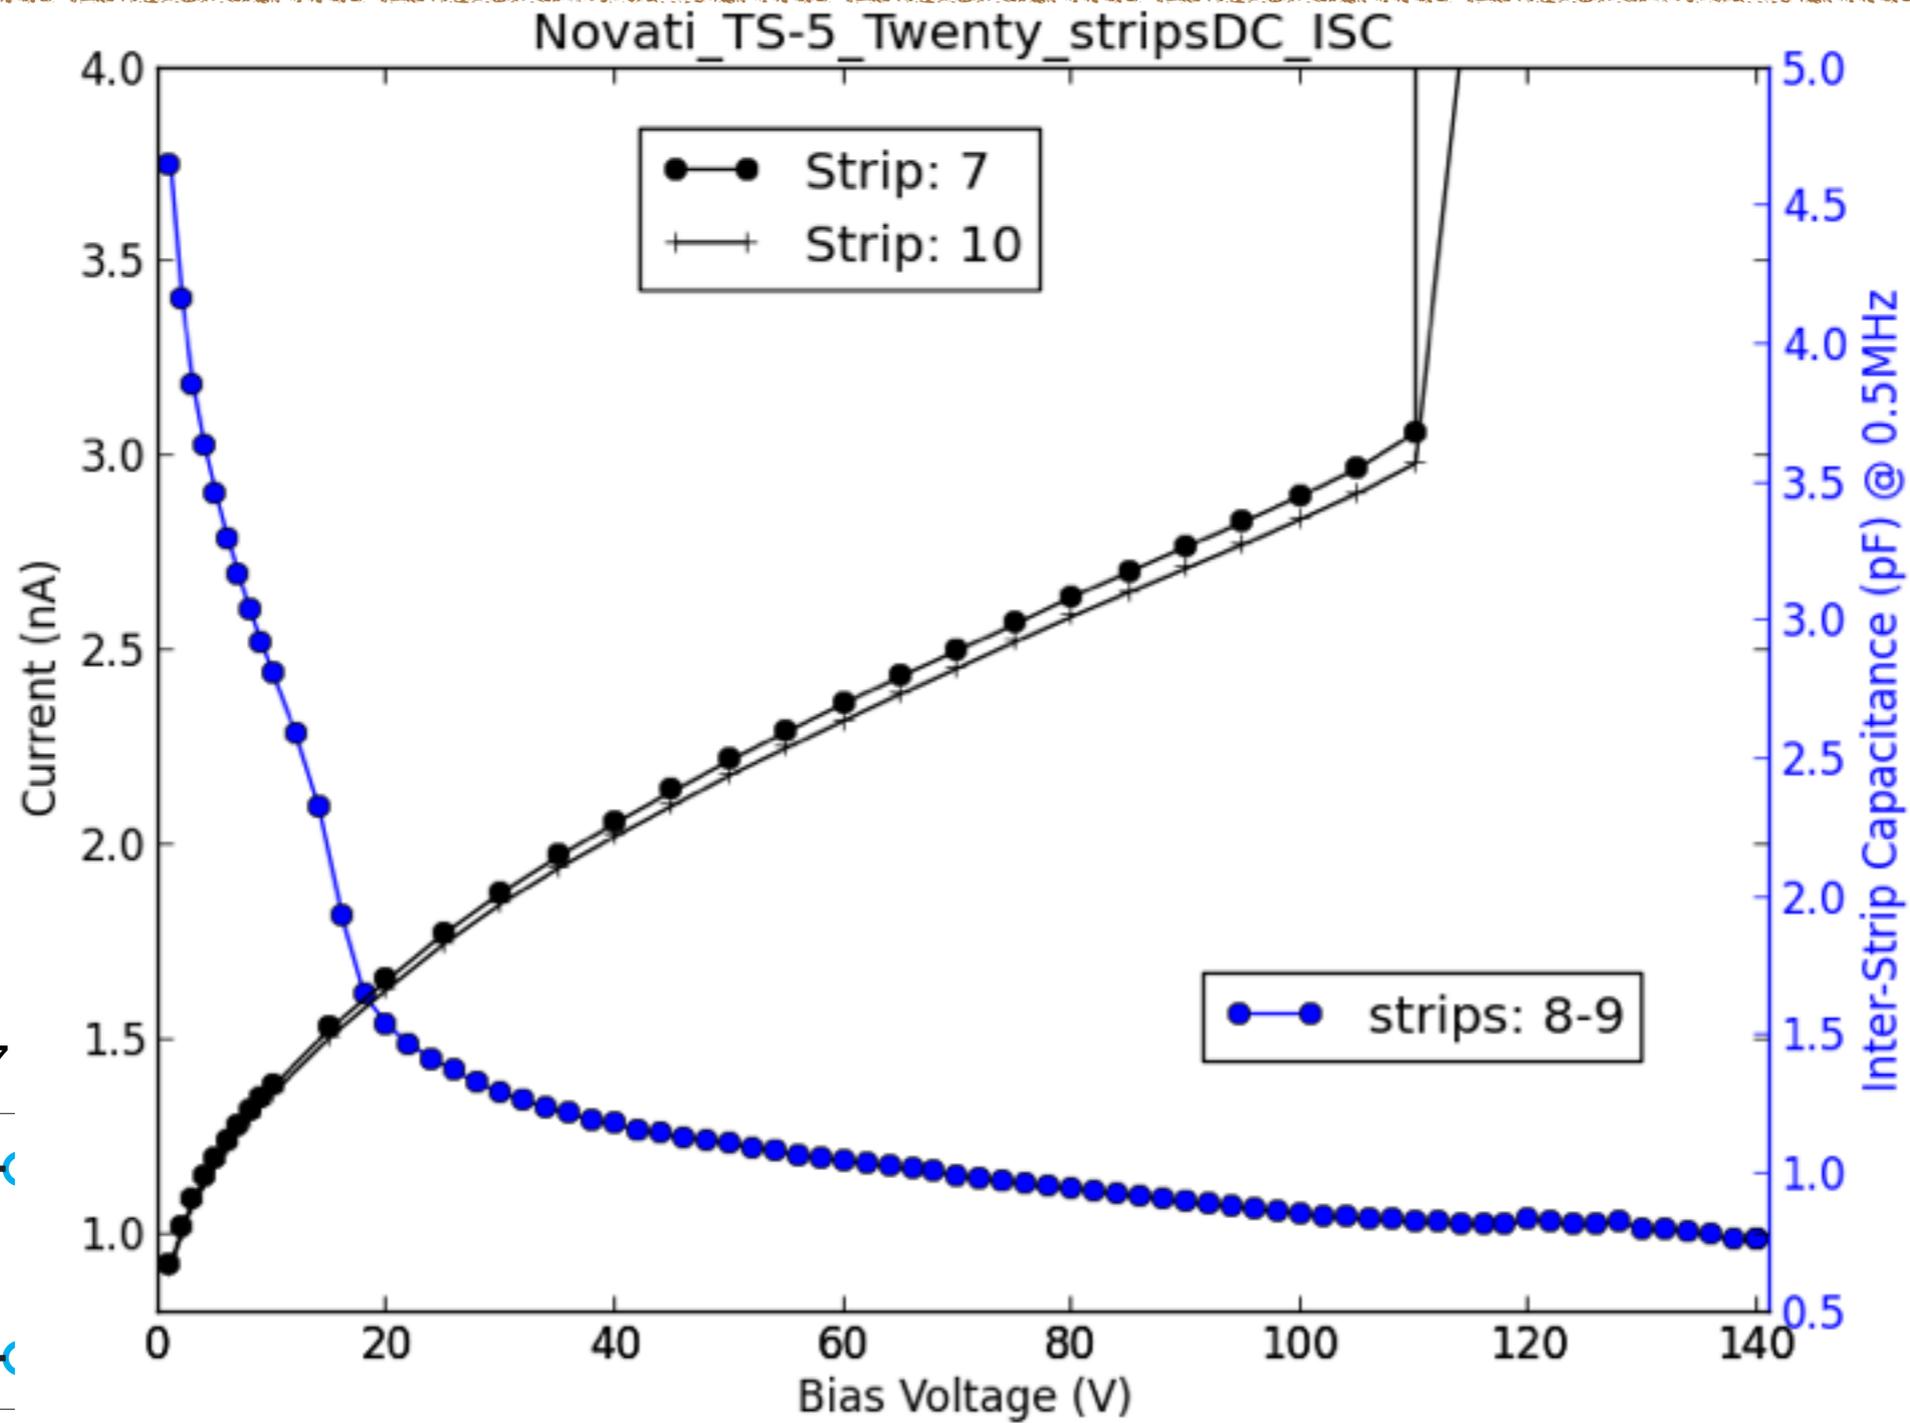
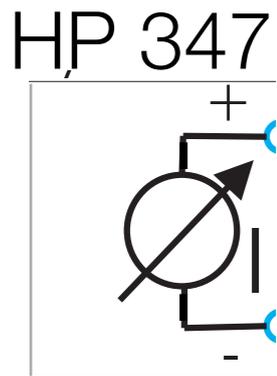
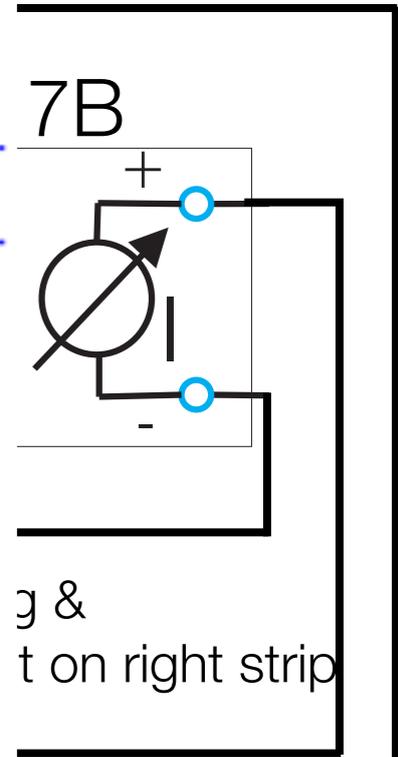
# Inter-Strip Capacitance: DC Coupled Twenty Strips

Measuring Current on left strip

Backplane

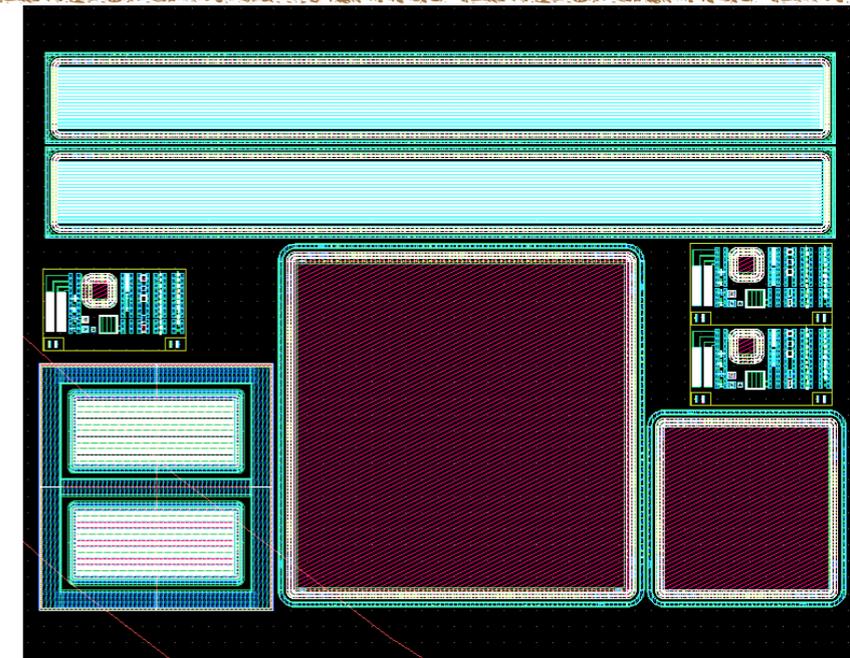
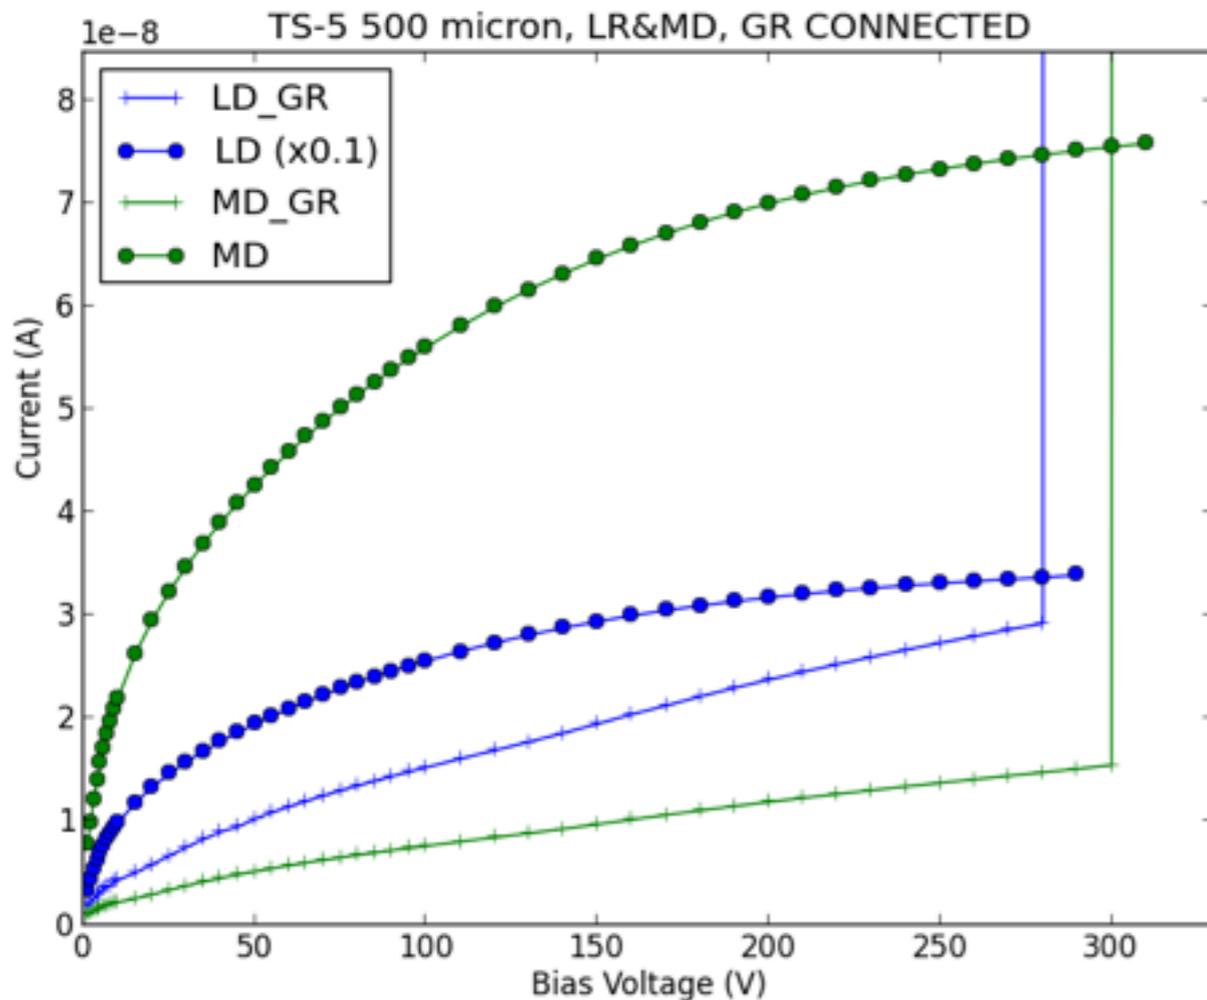
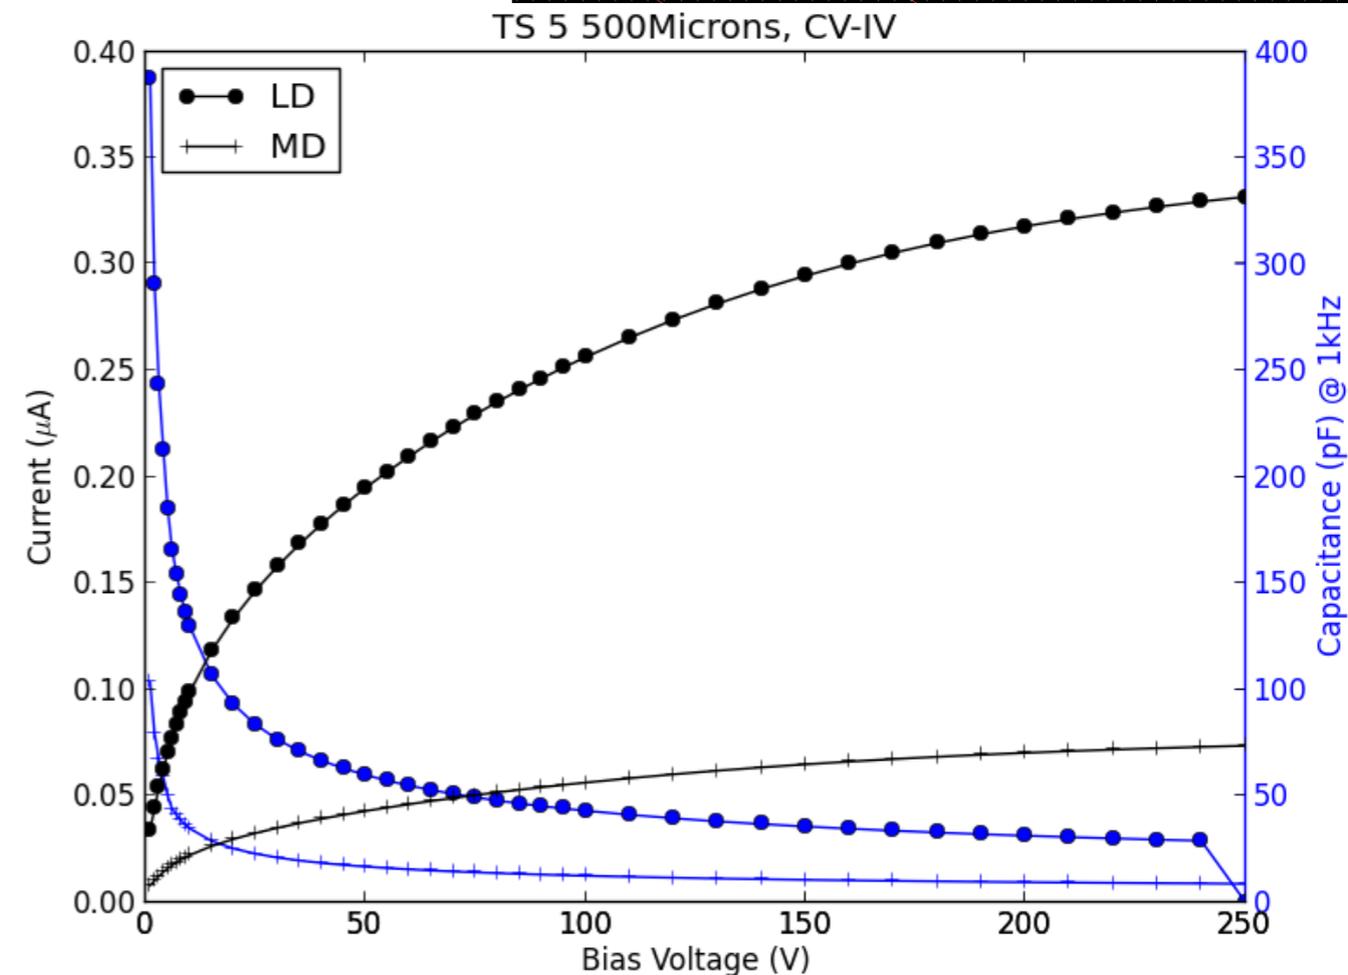
# Measurements on Diodes: TS5-500um

- Measurements on TS-5 thinned to 500um
- Structure diced from the wafer
- B-D voltage is significantly lower
- Diodes could not be depleted
