# Measurements on 8” Novati Wafer

## **USCMS Outer Tracker Workshop**

Brown University, Providence, RI, USA

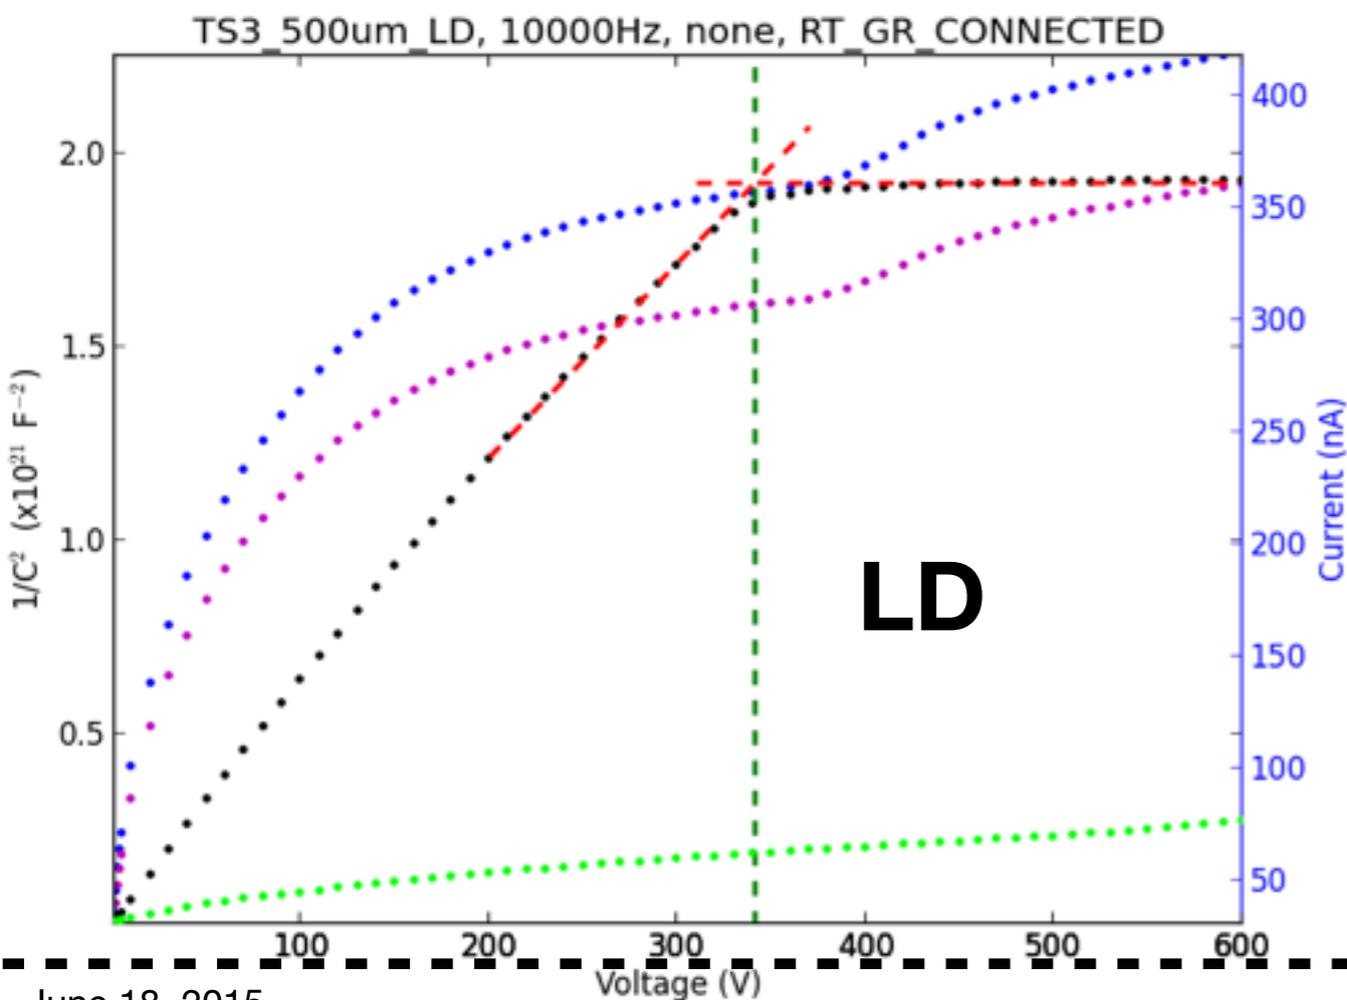
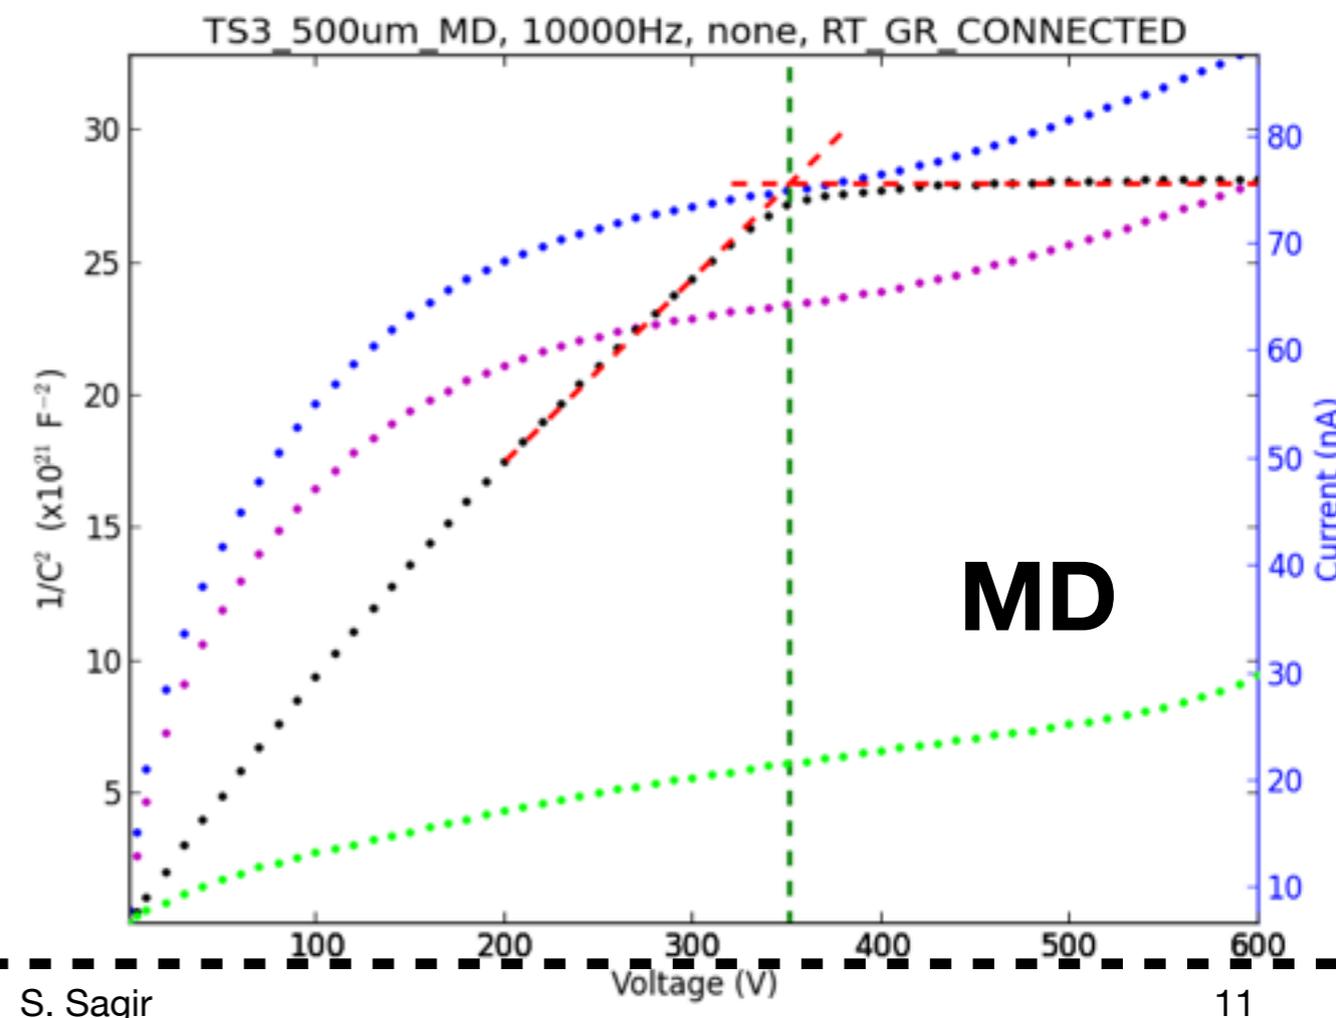
# Measurements on Diodes: TS3-500um

| | MD | LD |
| Depletion Voltage (V) | 351 | 341 |
| Leakage Current (nA) @20C | 64 | 306 |
| End Capacitance (pF) | 6 | 23 |
| Thickness ( $\mu\text{m}$ ) | 441 | 462 |
| Effective Doping Concentration ( $10^{11}\text{cm}^{-3}$ ) | 24 | 21 |
| Resistivity ( $\text{k}\Omega\text{cm}$ ) | 5.7 (7.4) | 6.5 (7.6) |

$$d = \frac{\epsilon\epsilon_0 A}{C_{end}}$$

$$|N_{eff}| = \frac{2\epsilon\epsilon_0 V_{dep}}{e d^2}$$

$$\rho = \frac{1}{e\mu_{e,h} |N_{eff}|}$$

(thickness fixed to 500 $\mu\text{m}$ )

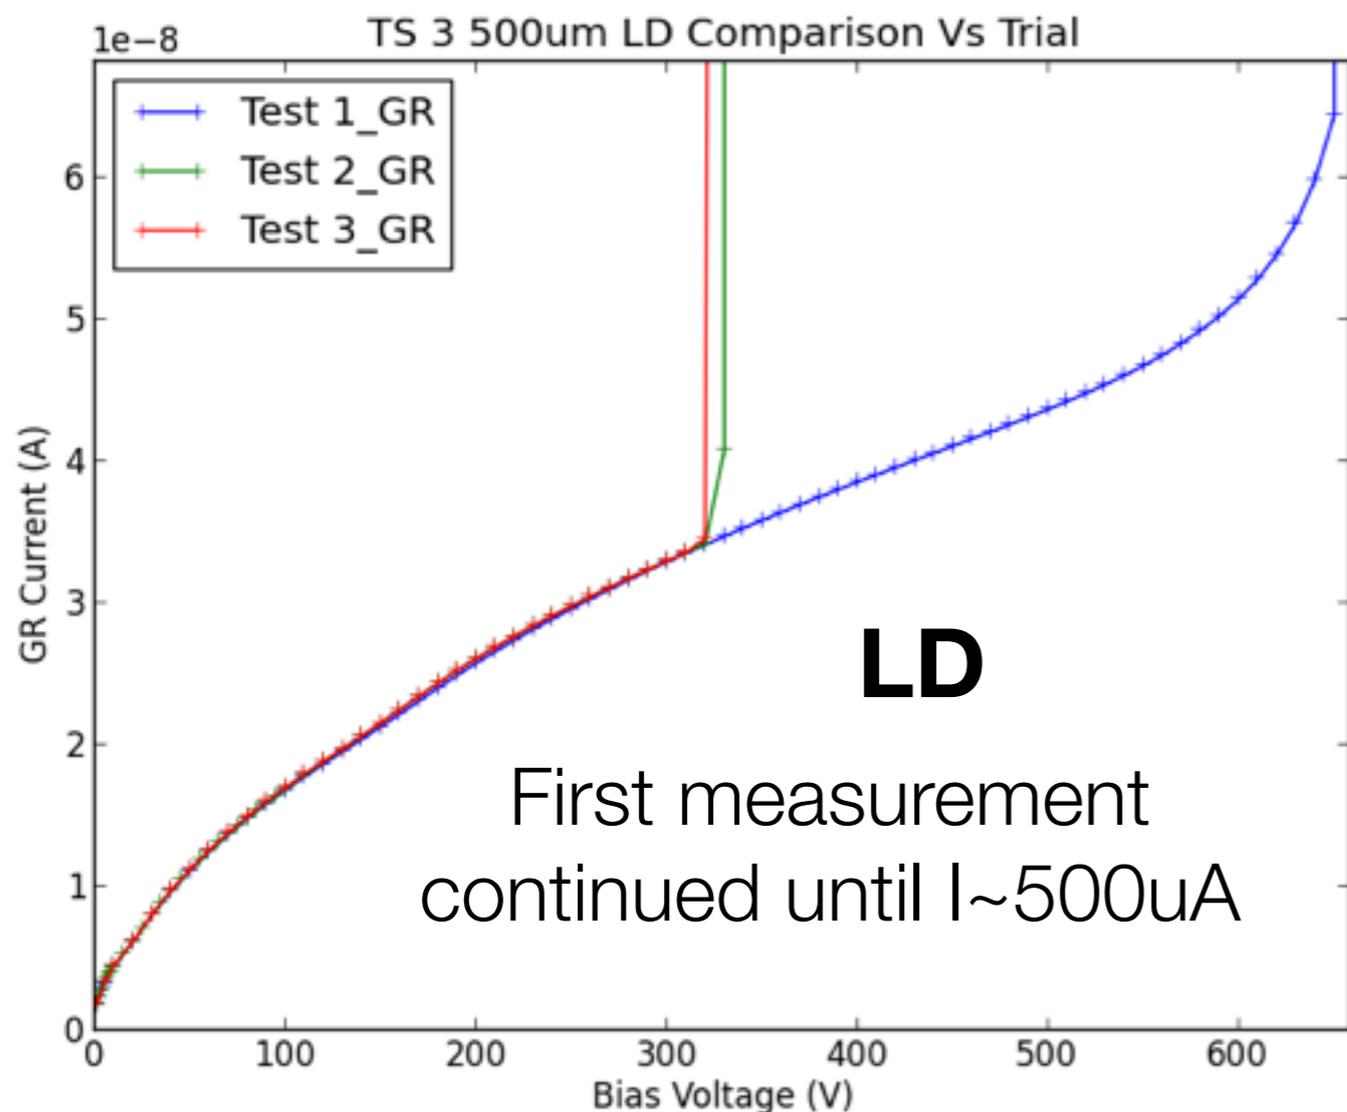
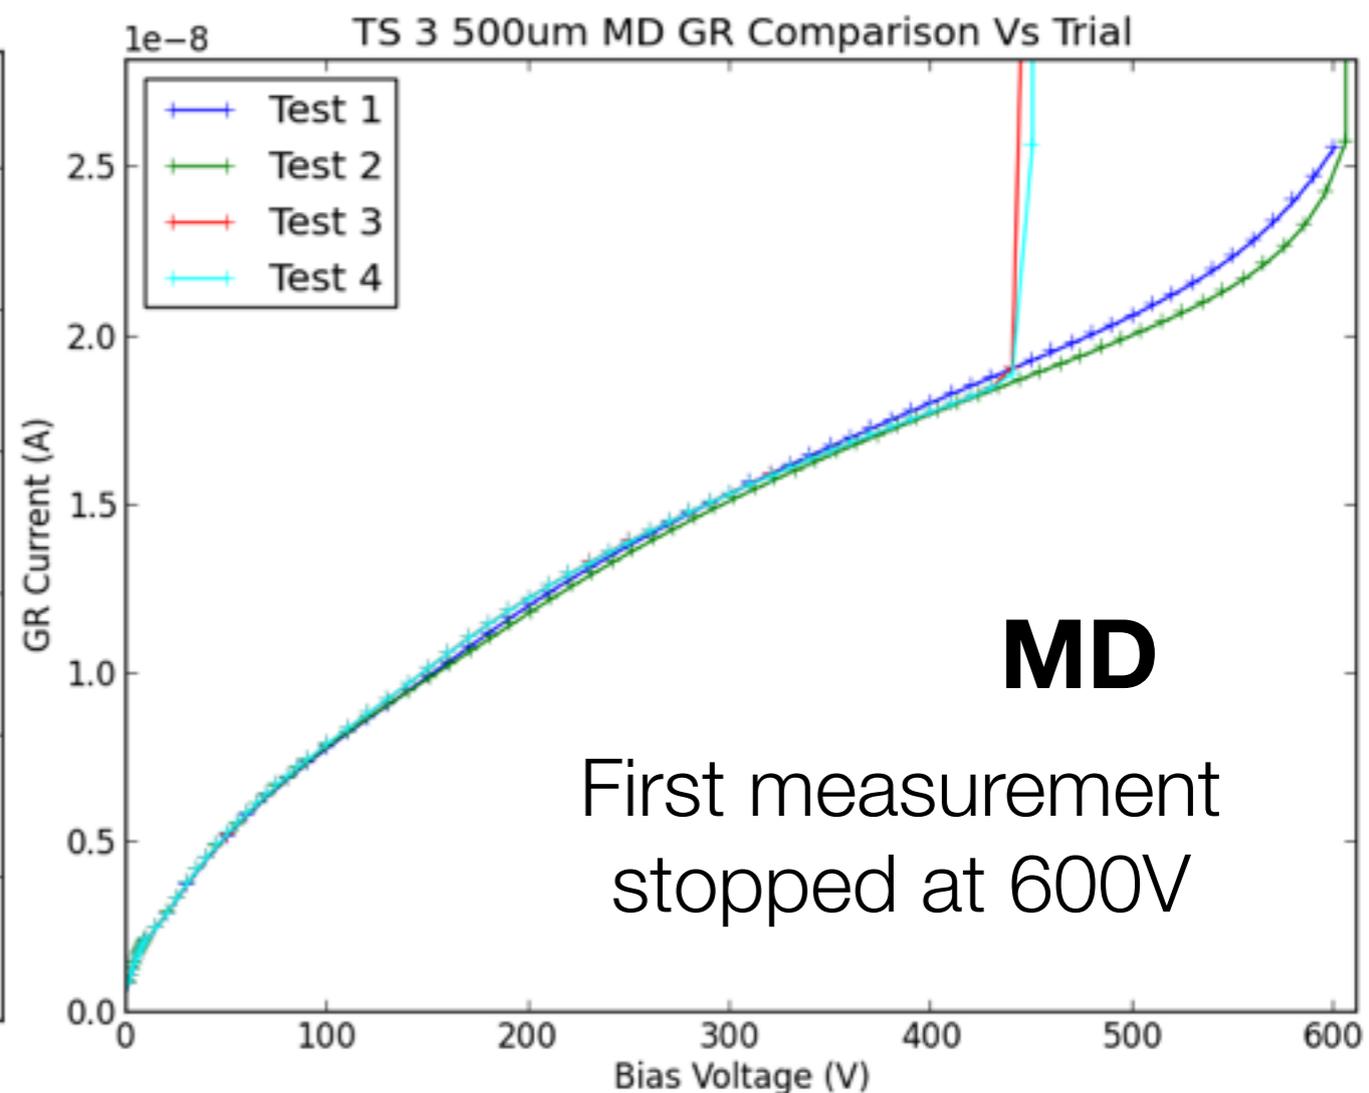
# Measurements on Diodes: TS3-500um

- We repeat the IV measurements on TS-3 structure
- After the first measurement, b-d voltage drops down to  $\sim 300\text{V}$  (LD) and  $\sim 400\text{V}$  (MD) and diodes can no longer be depleted

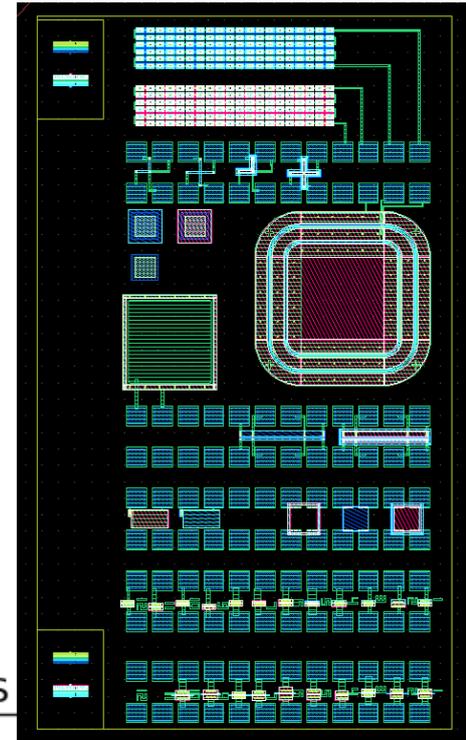
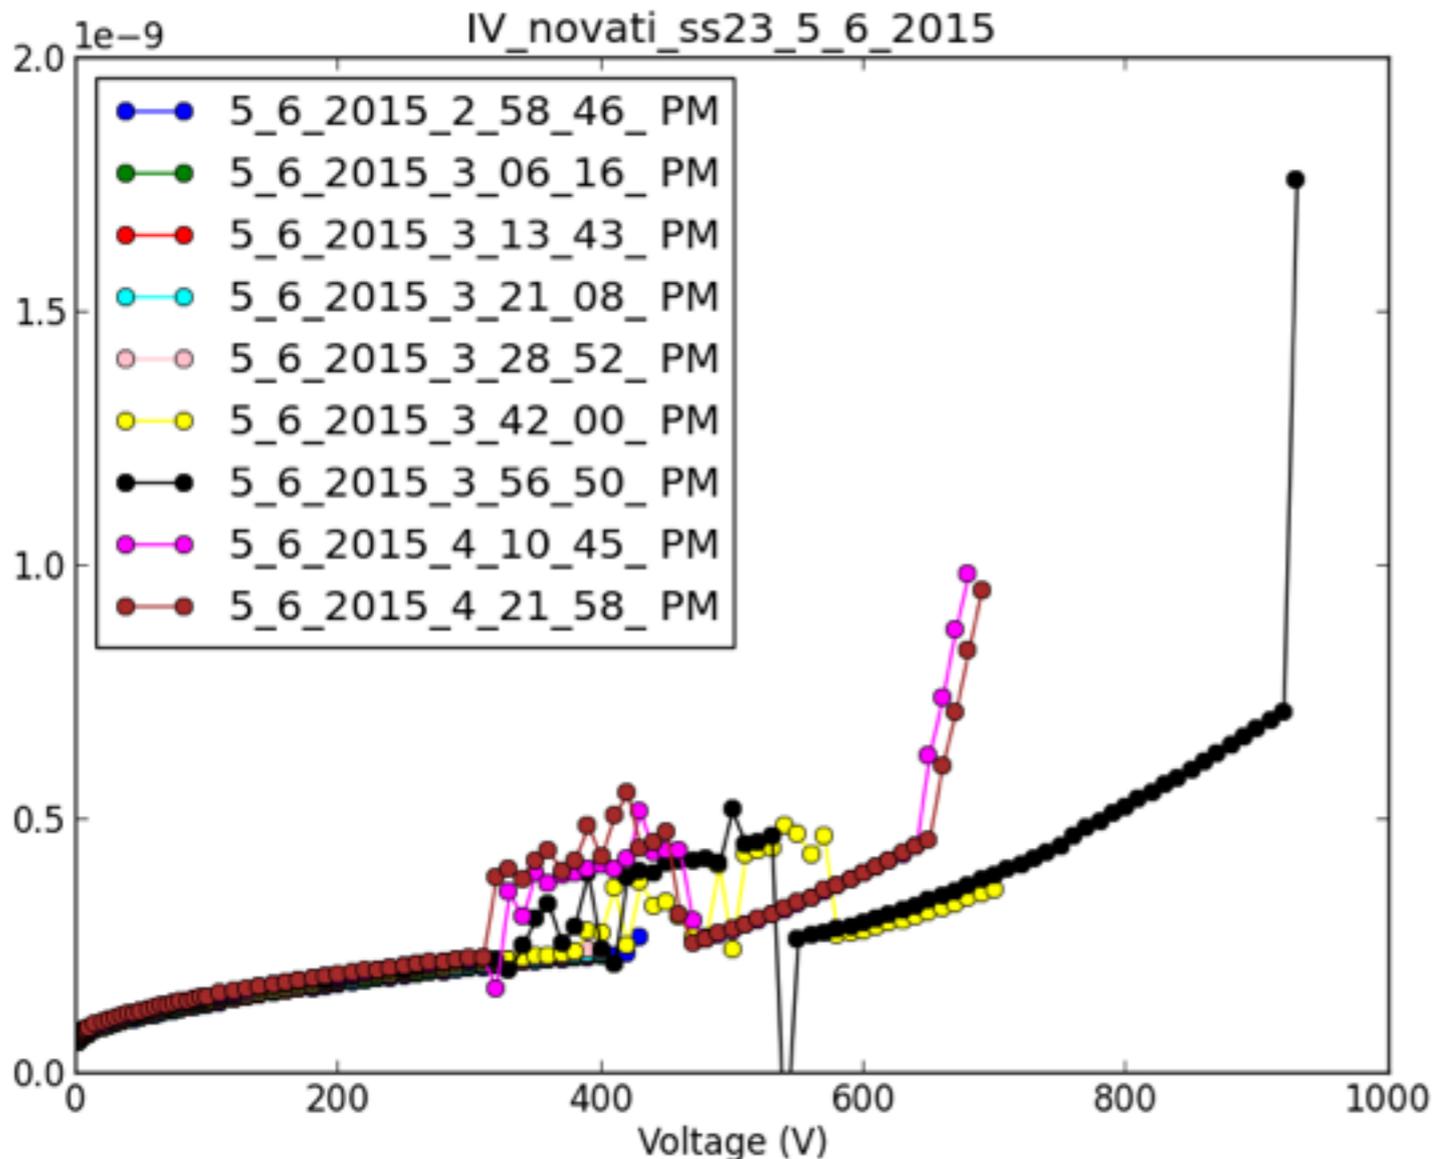
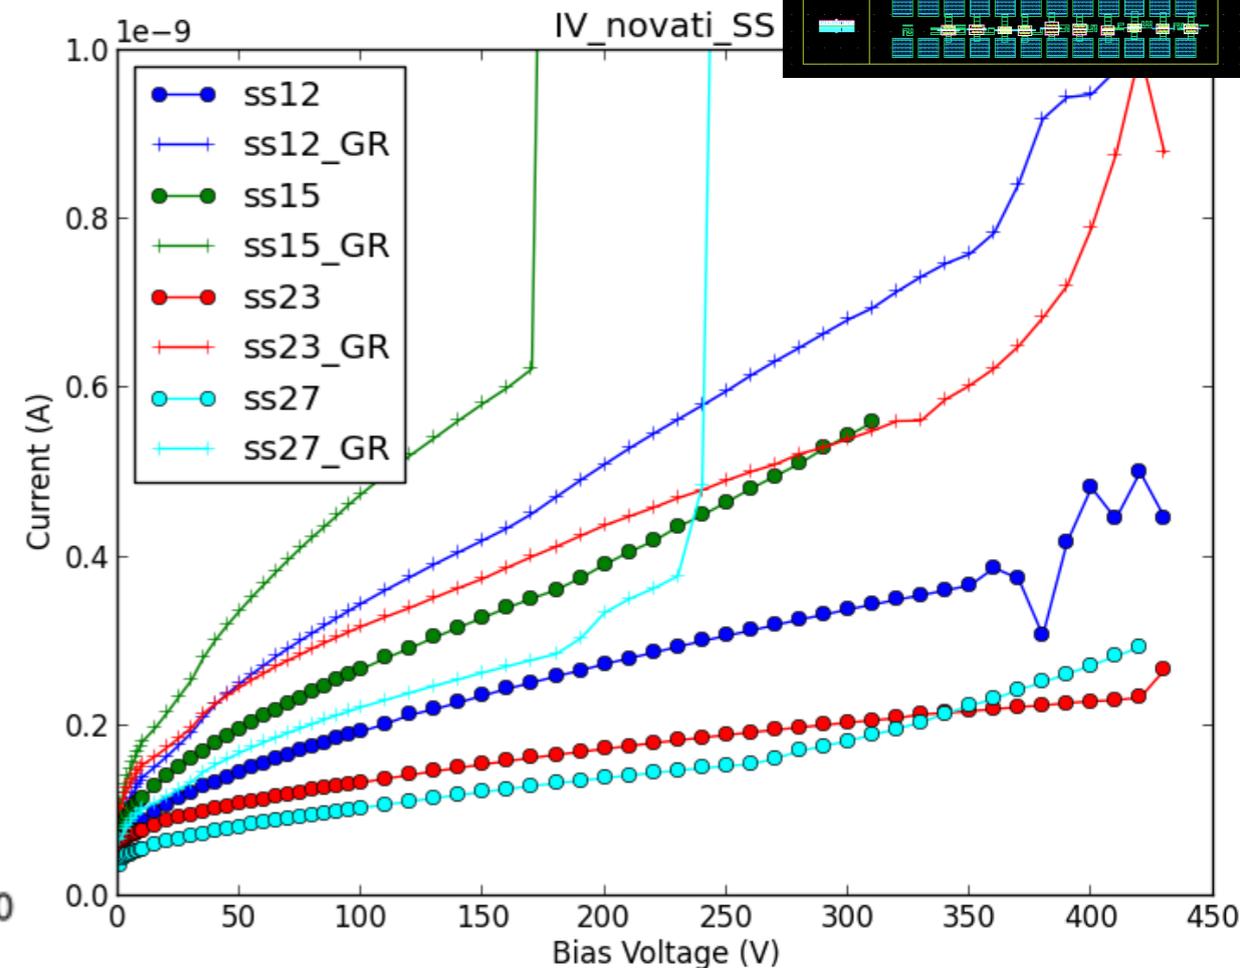
# Diode IV Characteristics: SS

- Diode in small test structure
- Current becomes rough around 300V and smooths out again until break-down
- Break-down voltage drops as the measurements repeated

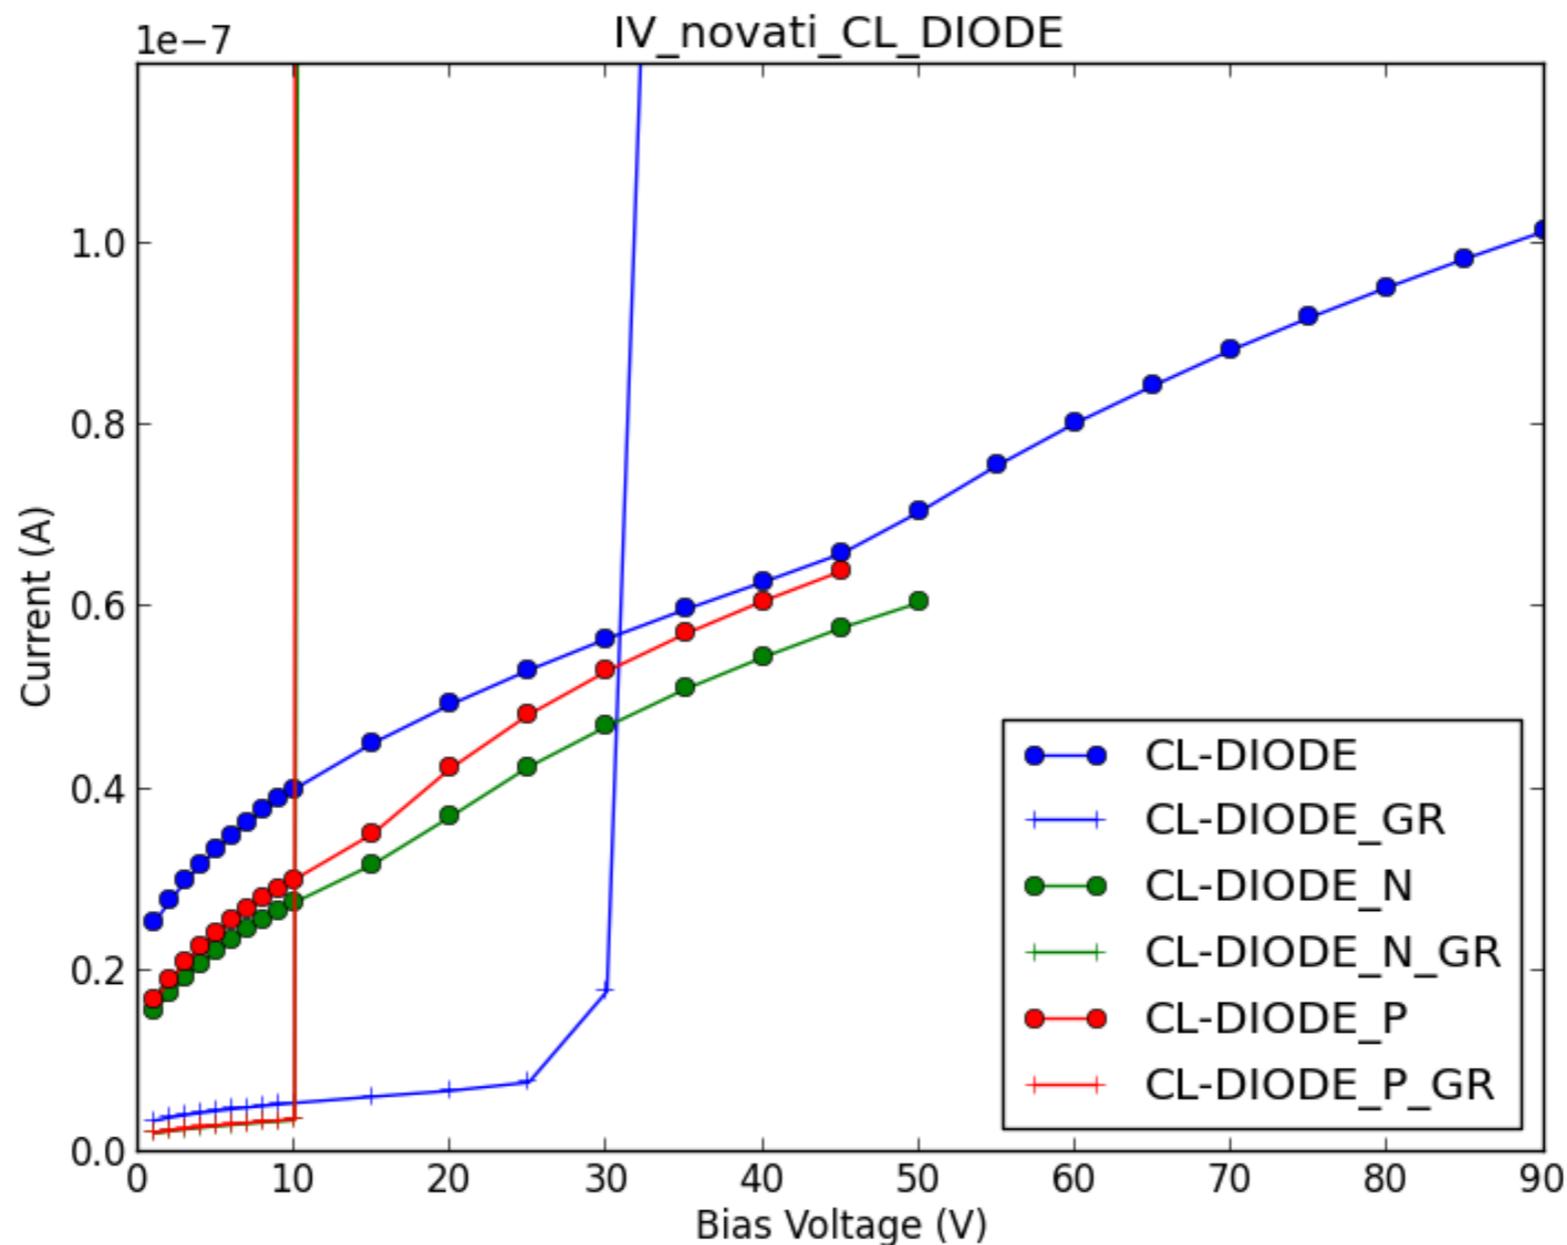
# Diode IV Characteristics: CL

- Diodes in CL Structure
- GR breaks-down around 10V and 30V

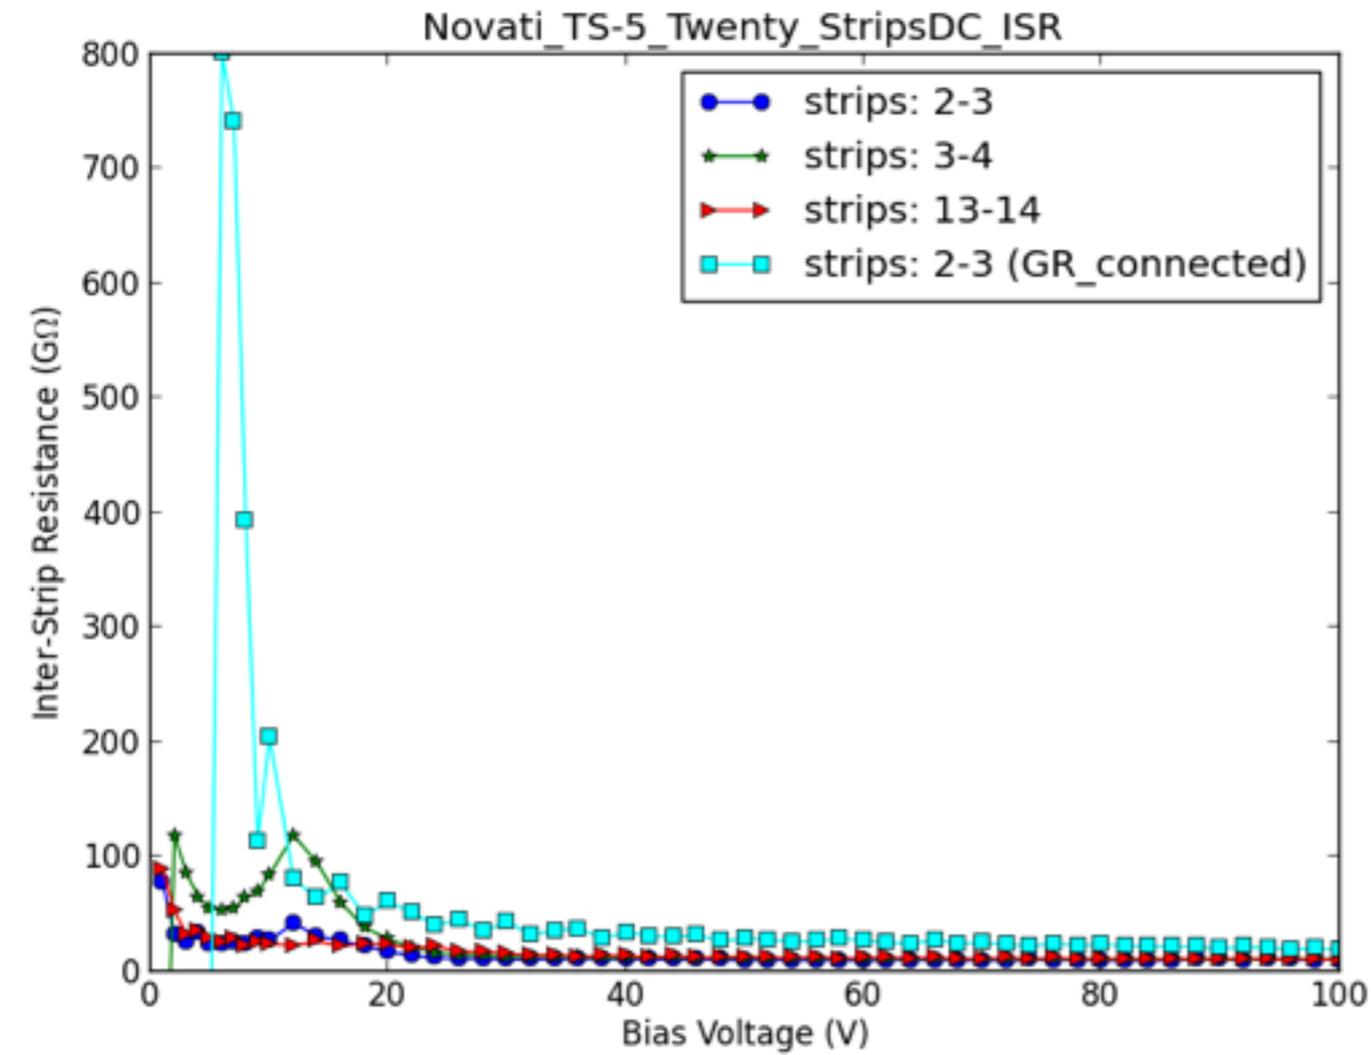
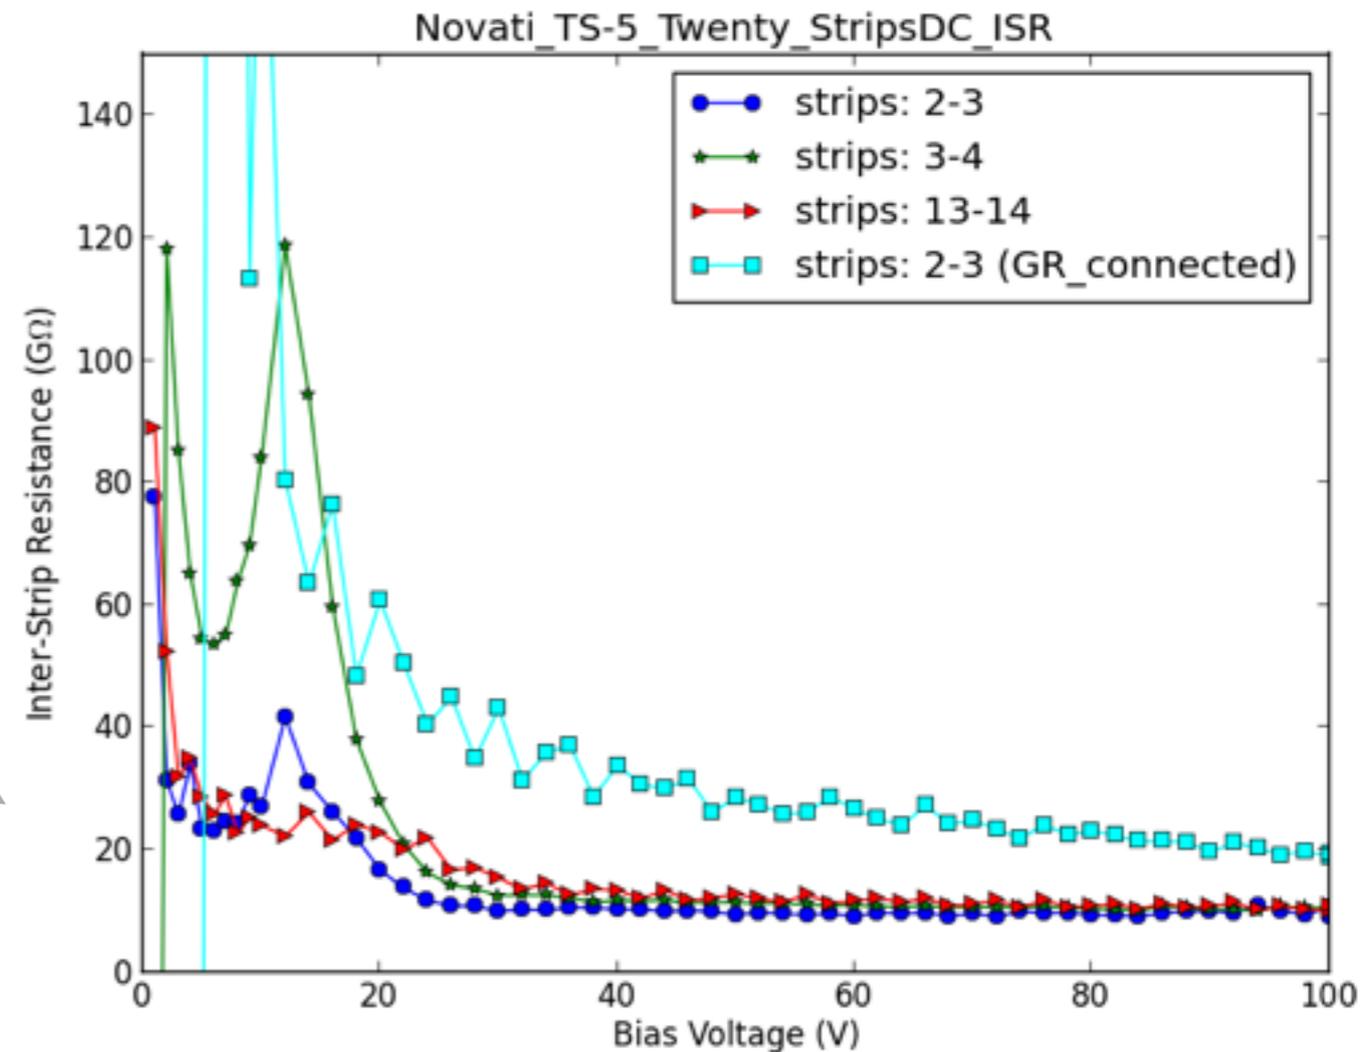
# Inter-Strip Resistance: TS-5/Twenty Strips DC

$$R_{int} = \left( \frac{d_I}{d_V} \right)^{-1}$$

Zoom-in
