# Fundamental Power Couplers Overview, Performance, and Plans at the Spallation Neutron Source

Mark Champion  
Research Accelerator Division  
Group Leader, Electrical and Radio-Frequency Systems

## The SNS Linac cavities are powered by four unique types of fundamental power couplers

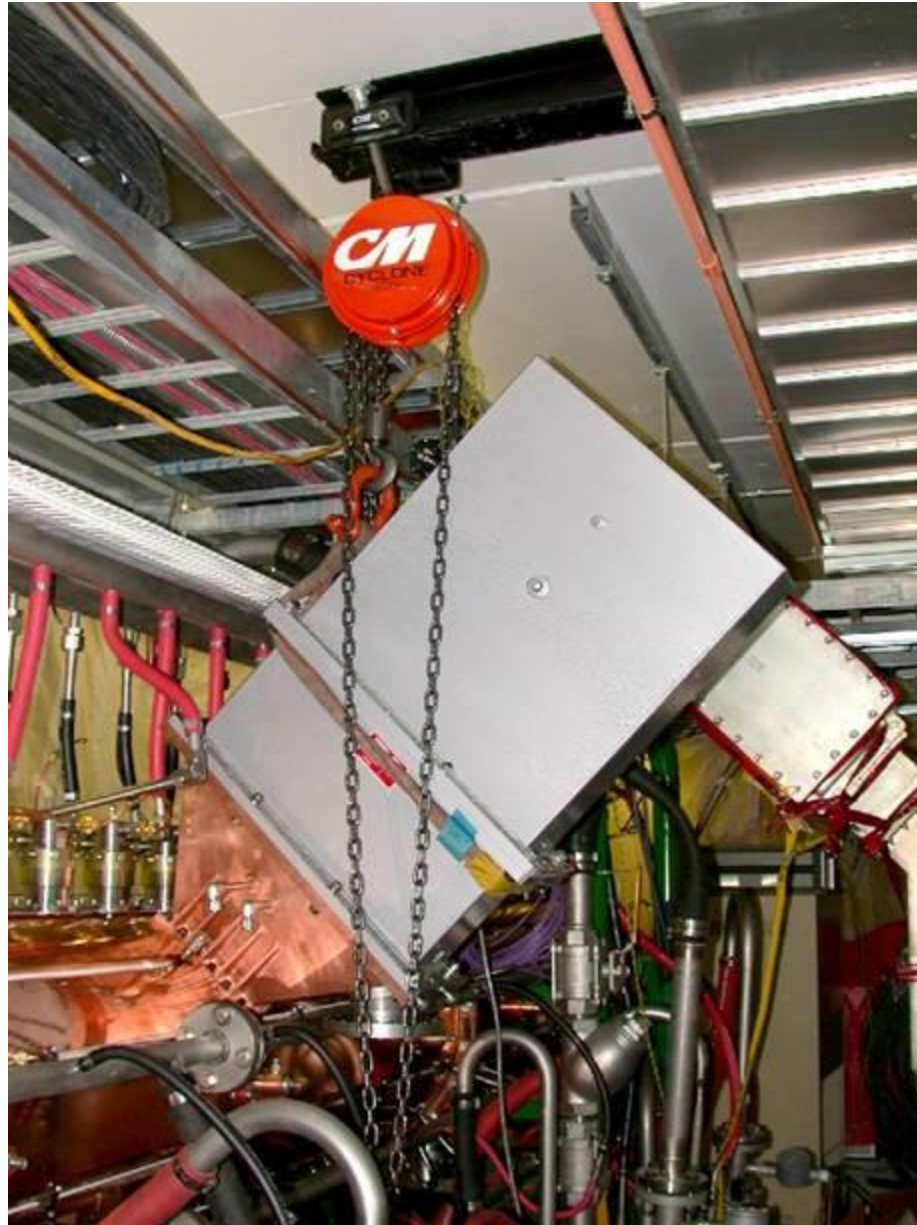
# Installation photo illustrating attachment of DTL coupling iris and waveguide to DTL tank

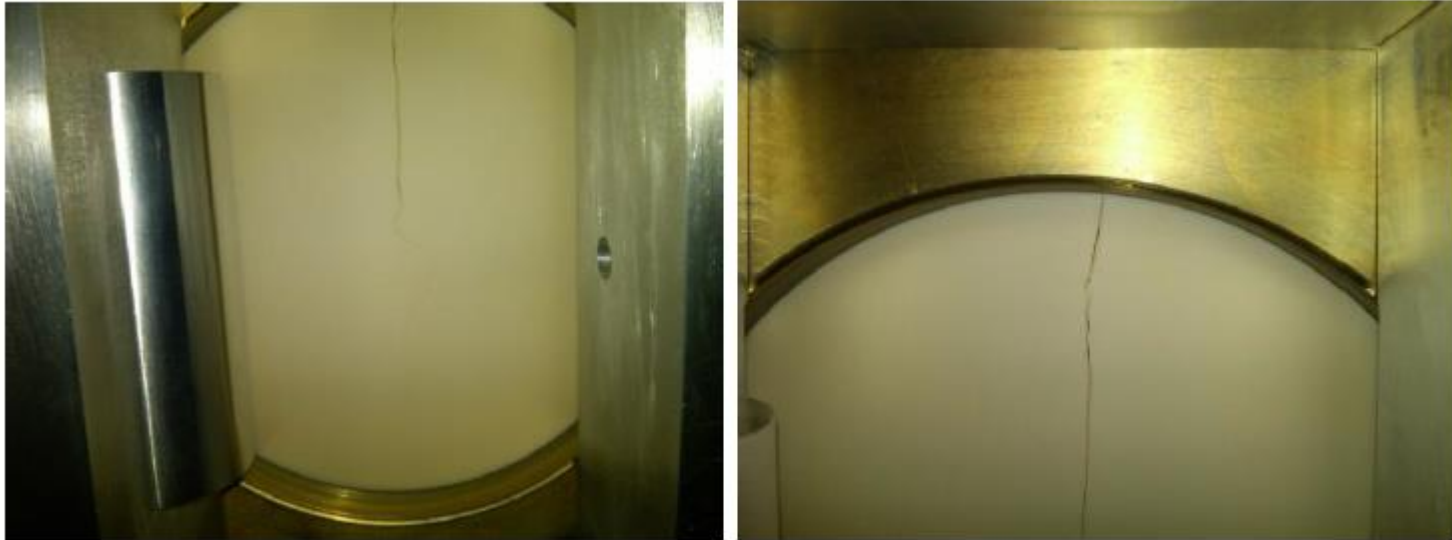
Figure 3 - CCL Window with fracture of ceramic window.

- **CCL2b window broken 11/2/07**
- **CCL3b window broken 2/3/11**
- **CCL4b window broken 1/28/12**
- **CCL1b & CCL4b windows replaced due to excessive arcing and vacuum activity July 2012**

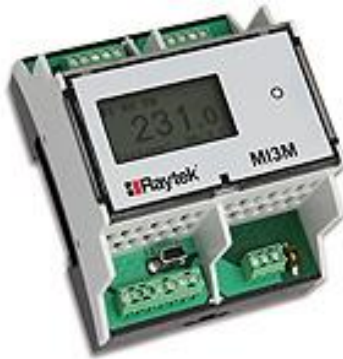
- Utilizes commercially available system
- Indirect measurement of surface window temperature
  - allows for tracking temperature changes in window
  - plan to implement interlock
- Integrated into EPICS via transmitter PLC
- Prototype system – installed on CCL3 & 4

Raytek Controller  
(in transmitter rack)

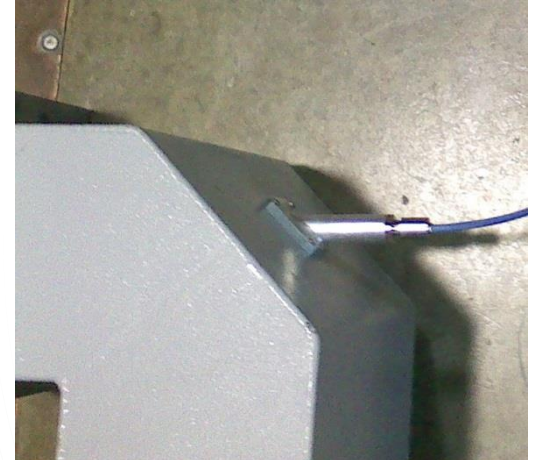
Sensor in waveguide  
(in Linac tunnel)
