Status and REX of XFEL couplers production

CERN, June 23rd 2015

Walid KAABI- LAL/Orsay

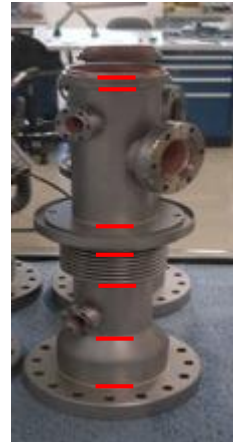
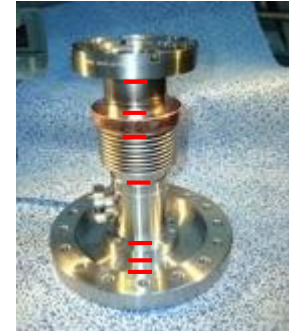
- 1st step: parts assemblies by brazing:

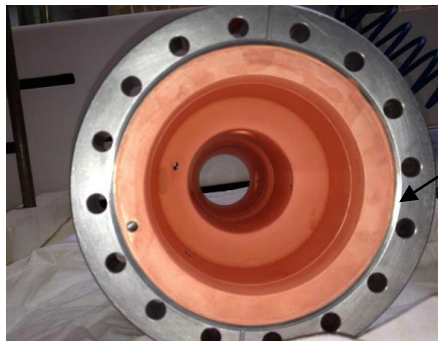
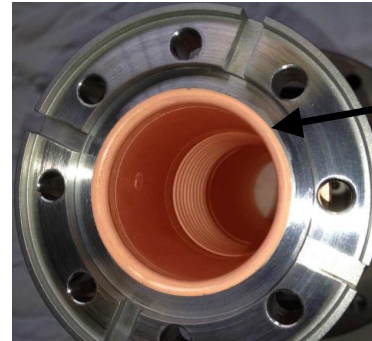
- 2nd step: RF Surfaces copper plating of the assembled parts:

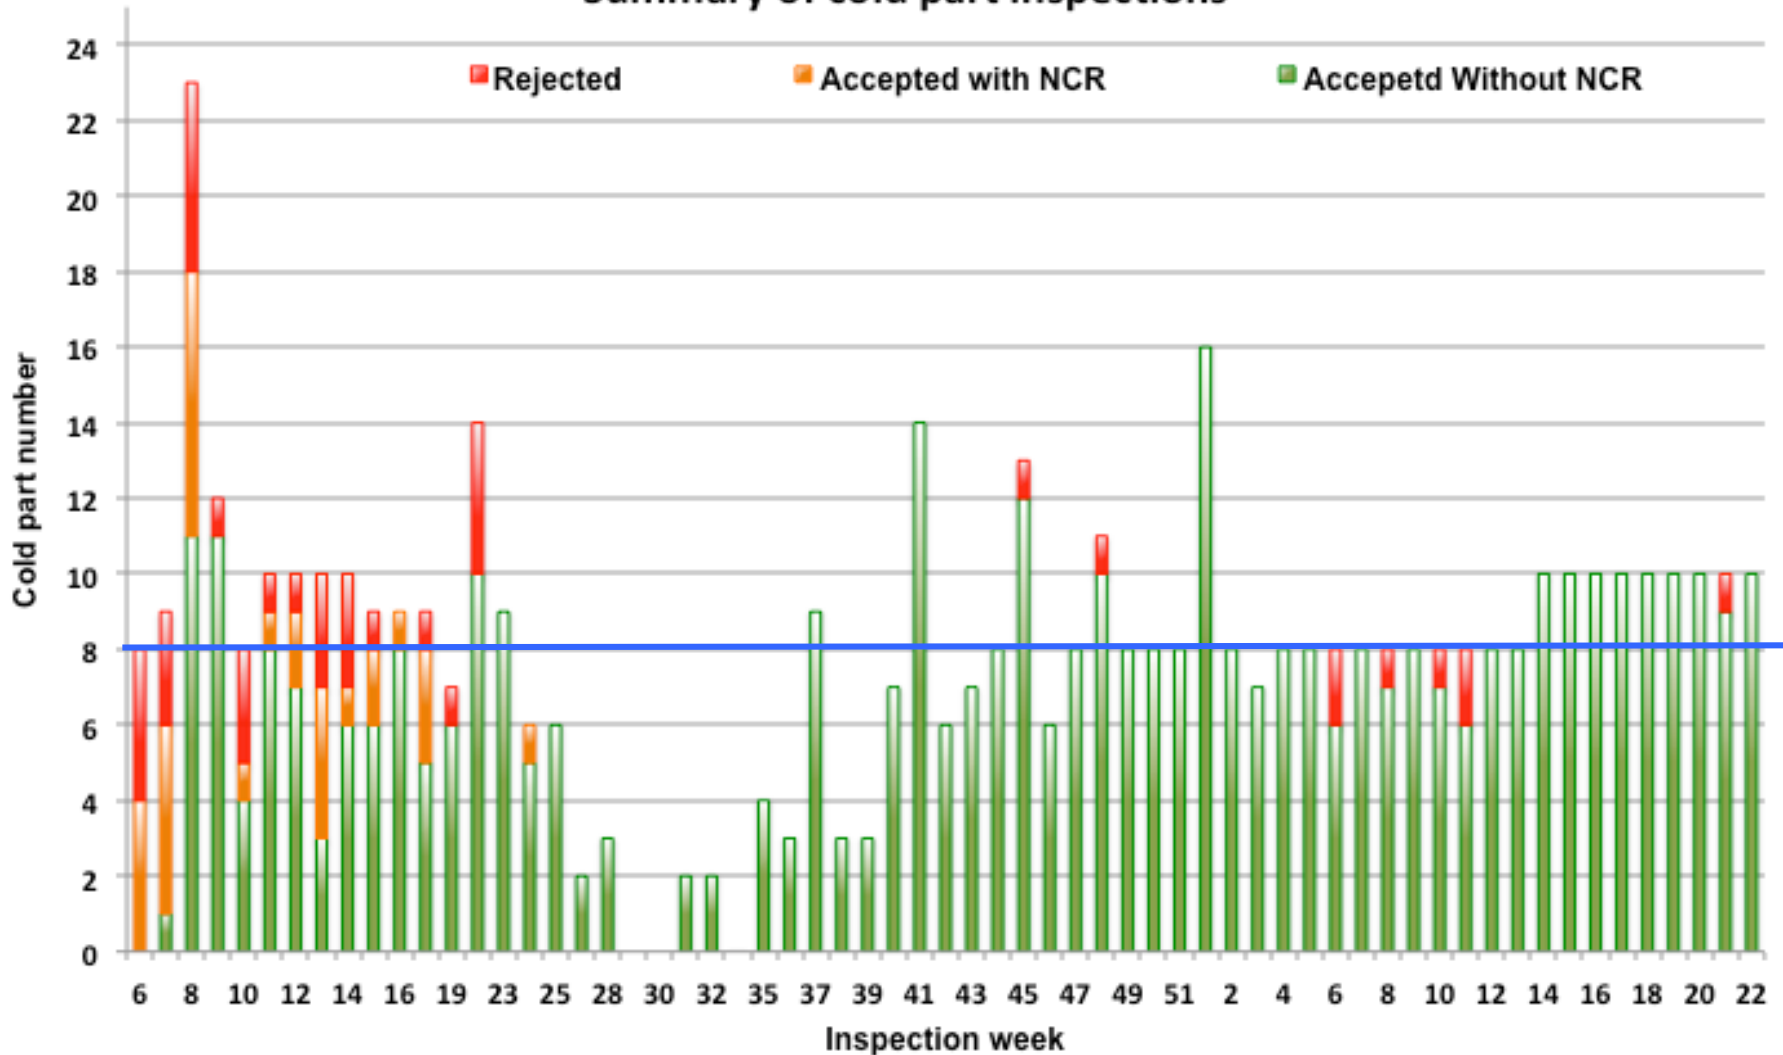
Summary of cold part inspections

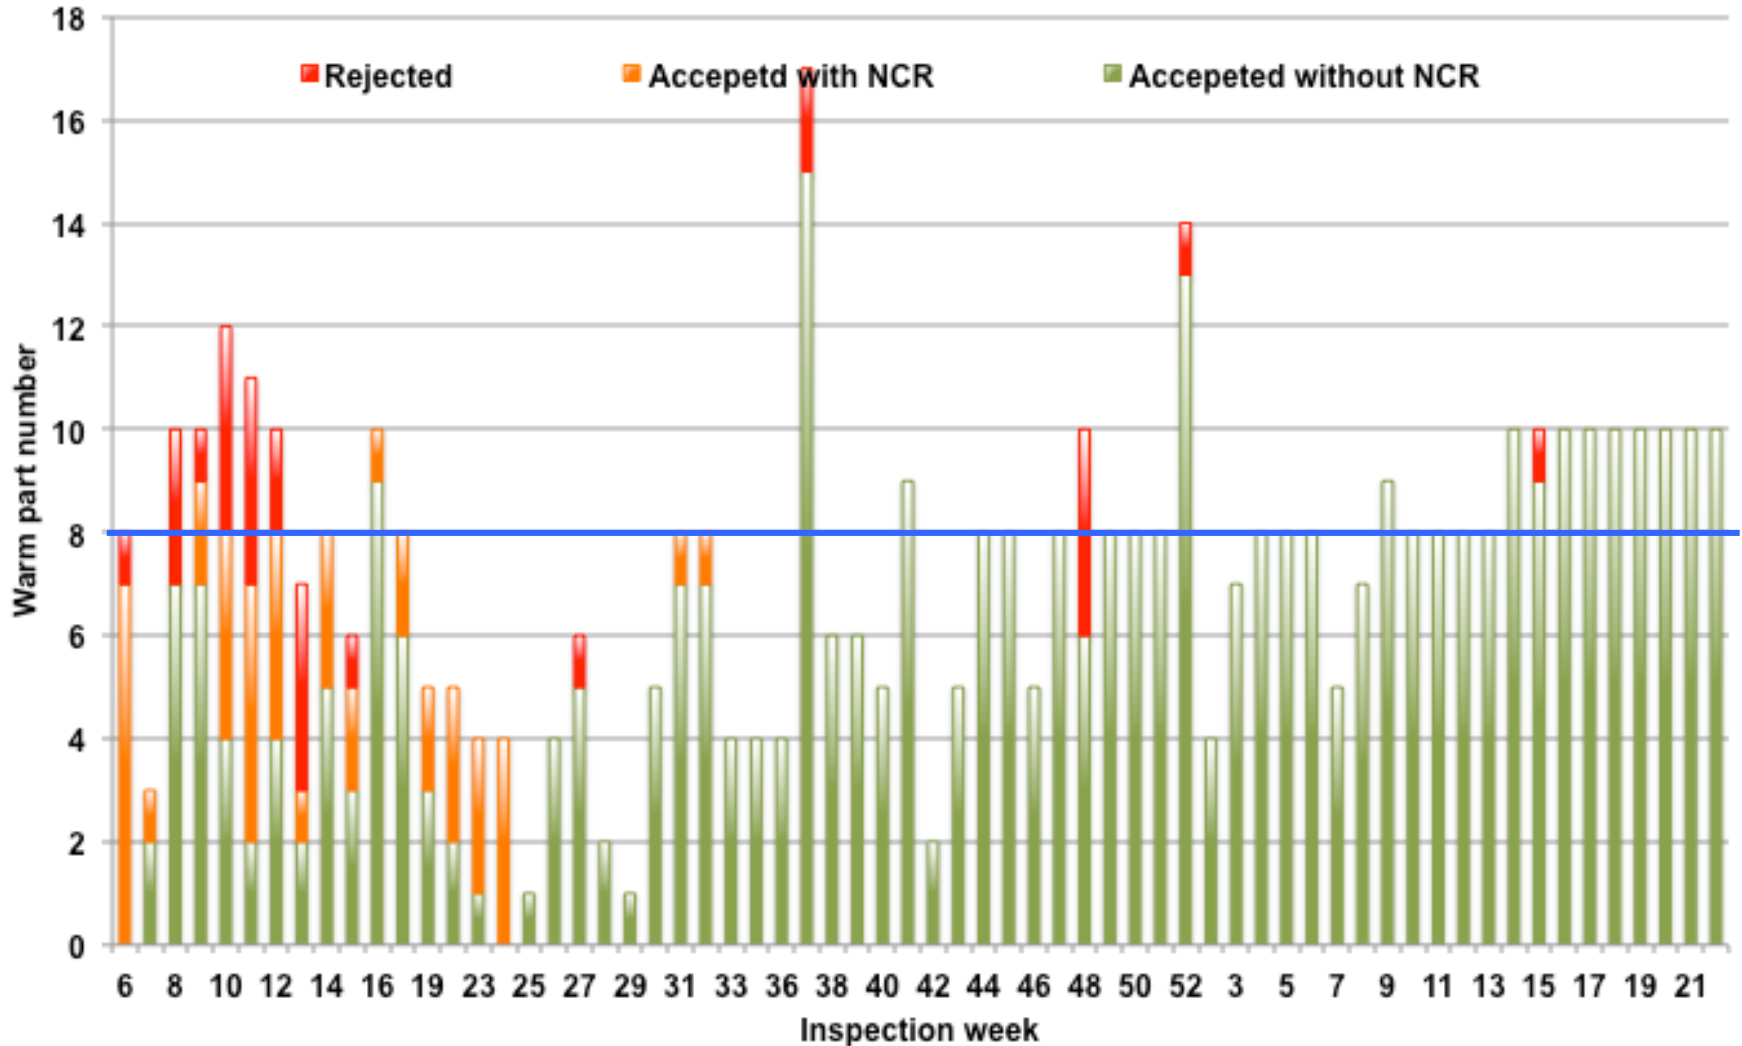
Summary of warm part inspections

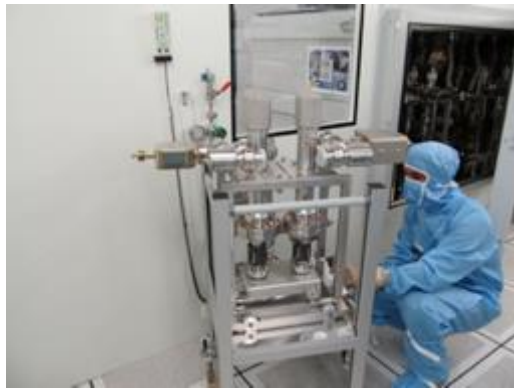
Leak test after reception

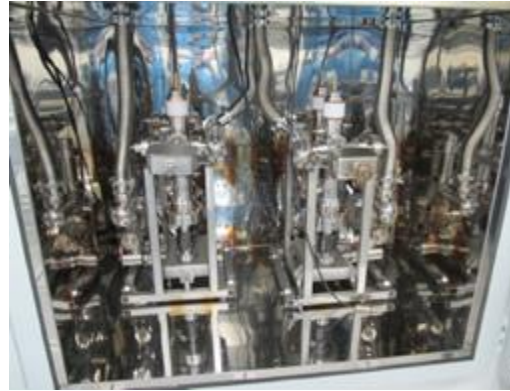
75h baking cycle at 150° C

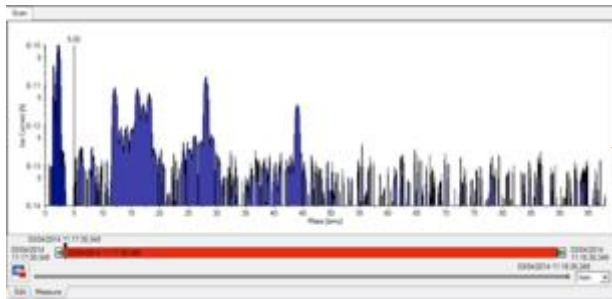
RGA spectrum recording

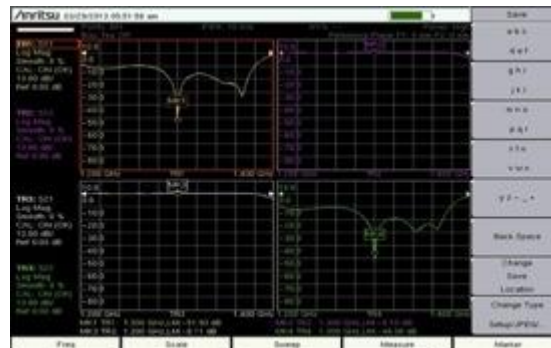
Antenna tuning

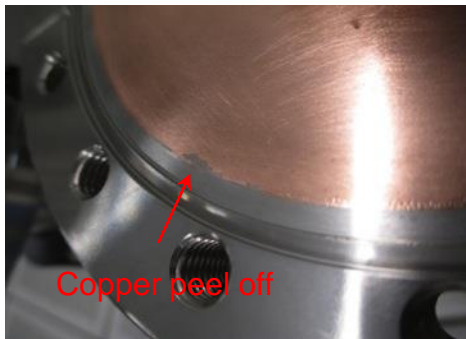
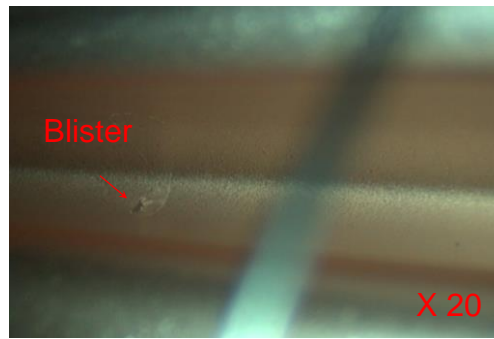
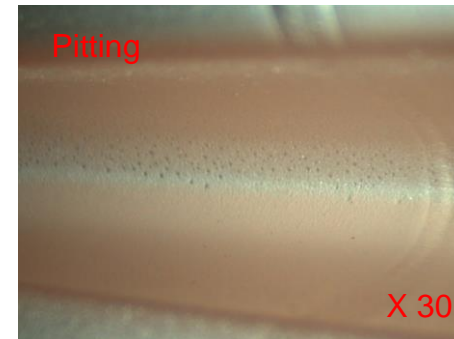
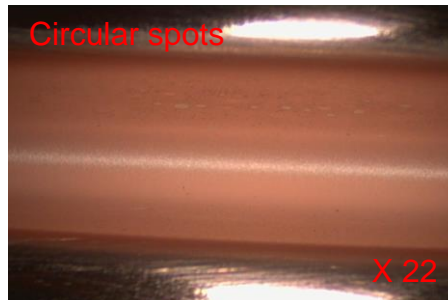
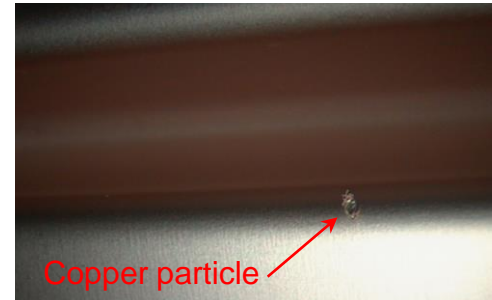
- **Copper plating defects** (mainly during ramp up phase and before production stabilization):

→ **Solved**: process improvement, setting acceptance criteria (defects classification by types, dimensions and number. Agreement in corrective actions and tests.

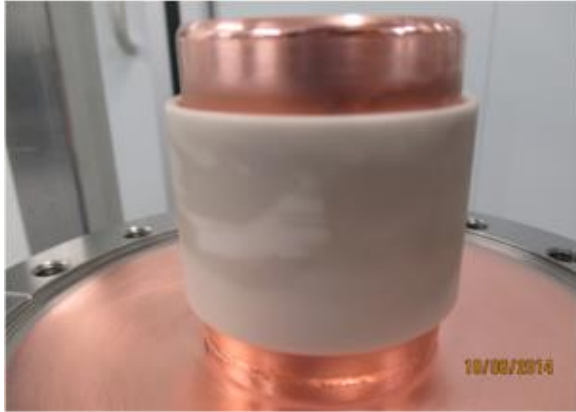
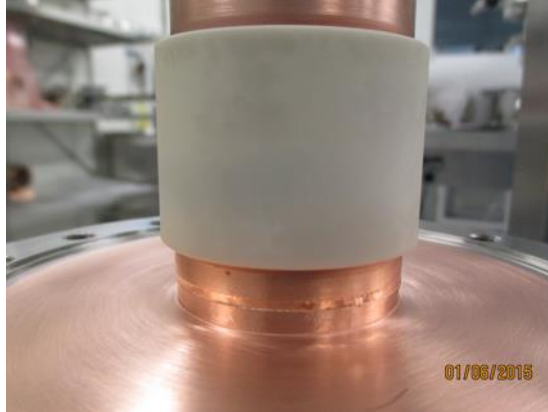
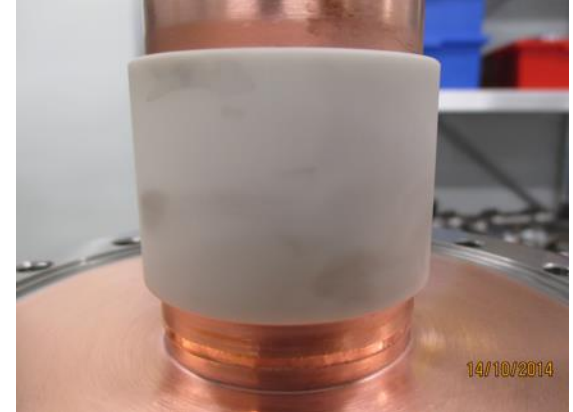
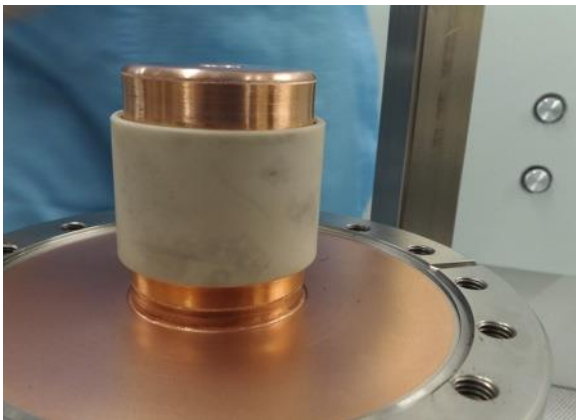
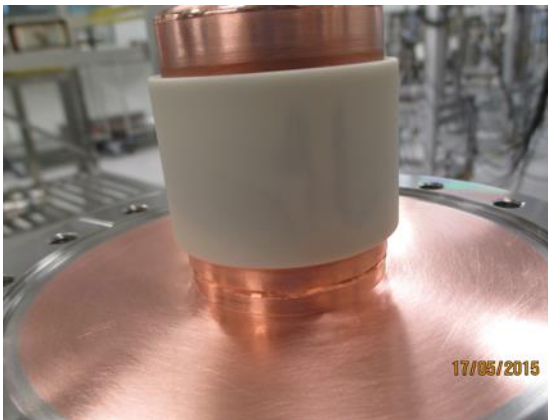
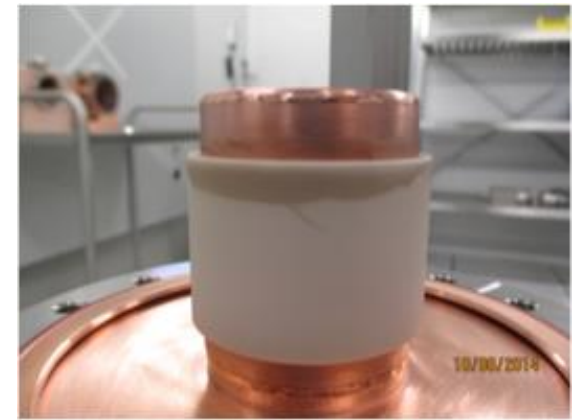
- Dark stain in the cold ceramics

→ **Not yet solved**, investigations are on going.

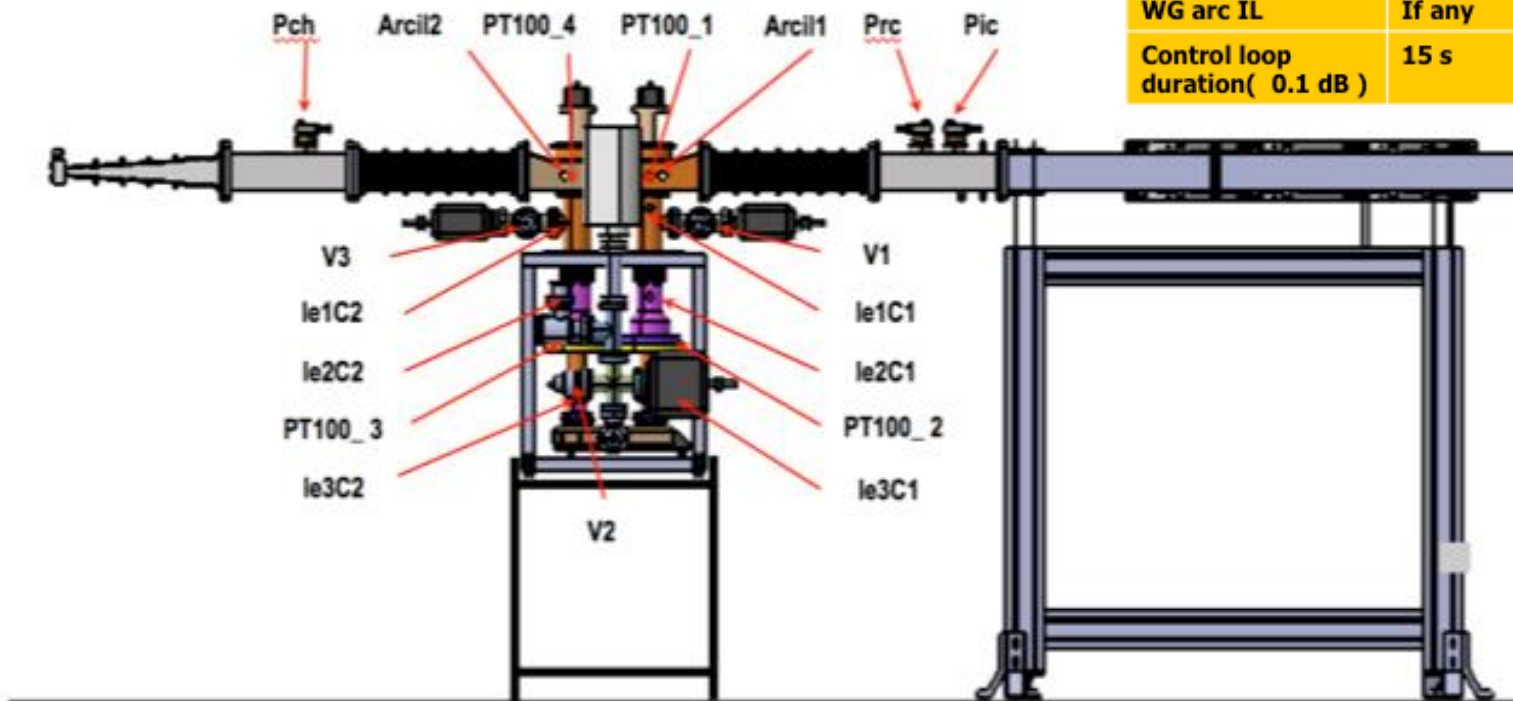
CP 331_Pair 115
Upstream coupler

Vacuum	1 st threshold (0.1 dB): SV1	$6 \cdot 10^{-7}$ mbar
	2 nd threshold (0.4 dB): SV2	$2 \cdot 10^{-6}$ mbar
	Interlock: IL	$5 \cdot 10^{-6}$ mbar
e- current IL	8 mA	
Light IL	none	
Ceramic Temperature IL	60°C	
WG arc IL	If any	
Control loop duration(0.1 dB)	15 s

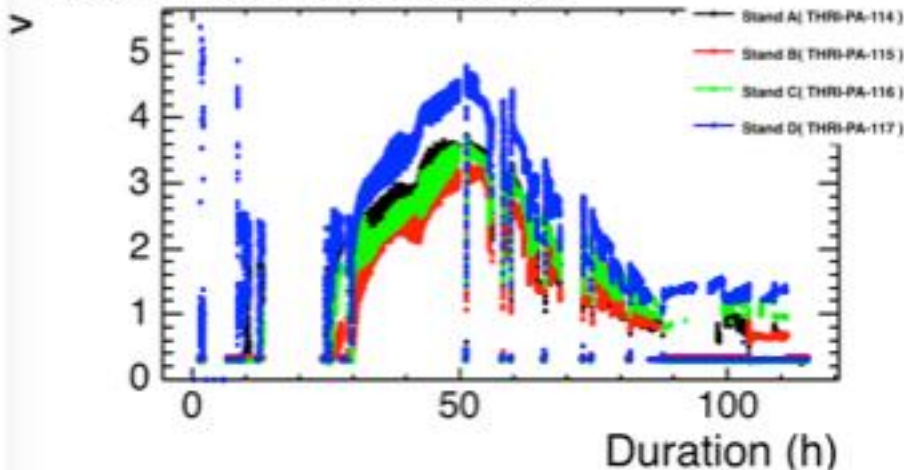
Conditionnement : 261 → Pickup (le1C1), All steps

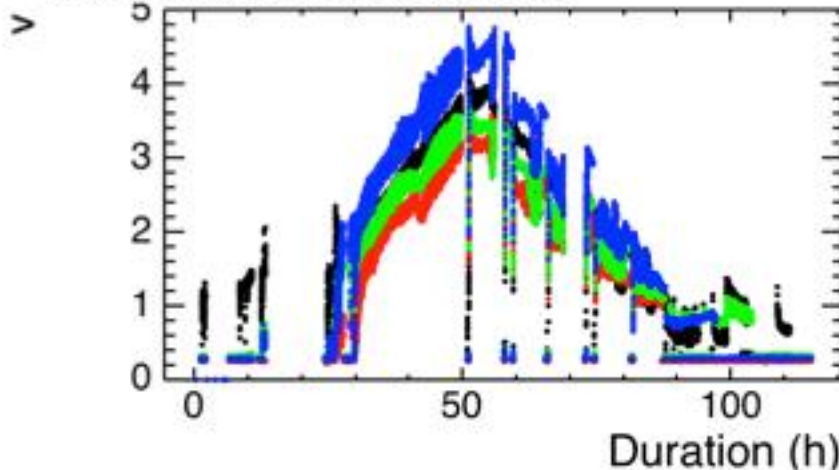
Conditionnement : 261 → Pickup (le1C2), All steps

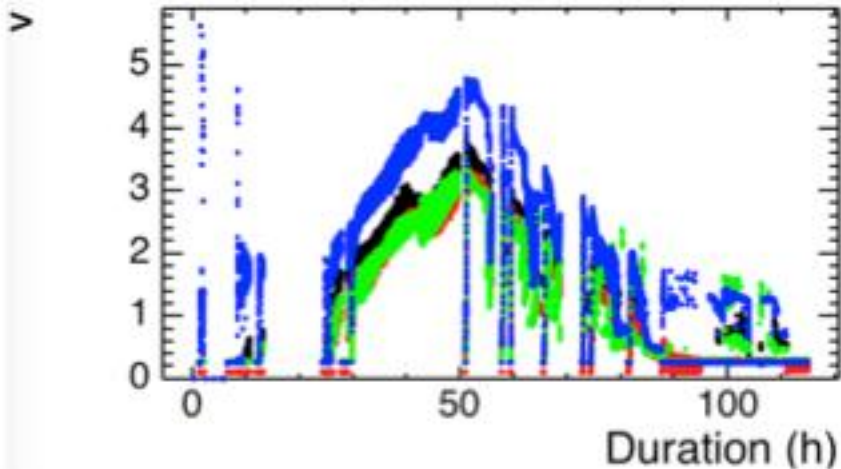
Conditionnement : 261 → Pickup (le2C1), All steps

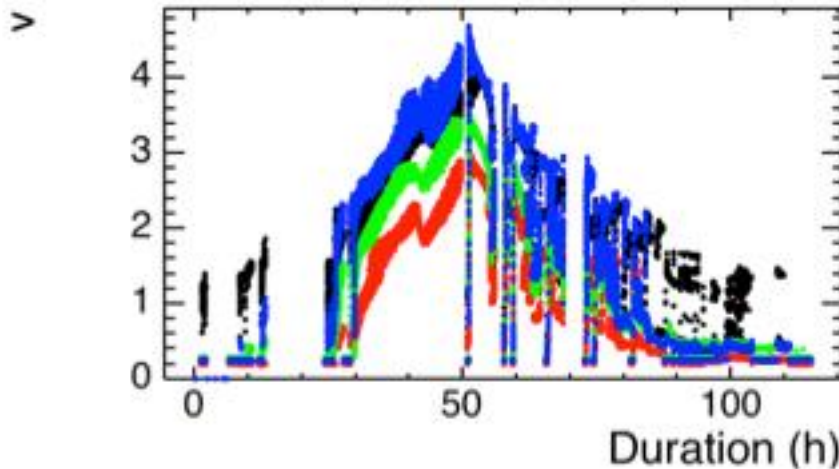
Conditionnement : 261 → Pickup (le2C2), All steps
