RF surface aspects at power couplers

Wolf-Dietrich Möller

Fundamental Power Coupler Workshop
June 23 – 24, 2015, CERN, Geneva

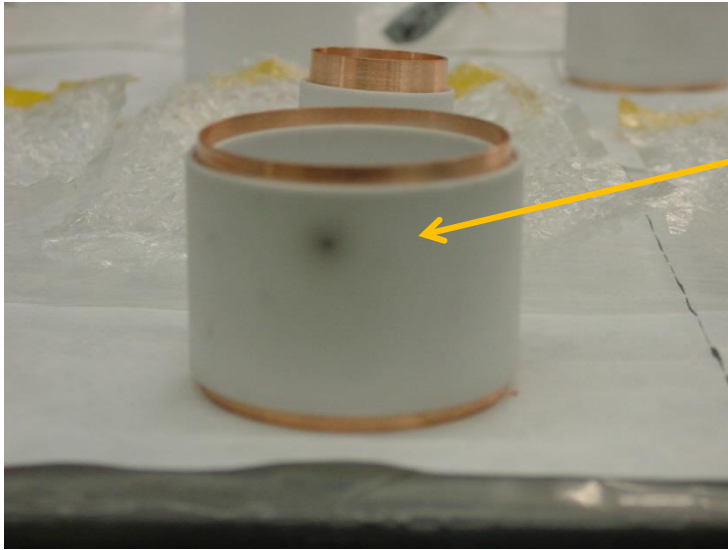
Ceramic inspection after brazing, before TiN coating

Appeared after brazing, is inside the material and cannot be removed by surface sand blasting

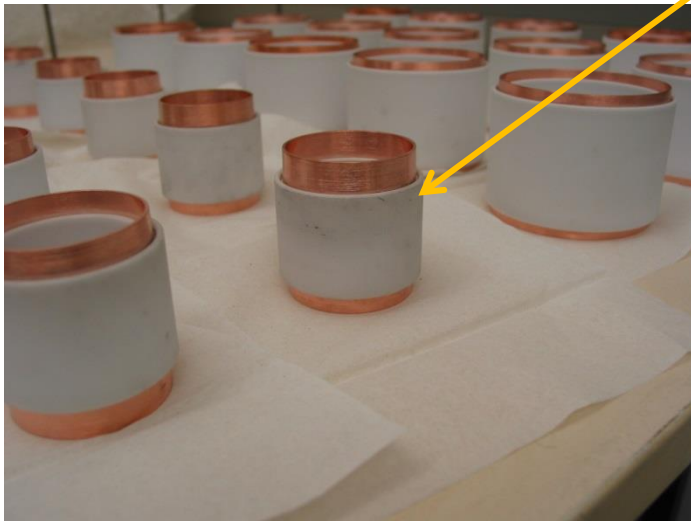
Appeared after brazing on surface, can be removed by sand blasting

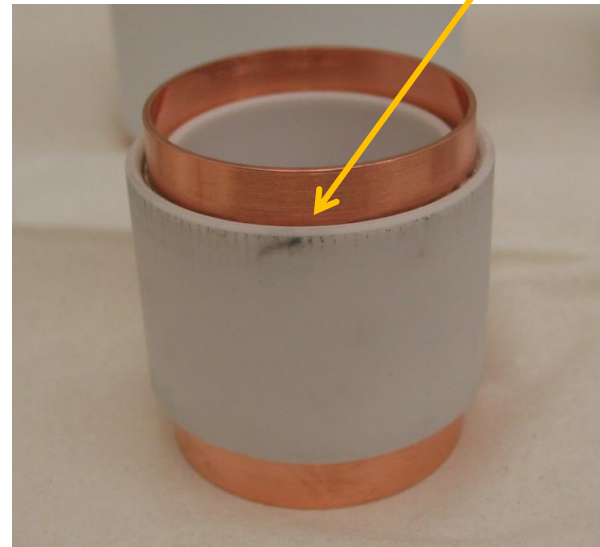
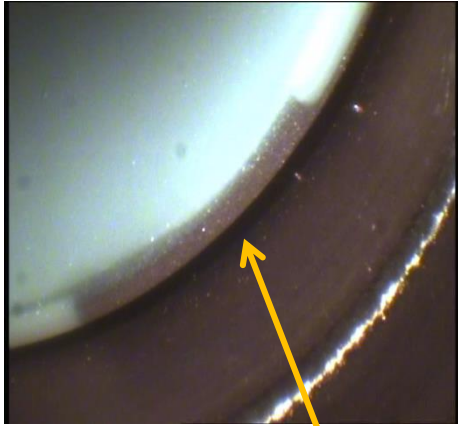
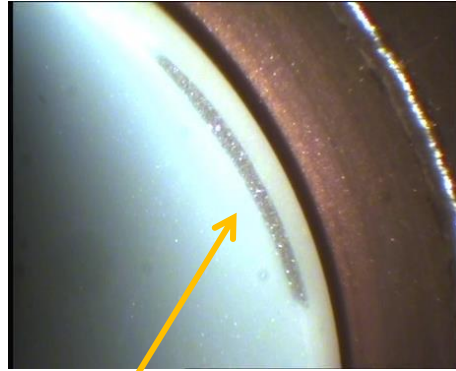
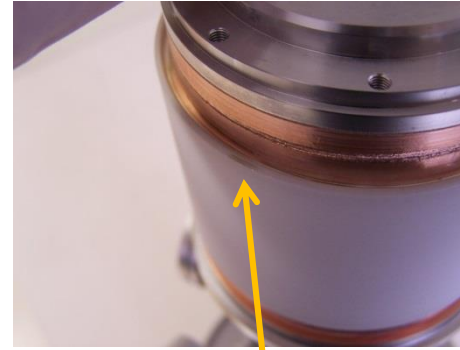
Ceramic inspection after e-beam welding

No TiN – can be sand blasted

Copper evaporation from e-beam welding,
Cannot be removed because TiN would be damaged

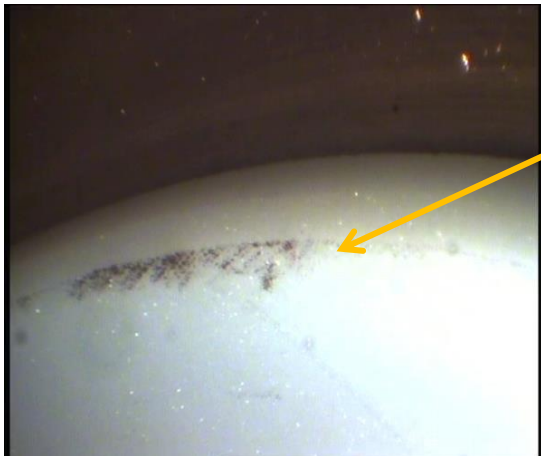
Metallic
residues from
friction with
tooling

- Can be sand blasted when not TiN coated
- Otherwise ceramic replacement

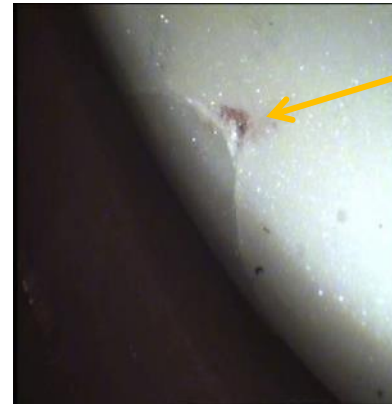
Edge broken,
ceramic has to
be replaced

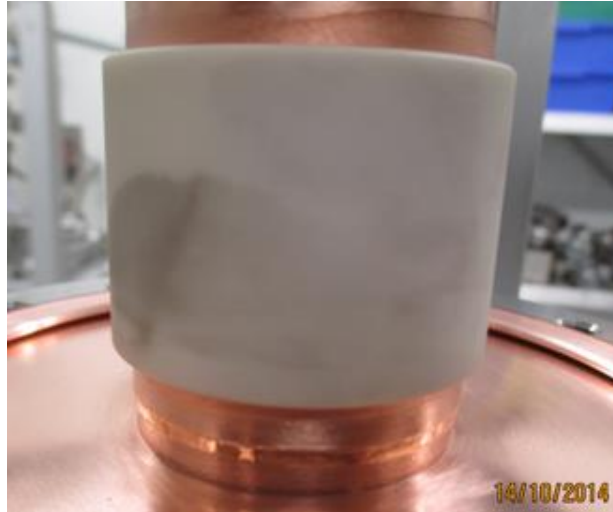
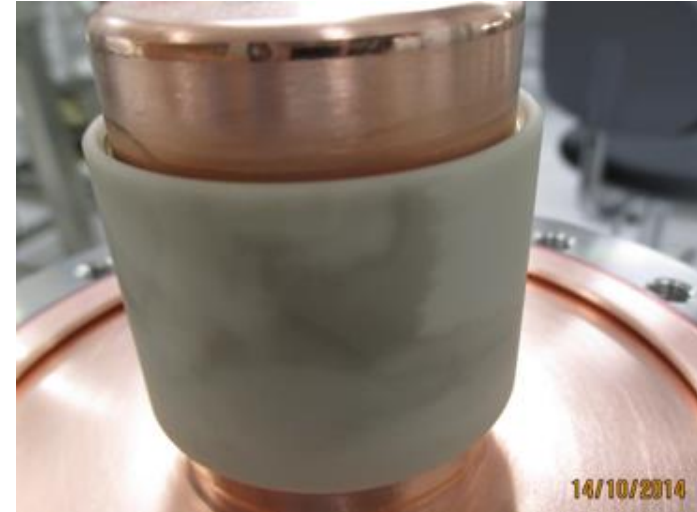
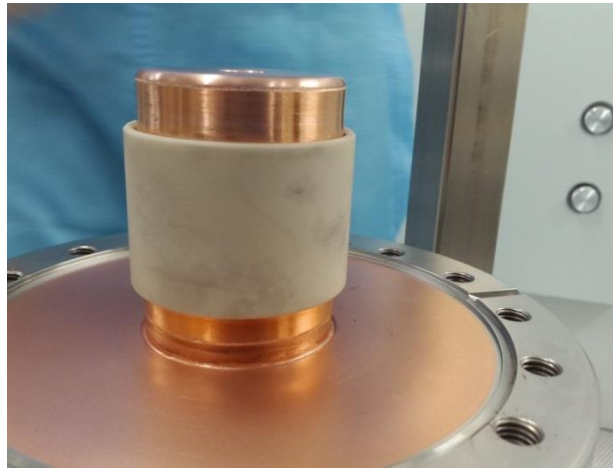
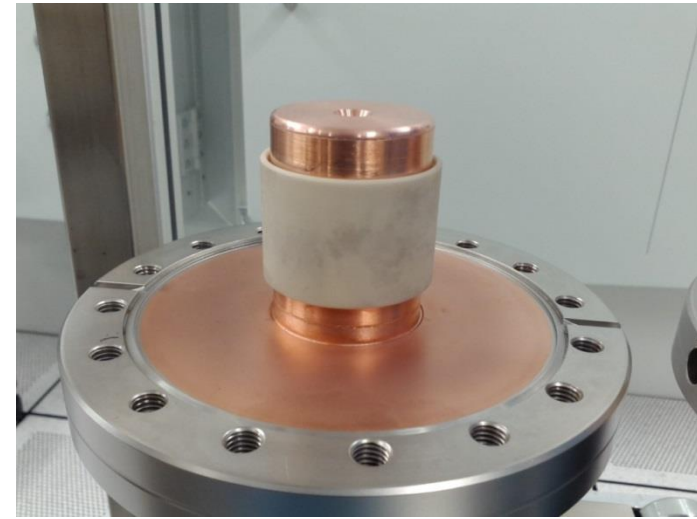
Ceramics after RF operation

- After RF conditioning on test stand
- Dark stains
- Origin unknown
- Analysis underway

Ceramic must be replaced

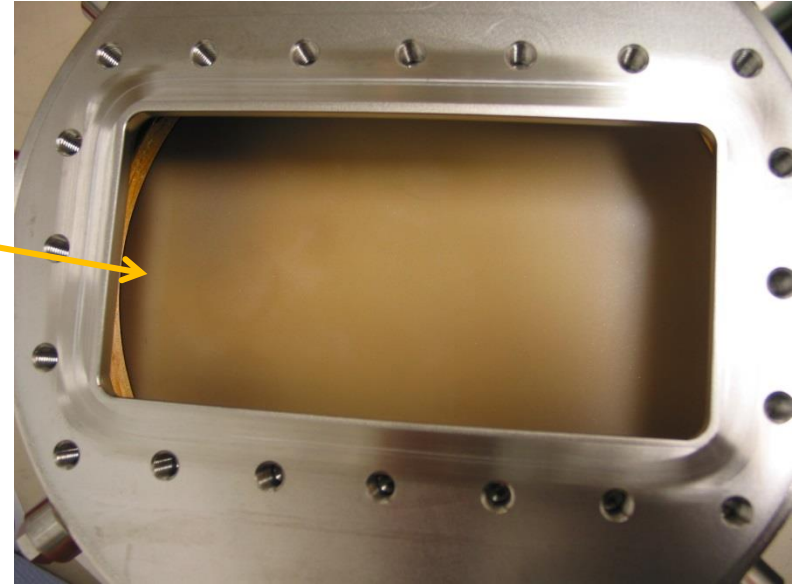
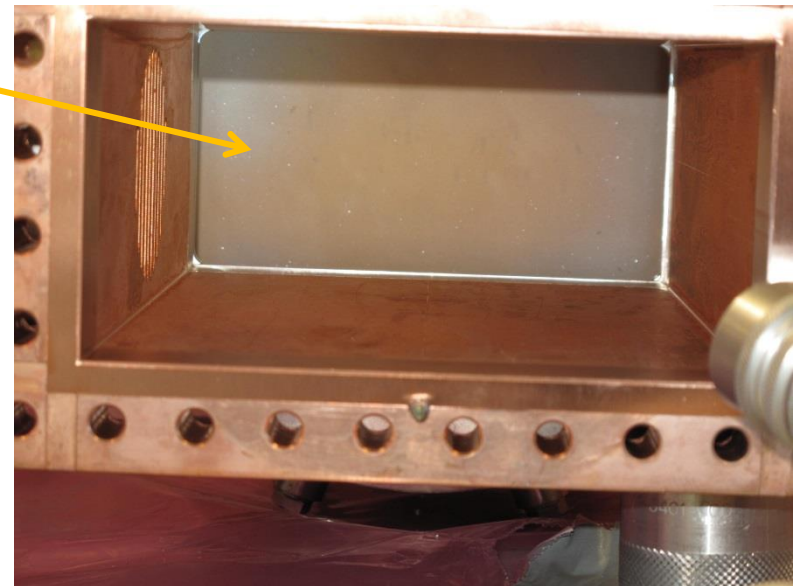
Wave guide window after years of operation

- Brown discoloration due to X-ray
- Gray discoloration unknown, no electrical resistance

Can be used without restrictions

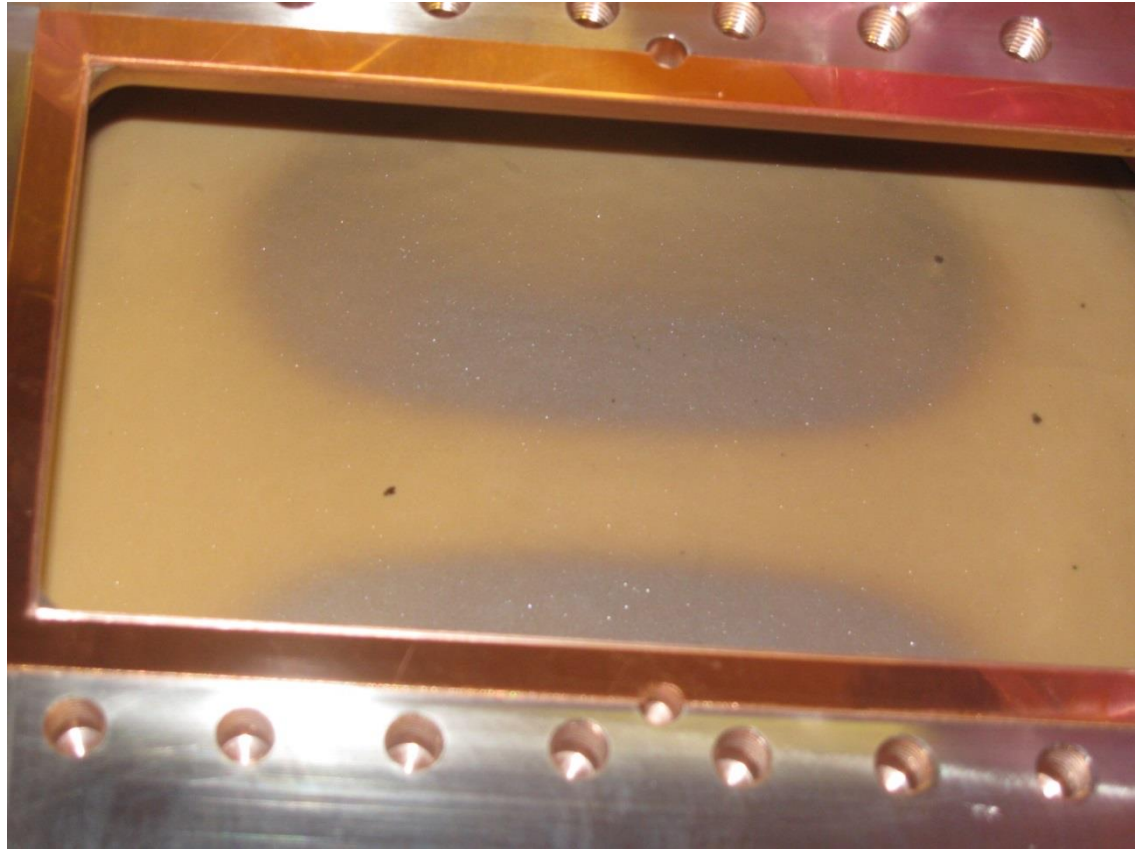
Wave guide window after month of operation

- Strong vacuum and light activities
- Gray discoloration unknown, brown comes from X-ray
- no electrical resistance measured (measurement days after disassembly)
- No increase of thermal heating observed

Looks like metallization => window was exchanged,

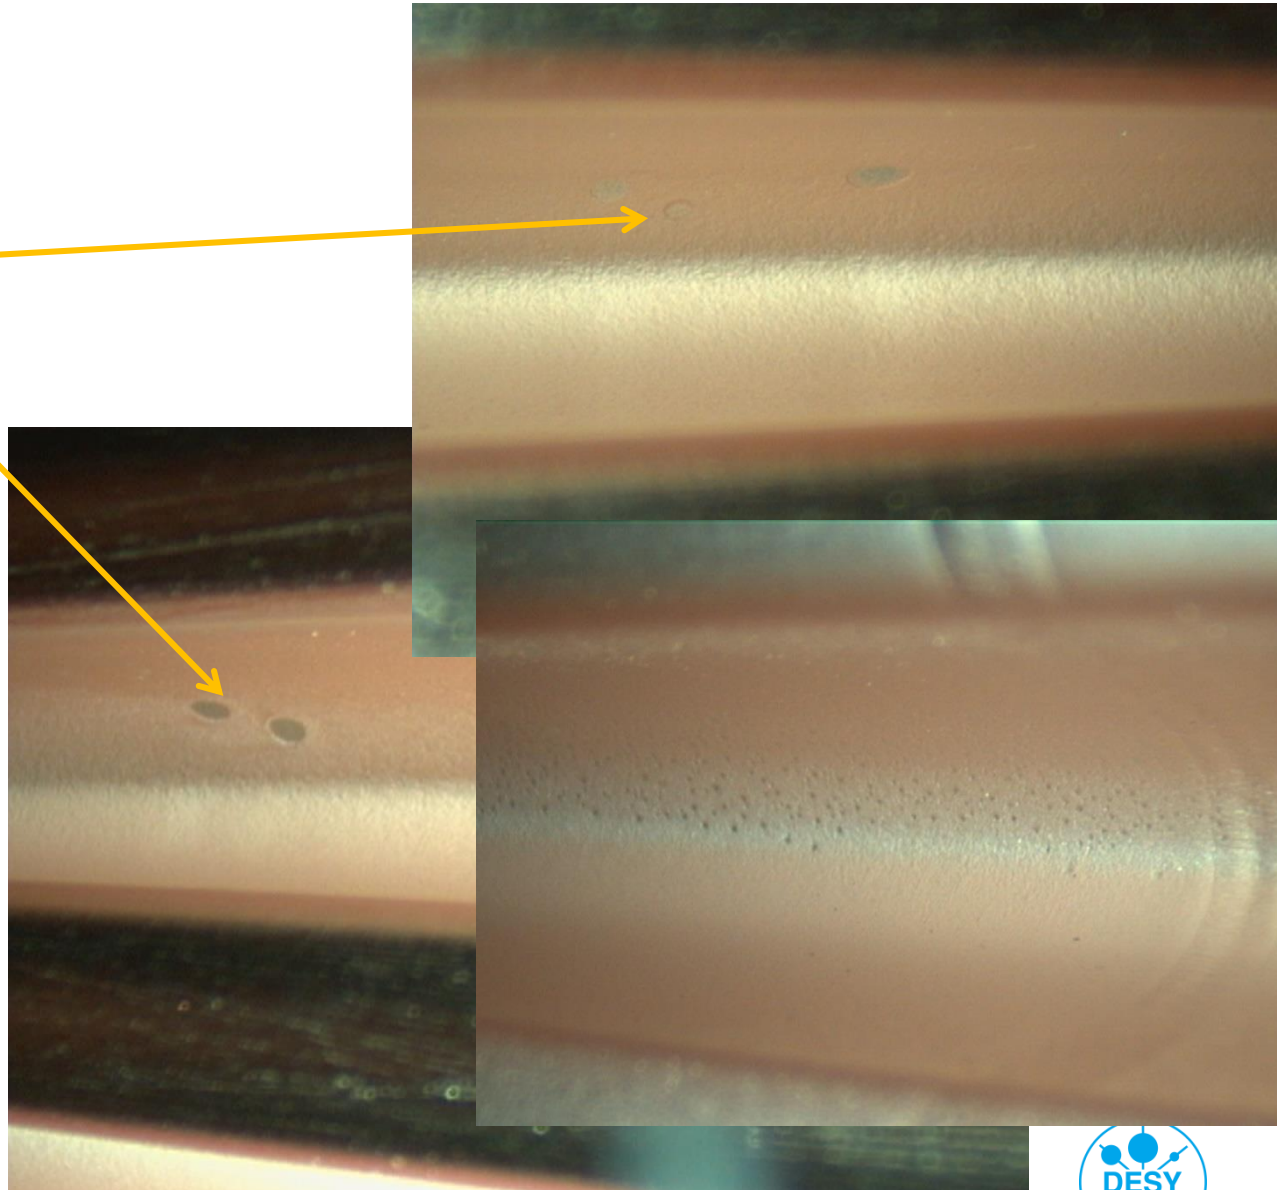
Bellow valley

- Circular defects
 - With copper
 - Without copper
 - Multiple holes

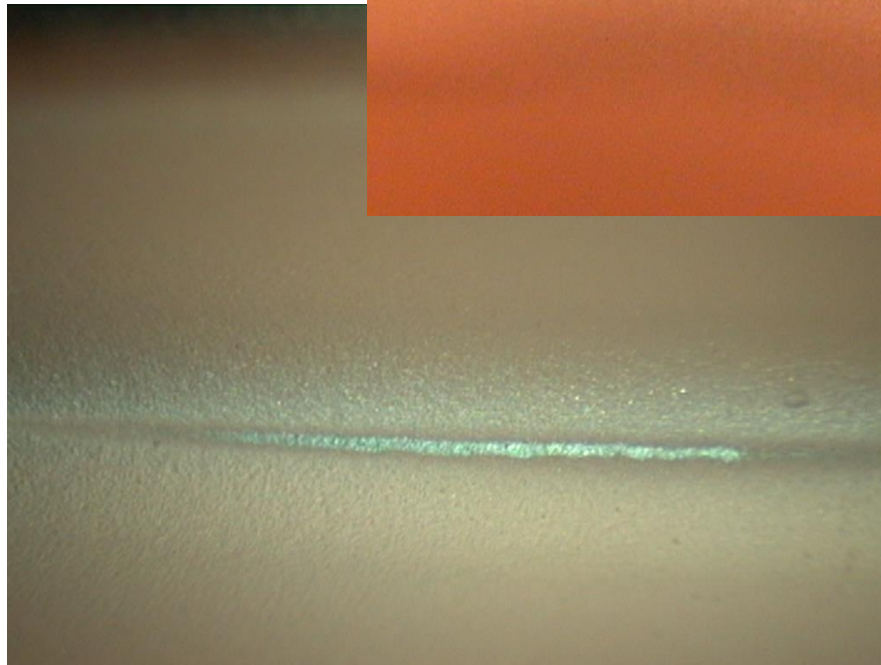
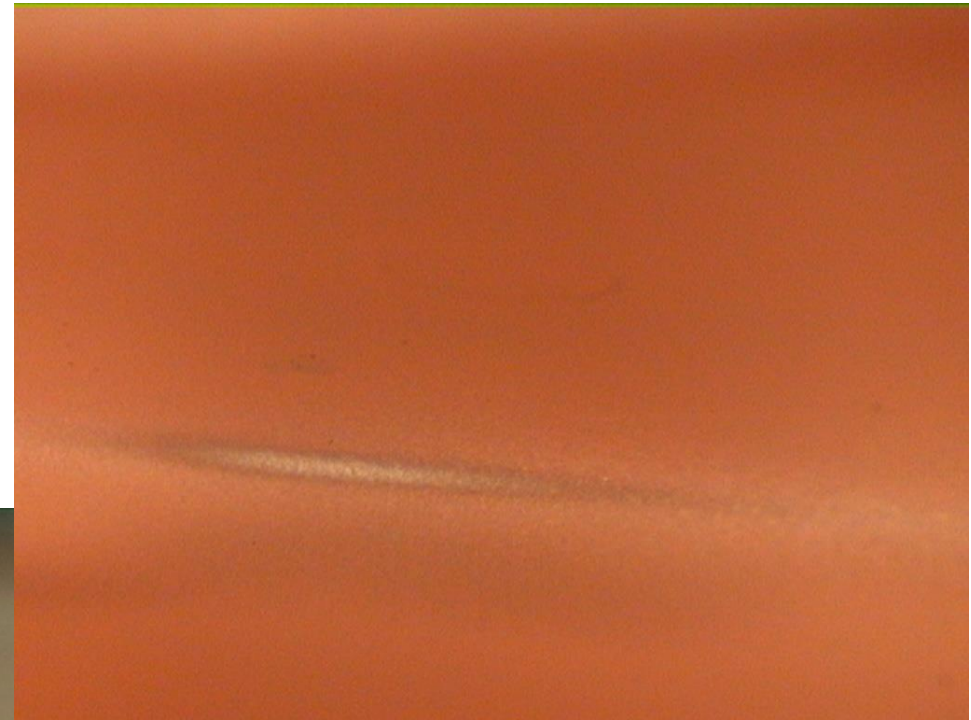
Bellow valley

- missing copper

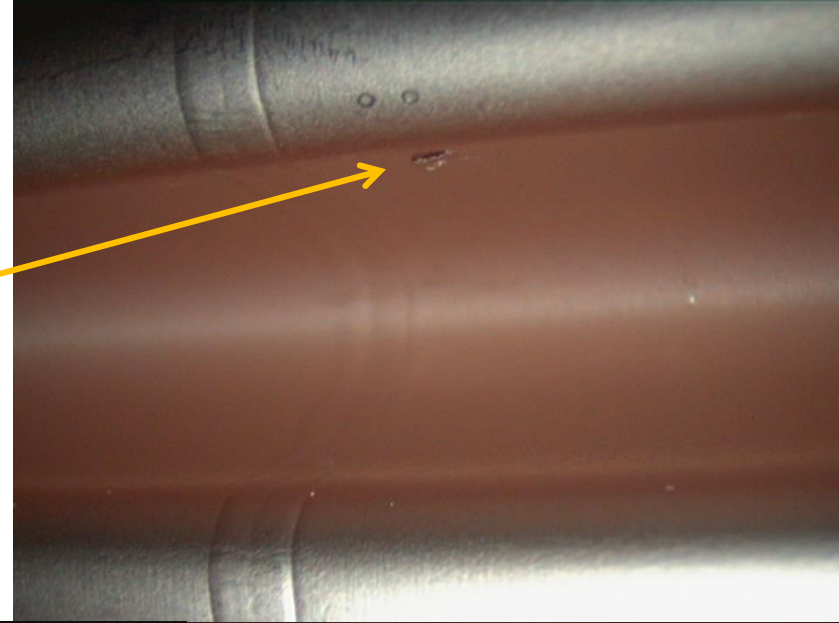
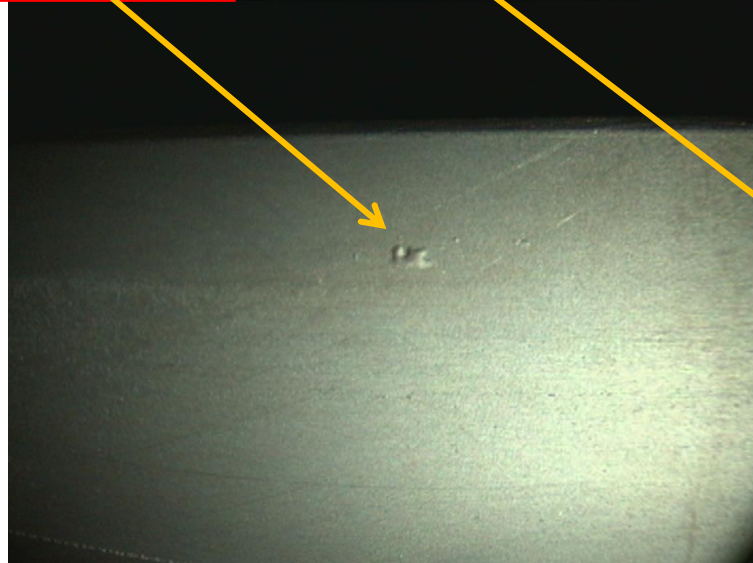
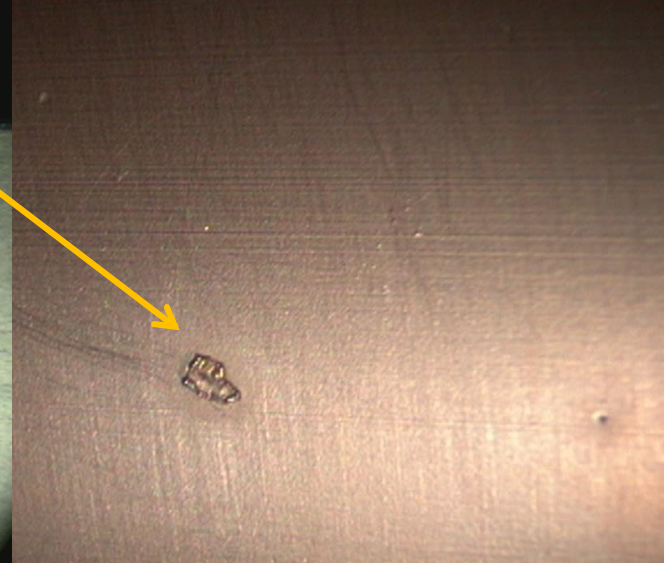
Bellow valley

- Particles on surface and embedded

- Loose particles and sharp edges => not accepted
- Some could be removed
- Embedded particles with soft edges are accepted

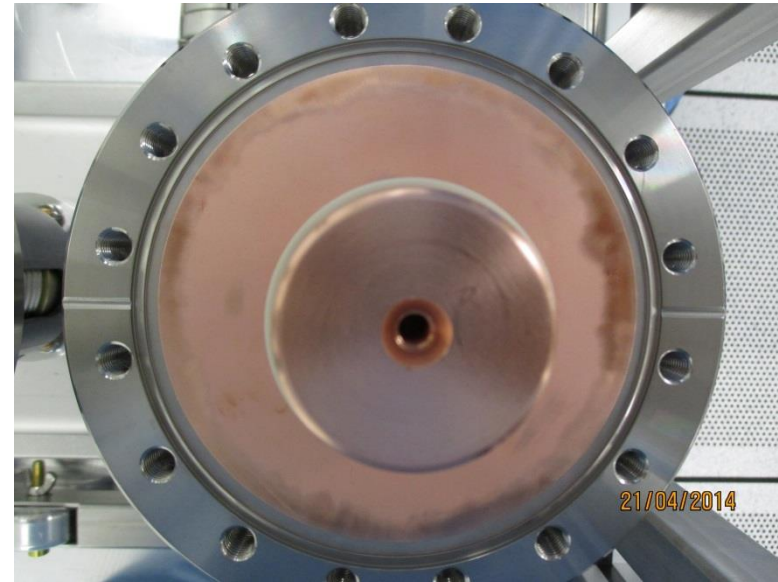
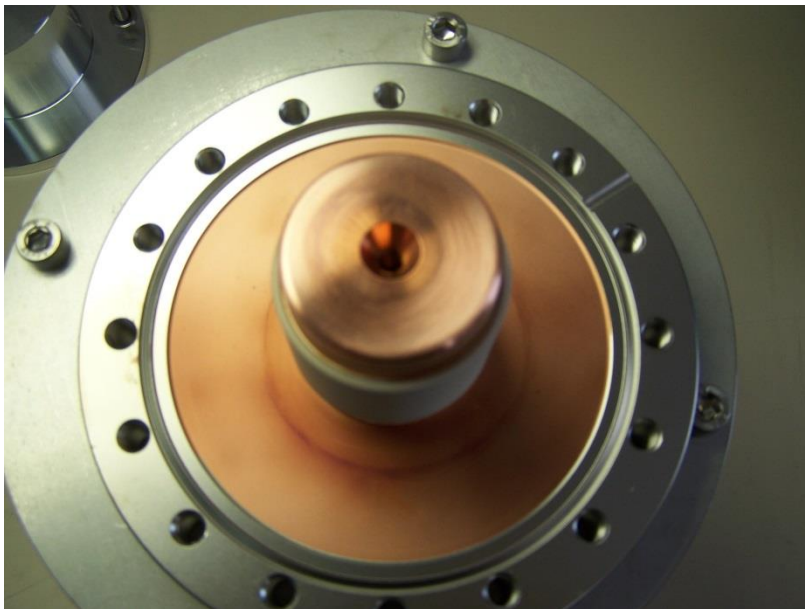
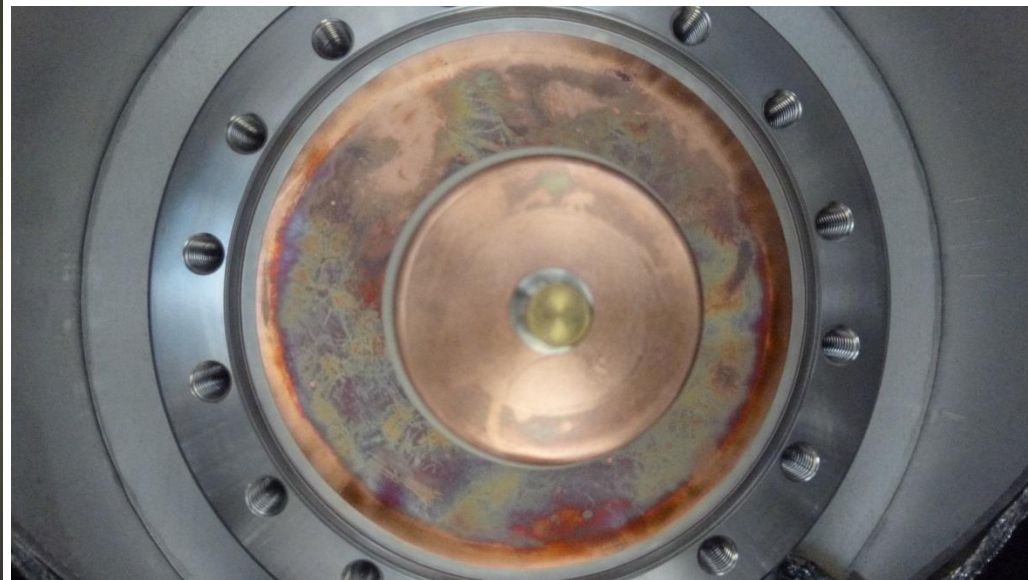
Copper plating after RF conditioning

- Discoloration on copper
- Can be removed by citric acid => must be CuO
- RGA is OK

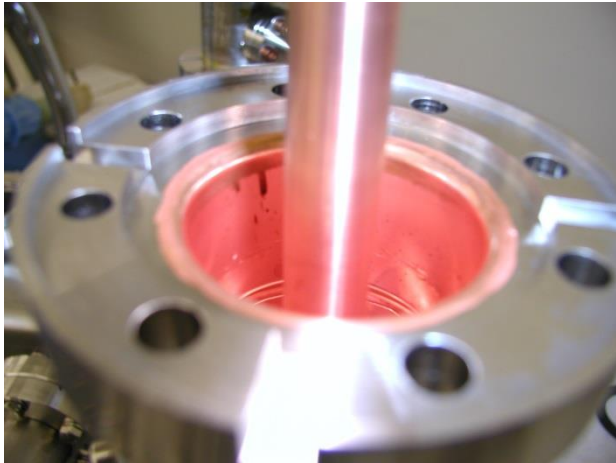
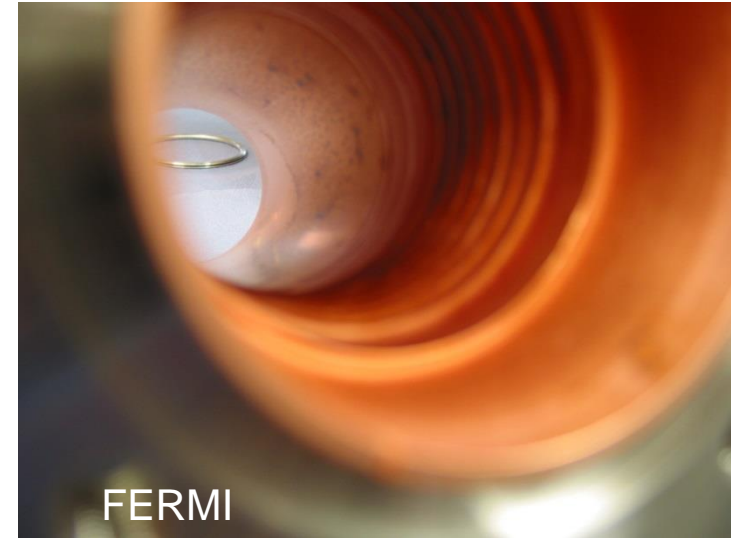
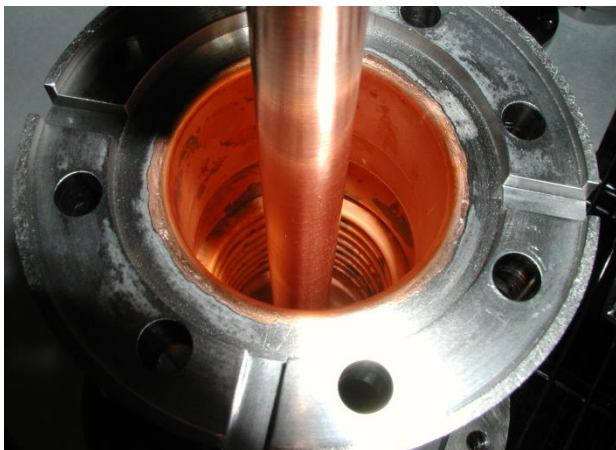
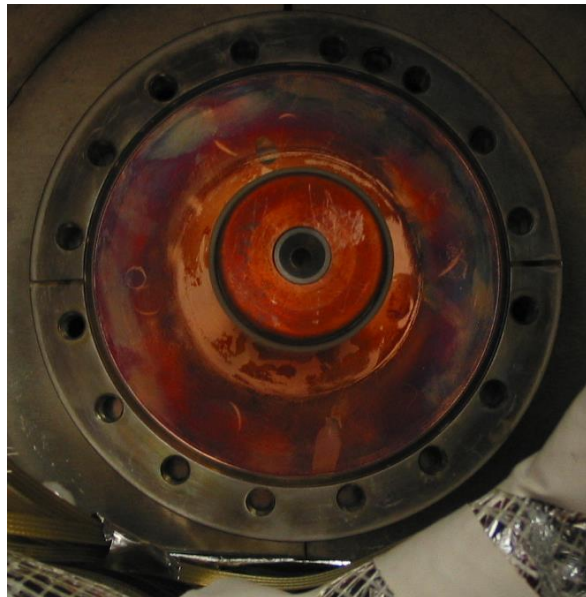
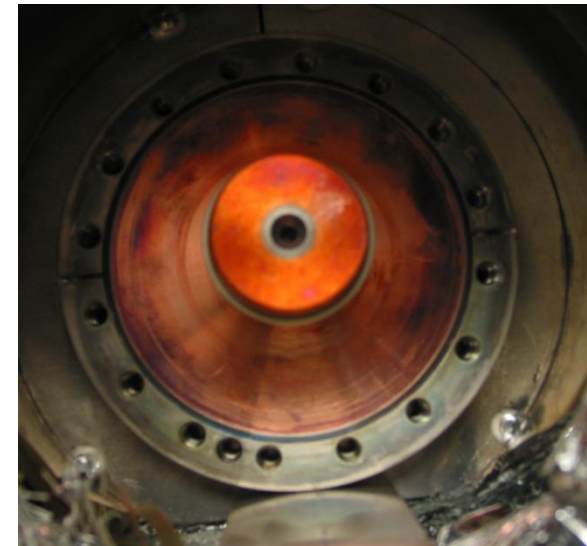
Copper plating after RF operating in modules (FLASH)

- Many stains and discolorations
- No restrictions during operation
- No hints in RGA
