The CMS Phase 1 Upgrade: Forward Pixel Detector Mechanical Support and Cooling

Maral Alyari on behalf of FPix Mechanics Group

38th INTERNATIONAL CONFERENCE ON HIGH ENERGY PHYSICS | AUGUST 3-10, 2016 | CHICAGO

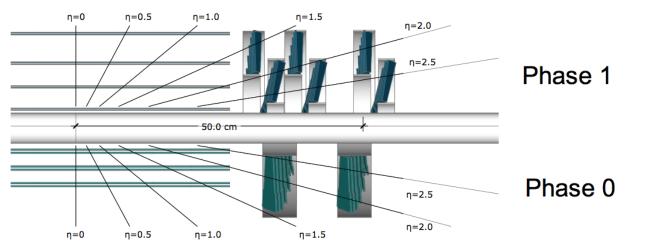
Mechanics Design Motivation

- Reduced material per disk compared to Phase 0 even with an additional disk
- Easier production and maintenance

Higher instantaneous luminosity causes unacceptable dynamic inefficiencies due to buffer overflows. The more complex track pattern recognition due to higher pileup require an additional pixel detector layer to maintain good efficiency. The Phase 1 pixel detector replacement addresses these shortcomings

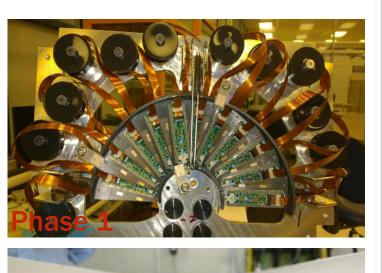
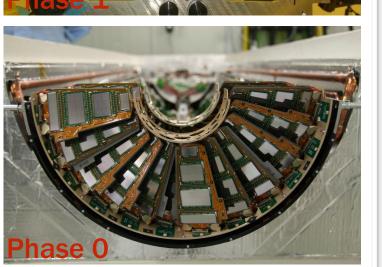
Rear Section

4 Half Cylinder Support tubes

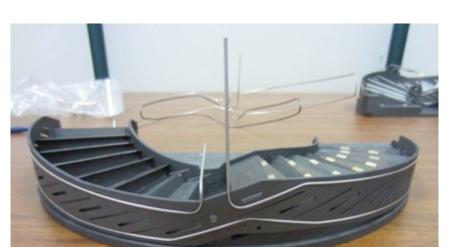
Half Disk Production

- 110 TPG panels (Thermal conductivity to 4 times copper)
- Drill holes to aid encapsulation
- Encapsulation with CF layer and laminate grounding mesh
- Cut into blades

Machined graphite rings with grooves;

316L stainless steel seamless tubing;

Stainless steel tubes for CO2

304L VIMVAR coupling parts

Glued TPG blades

Carbon fiber facing

- **Bond blades to graphite rings** Bend cooling tubes to shape
- Embed cooling tubes in graphite rings and glue CF
- Coat TPG blades and all faces of graphite/CF facing with

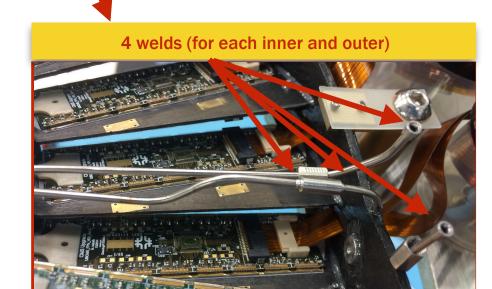
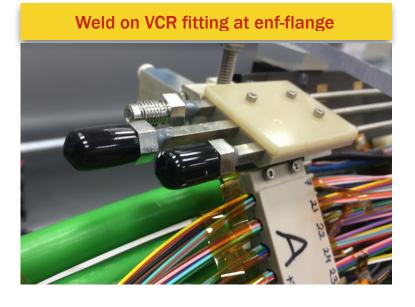
Location of FPIX Welds

- 6 stainless steel CO₂ cooling loops/HC (supply-HD-return)
- 8 Welds per loop 48welds/HC, 192 welds in FPIX

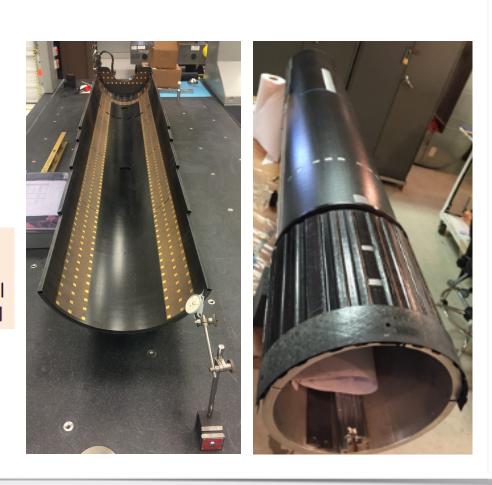
Half Cylinder Production

Tubing are installed prior to electronics integration

As purchased nominal tube sizes: HD tube: 1.65 mm OD, 0.10 mm thick wall Supply tube: 2.41 mm OD, 0.13 mm thick wall Return tube: 3.07 mm OD, 0.20 mm thick wall

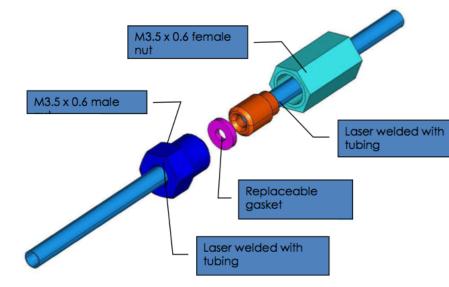
CO2 Removable Coupling Design

Based on proven VCR metal sealing technology of commercial part
