# Quench performance 11T model magnets

Gerard Willering  
CERN, TE-MS-C-TF  
23-09-2015

# Training of the 3 models

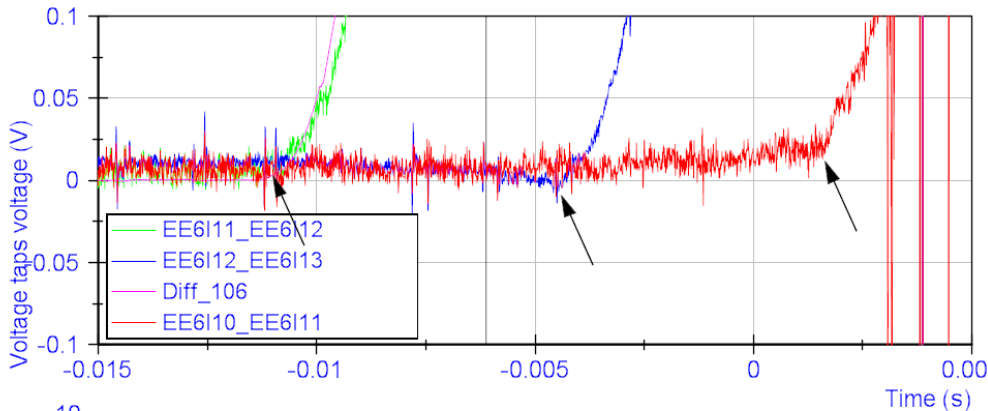
# Quench localisation with pickup coils

Very good agreement between the results for quench localisation. Possibly more info can be extracted.

This will be a new standard measurement for the next series of tests,

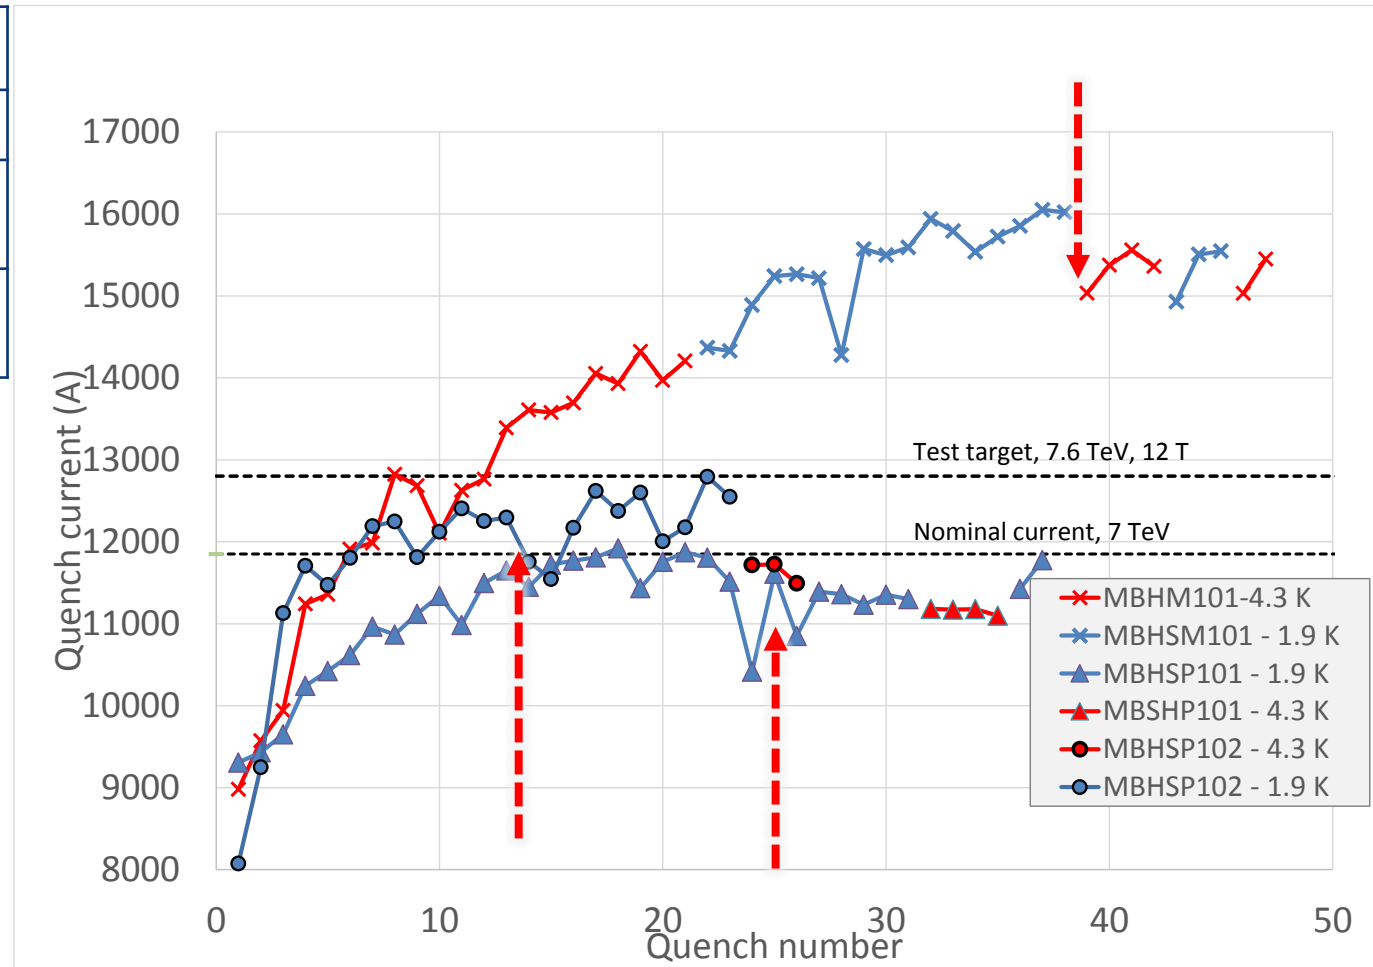
Name	Coils	$I_{ss}^*$
MBHSM101	105	16.7
MBHSP101	106	14.5
	<b>107</b>	14.4
MBHSP102	<b>106</b>	14.5
	108	14.8

$I_{ss}$  calculated by Susana with Roxy with extracted strand data from Bernardo.

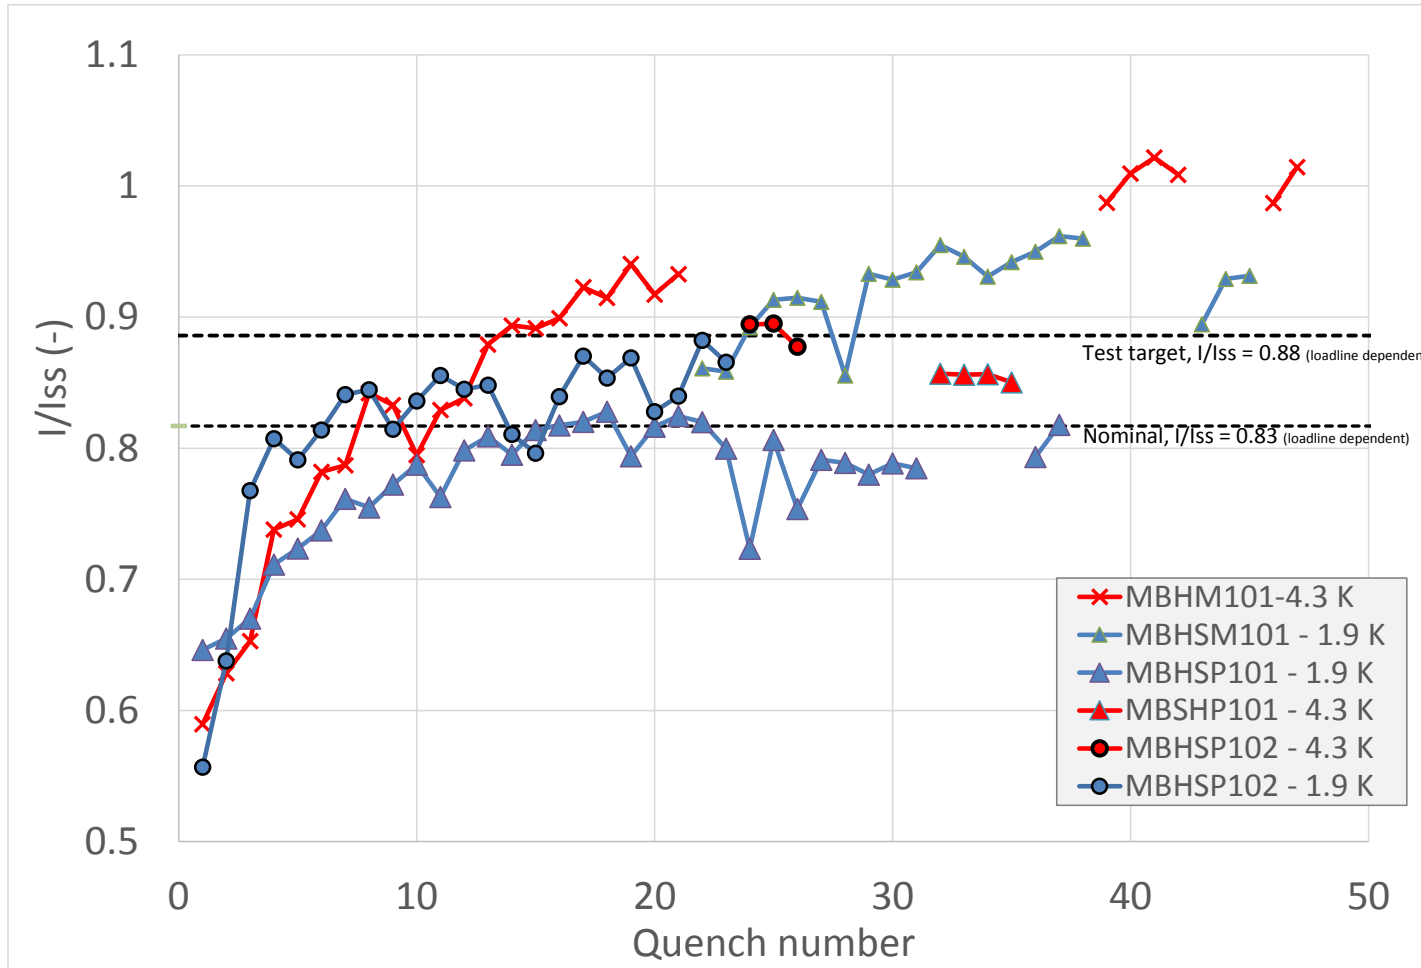
Training of MBHSP102 biased since coil 106 was already trained before.

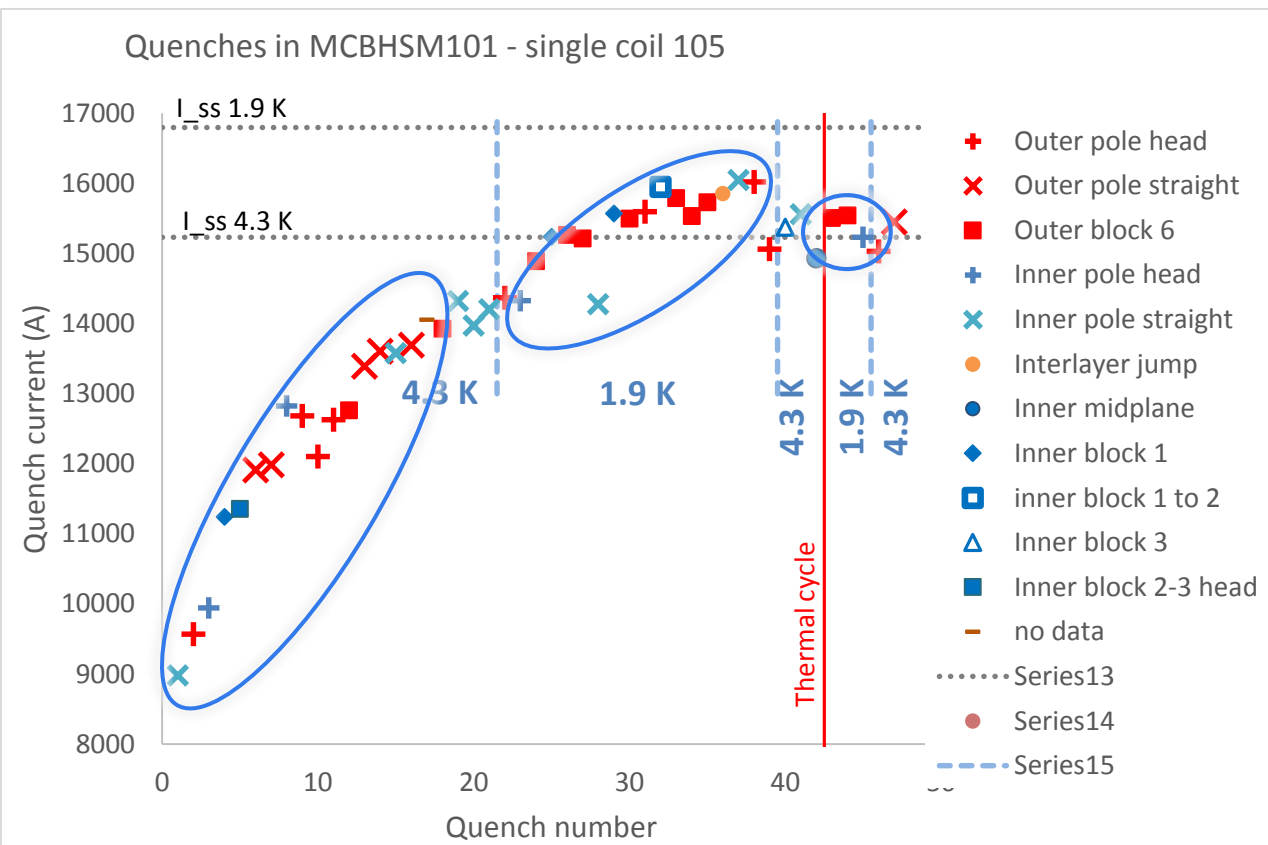
# Training in the single coil HCMBHSM101- coil 105

Initial training 4.3 K  
mainly around the pole

Initial training 1.9 K mainly on  
outer block 6

Slight detraining after the thermal  
cycle for 1.9 K, not for 4.3 K.

The training is rather random without real 'weak spots'.

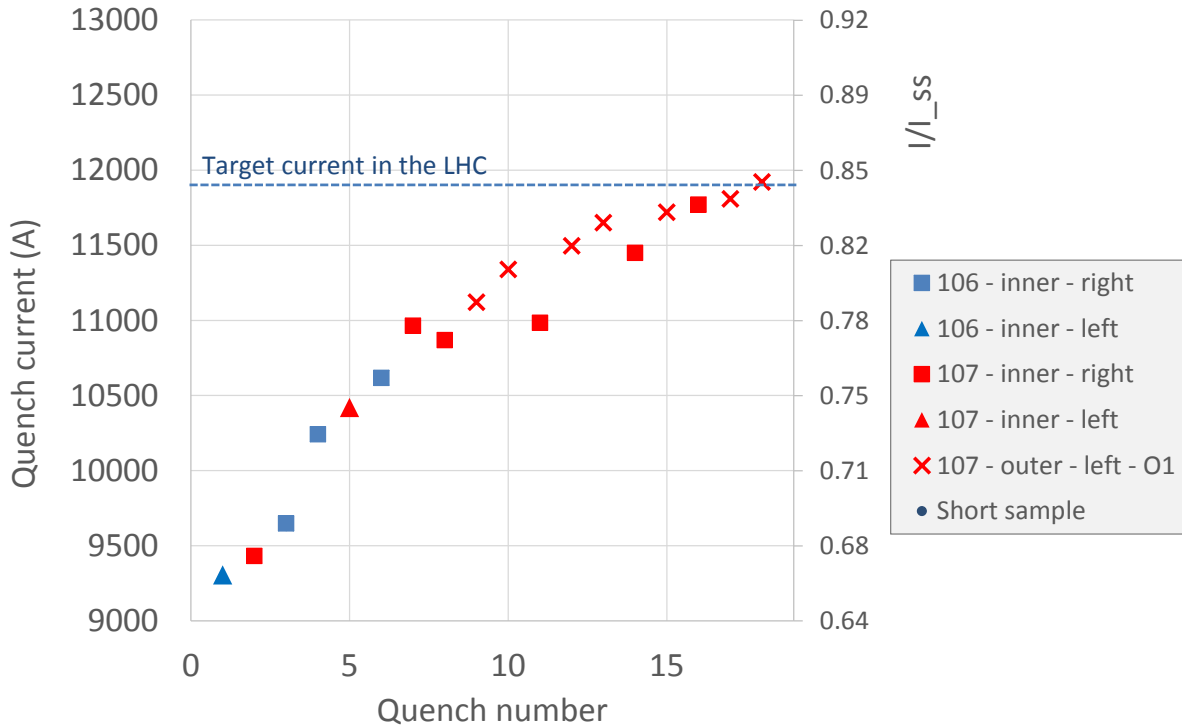
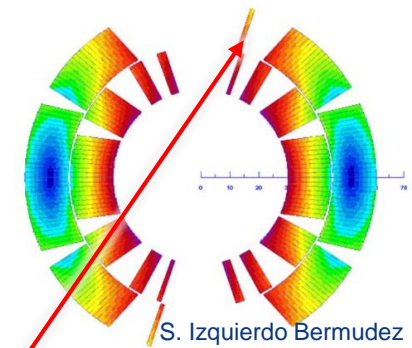
# Training in the single coil MBHSP101- coil 106-107

4 quenches initiated in coil 106, no more quenches from 10.6 to 11.9 kA!!

Initial training looks OK for coil 107 except for 2 specific spots.

Target of 11.85 kA is reached.

Location	# quenches
Coil 106	4
Coil 107 at O1	7
Coil 107 inner layer around key end	6
Coil 107 around I12	1

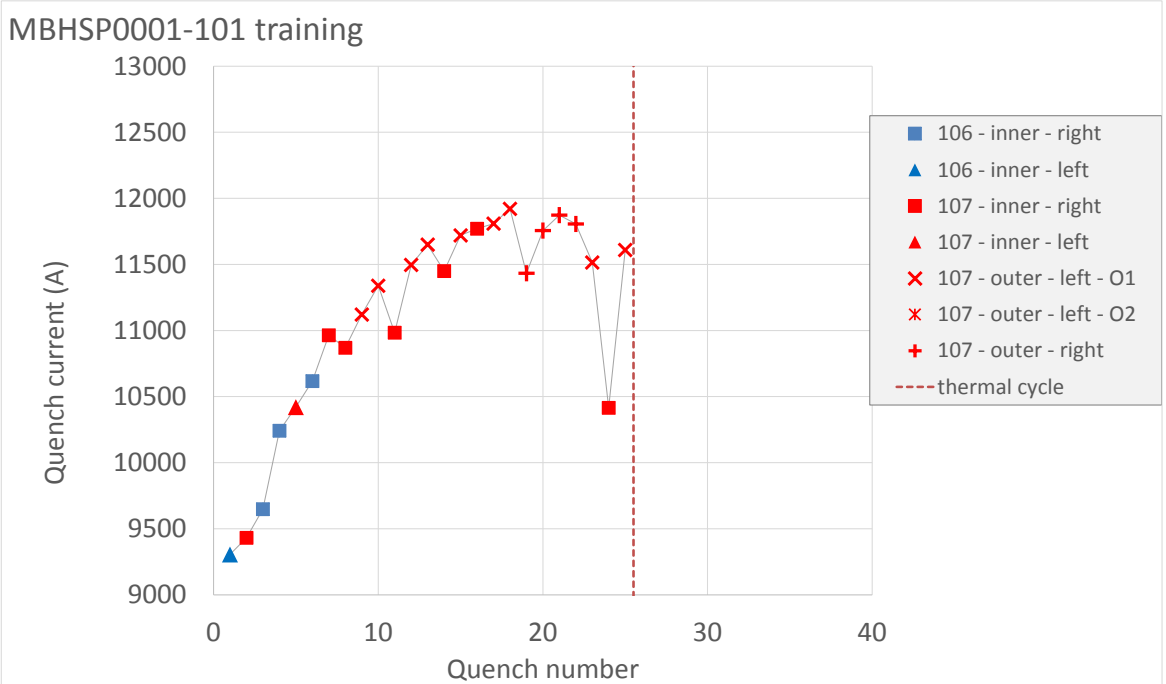
# Detraining or possible degradation in the single aperture at 1.9 K

The detraining and quenches around voltage tap O4 are remarkable in quench 19 to 22

A strong detraining quench followed in quench 24.

Quench 19 to 22	Outer layer, close to Vtap O4
Quench 23, 25	At Vtap O1
Detraining 24 (50 A/s)	Close to Vtap I12

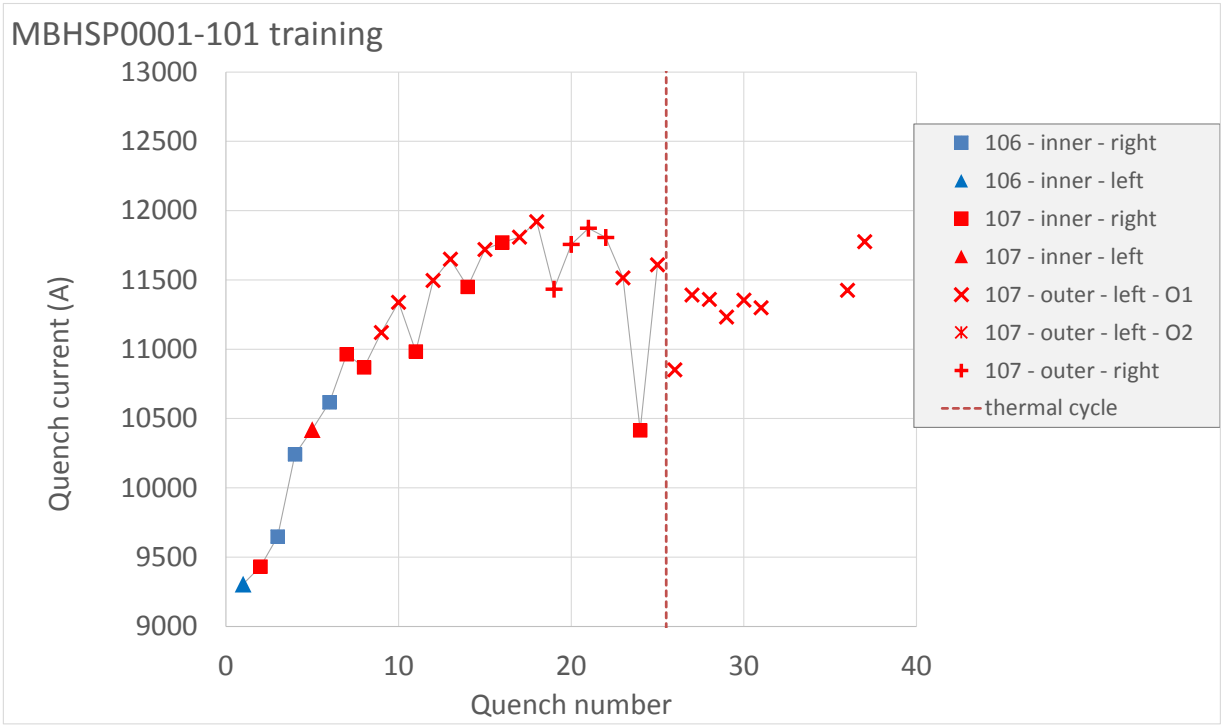
# After thermal cycle at 1.9 K

Quench 26 to 31 at 1.9 K show a rather limited quench current, always quenching in the same location.

Apparently the coil was degraded after thermal cycle for 6 quenches, but after the tests at 4.3 K the quench level increased to 11.76 kA.

All quenches from quench 25 at 1.9 K in O1

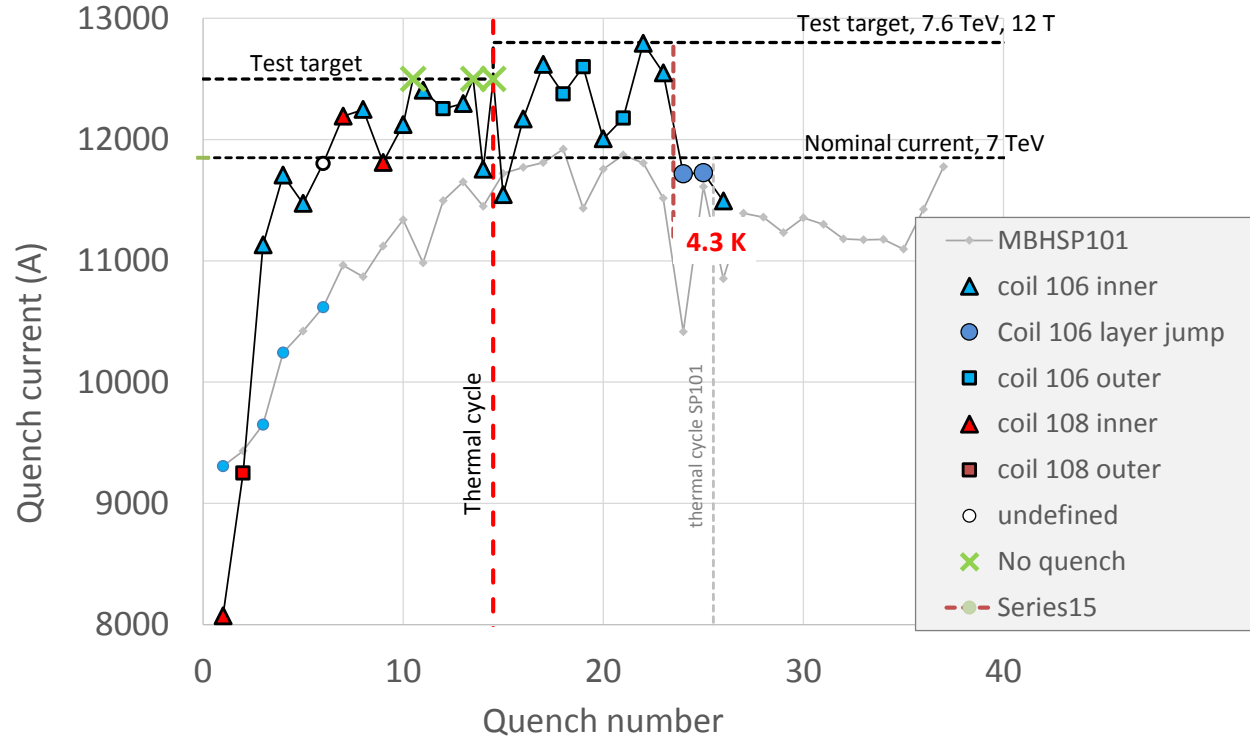
- **6 quenches** to nominal
- 10 quenches to initial target of 12.5 kA
- Only 3 or 4 re-training quenches for coil 106 after de-collaring and re-collaring
- Coil 108 only showed 4 or 5 (de)-training up to 12.3 kA, it never quenched again up to 12.8 kA.
- Memory after thermal cycle is good, with one quench just below nominal.
- Target of 12.8 kA (12 T) reached in the second cool down.

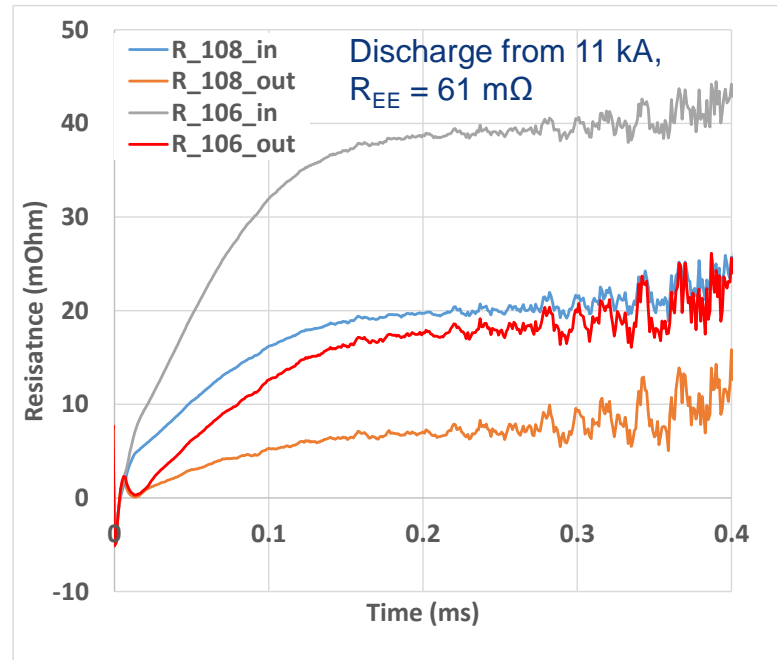
# Quench back - Energy extraction tests – MBHSP102

EE switch opened, no QH firing.  
All resistance in the coil due to  
quench back.

Coil 106 and 108 have about the  
same start time of quench back,  
but resistance growth in coil 106 is much  
faster.

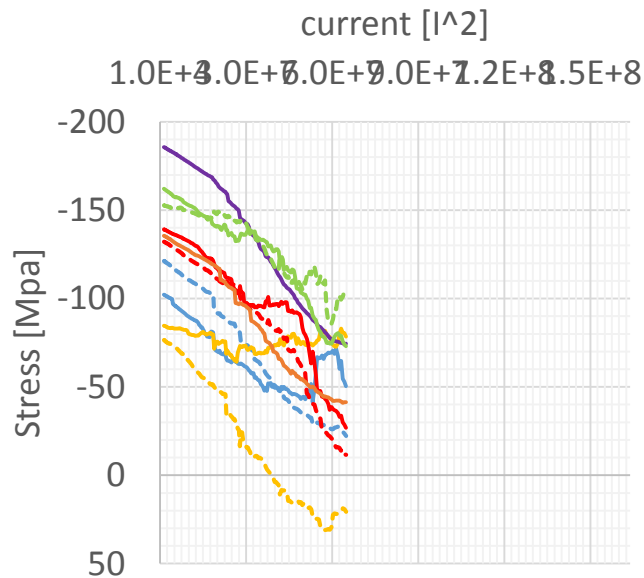
Quench #1 8kA traction Collars

Change of mechanical behaviour during the test campaign. Continuous powering causes some sort of settling in the system.
