Collaboration meeting on DS 11T Dipole grounds

CERN technological choices: Cable insulation and coils

D. Smekens

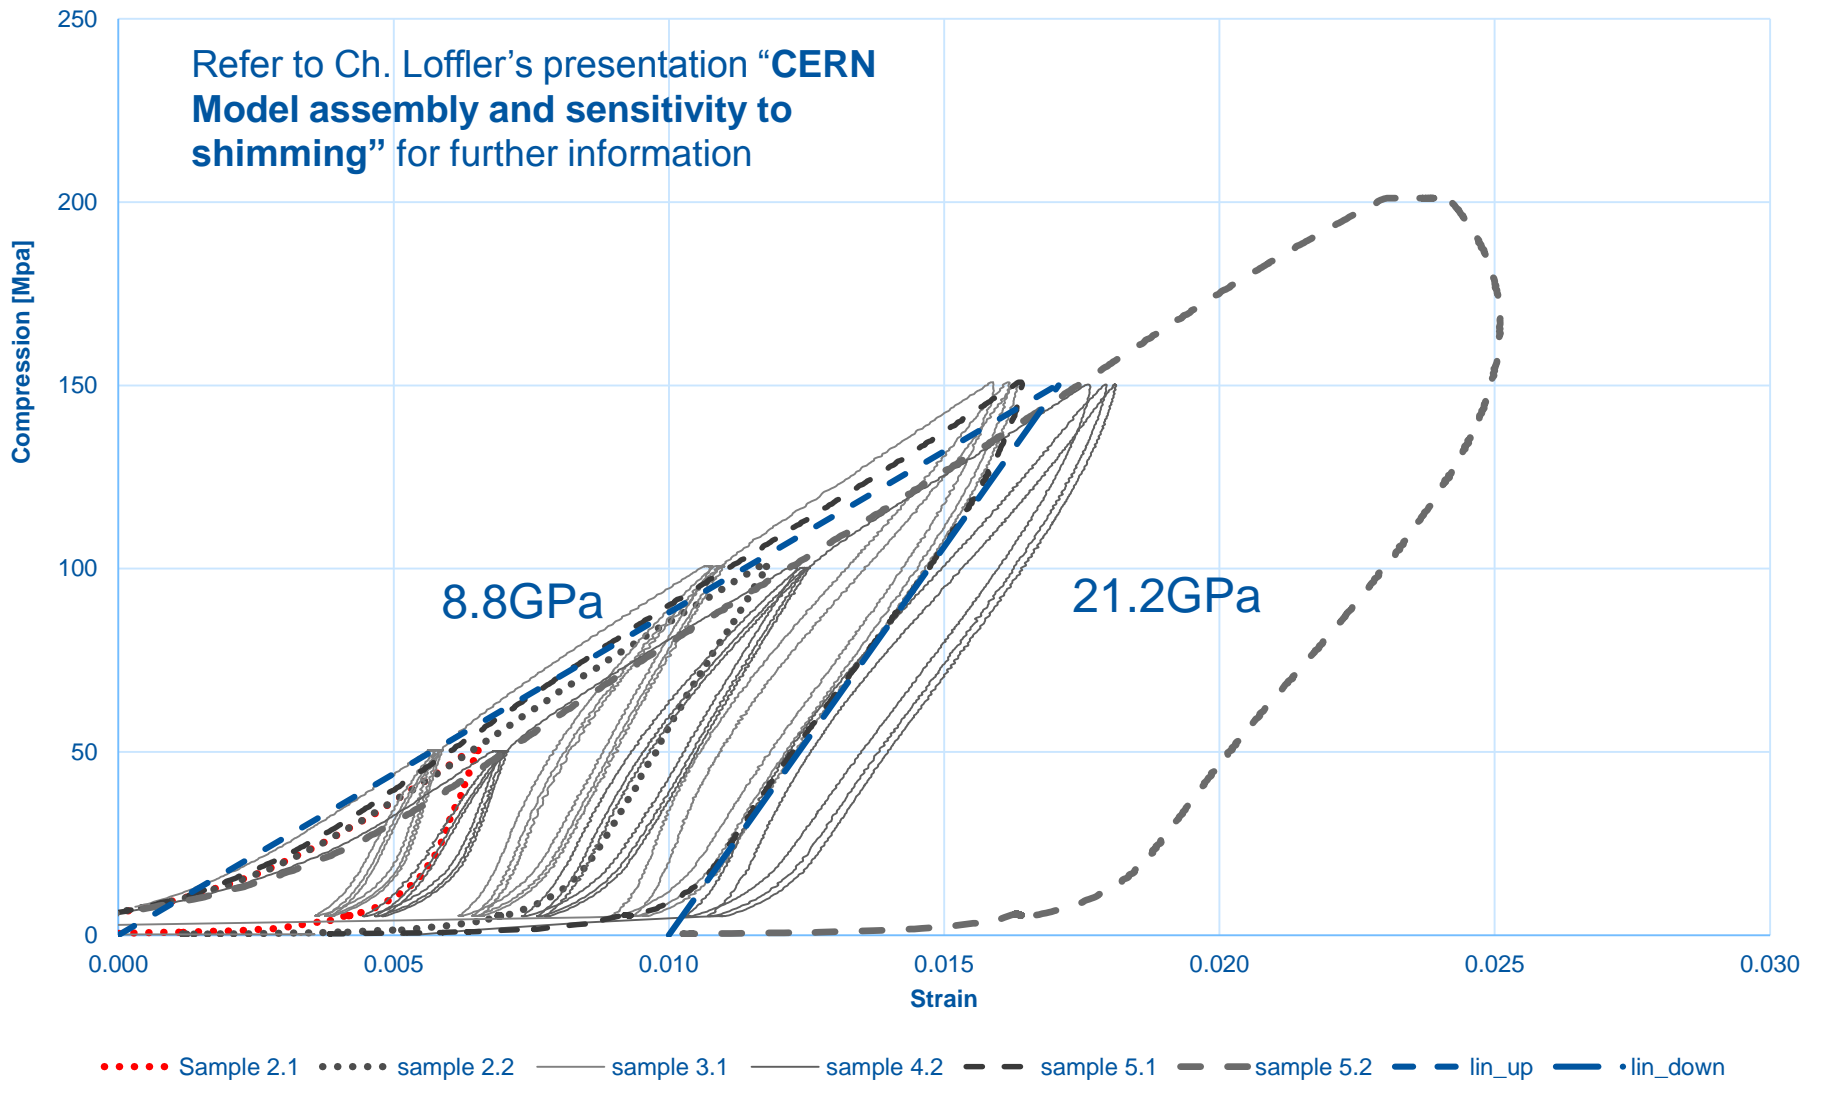
10-stacks: Stress-Strain behavior (at RT)

Refer to Ch. Loffler's presentation "**CERN Model assembly and sensitivity to shimming**" for further information

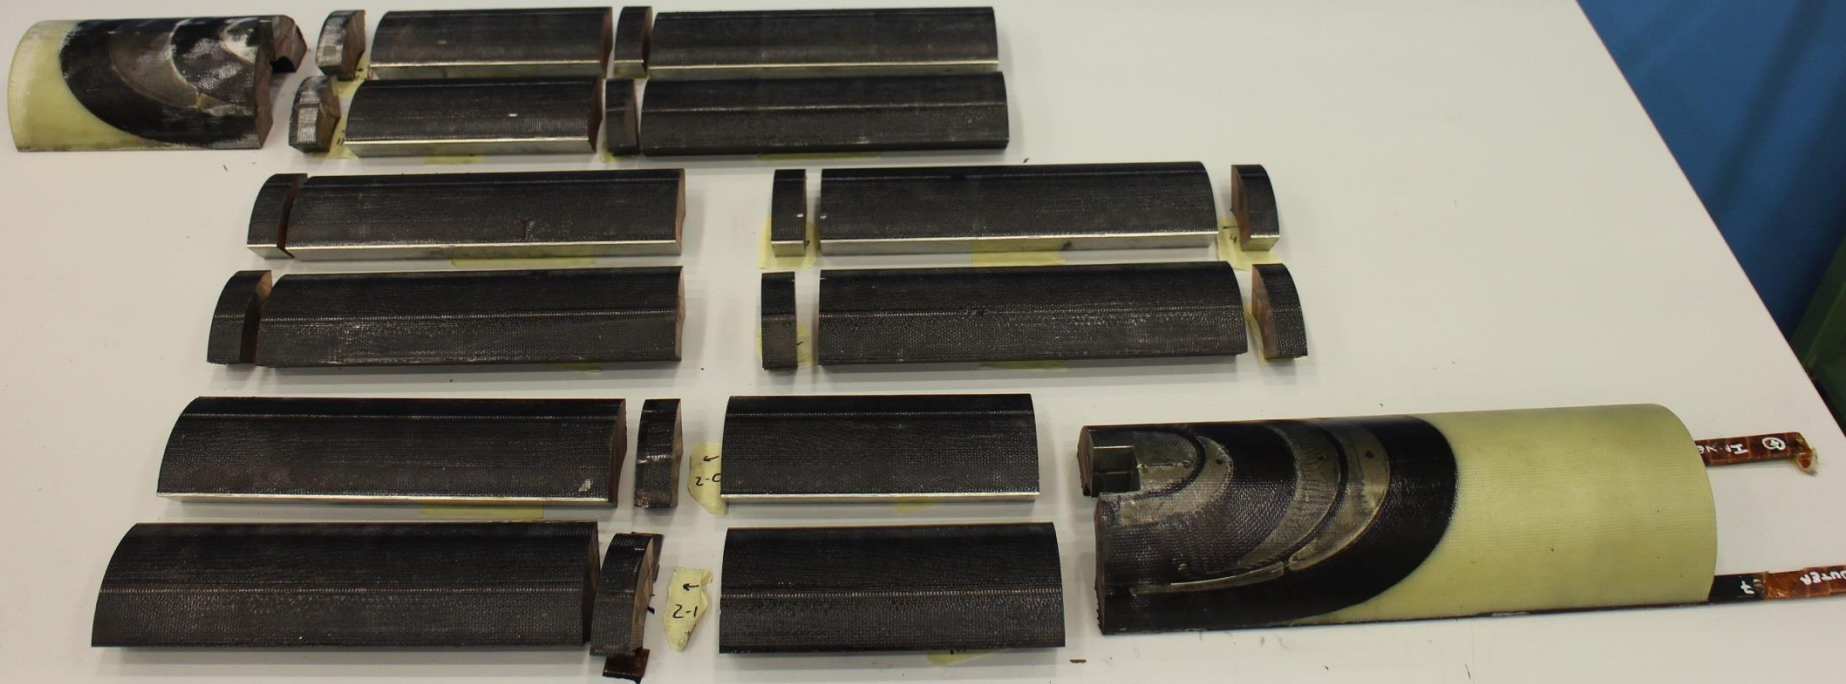
Coil #107 prepared for autopsy

Coil #107 (RRP108/127), tested in aperture SP101 in 2014

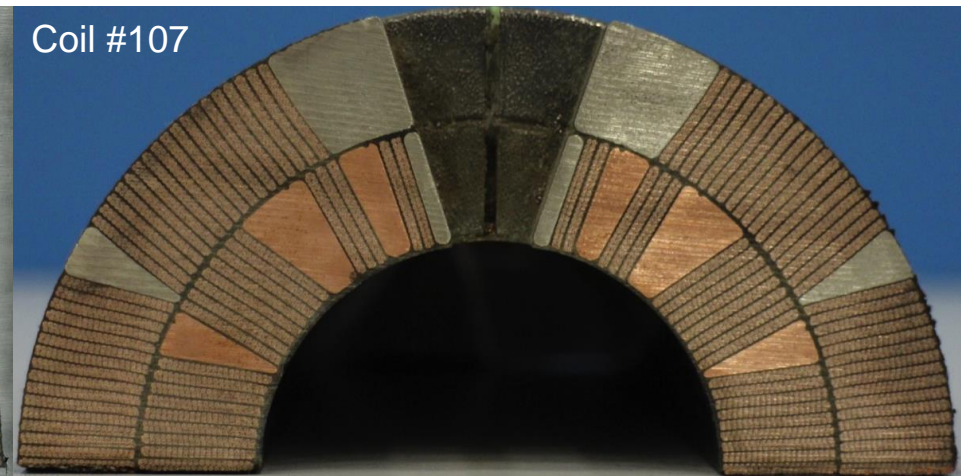
Autopsies

- Metallurgical examinations of coils:
- Sample preparation is difficult and lengthy
 - Protocols are not yet fully defined
 - Kills the coil

Extremely valuable to find and characterize defects.

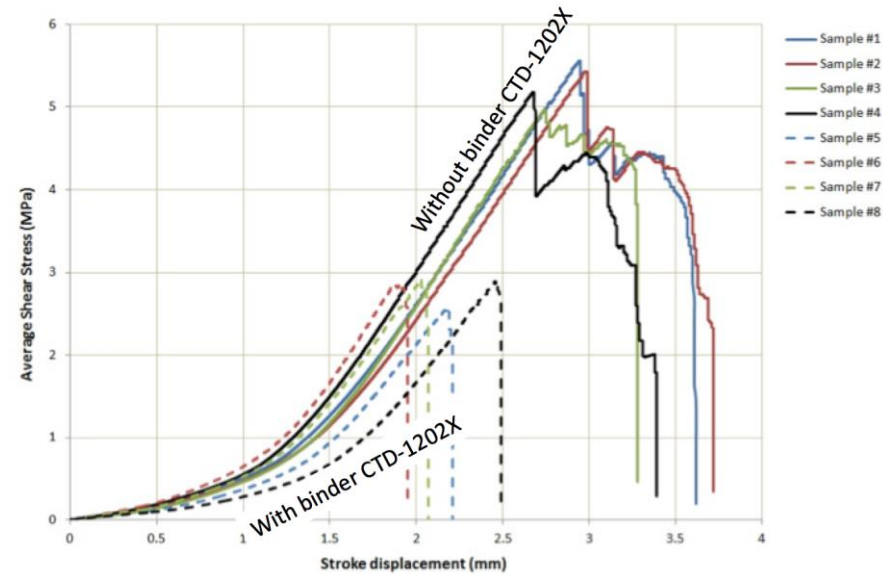
Shear tests

Tests⁽¹⁾ realized on lap joints show that ceramic binder may significantly reduce the bonding strength

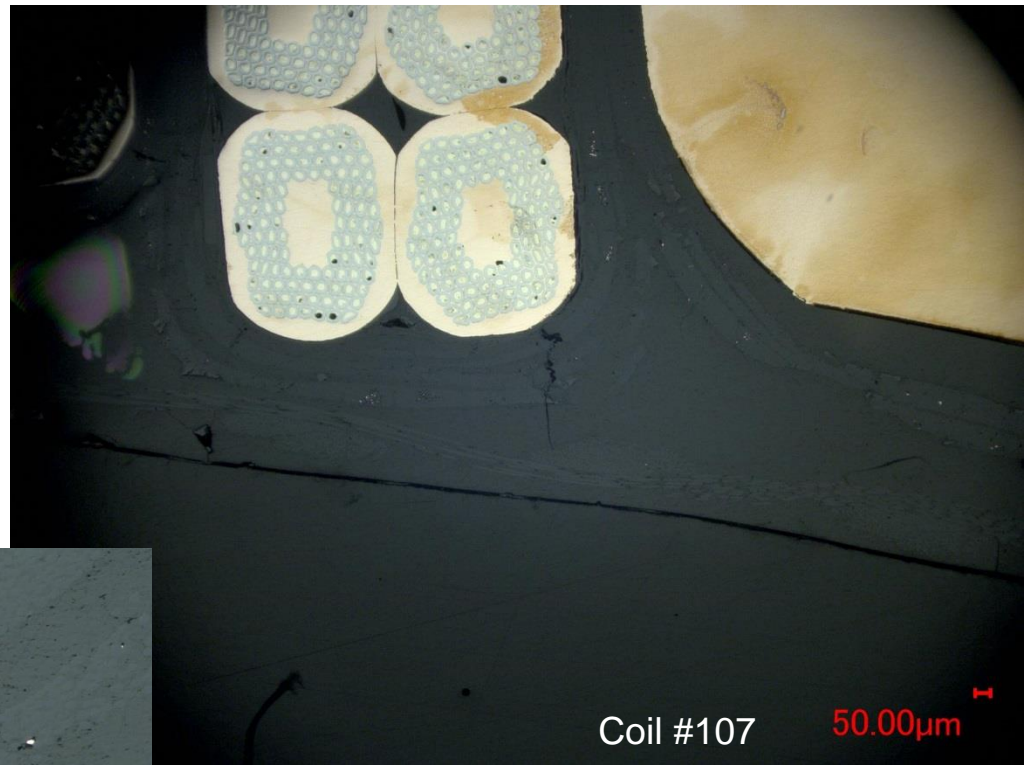
Crack Propagation

A crack spotted in coil 107.
from strand to outward. The
mica layer is not perforated.
Crack propagation to be
investigated
