Electrical Integration

MPB October 2015

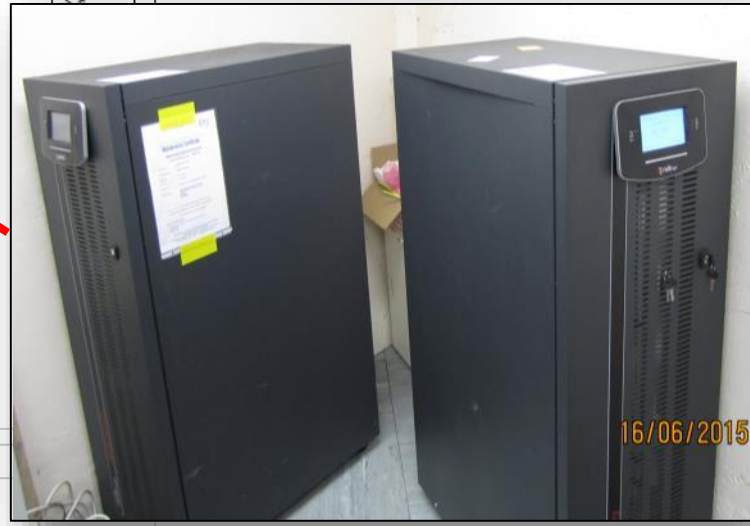
Rack Room 2 – UPS and AC Infrastructure

All the electrical infrastructure for Step IV has been installed and Certified as compliant with Electrical Regulations

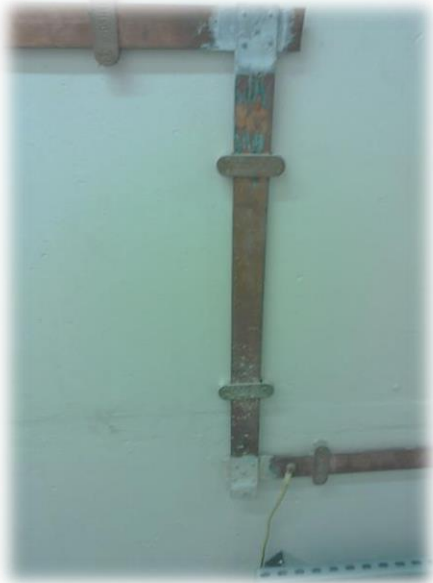
50mm x 6mm Busbar
North, South & West walls

- Electrical Functional / Safety Earthing has been enhanced in the MICE Hall with the installation of a 50mm x 6mm copper busbar.
- Additional busbar earthing has been installed under metal floor to improved equipotential bonding.
- Bonding to support structures, cable management and steel plates has been significantly improved.
- Earth bonding between the MICE Hall and RR2 has been enhanced with copper busbar connected between the 2 areas and the cable management is now appropriately bonded.
- 70mm² earth cables have been installed between each magnet and the main earth busbar located on South wall.

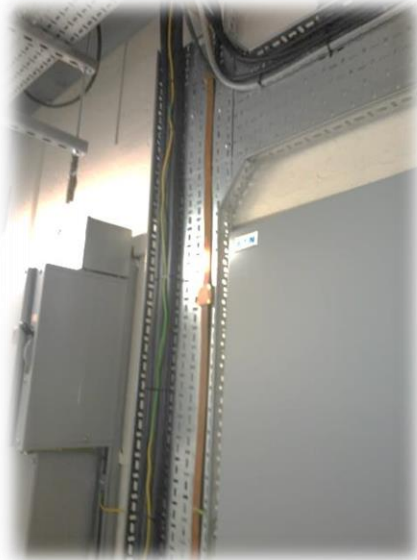
25mm x 3mm Busbar
NE corner

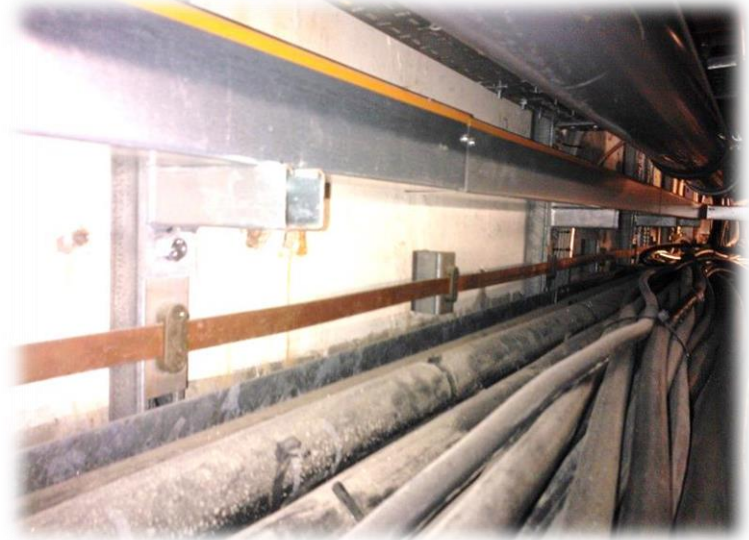
25mm x 3mm Busbar in main trench

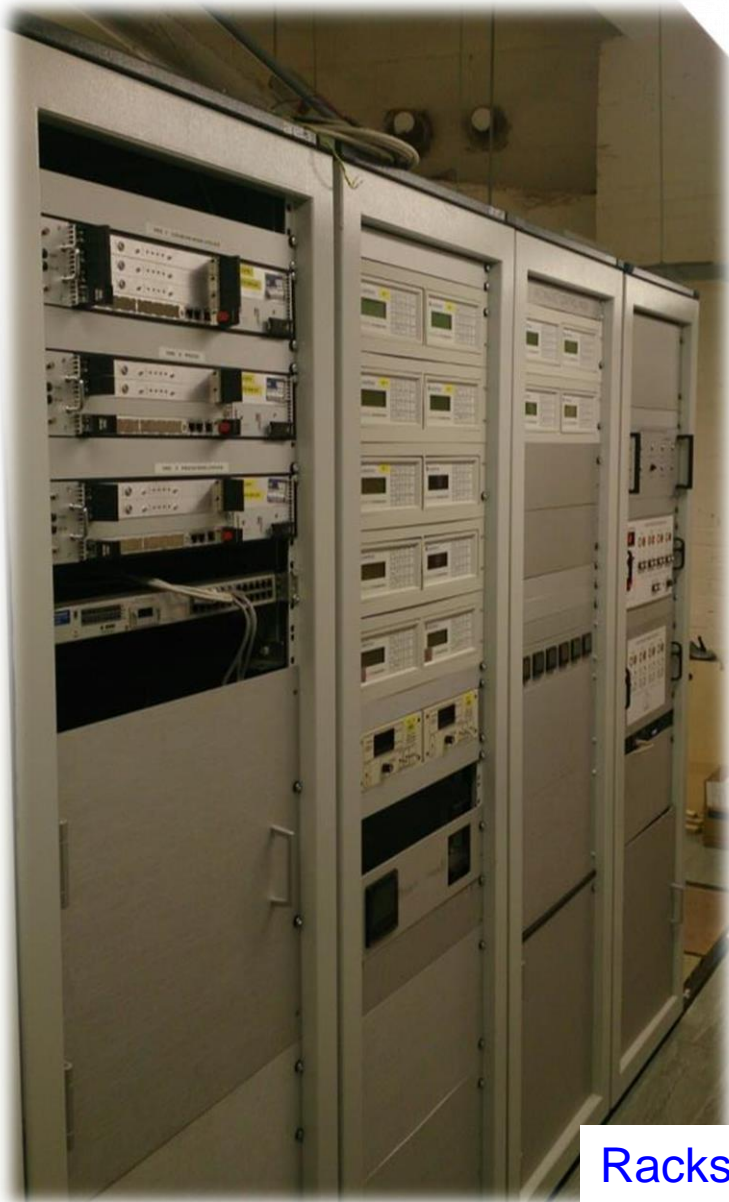
FC & SS Instrumentation & Control Racks

- All Instrumentation cables have been installed and terminated
- All magnet temperature sensors checked, some sensor issues have been identified on the SS magnets.
- Temperature curves programmed for FC.
- Temperature curves for SS still to be finalised – some issues sourcing the calibration data.
- Helium level sensors measured and checked for SS and FC.
- Anti-icing heater commissioned for FC – reliability issues need to be resolved
- Fans for anti-icing on SS fixed to magnet and terminated – reliability issues need to be resolved.
- Pressure heaters commissioned for FC.
- Pre-cool heaters for SS commissioned.
- Main pressure vessel regulation heaters for SS commissioned.

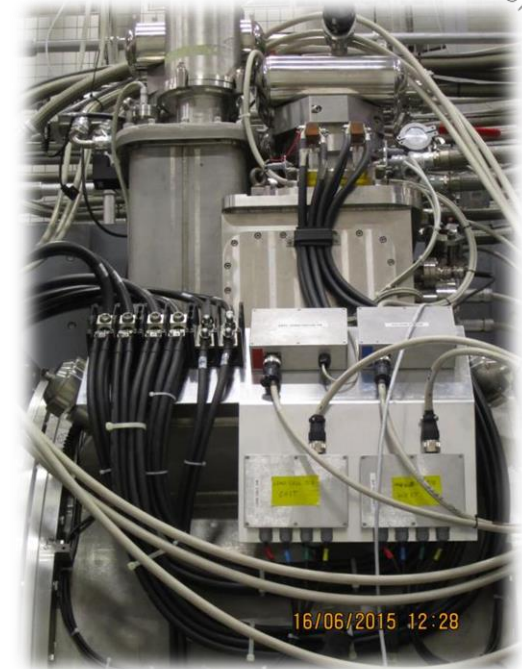
DC and Instrumentation cables

- 5 DC link boxes have been installed in MICE Hall.
- 240mm² and 70mm² cables have been installed from RR2 to link boxes.
- 95mm² and 70mm² cables have been installed between DC link boxes and magnet local termination point.
- DC link boxes will enable the FC and SS to be changed from Solenoid to Flip mode and vice versa.
- All control interfaces for FC have been relocated to the top of the North side for convenient access.
- Cables have been installed and commissioned for the FC Load cells and are being monitored.

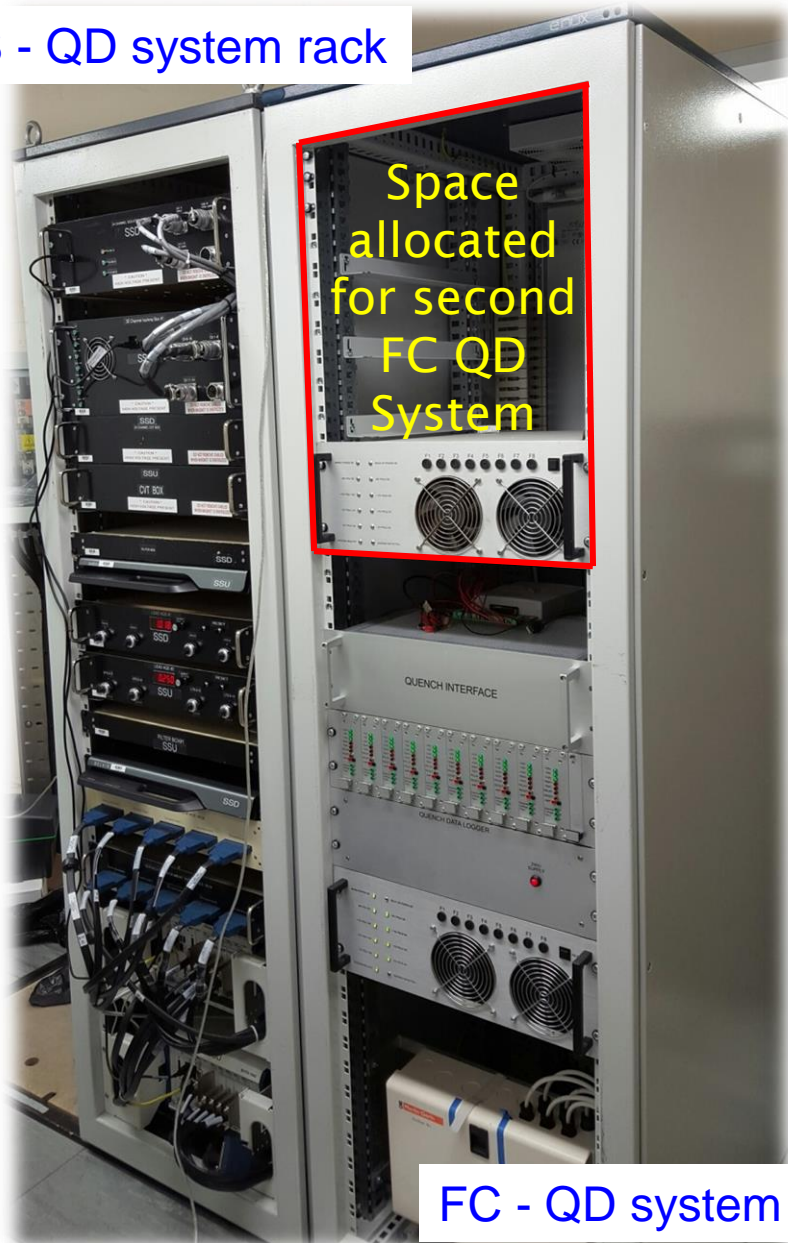
SS - QD system rack

- SS QD system rack has been installed in RR2 and commissioned with the control system.
- SS voltage tap cables were installed, but there are still quality issues with the connectors.
- SSU has been fully trained to 285A and the QD system has operated reliably.
- SSD has been partially trained, but there has been issues with a broken voltage tap wire and magnet component failure.
- FC QD system rack has been installed in RR2 and calibrated with magnet.
- The FC magnet has been operated at 10A, the circuit still needs to be optimised before ramping to nominal current.
- A full systems check was performed on both QD systems before powering magnets.

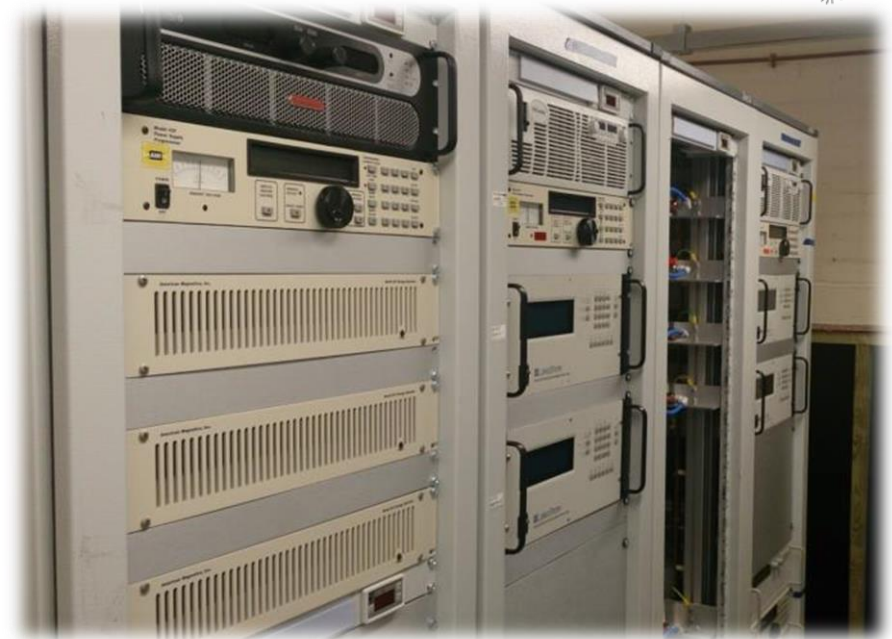
Racks installed in RR2

- SS power supplies have been fully commissioned with control system.
- Full electrical sign off of all interlocks and controls checked and signed off.
- Power supplies have successfully provided power for full training of SSU, and partial training of SSD.
- Solenoid valves fitted to transfer cooling to towns water in case of a fault with the chiller/ air blast unit.
- FC power supply has been commissioned and tested.
- FC power supply has been ramped successfully to 10A, further testing of the magnet is ongoing (114A solenoid mode???)

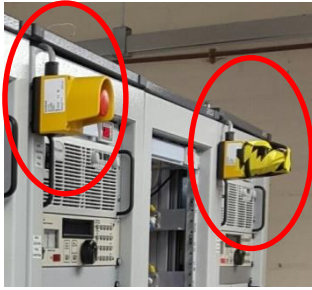
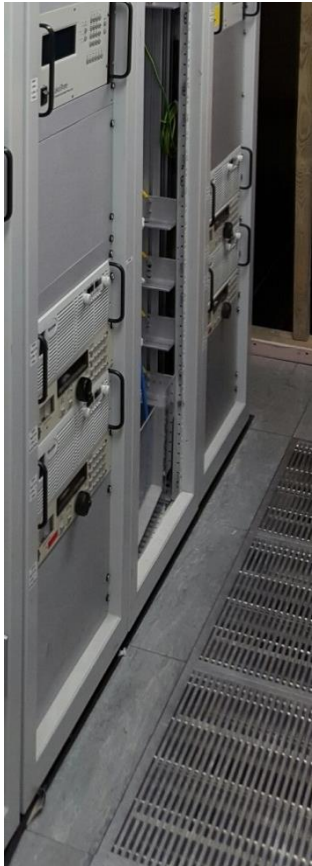
Emergency Off buttons installed on SS racks

- Emergency Off buttons have been installed on the SS power supply racks.
- These buttons open the DC contactors and artificially quench the magnet if pressed.
Currently there is **no** alternative way of discharging the magnet energy without software reliance.

- A report detailing the emergency off procedure hierarchy has been issued and is awaiting agreement.
- There are options available to remove the reliance on software, which include replacing the AMI 420 with AMI 430 controllers.

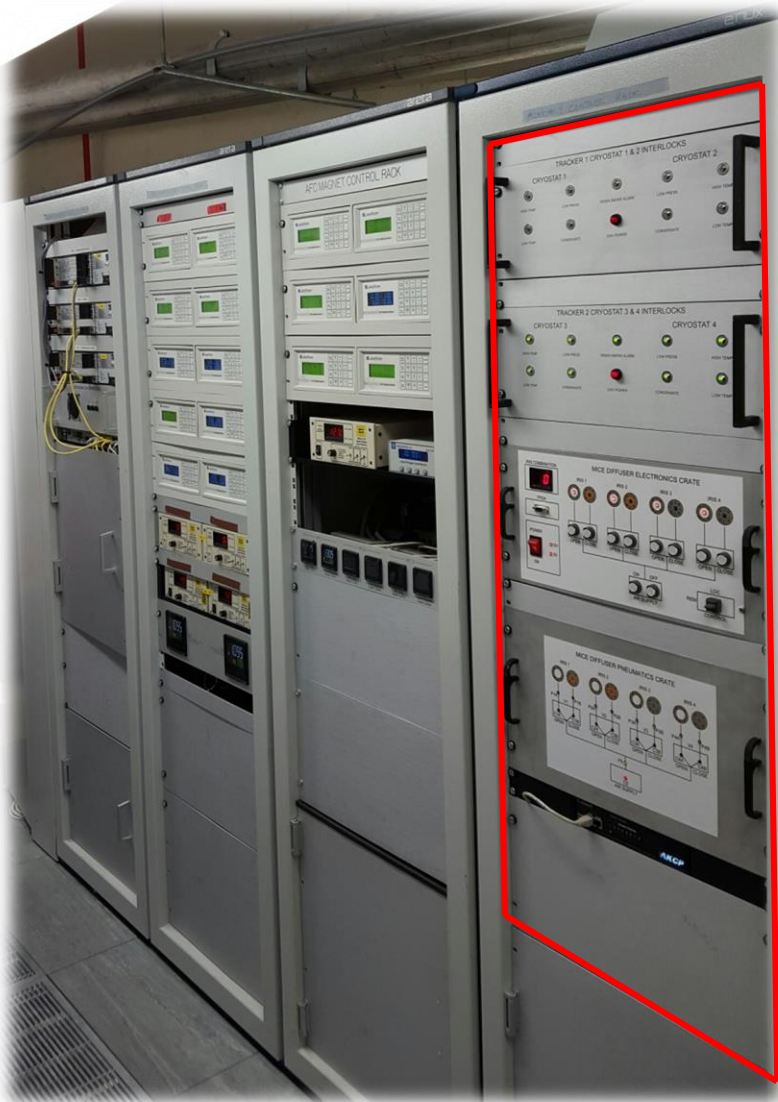
Auxiliary (Diffuser and Tracker) Control Rack

- The tracker control rack has been installed in RR2 to allow ease of access.
- 2 Control crates have been manufactured for housing in RR2 rack and containing the Canbus modules.
 - Both crates is are completed, tested and in position in RR2.
- Full system commissioned and verified tracker can be controlled from RR2.
- However some rack modification required to control AC power to the WIENER cryostat.

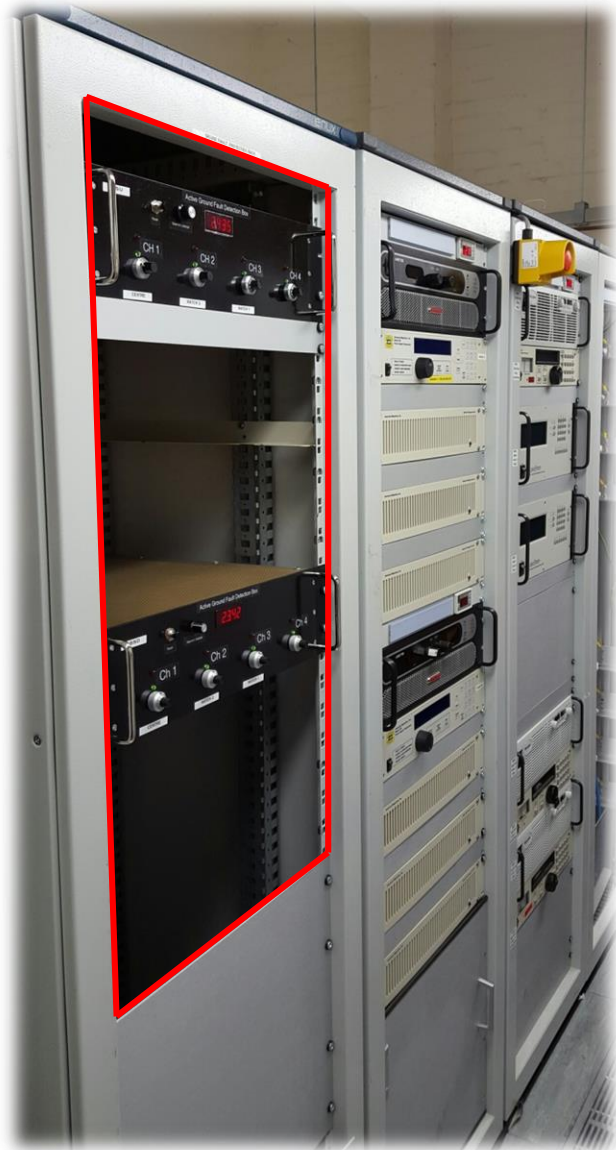
Ground Fault Protection

- FermiLab designed and assembled the ground fault protection crates.
- The 2 crates have been installed and tested with the SS circuits.
- They were used to identify the earth leakage issues on the energy absorber diodes.
- The system did initially suffer from over sensitivity issues and caused spurious trips. The topology used only works when connected to a circuit which has a relatively high impedance to ground.
- Unfortunately for the FC magnet the centre of the energy dump circuit is referenced to ground, to minimise the voltages generated during a quench.
- An alternative solution was designed and implemented for the FC magnet.

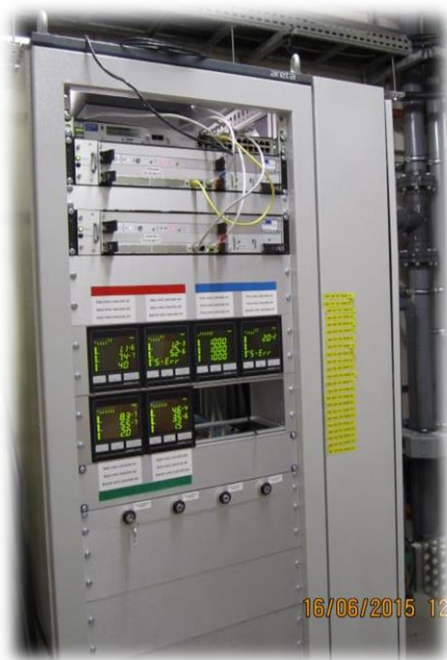
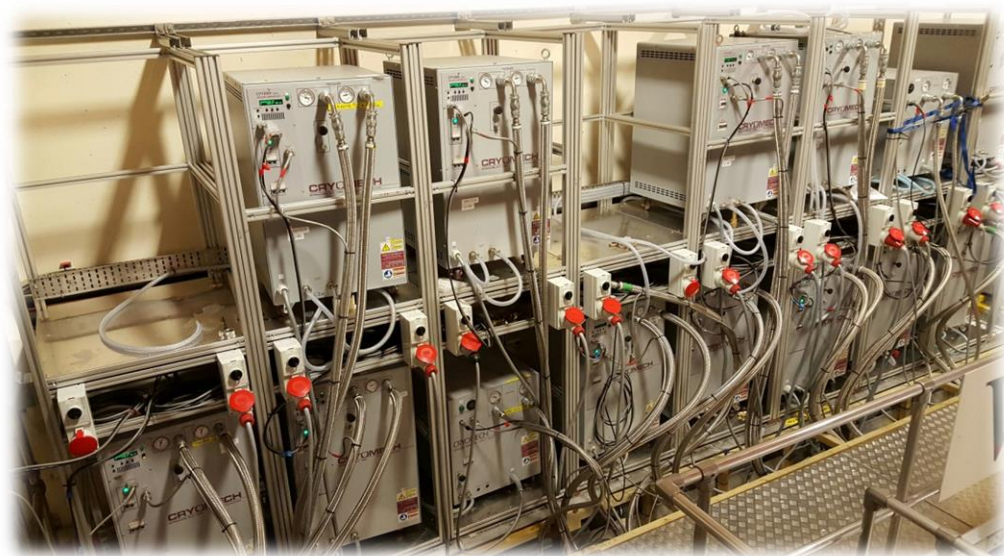
Some of the FC compressors moved closer to improve cooling efficiency

- Vacuum / compressor rack has been installed and commissioned in North / West corner
- Extra shut off valves were requested for the SS turbo pumps, these are now operational.
- Control philosophy for backing line scroll pumps has been finalised and implemented.
- Hard wired vacuum status provided to RR2.
- RS232 controls interface for compressors commissioned and operational.
