# CNGS Overview

Konrad Elsener

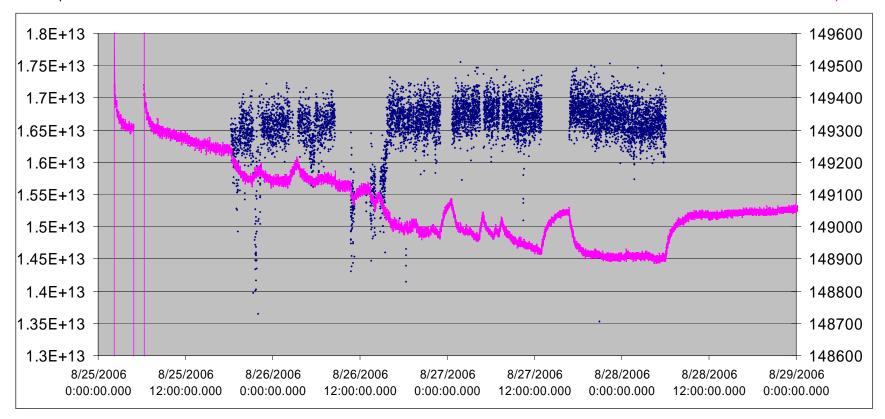
## horn current [A]
