# Status of T2K Horn Prototypes

T. Sekiguchi (KEK)

for T2K Target & Horn Group

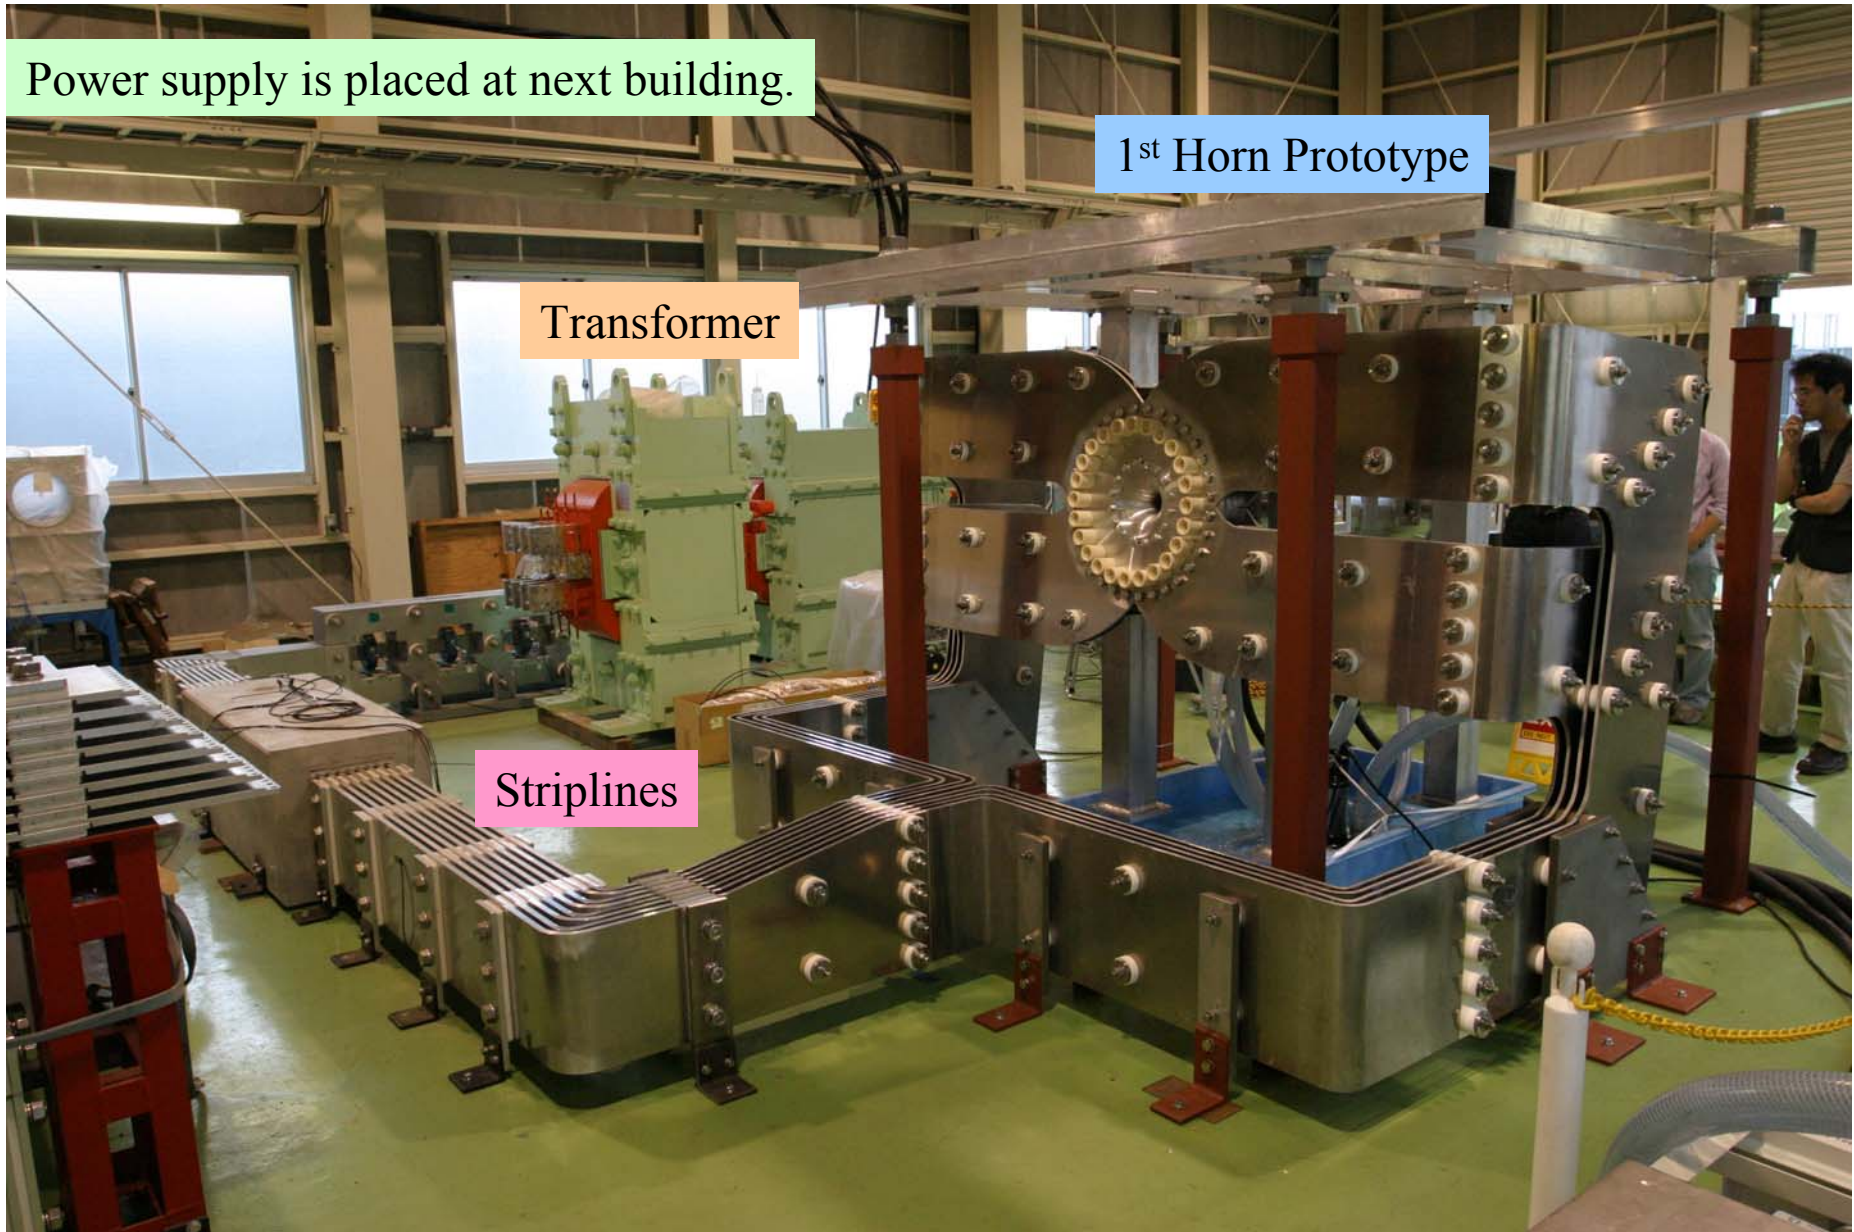
# Horn Test Facility

Power supply is placed at next building.

1<sup>st</sup> Horn Prototype

Transformer

Striplines

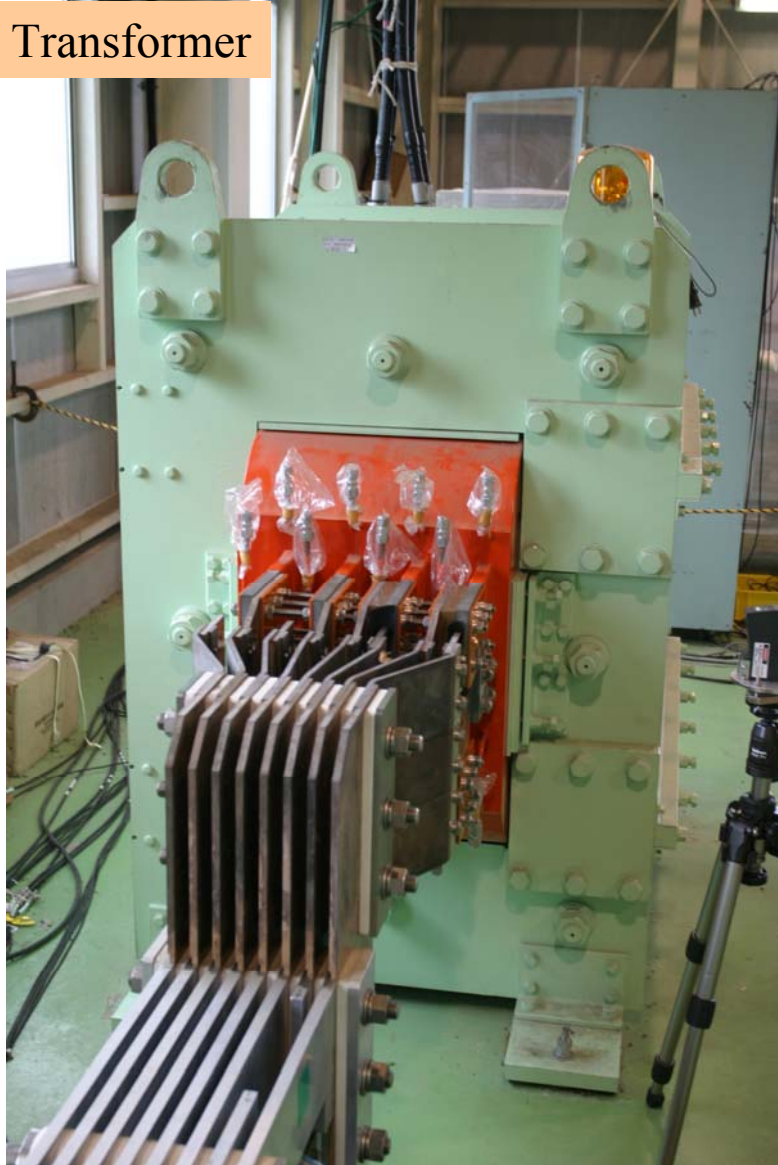
Transformer

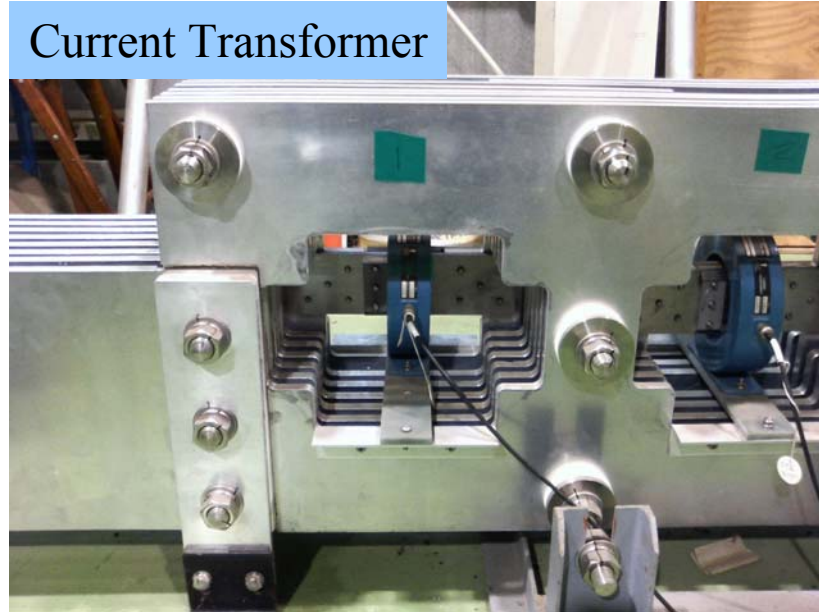
Current Transformer

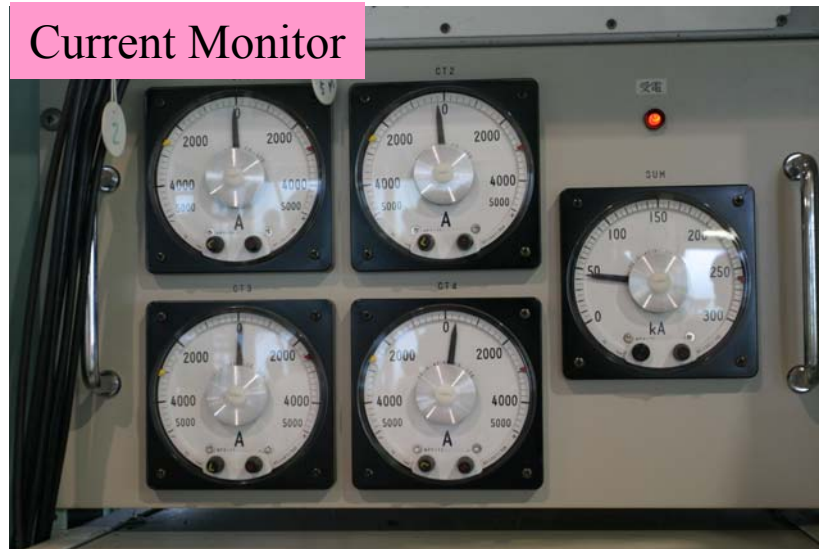
Current Monitor

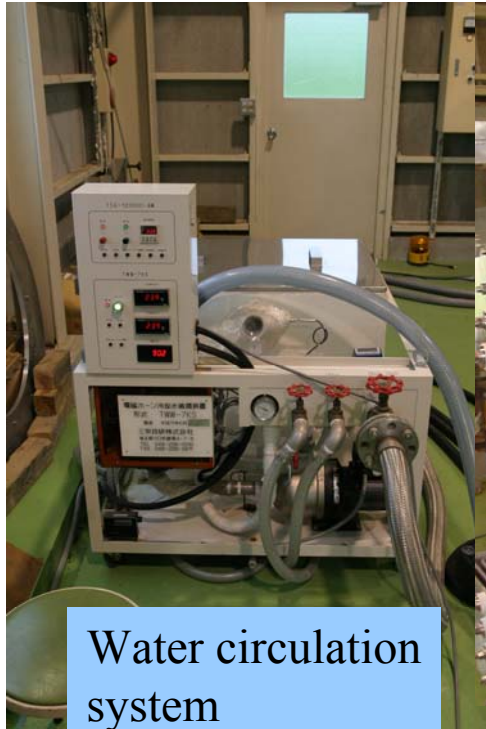
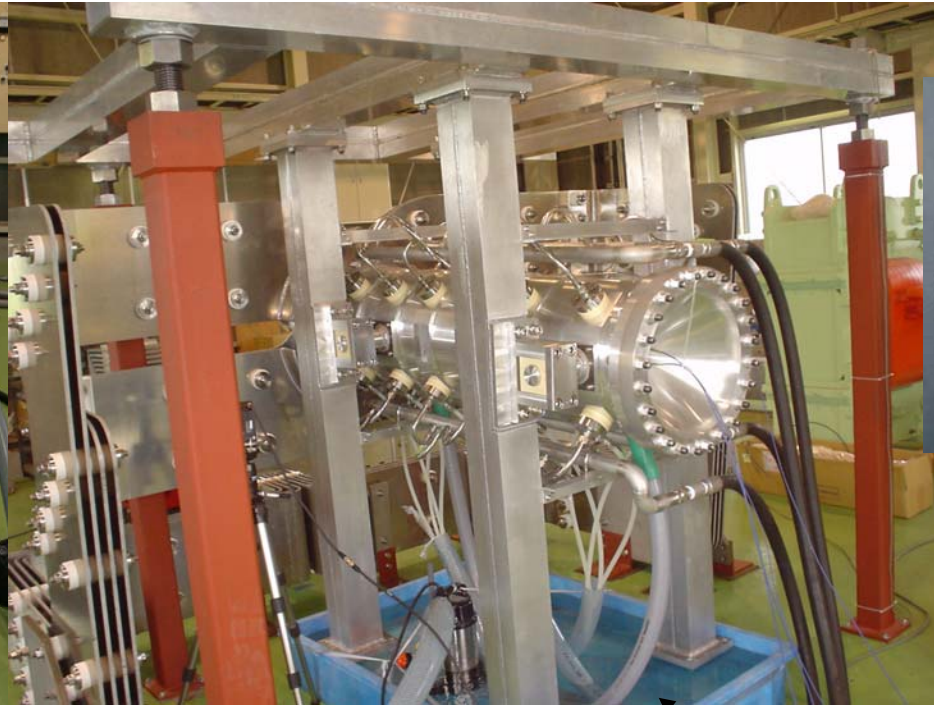
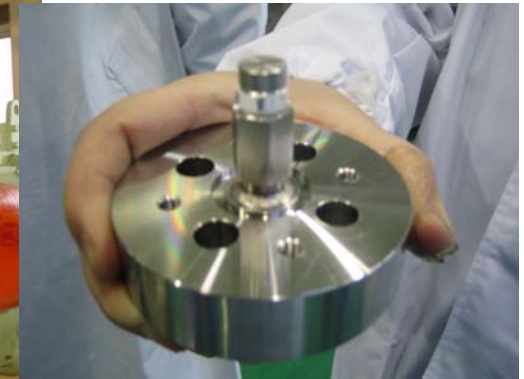
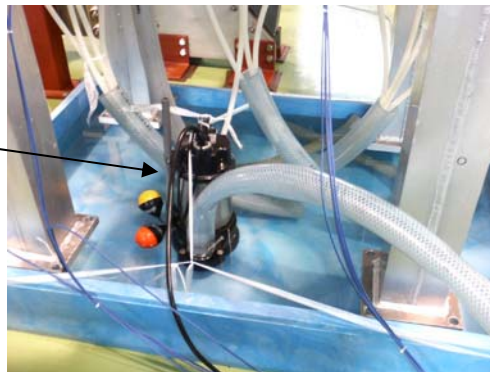
# Water Circulation System for Prototype

Drain tank is not completed yet. It will be attached in early October.

Water circulation system

Water nozzle

Pumping up water to the buffer tank

Temporary drain tank

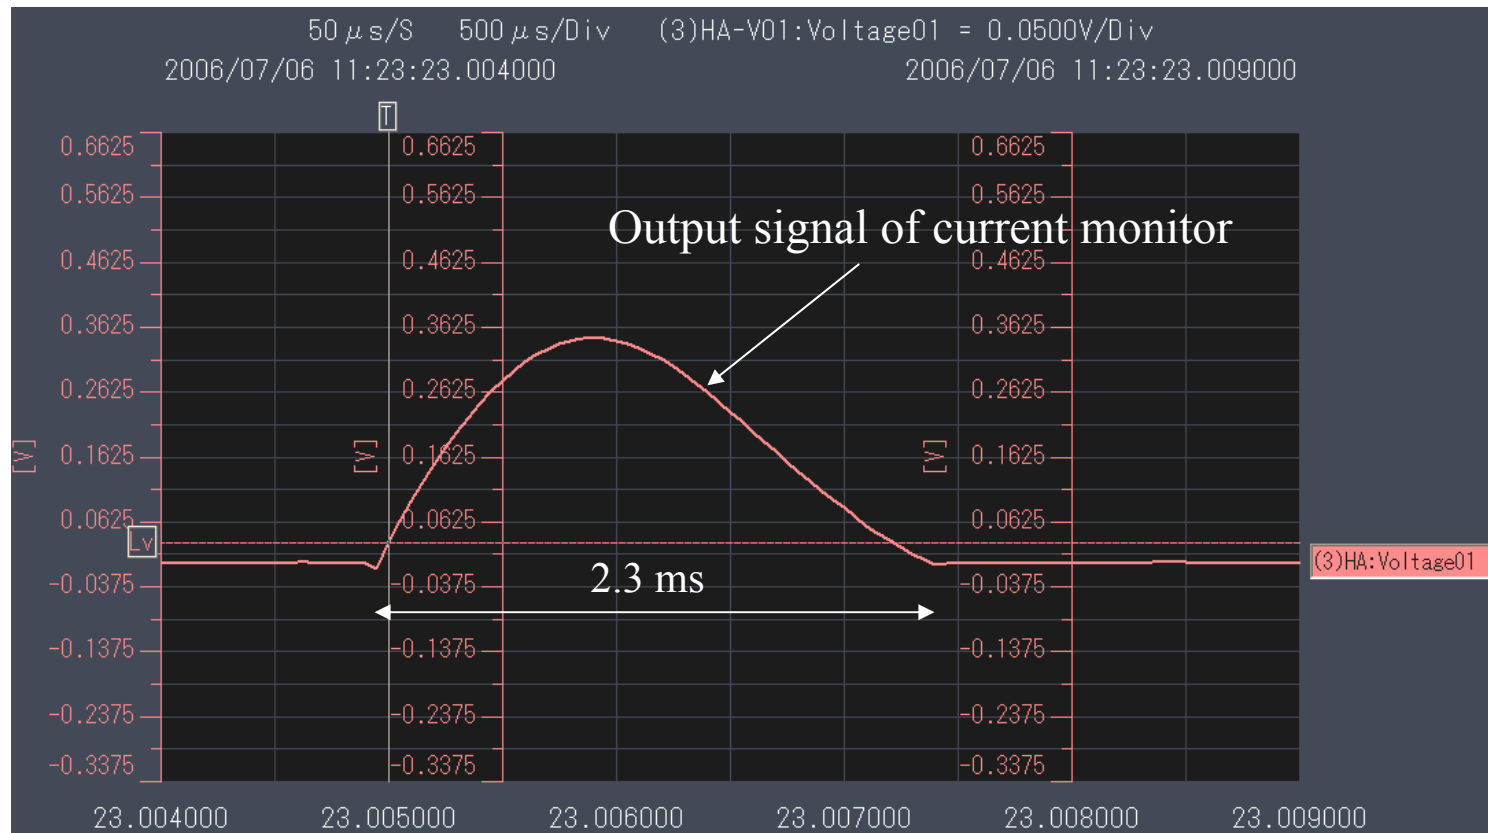
# 1<sup>st</sup> Horn Operation

- May 24<sup>th</sup>: First excitation
  - Pulse width  $\sim 2.3$  ms  $\Leftrightarrow 0.7$  ms (spec.)
- $\Rightarrow$  Need to change capacity of power supply.

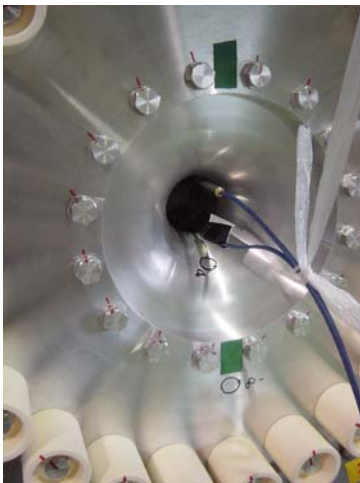
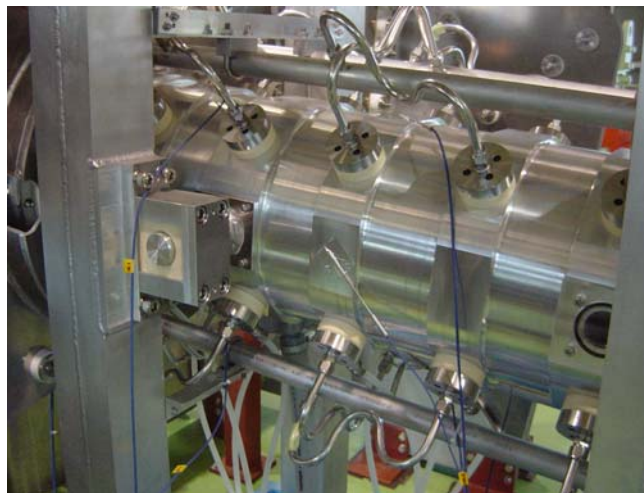
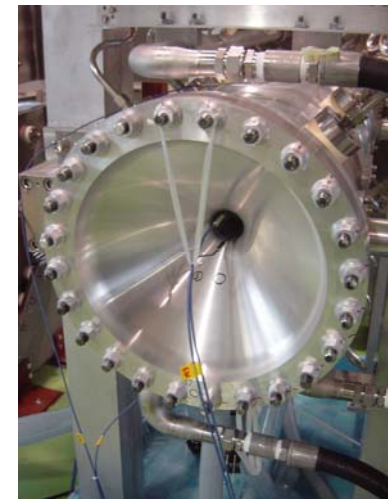
# Temperature Measurement

Temperature measurement with thermocouples

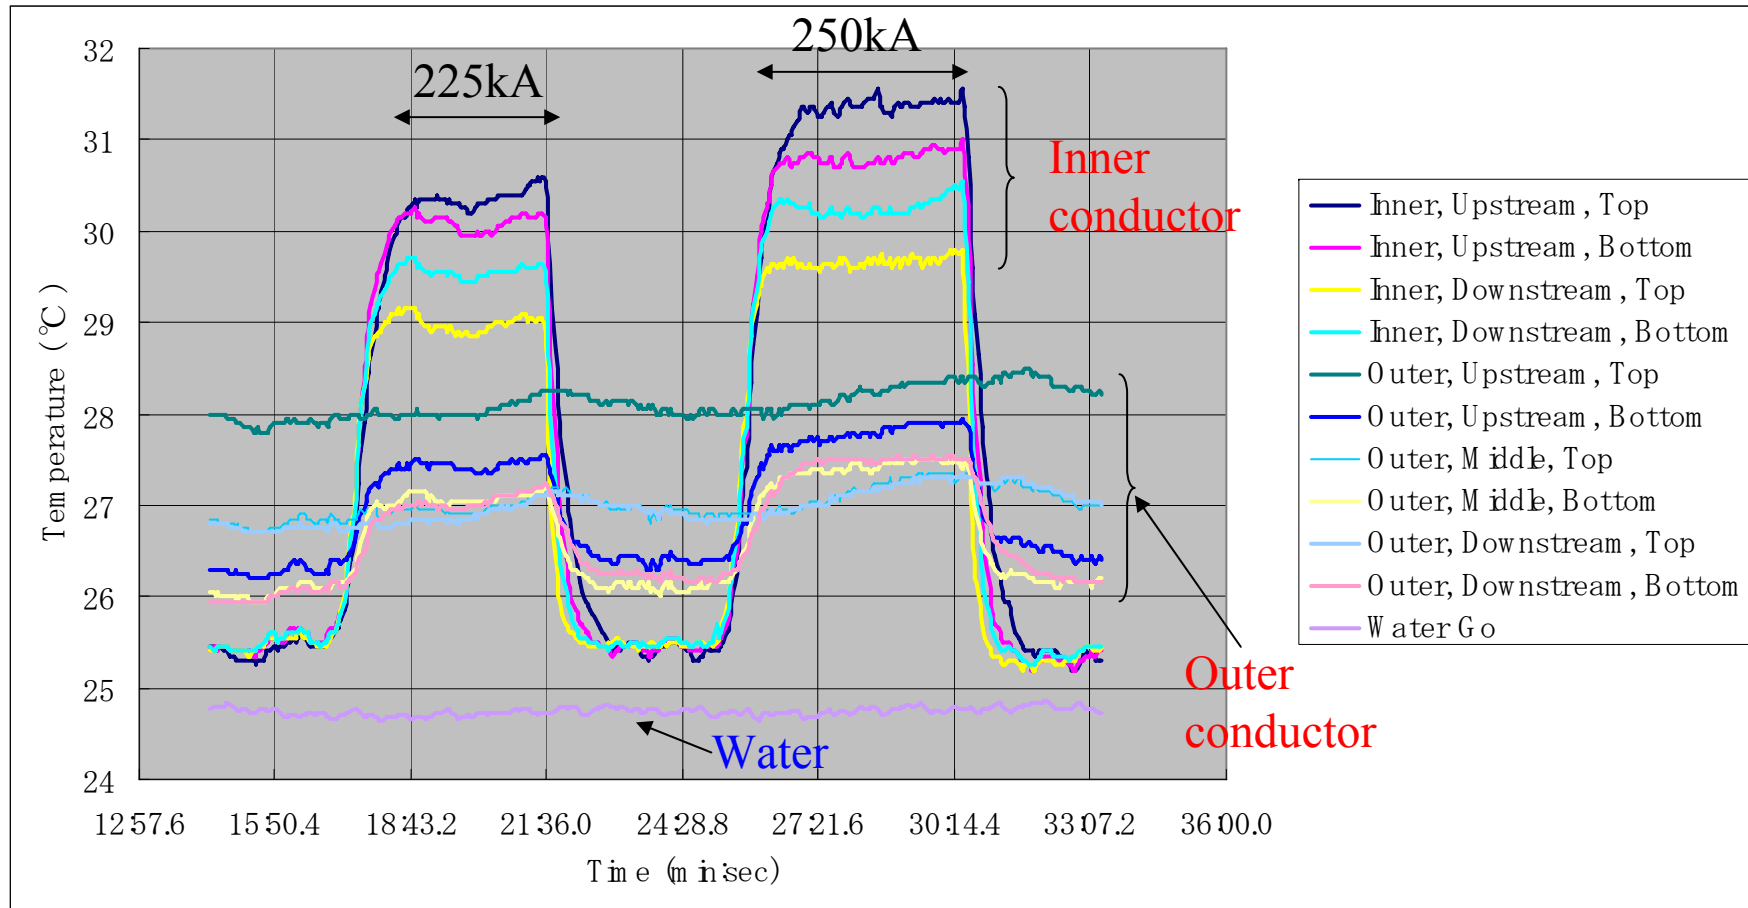
# Temperature vs. Time

Top part of outer conductor is not cooled by water.

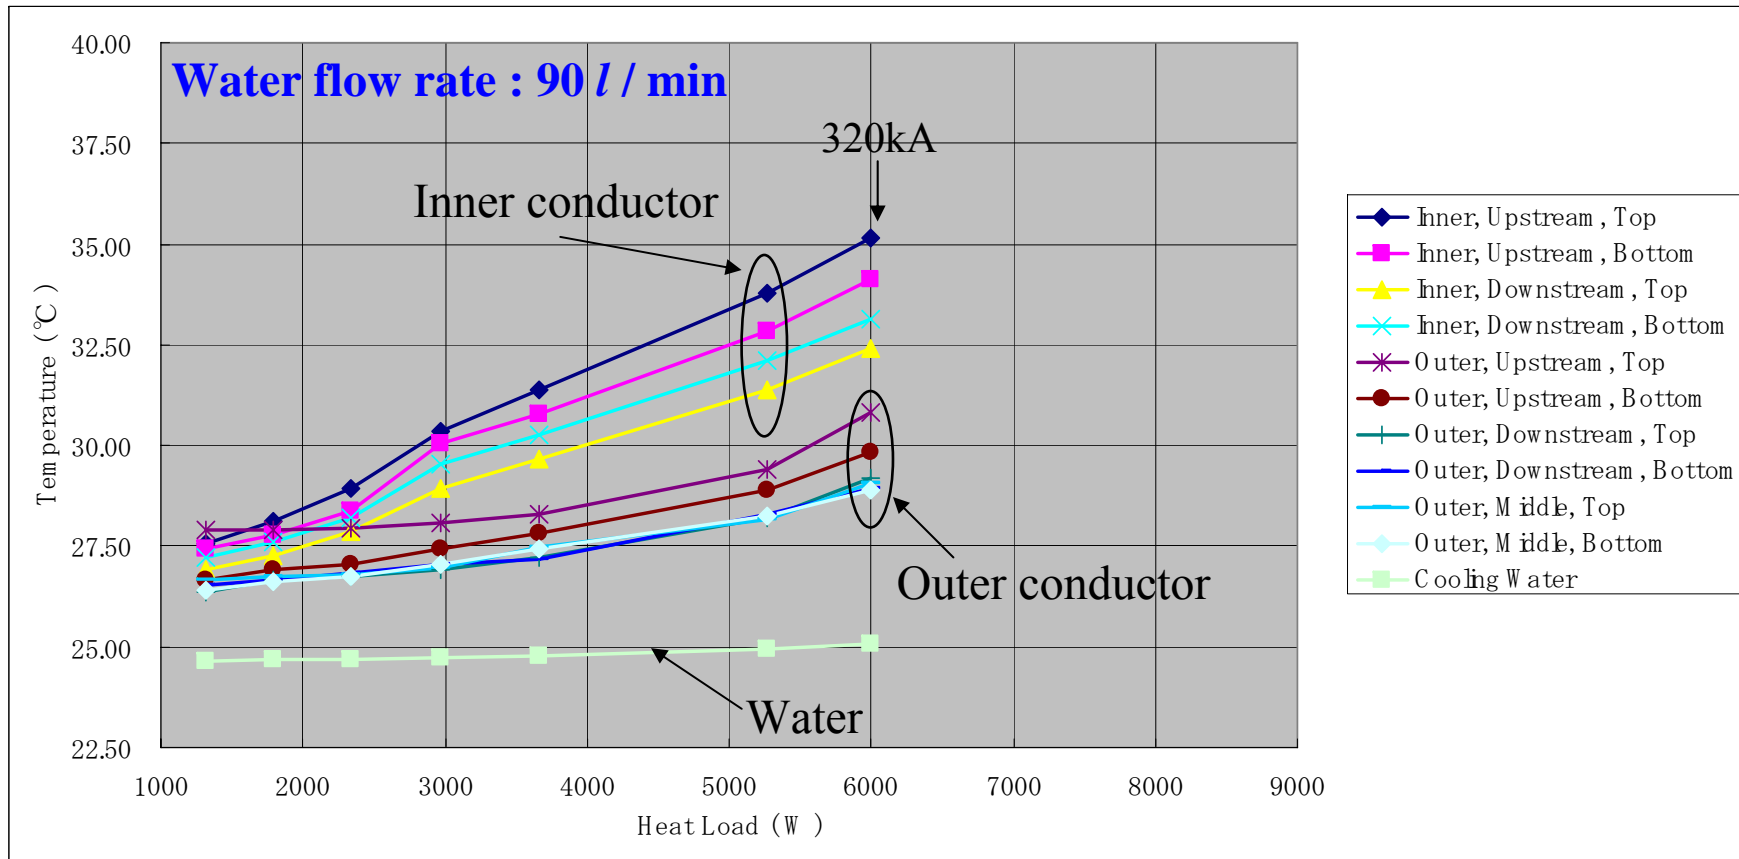
# Heat Load vs. Temperature

Heat load at inner conductor: ~95 % of total  
outer conductor: ~5 % of total

Temperature increase linearly to heat load.

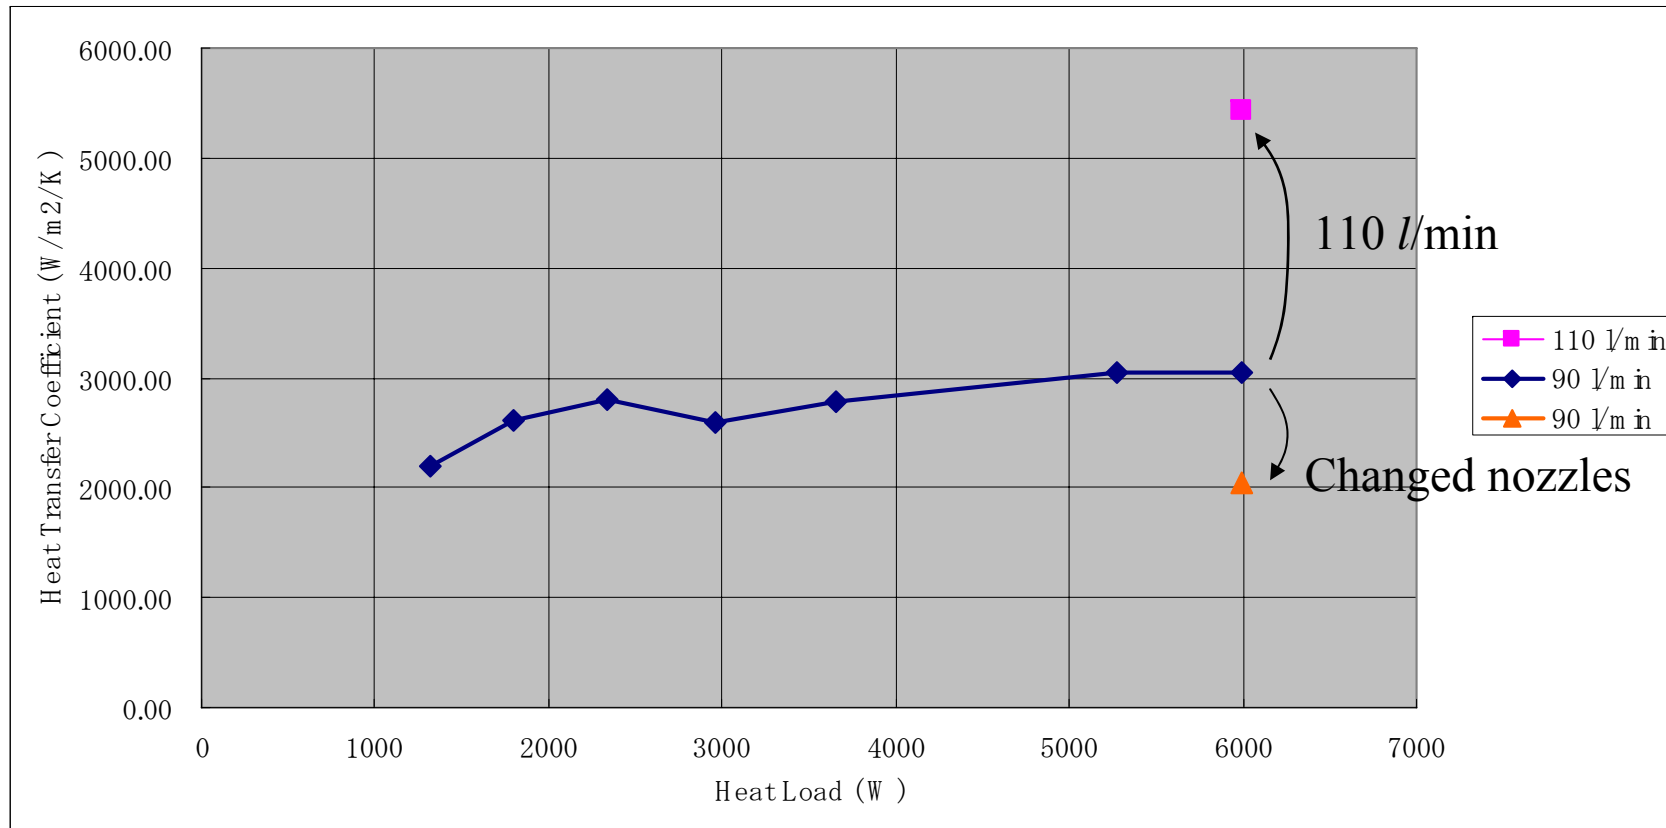
# Heat Load vs. Heat transfer coefficient

- 90 l / min (default nozzle) : ~3 kW/m<sup>2</sup>/K
- 110 l / min (default nozzle) : ~5.4 kW/m<sup>2</sup>/K
- 90 l / min (small diameter nozzle) : ~2 kW/m<sup>2</sup>/K

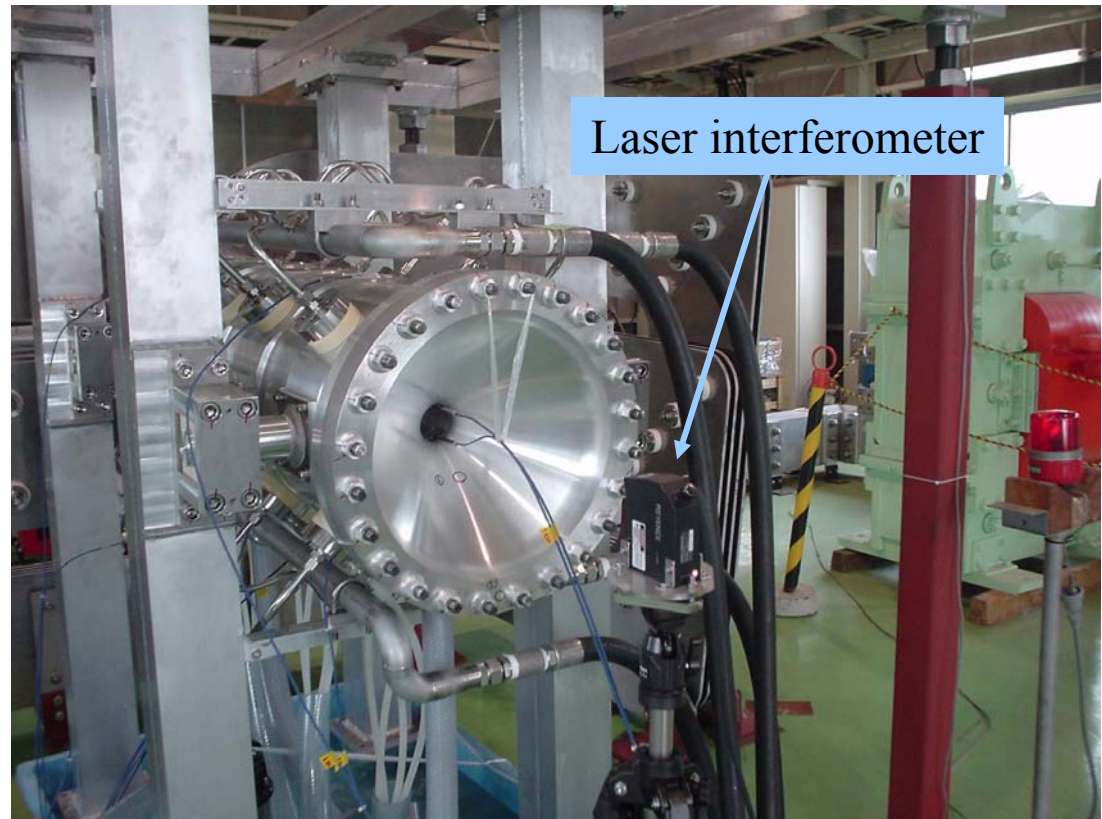
# Displacement measurement

- Motivation is to check the mechanical strength of the horn.
- Pressure due to Lorentz force
  - 2.5 MPa at inner conductor
  - 0.05 MPa at striplines
- Instrument for the measurement
  - Laser interferometer
    - 50 kHz sampling rate
    - 2  $\mu\text{m}$  resolution

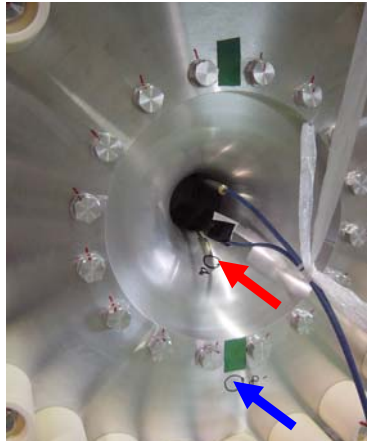
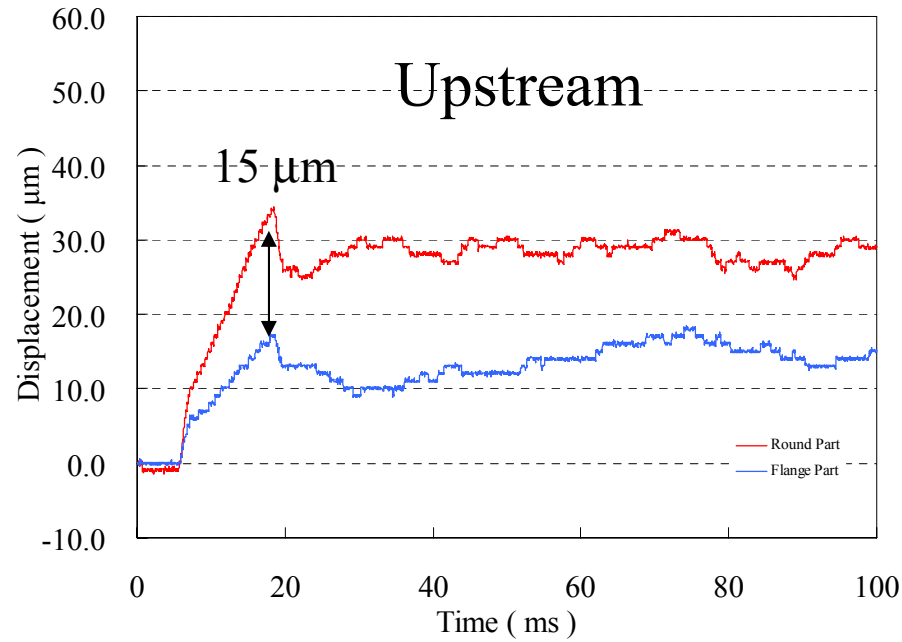
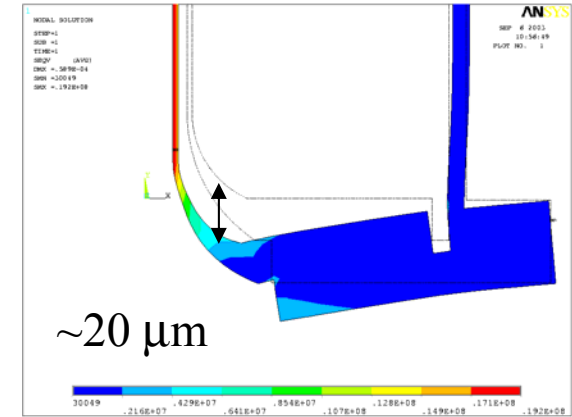
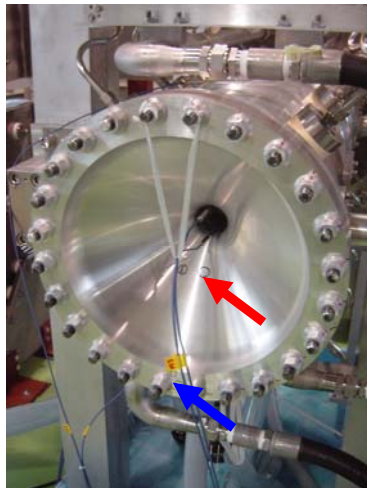
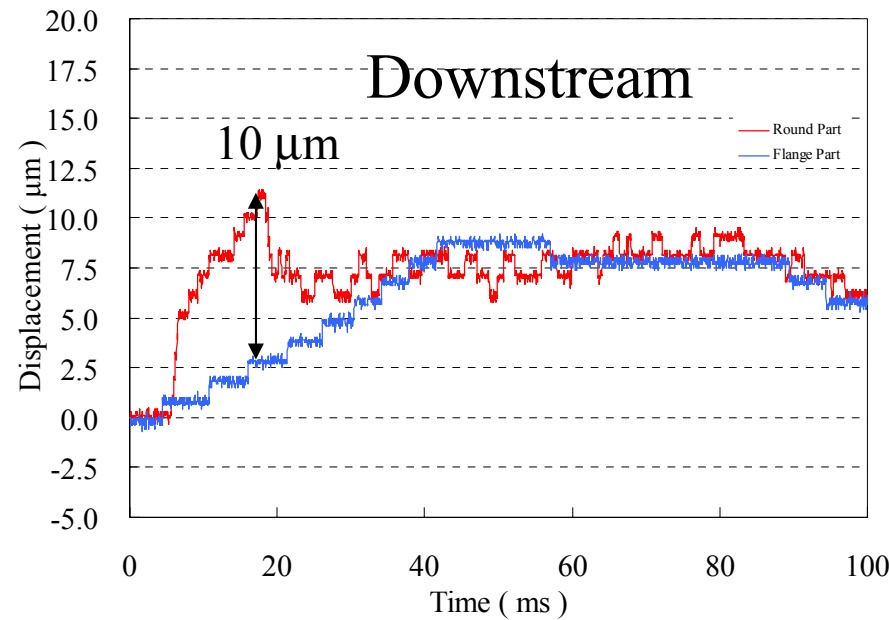
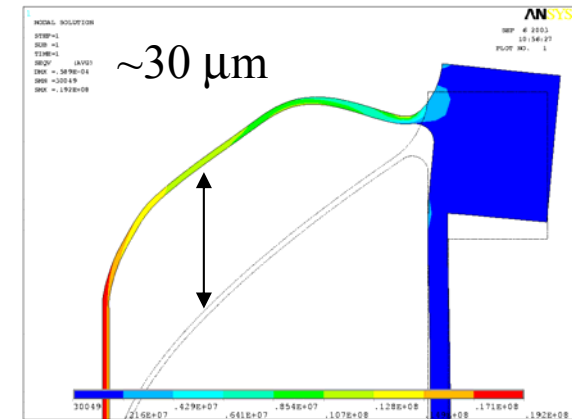
# Inner Conductor

Reference point

FEM analysis

Position	Measurement	Expectation
Upstream	~10 $\mu\text{m}$	~30 $\mu\text{m}$
Downstream	~15 $\mu\text{m}$	~20 $\mu\text{m}$
Stripline (vertical)	~50 $\mu\text{m}$	~500 $\mu\text{m}$ ? ←
Stripline (Ear)	~5 $\mu\text{m}$	~300 $\mu\text{m}$ ? ←
Transformer	~45 $\mu\text{m}$	-
Frame	~5 $\mu\text{m}$	-

- Inner conductor is sufficiently strong.
- Results of FEM analysis for stripline distortion need to be checked.

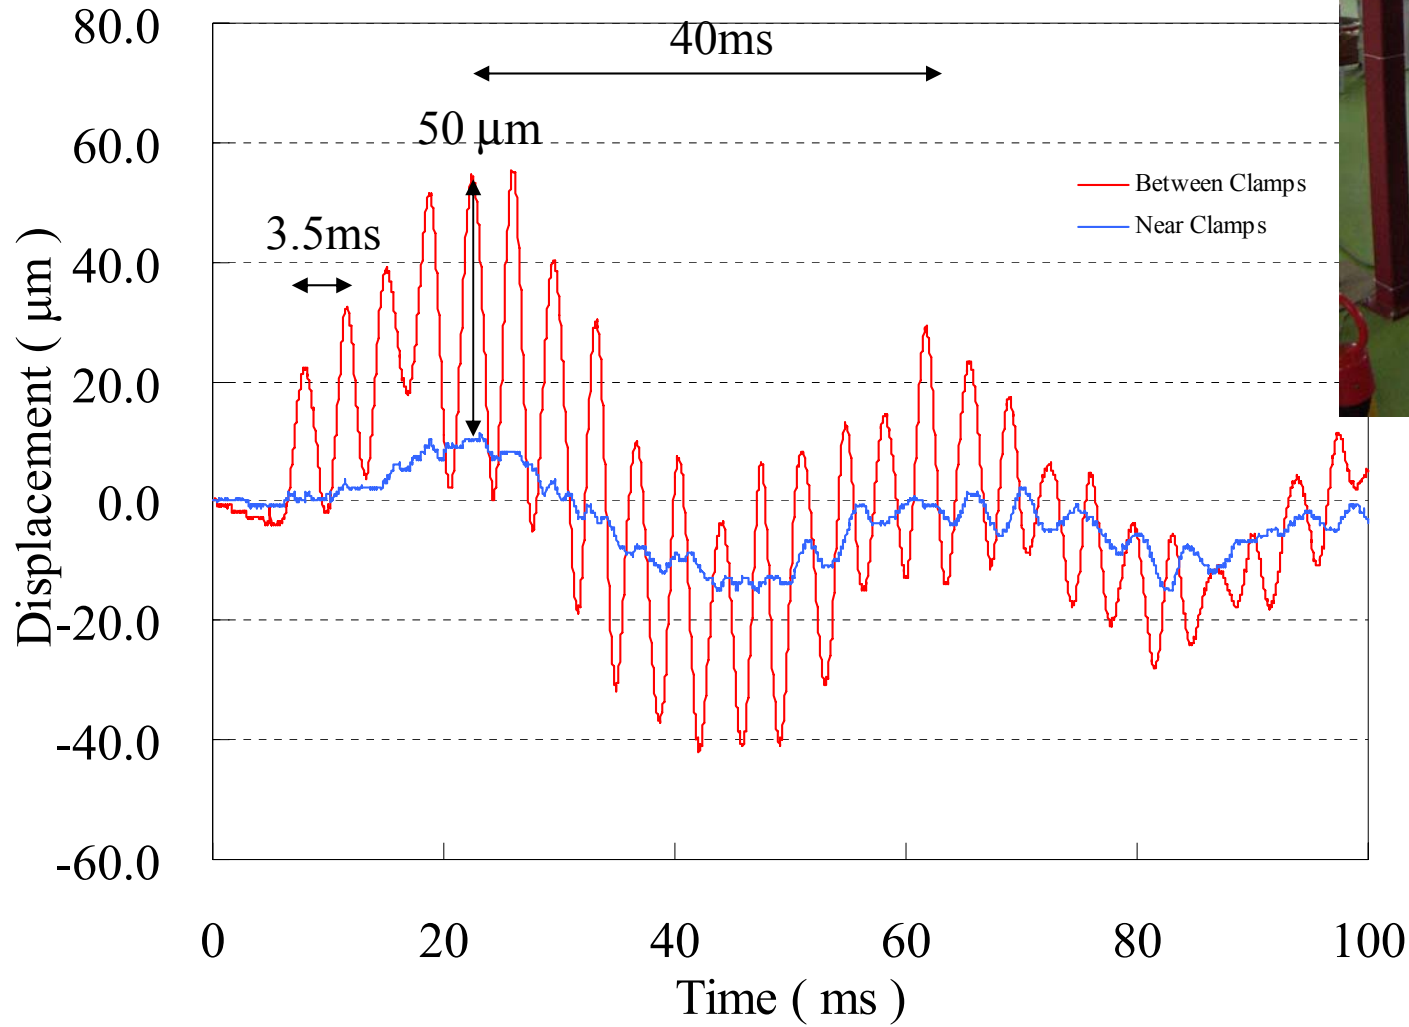
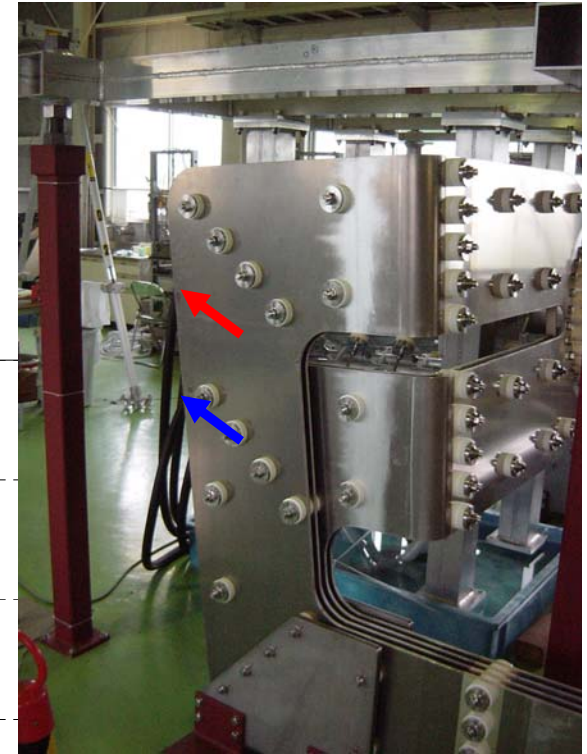
# Stripline ( Vertical Part )

Long term vibration ( $\sim 1.5$  s),  
but gradual dumping by next pulse.

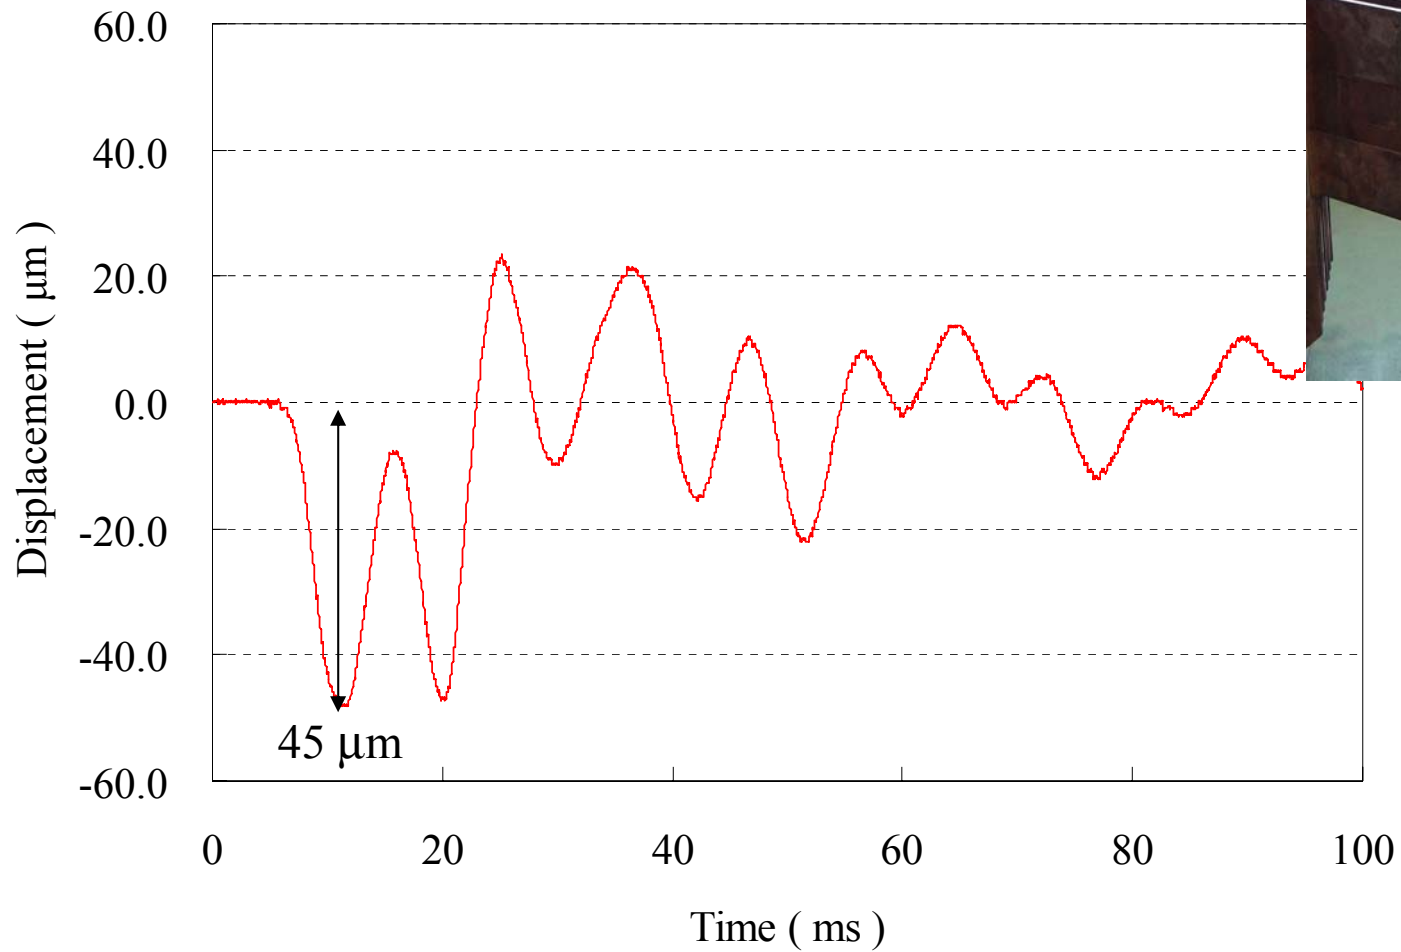
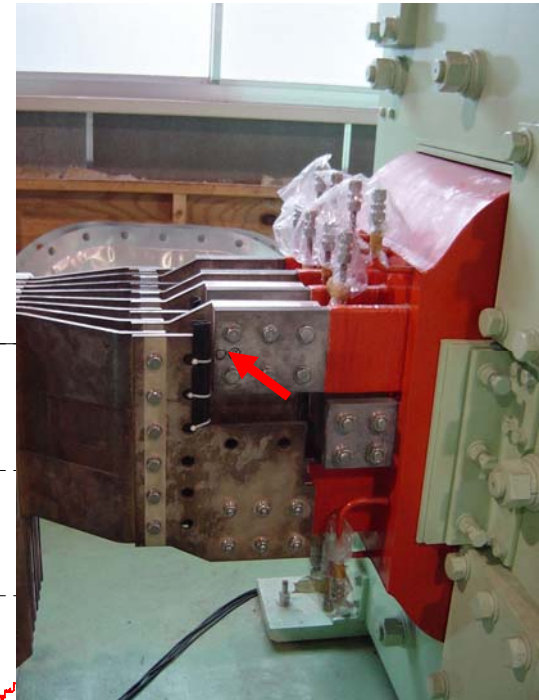
# Transformer

Large distortion at the transformer

Bad situation, since we will use this transformer at physics run.

Fix the transformer plates with long bolts.

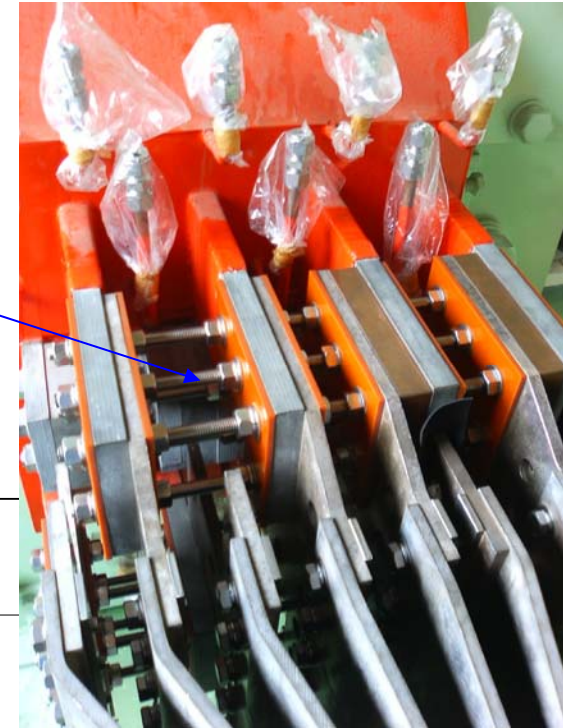
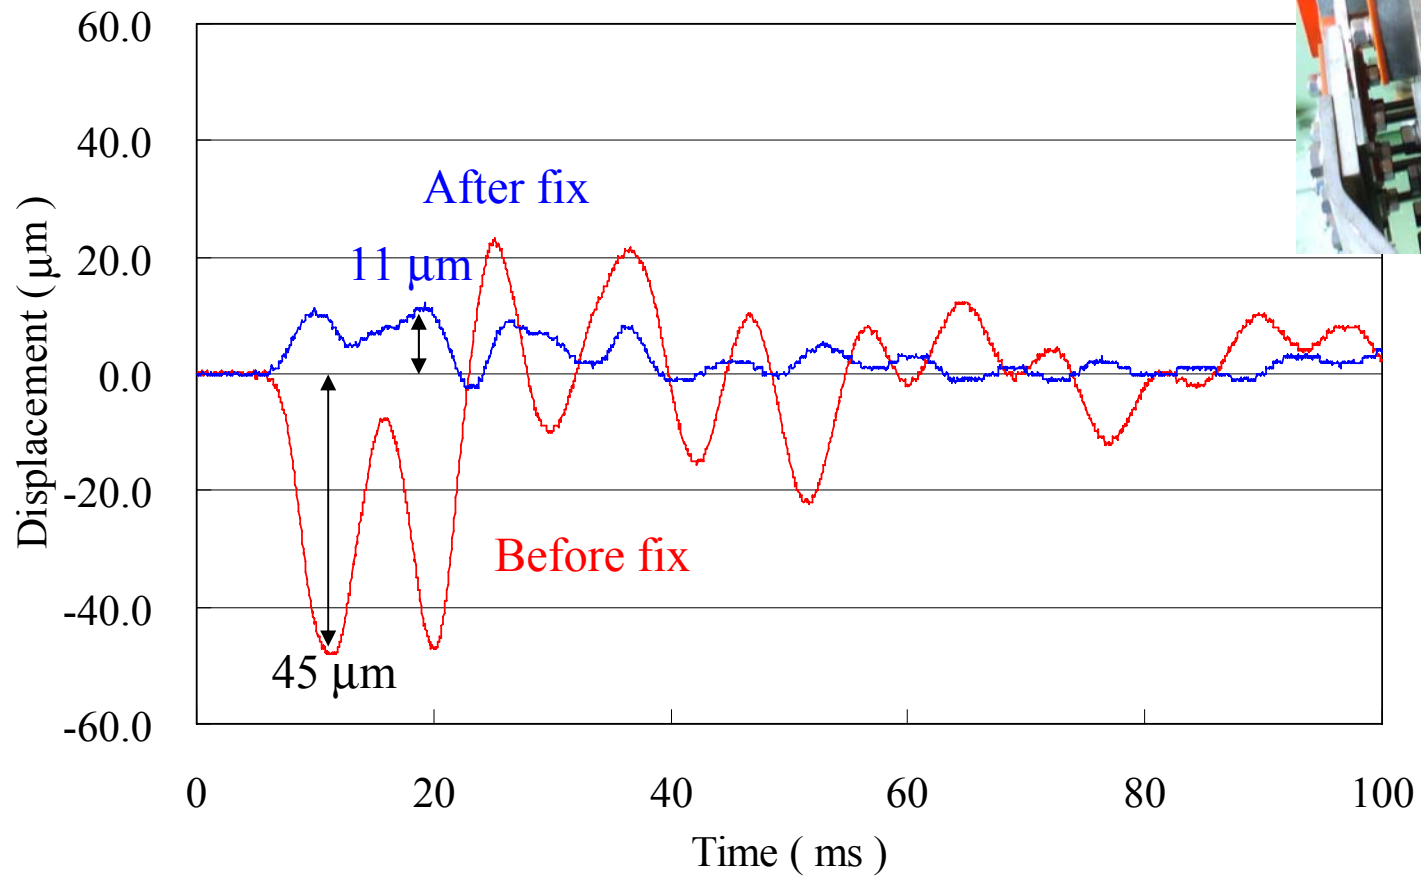
# Transformer

Magnitude of the distortion reduced.

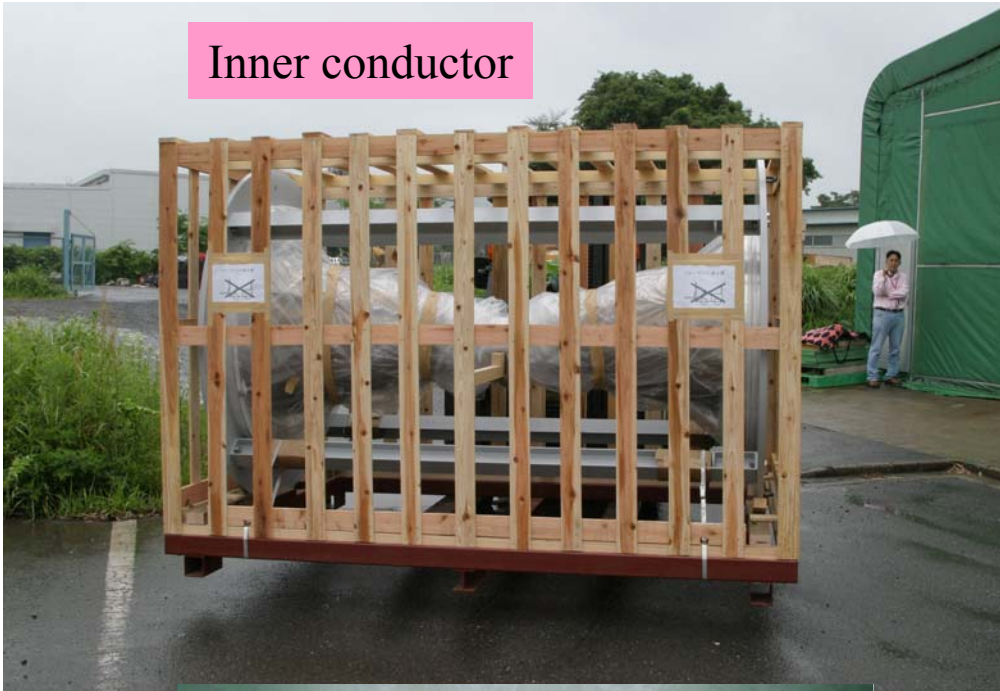
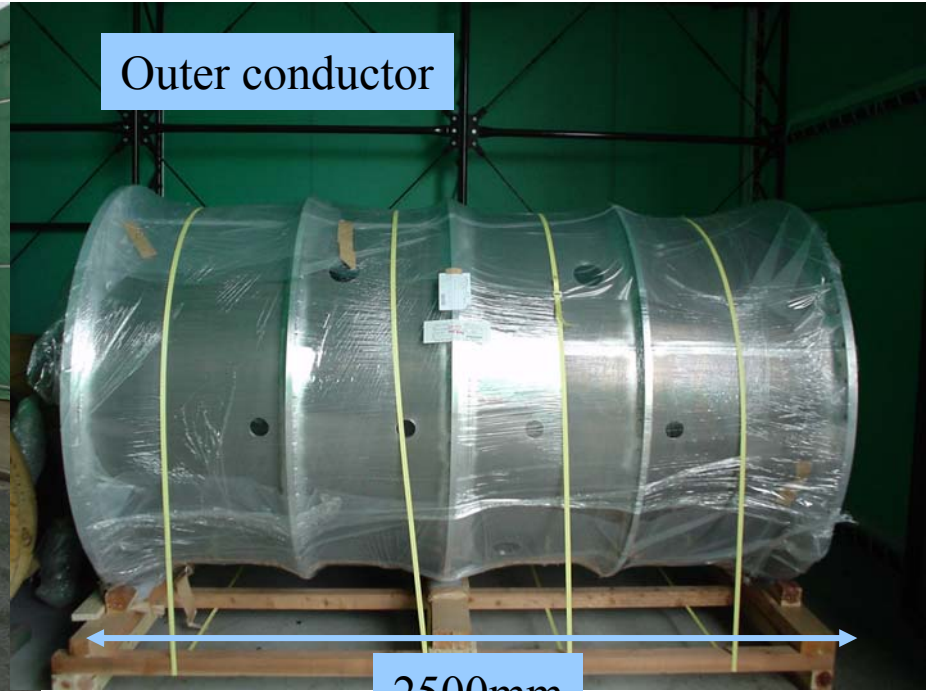
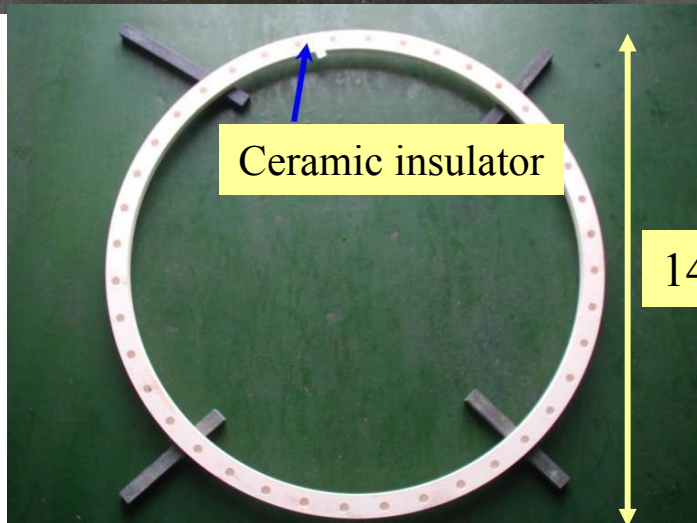
# 3<sup>rd</sup> Horn Prototype

Inner conductor

Outer conductor

2500mm

Ceramic insulator

1440mm

Assembling will be done within this fiscal year

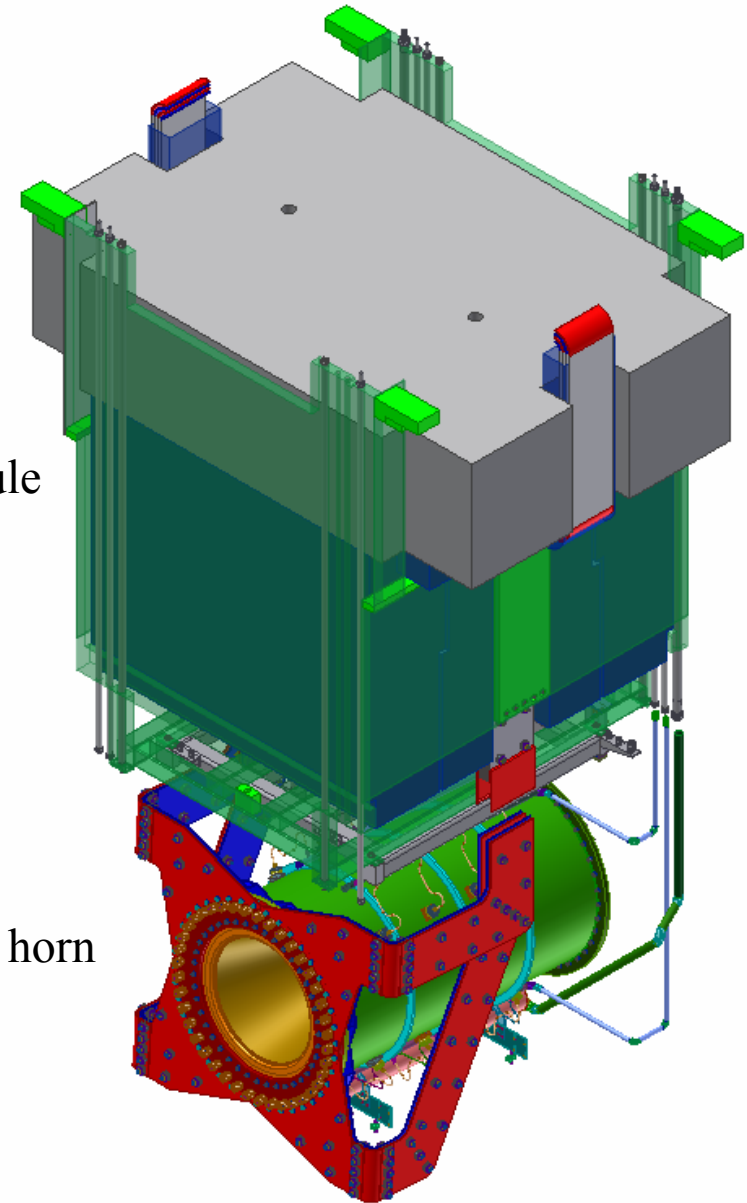
# Current Operation with Full Setup

3<sup>rd</sup> horn and its support module will be produced in this fiscal year.

Support module

Test operation will be performed with full 3<sup>rd</sup> horn configuration.

3<sup>rd</sup> horn
