# Status of T2K Horn Prototypes

T. Sekiguchi (KEK)

for T2K Target & Horn Group

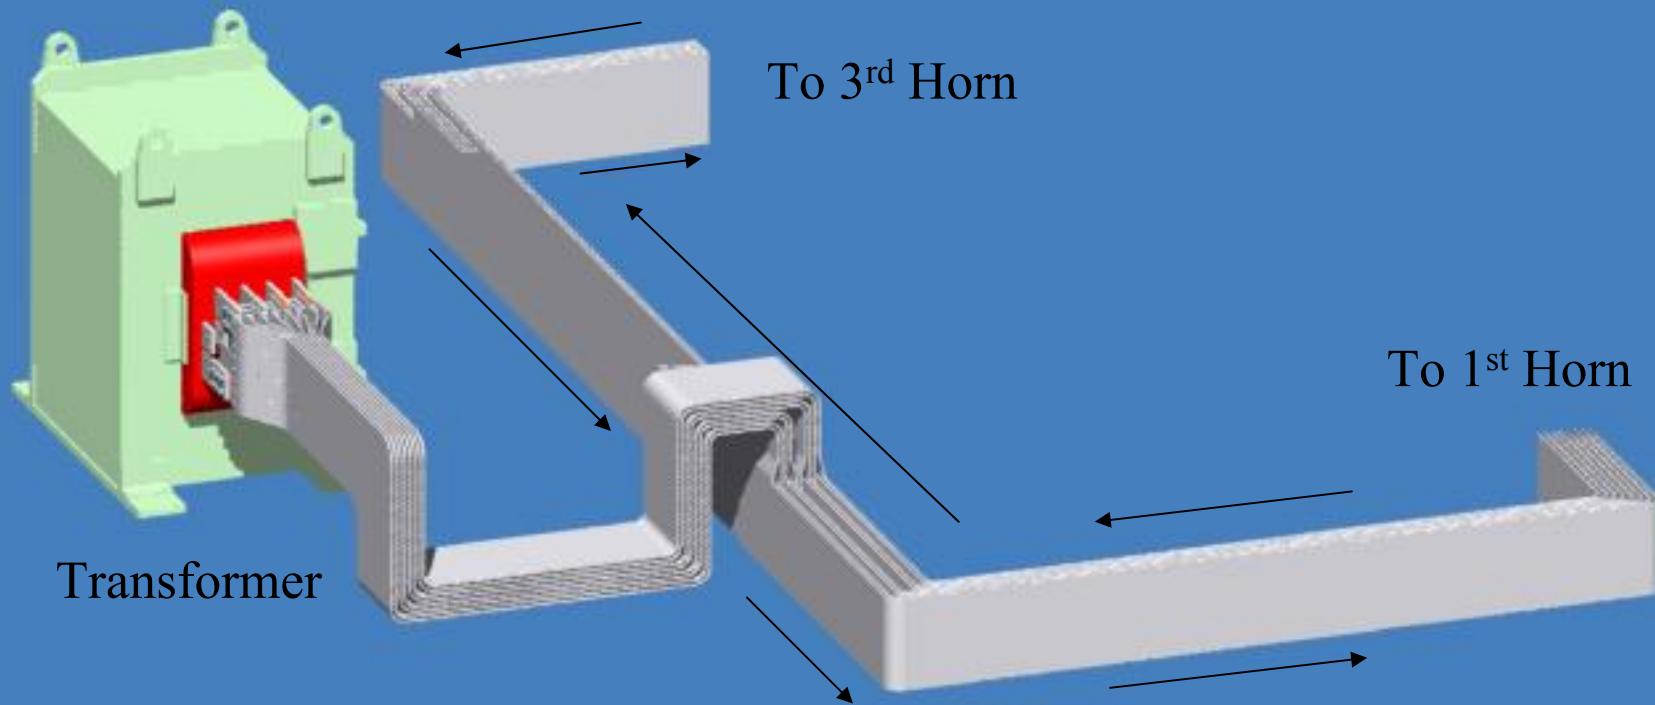
# Two Horn Serial Connection

2<sup>nd</sup> and 3<sup>rd</sup> horns will be connected serially.  
In horn test facility, 1<sup>st</sup> and 3<sup>rd</sup> horns will be connected for test.
