Comparative study of proton induced radiation damage in plastic scintillators for the Tile Calorimeter of ATLAS

Presented by: Harshna Jivan

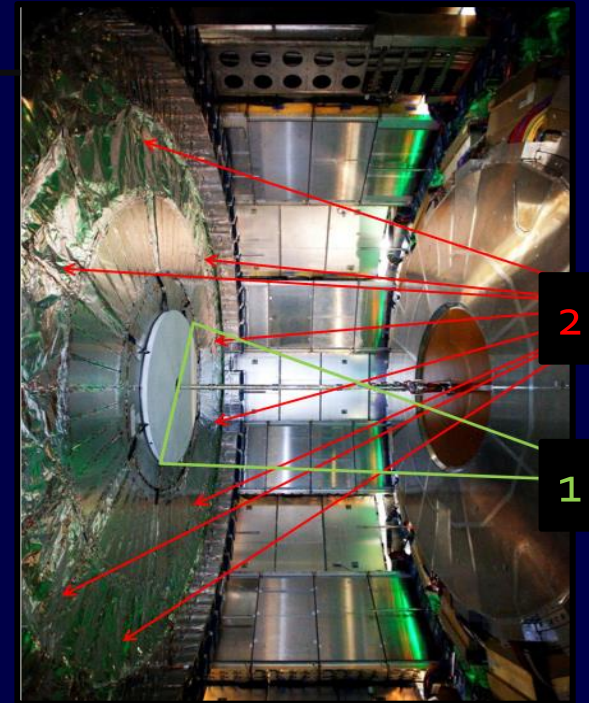
- Gap regions contain additional scintillator plates distributed radially. [1: MBTS scintillators, 2: Crack scintillators]
- During Run1, crack scintillators exposed to ~100 Grays per year. Expected to increase with Run2.
- It is predicted that scintillators in the Gap will sustain a significant amount of radiation damage during HL-LHC run time and may require replacement during the 2018 upgrade.
- Thus, conducting a comparative study into radiation hardness of several "radiation hard" scintillators available.

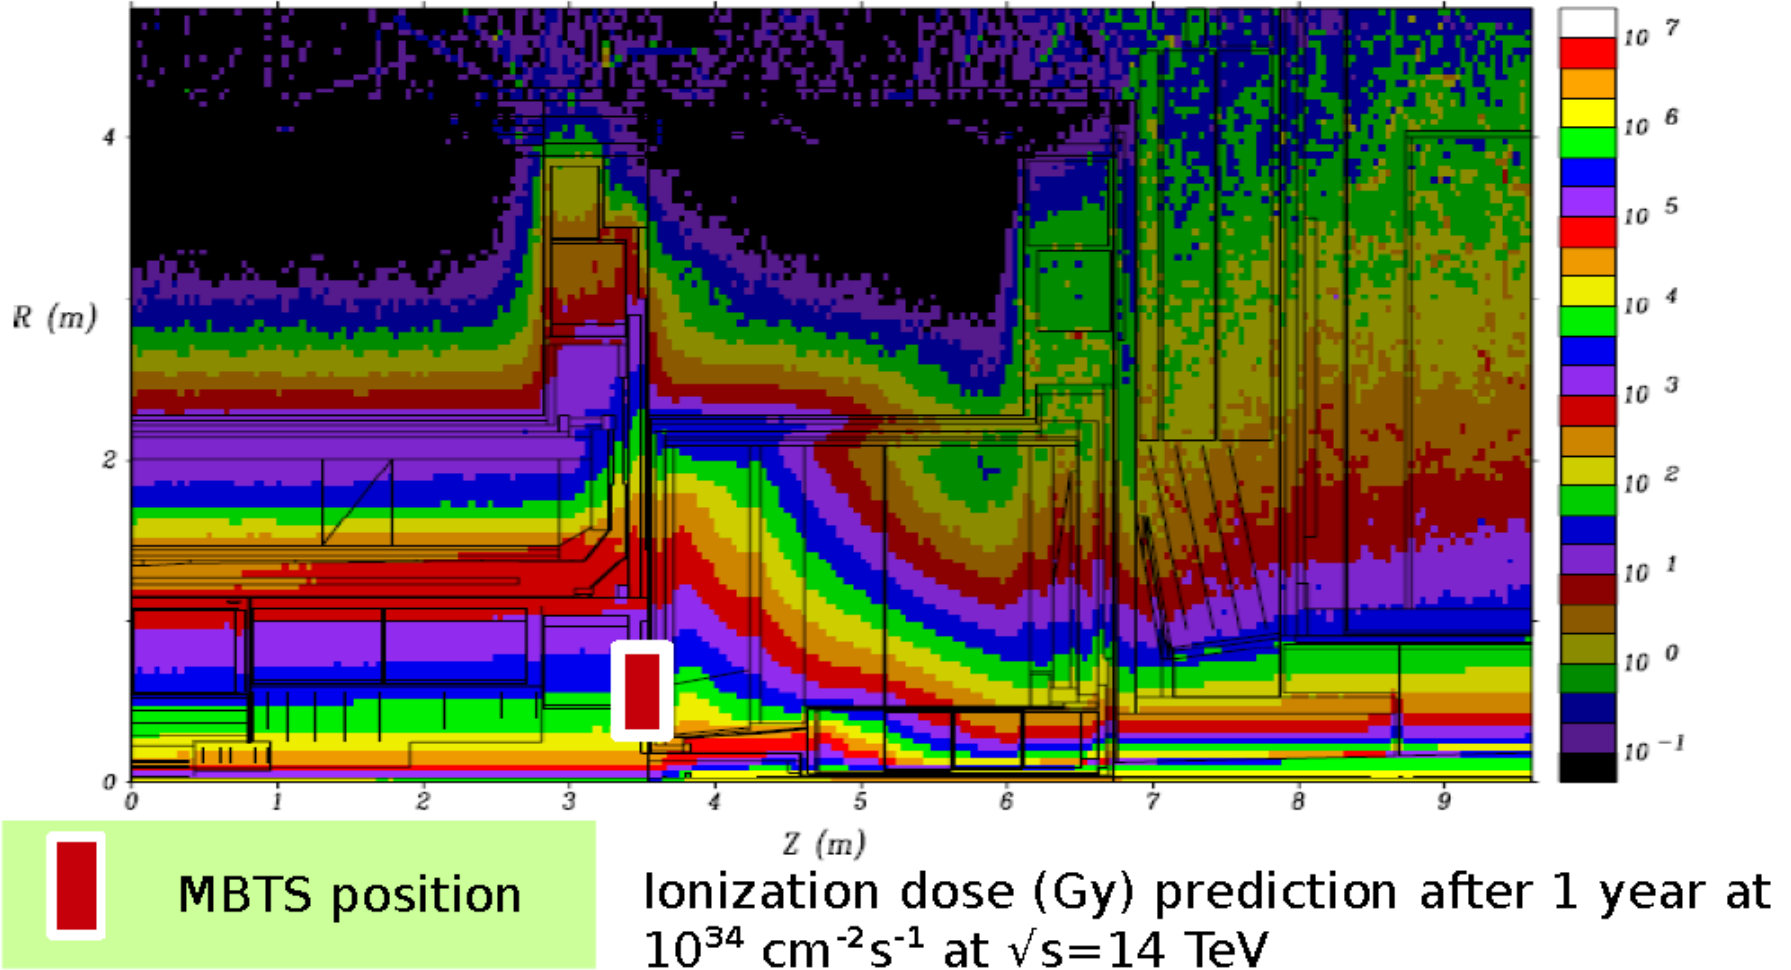
- During Run 1 → MBTS accumulated $\sim [0.1-0.4] \times 10^4 \text{ Gy}$
- At 10^4 Gy → Predict $\sim 50\%$ Light loss due to transmission

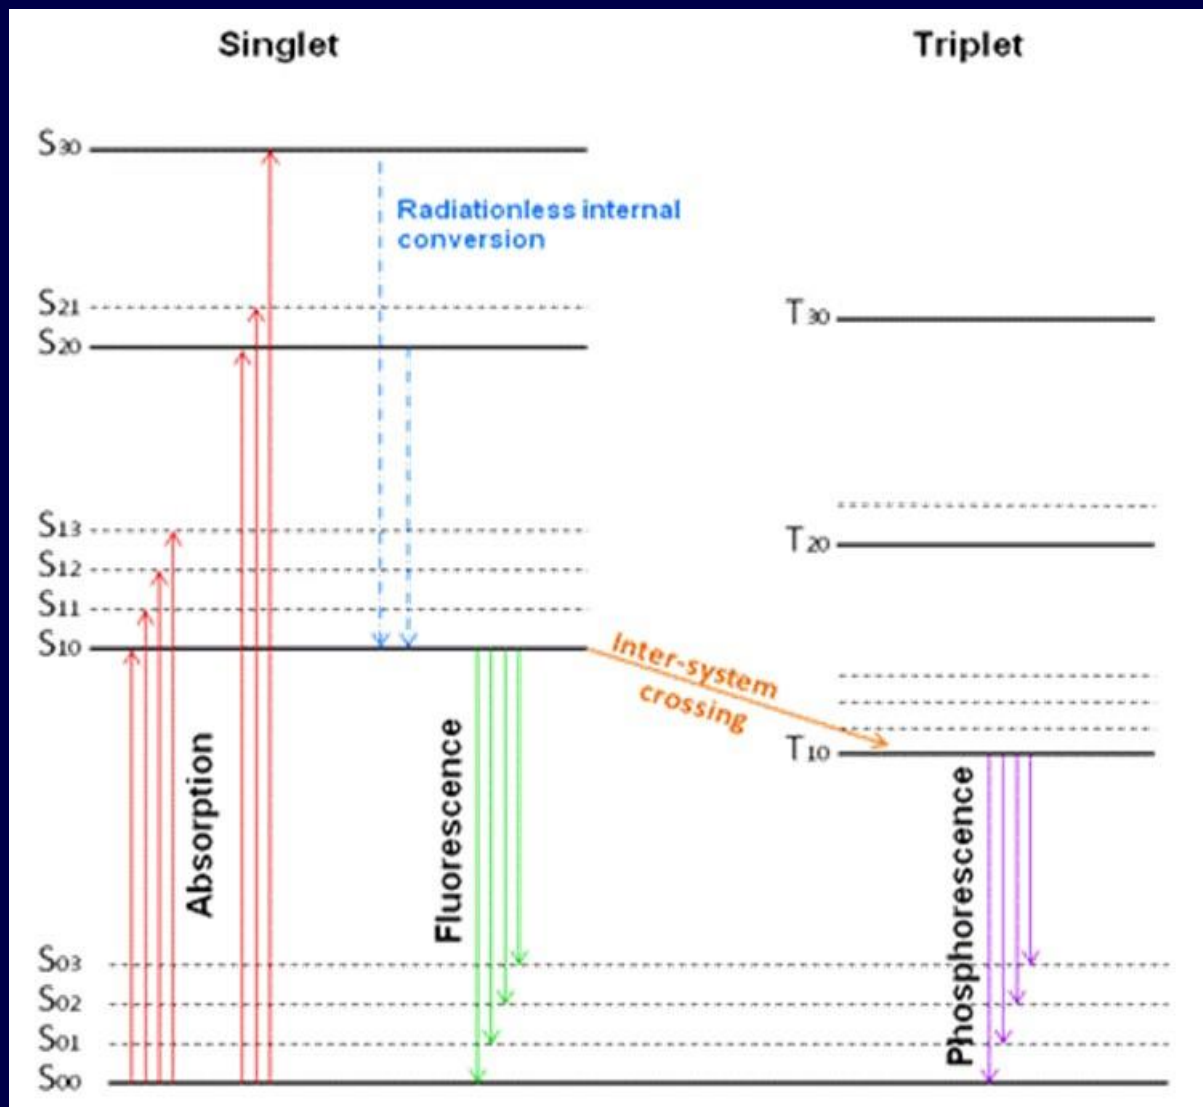
- The basic mechanism behind scintillation is the **fluorescence** process undergone by delocalized π -electrons arising within the benzene ring type structure.

Energy level diagram of an organic molecule with π -electron structure

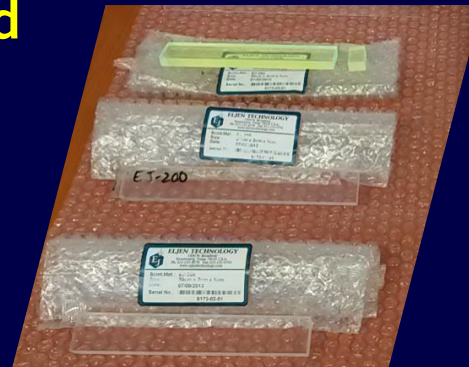
Base: Polystyrene

Primary fluor: PTP

Secondary fluor: POPOP

Base: Polyvinyl Toluene

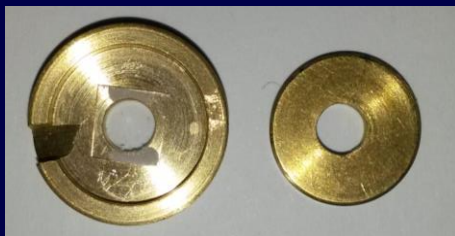
- The samples were then mounted to a holder using carbon tape.
- A fine polishing process was followed using a complementary polishing direction.

- Polished samples were then placed in holders prior to irradiation.

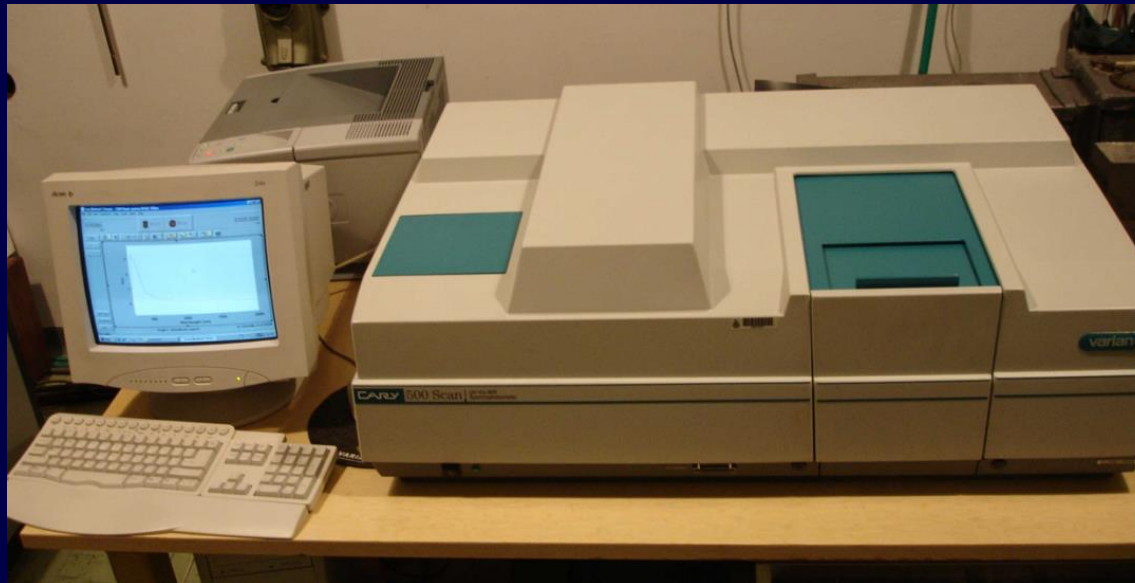
Transmission vs Wavelength For EJ200 at different Exposure Doses

- Conducted using the Varian Cary Spectrophotometer.
- Taken over wavelength range of 200-800 nm.
- Spectra are measured before and after irradiation.
- The ratio of transmission in the irradiated vs unirradiated sample is then taken

Across all grades, healing occurs exponentially, with the most significant healing occurring overnight. Photobleaching is the likely cause of this healing.

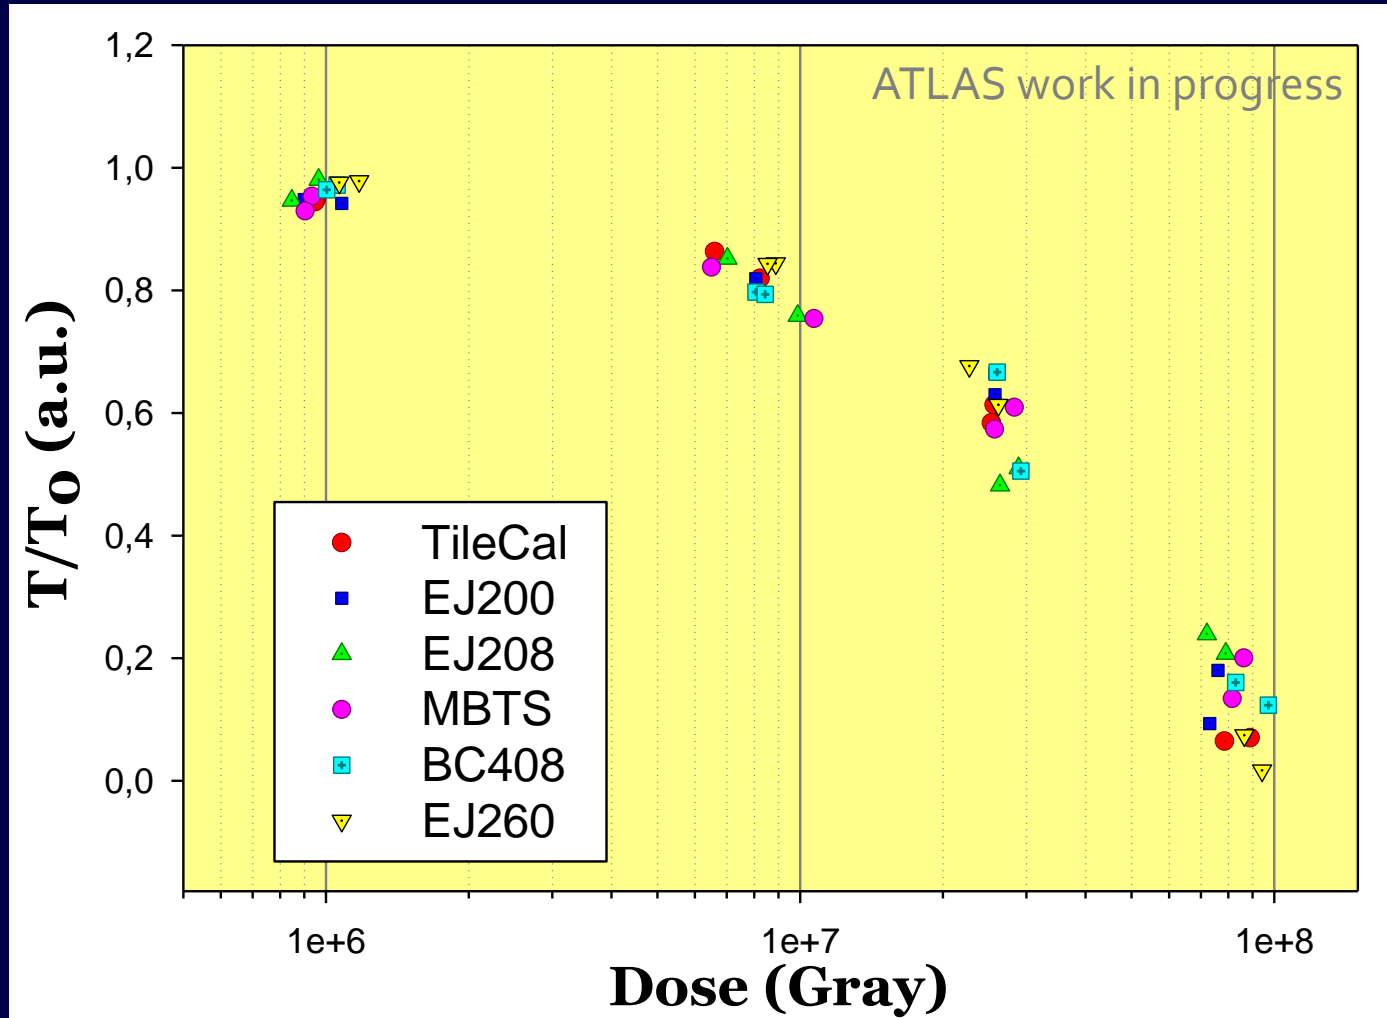
Relative Transmission loss at 420 nm

- Consider transmission loss around 420 nm. Wavelength range where blue scintillators typically emit and absorption peaks in Y11 fibers occur.
- EJ208, Bicron and Dubna (MBTS type) perform well.
- For overall transmission loss however, consider collective loss along regions coinciding with absorption regions.

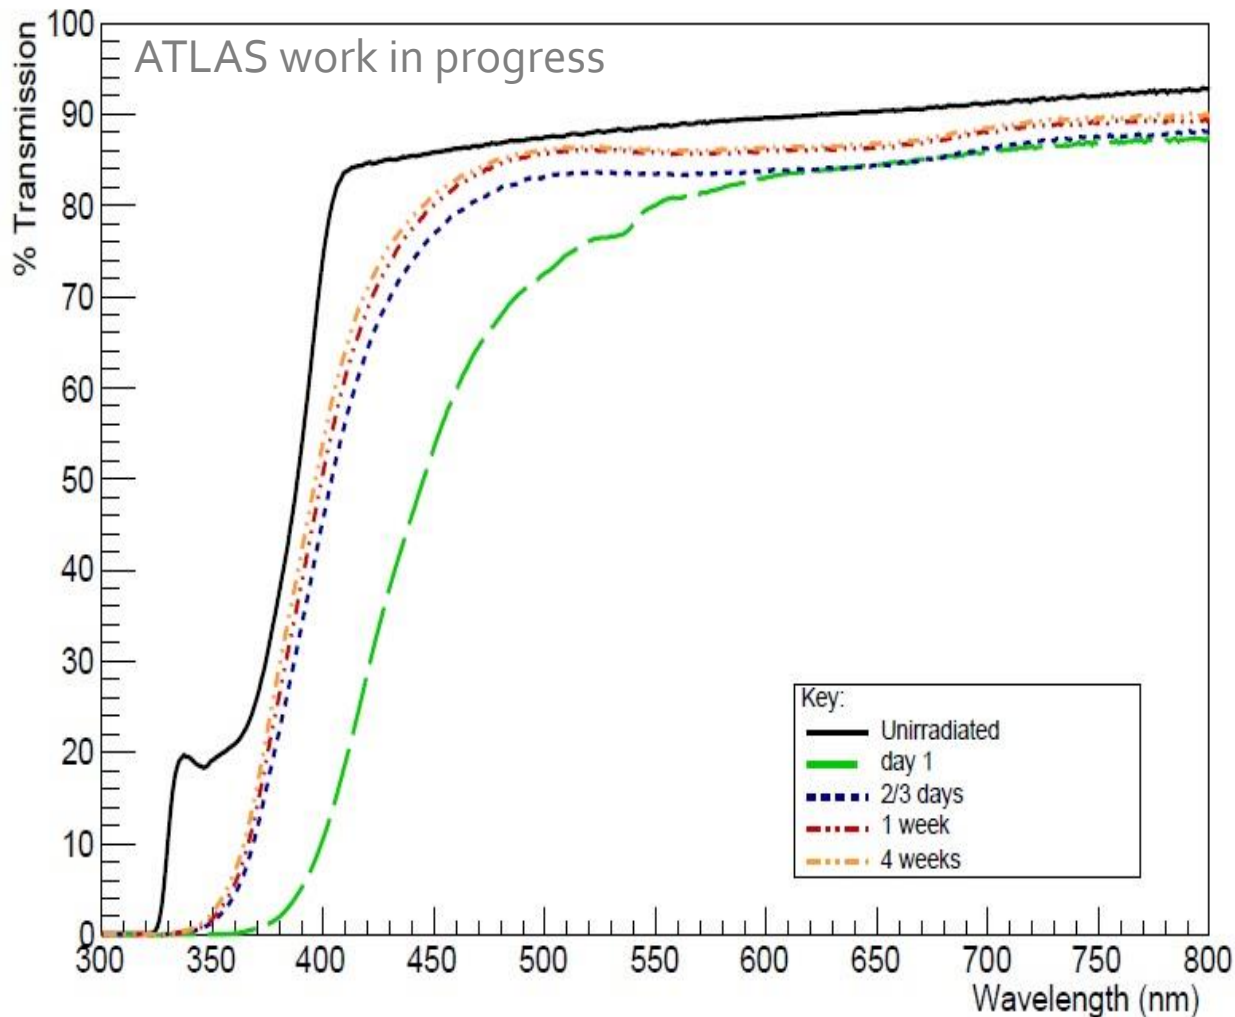
Transmission vs Wavelength For EJ 200 on different days

Healing of 25 MGy irradiated EJ200 scintillator sample.

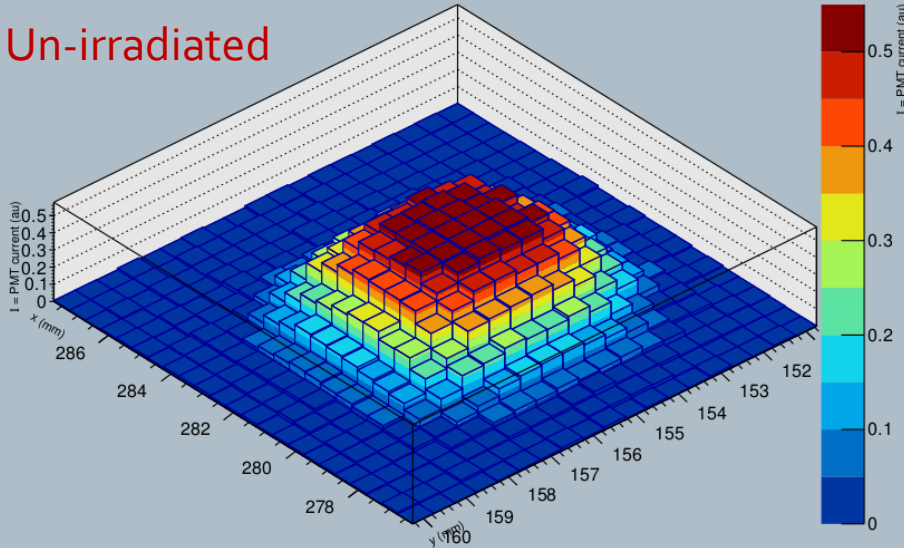
Un-irradiated

- Some preliminary results
- Can see decrease in overall light response of scintillator
- To gage loss, take ratio between integrated signal in irradiated sample to un-irradiated sample.
- Technique is very sensitive to systematics, therefore will also be testing light yield after UV laser excitation as well

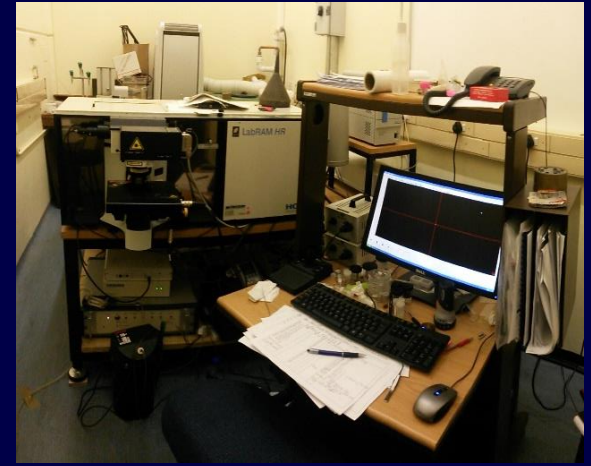
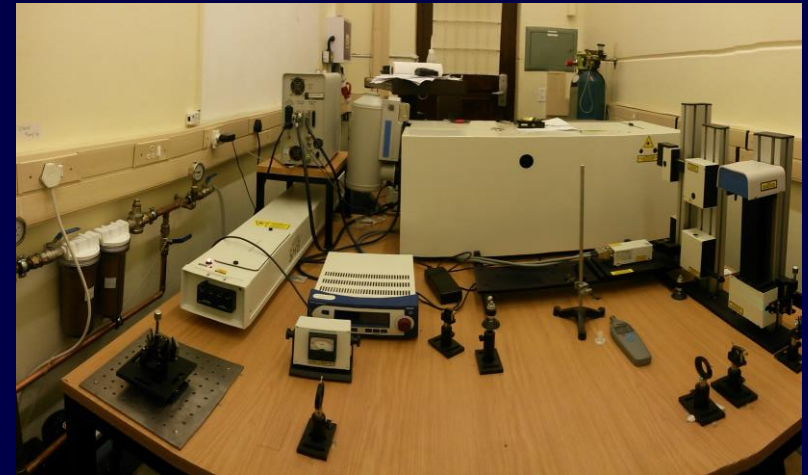
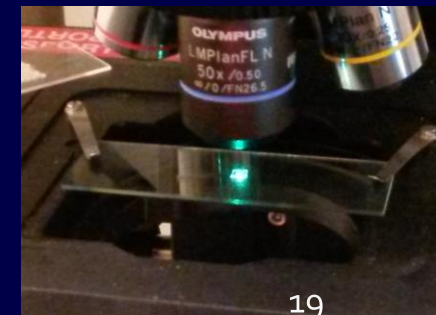
- A 514.53 nm Argon laser excites vibrational modes within the sample.
- These de-excite and release photons of a characteristic wavelength.
- The Raman spectrum obtained corresponds to the intensity of photons detected at various wavelengths
- Indicates vibrational modes and hence bonding structure present in the sample.

- Raman spectroscopy results for EJ200 shown below.
- Background fluorescence increases with dose, because sample absorbs more light at 514 nm with increased dose. (Seen in transmission spectra)
- NB: The various spectra overlap but I added a constant to the 800 kGy and 8MGy spectra for visual impact

- There is a small change in the specie content after irradiation. The scintillator heals significantly 4 weeks after irradiation
- Damage occurs to the benzene ring. As a result of the CH type bonds breaking, hydrogen lost from the benzene ring could be lost to free radicals.

- A significant amount of healing is observed both in the transmission spectra and in the structural recombination seen from the Raman data 4 weeks after irradiation.

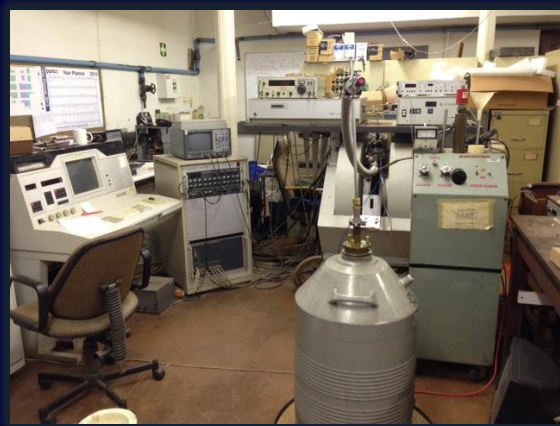
We study unpaired electrons in the plastic scintillators using EPR, by placing them in a large magnetic field and applying a resonant frequency that satisfies:

$$\Delta E = h\omega_0 = g\mu_B B_0.$$

From the value of the magnetic field at the peak, the g-factor can be computed using:

$$g = 2\pi\omega_0 \frac{m_e}{eB_0}$$

- EPR studies will give us a better indication of the free radicals formed by the damage.

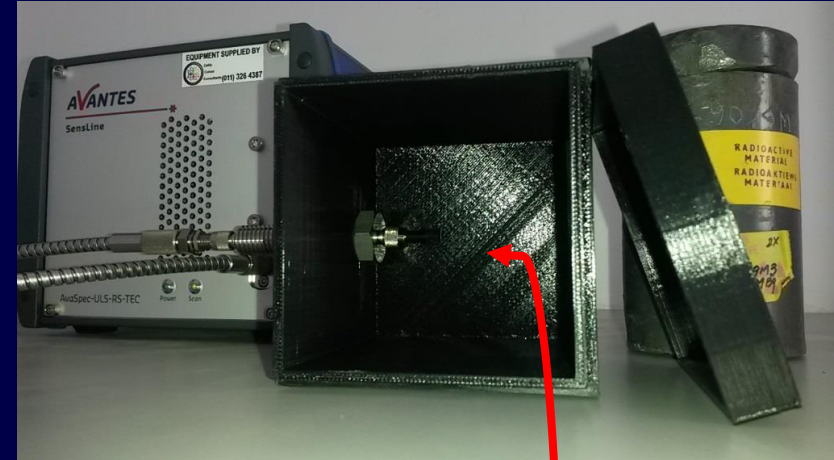
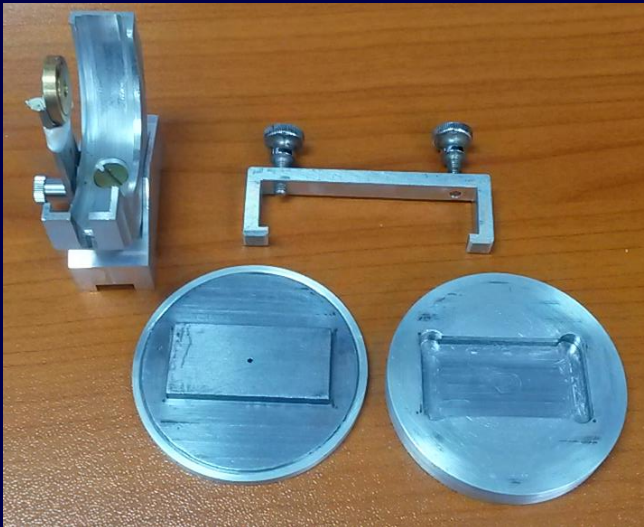
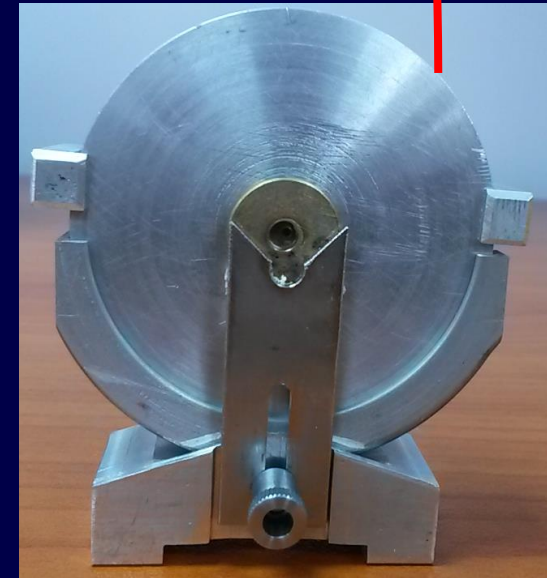
- Will encompass a Sr90 radio-active source housed in a lead container with a collimated outlet.
- Sample will be mounted on a holder attached to the lead container.
- Spectrometer will detect light emitted by the scintillator in response to 0,5 MeV beta particles emitted by source.
- Set-up will be housed in light tight box.
