10 kA joints for Multi-Tape HTS Cables

J. S. Murtomäki, G. Kirby, J. van Nugteren, P.-A. Contat, O.S. De Frutos, J. Fleiter, F.-O. Pincot, G. de Rijk, L. Rossi, J. Ruuskanen, A. Stenvall and F. J. Wolf

*Magnet Technology
2017, Amsterdam, NL*

EuCARD-2 High Temperature Superconductor (HTS) Project

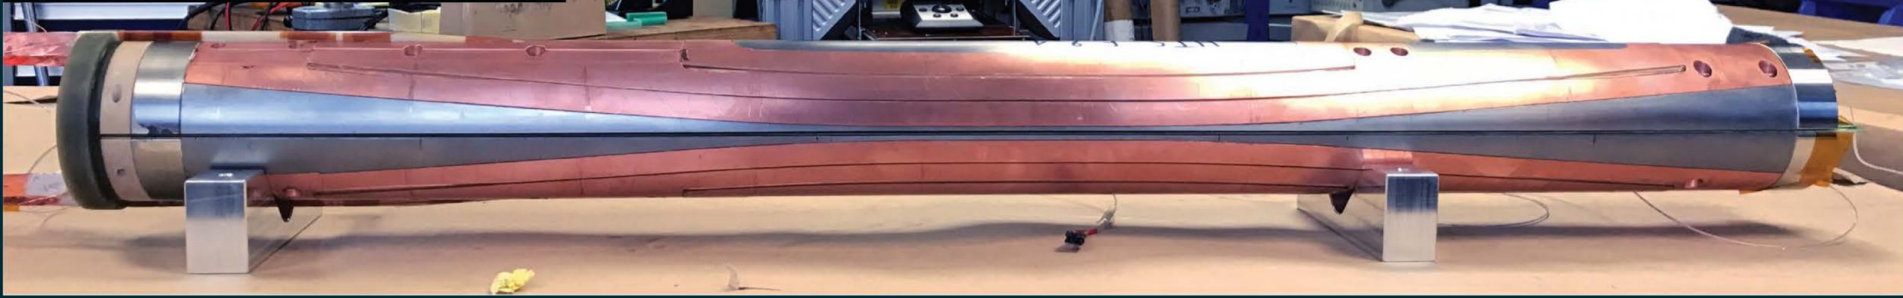
SIDE VIEW OF THE TWO ASSEMBLED AND IMPREGNATED FEATHER-M2 POLES

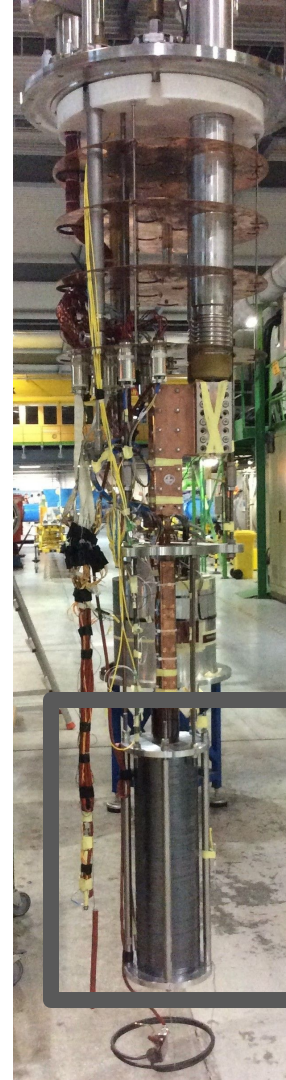
Feather M0.4

“Inexpensive”
race track
Roebel test coil for
testing and solving
problems of FM2

Right: FM0.4
Ready to be
moved into
cryostat In a
test
insert

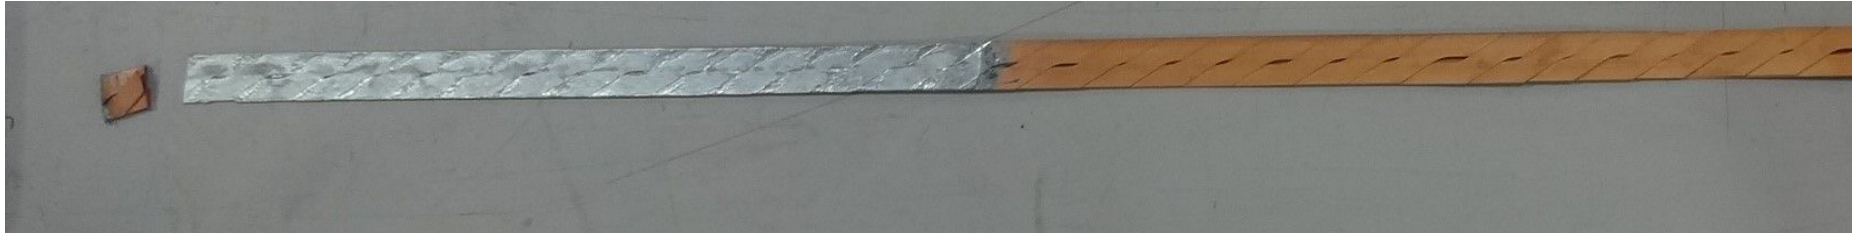
Current leads: First thing to come in mind was to try

- “Conventional LTS type”
Soldered block cable joint

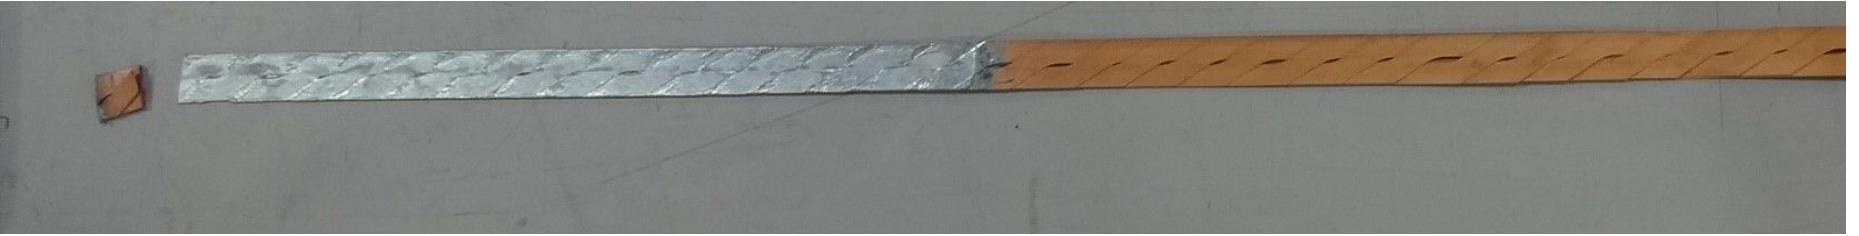
Connect the soldered part of cable with a clamp directly to cryostat bus bar ---> **NOT GOOD**

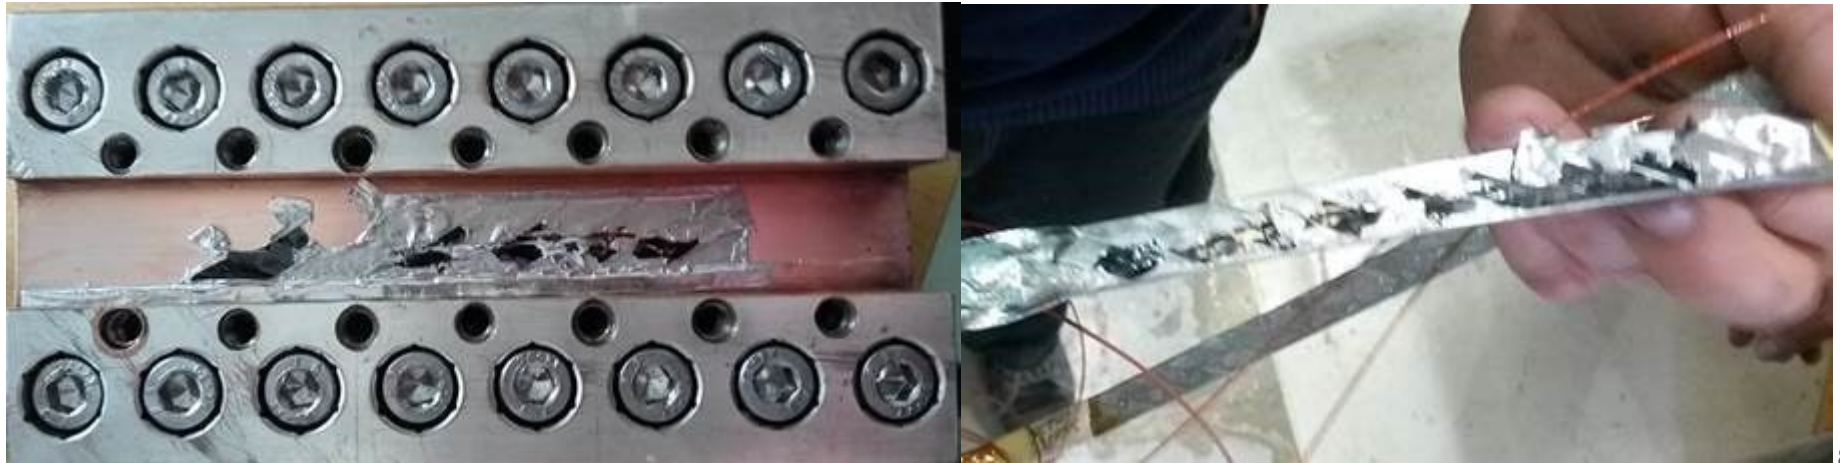
Cable delaminated, when disconnecting the cable from the clamp

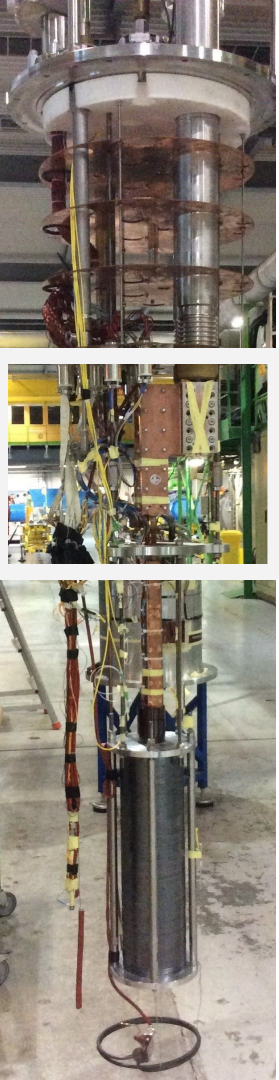
Adapter surface

Current leads

Top clamp extension (invisible)

M6 bolts to provide light pressure on cable

Top clamp Adapter

Roebel cable

Bus bar

Adapter

Adapter contact

15 mm Groove

Cable soldered on copper back strip

Indium layer

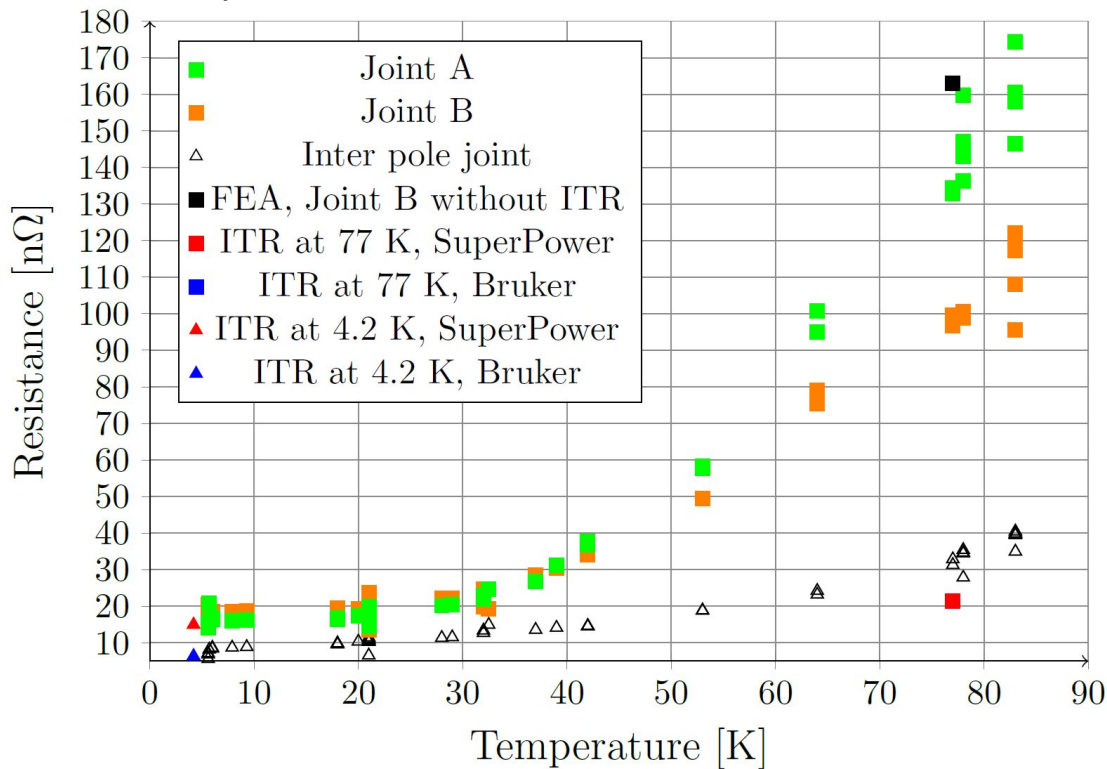
Comparable resistance between the Fin block and the soldered cable joint is close to the points for the inter pole joint since there is Indium to improve the contact

Solder: Sirius 1 Di-86-3 Sn62Pb36Ag2

Inter pole joint
8x M4 bolts T~22 Nm

5x indium sheets were set between inter pole Fin-blocks, while the lead joints have none.
