RF Preparation for Beam in 2009

E. Ciapala, on behalf of the AB-RF Group

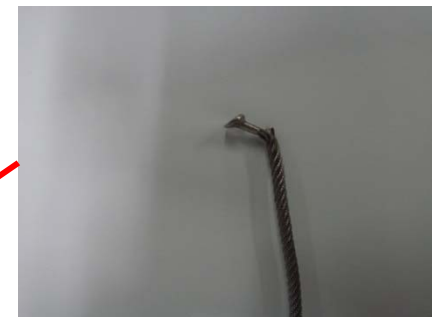
Torsion bar

Broken cable !

- Dowel blocking in its lever, - New cables and dowels made for all cavities

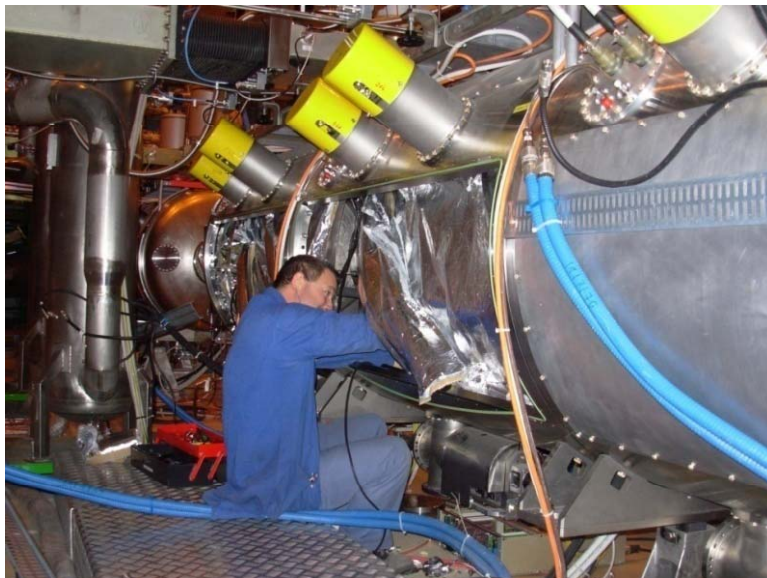
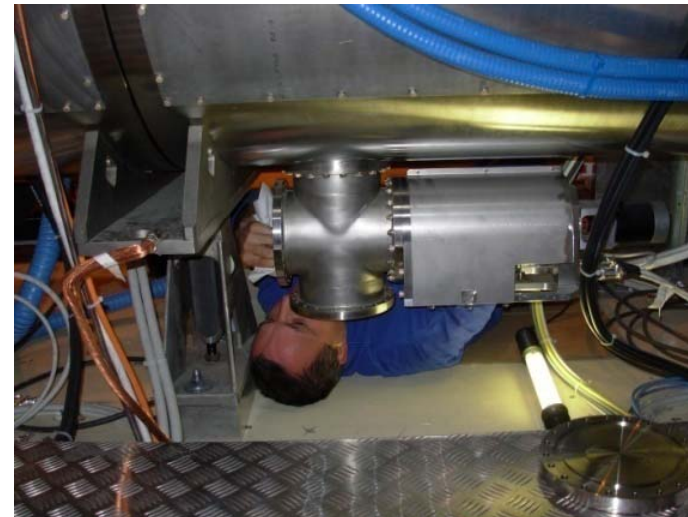
- Fortunately can be repaired in-situ, thanks to removable covers on cryostat

Nevertheless a tricky job,
But nearing completion – End of this week
