IBL – Introduction

Pixel detector originally designed to replace innermost Pixel layer called B-Layer

ACES 2016, CERN

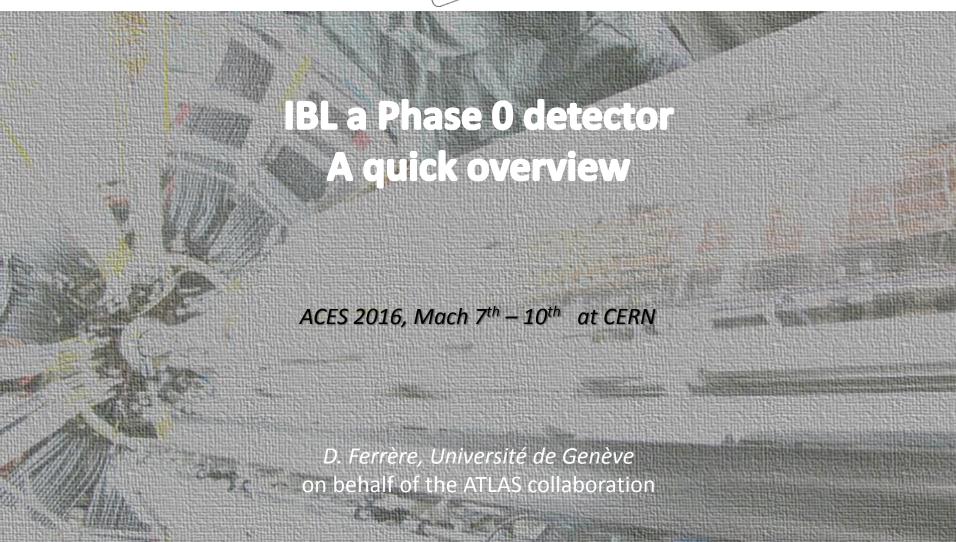
Reduced LHC beam pipe radius (OR of 24.3 mm) offers a new option → IBL

- Improved tracking performance and robustness
- Improvements to sensors, front-ends, back-ends, module design, cooling

- 14 staves overlapping in phi, surrounding beam pipe at ~3.3 cm from the beam axis
- 0.13 m² of silicon surface and 12M of readout channels
- Instrumented stave (32 FE chips) consists of 12 planar and 8 3D sensor modules along 664mm
- IBL package of 7 m long and inside only an envelope of 10 mm in radius (clearance < 1mm)

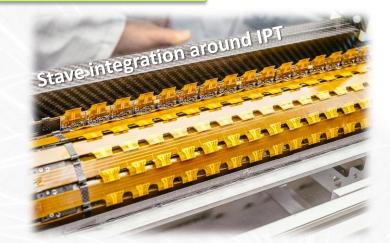
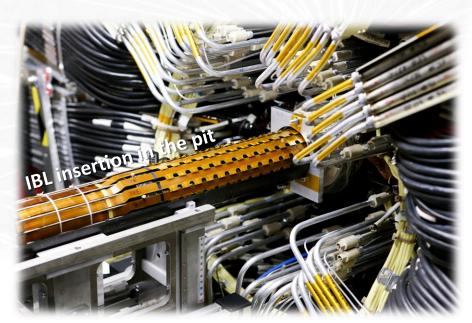
IBL Commissioning in ATLAS

- Aug 2014 March 2015: Integration into ATLAS DAQ, Cosmic data taking with 2T B- field
- October 2014: LHC beam pipe bake-out @ 230 °C & IBL < 0°C, stable C0₂ cooling
- May 2015: First low luminosity, "Quiet Beam" collisions to commission experiment

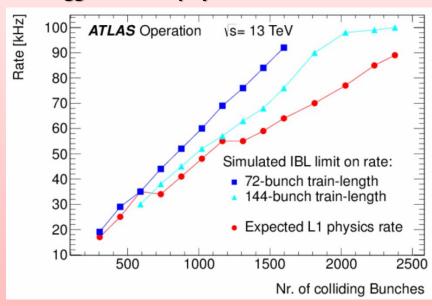
Trigger rate for physics and IBL limitation

Digital supply line is susceptible to current fluctuation when receiving triggers

- ➤ **IBL protected** against wire bond oscillations by limiting the number of triggers in resonance region.
- Protection is called FFTV (Fixed Frequency Trigger Veto).
 Level of protection was:
- Dependent of the LHC filling scheme and bunch pattern
- **Essential** during some trigger mishandling
- Never a limitation for data taking (even if close)

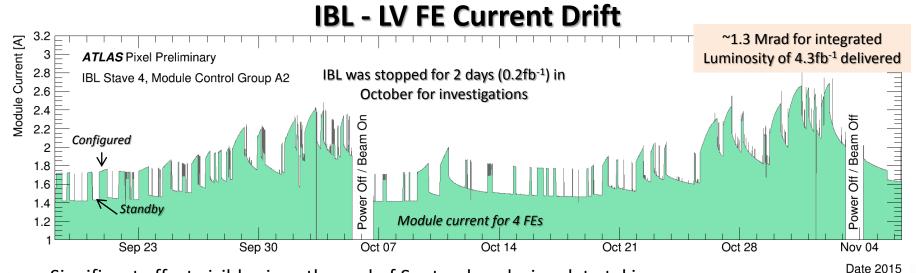
IBL- Front-end LV current drift

- Significant effect visible since the end of September during data taking
- Understood to be a FE N-MOS transistors leakage due to charged defects built-up at the Silicon Oxide
 interface and cumulated by ionizing dose → Known features but not tagged during construction
- It is an effect that is related to dose rate (traps built-up at the STI) and temperature (annealing)
- Lab investigations are ongoing → operational recommendations are expected

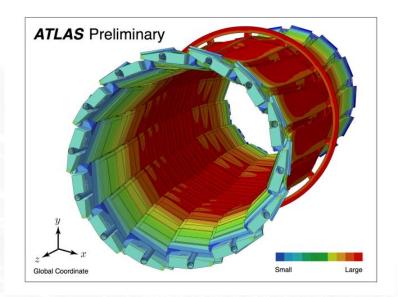
IBL distortion summary:

- Issue discovered early in 2015 during cosmic runs
- Temperature dependency exhibited O(10 μm/K)
- Origin: CTE mismatch between the service bus and stave that twists the stave and a rotation free central ring
- Confirmed by the mechanical engineers with 3D simulations and lab measurements
- Direct impact on the tracking performance
- Alignment correction was sufficient to mitigate the effects
- Temperature and cooling stability ok until September

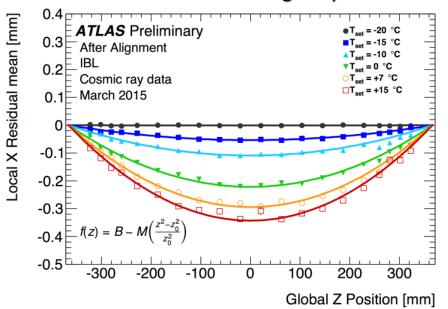
Distortion versus cooling temperature

Early studies of the IBL cooling and stave stability was satisfactory and rms not exceeding 0.2K which is also compliant for the required alignment stability

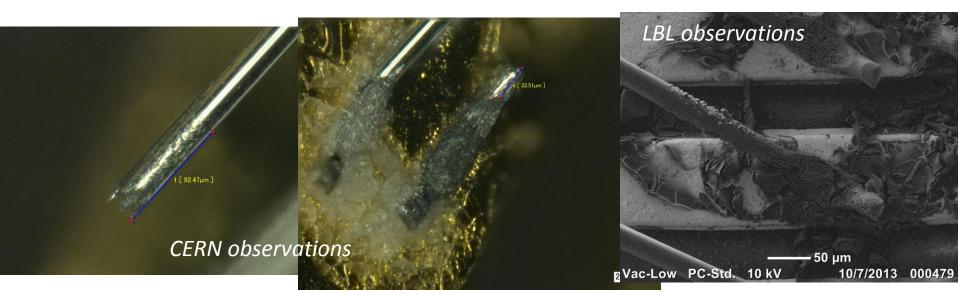
September 2013: **Corrosion issue** found accidentally after 2 staves got frozen and identified that the half of the already produced staves were affected.

- → A complete rework of the staves took place and with an impact on the schedule
- Origin: DI water tests allowed to observe an extreme sensitivity of wet flex surface which with the galvanic coupling and the presence halogen explained the chemical attack of the Al-wire.
 - White persistent residue Al(OH)3
 - Detected halogen in samples taken from production staves after corrosion spotted
- Further investigations: Intense cleaning of bare flex, alternative metallization (ENIG, Galvanic) was always showing susceptibility to the chemical attack

Protection of the wire bond feet is the solution to guarantee against surface water contamination
