Outline

Klystron Specification

2009 Klystron Procurement Goals

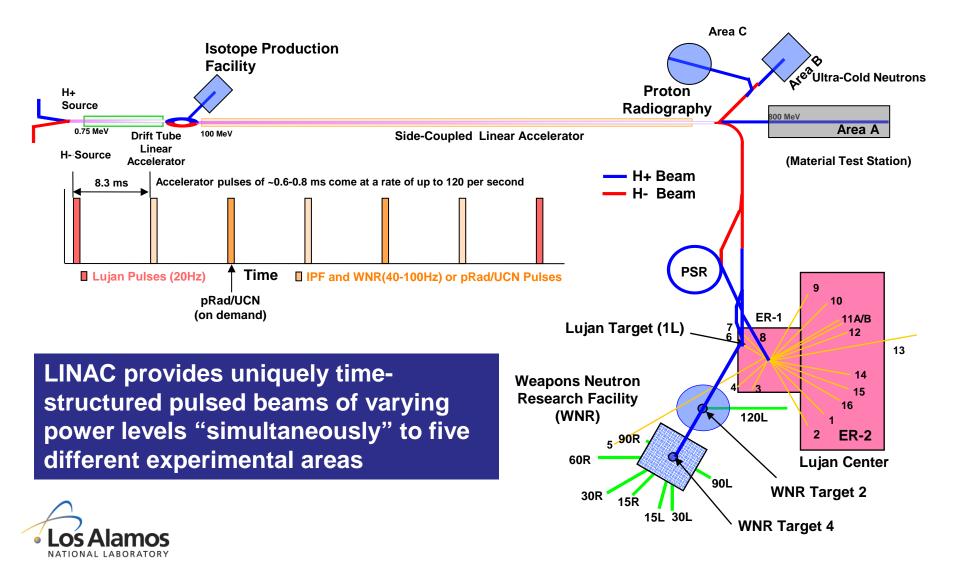
The heart of LANSCE is a very flexible 800-MeV proton linear accelerator (LINAC)

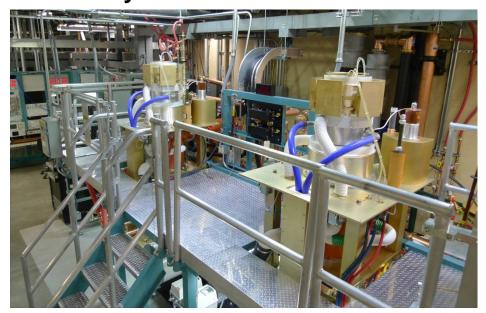
4 – 201 MHz, 3.4 MW Gridded Tube Systems

LANSCE Nominally Operates 120 Hz, 825 usec RF Pulses, 625 usec Beam Pulses

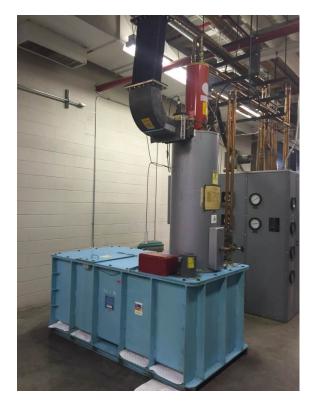
44 – 805 MHz, 1.25 MW Klystron Systems

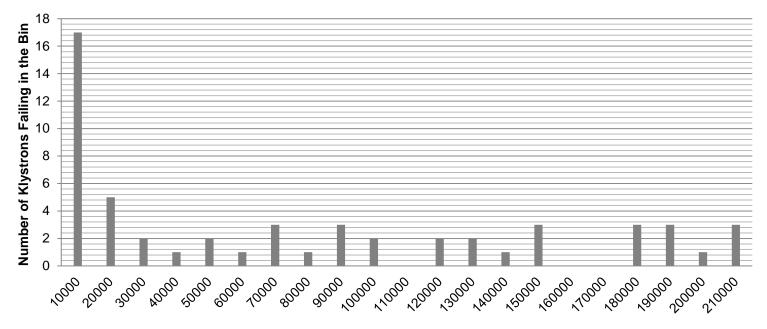
Vendor A Klystron Failures Binned in 10,000 hour Increments (old plus new) – Start of a Bathtub Curve

Filament Hours at Failure in bins of 10,000 hours

Average hours on failed klystrons – 71,712 filament hours Average hours on failed klystrons, if the klystron survives first 13,000 hours – 110,000 filament hours

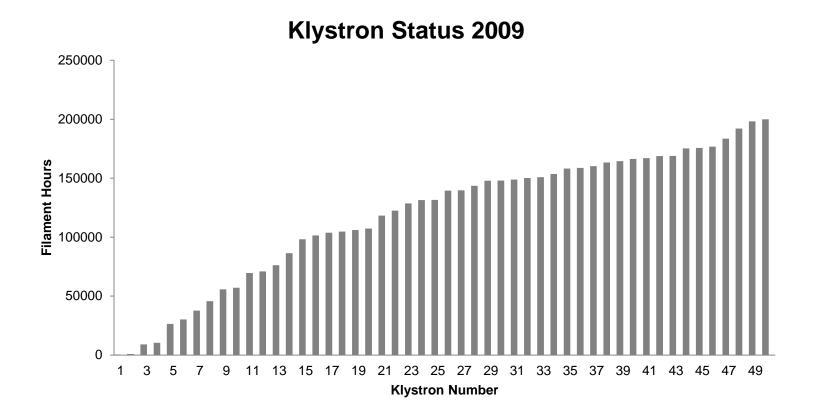
Klystron Status at the Start of the Order

6 Spare Klystrons, Average Filament Hours 118538

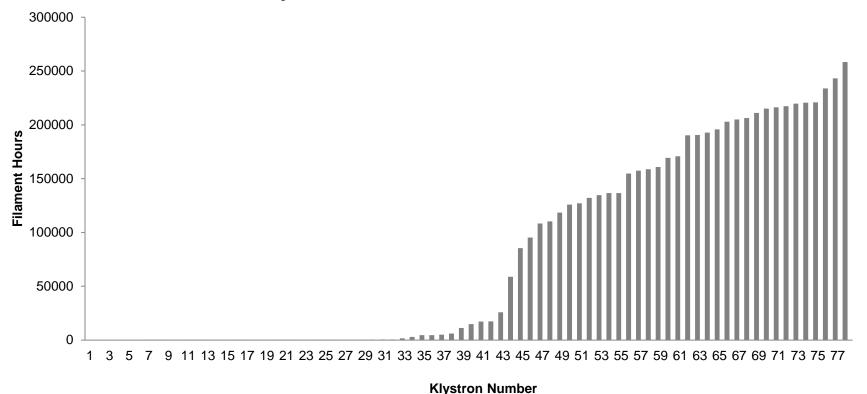
Current Klystron Statistics

34 Spare Klystrons, Average Filament Hours 78190
