Markus Schneider :: RF Group :: Paul Scherrer Institut

# Status of the High Intensity Cyclotron RF-System at PSI

Ninth CW and High Average Power RF Workshop

21 - 24 June 2016

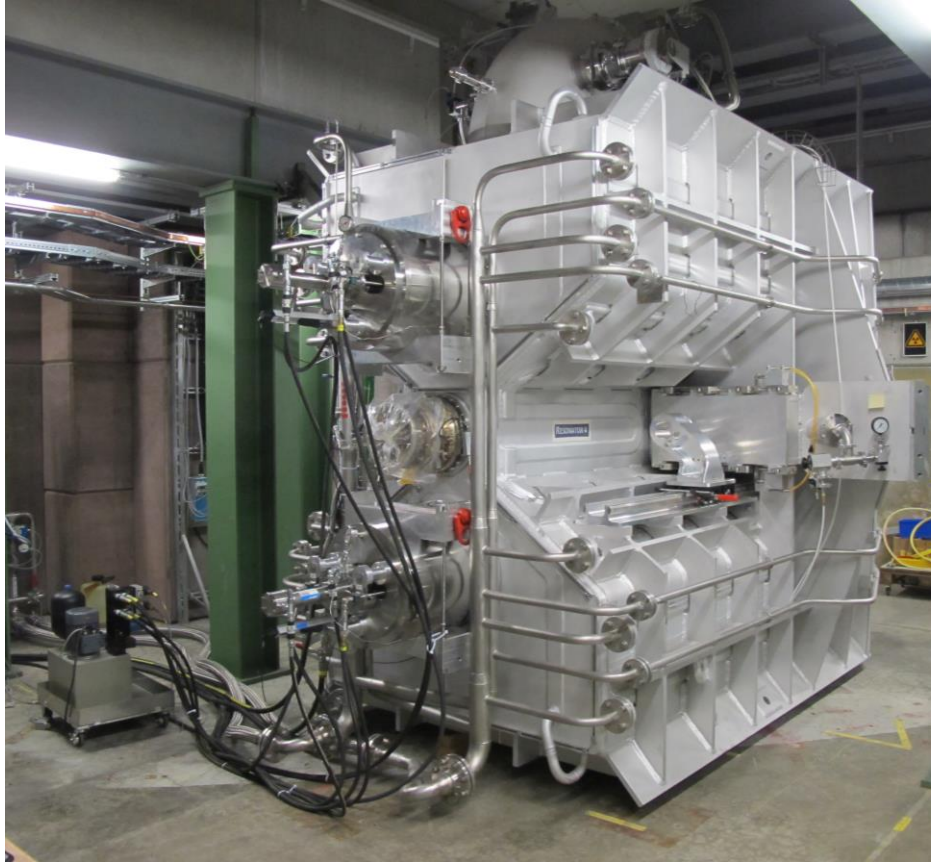
# Status upgrade Injector 2: Resonators

Test bunker had to be moved:  
 Old systems not any more supported  
 -> new psys  
 -> new vacuum system  
 -> new data acquisition system

Commissioning end of June 2016

Tests of resonator 4:  
 -> final design tuners  
 -> bridge between lips (electrodes)  
 -> calibration of gap voltage

Shutdown 2018: installation of Resonator 2 as vacuum chamber  
 Shutdown 2019: commissioning of new rf – system for resonator 2  
 installation of Resonator 4 as vacuum chamber  
 Shutdown 2020: commissioning of new rf – system for resonator 2

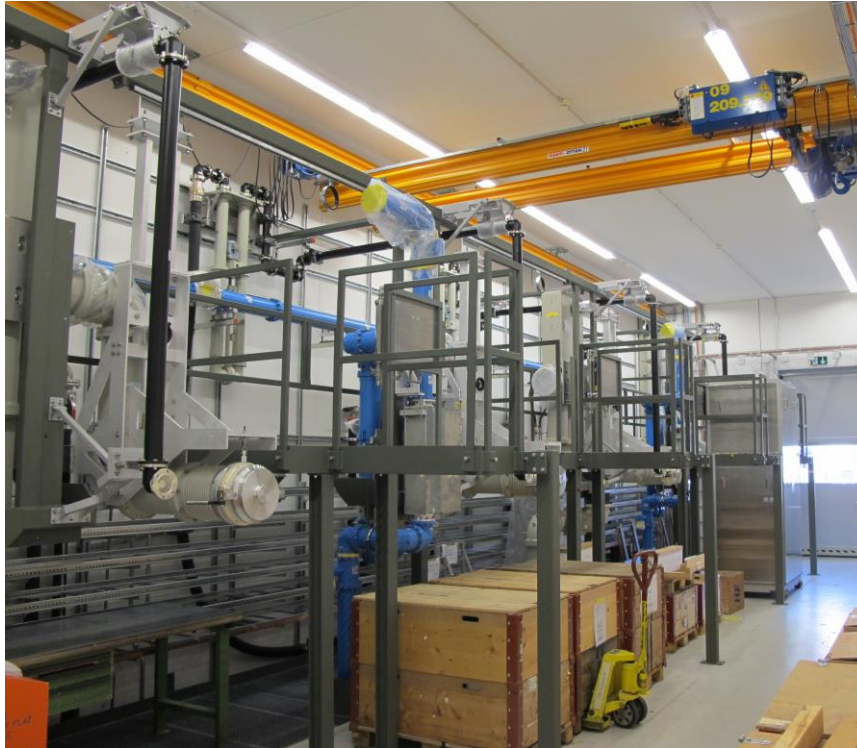
Installation of transmission line  
for new final stages

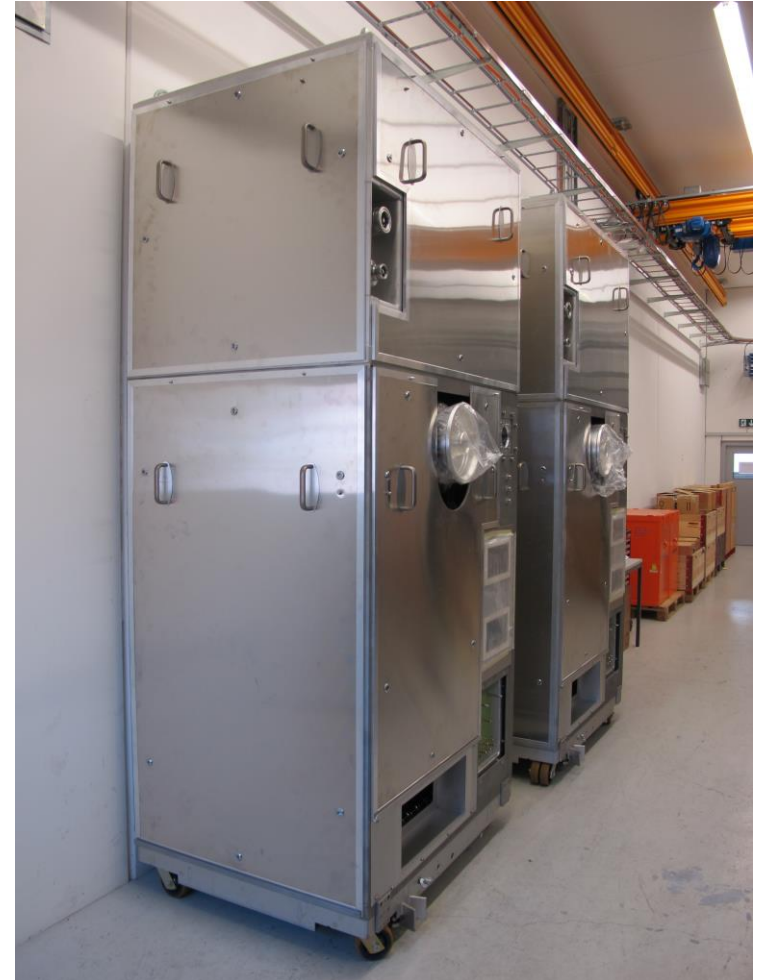
2 x 1MW Amplifiers assembled

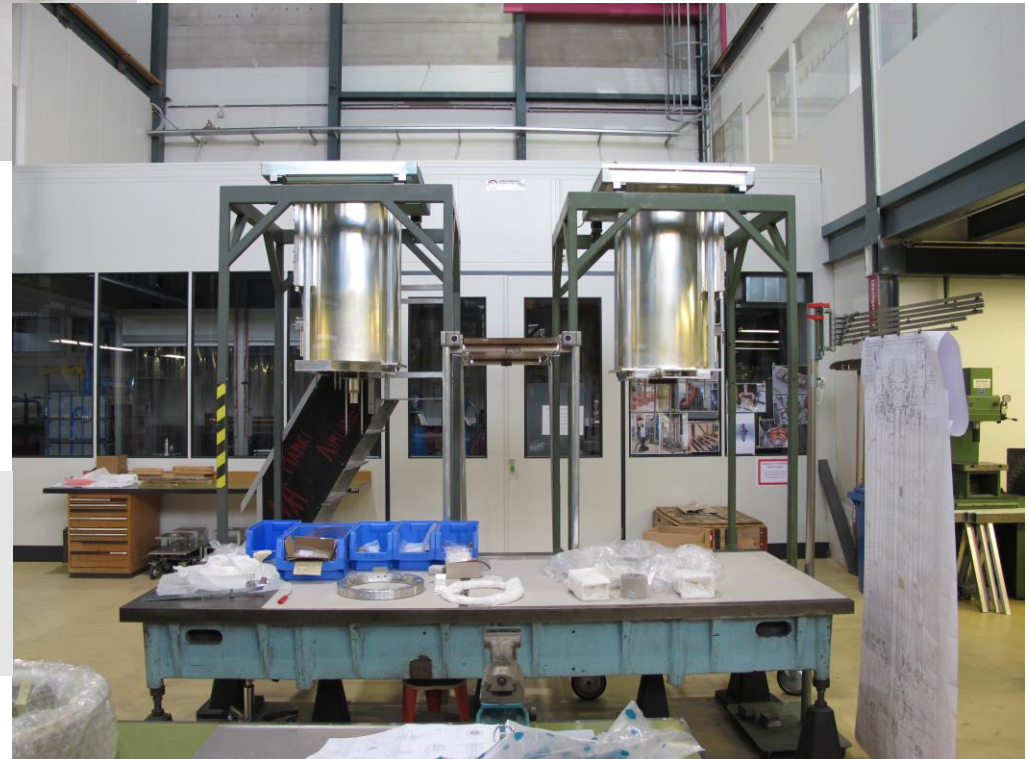
1 final stage tested on load

Test of 4 units until end of 2016

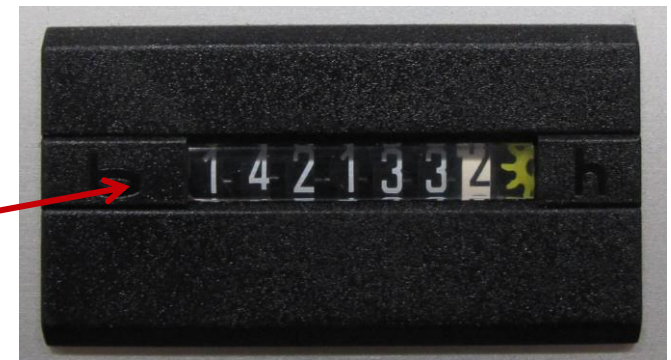
Filament hours counter station 3

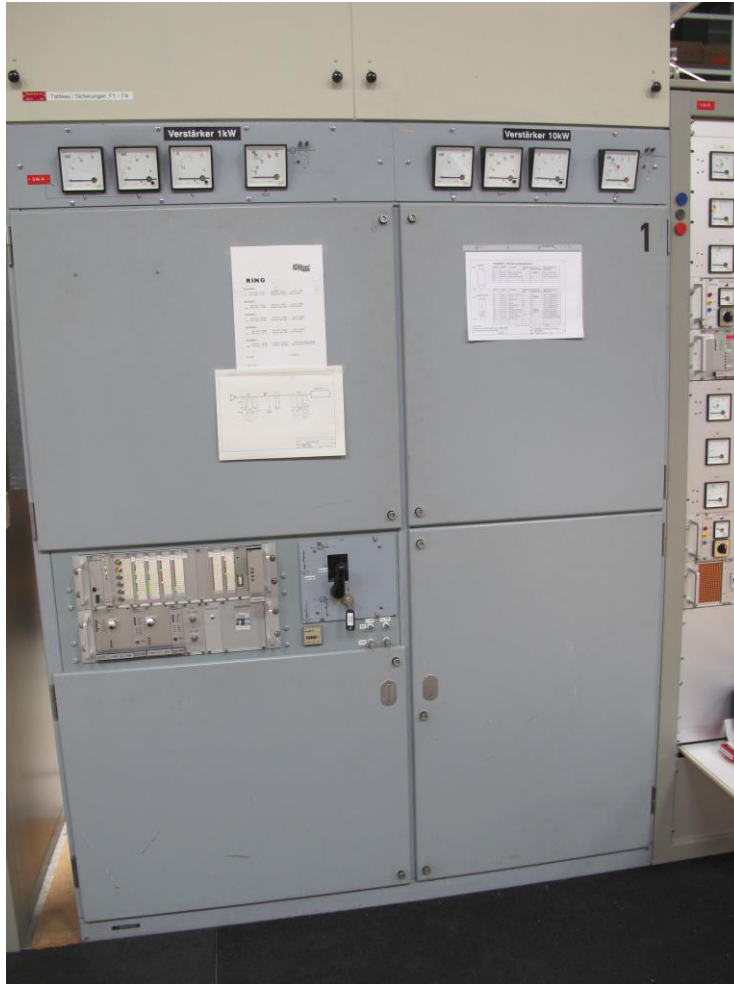
1 / 10 kW amplifier @ 50MHz

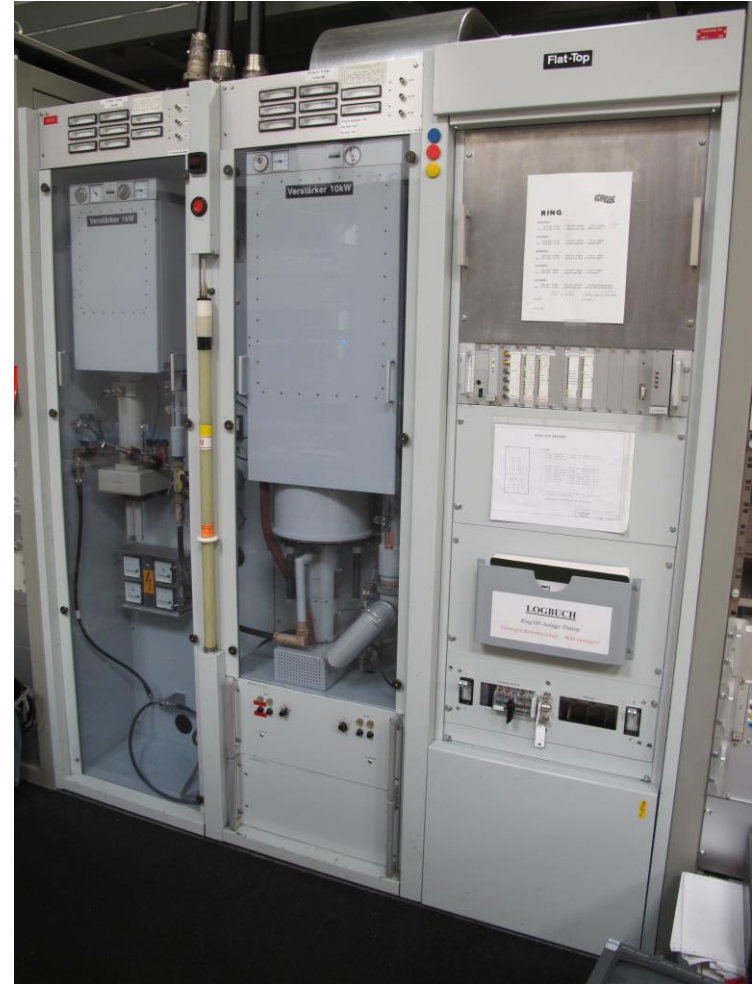
1 / 10 kW amplifier @ 150MHz

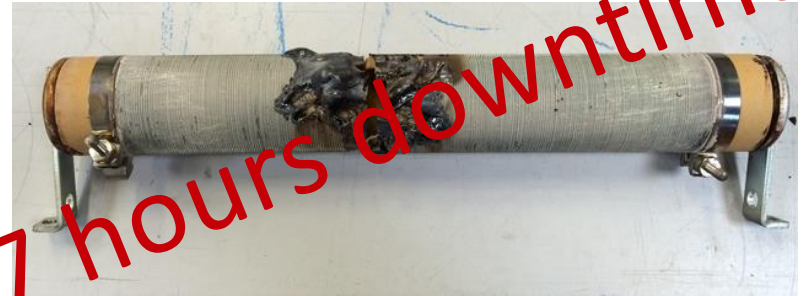
# Problems Anode PS Flattop in 2014

- Resistor in filter in Anode PS overheated during failure analysis
- high losses in filter
- Missing branch in 12 pulse rectifier
- 1 Diode was blown up
- 5 Diodes had a short
- Inspection of all diodes in 100kW Anode PS by measuring isolation
- Shutdown 2015  
600 diodes tested.

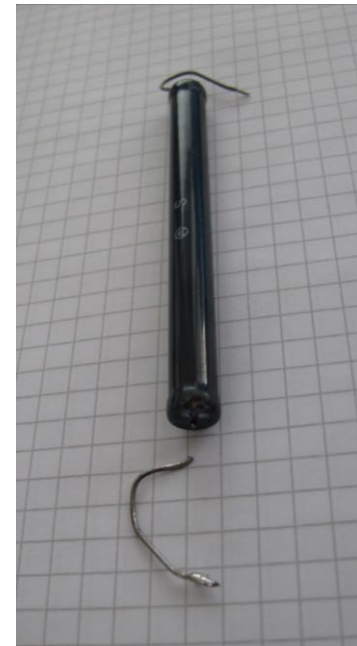
# Cav. 2 100kW amplifier resistor in Anode PS

Spark on HV divider in anode power supply due to broken wire at resistor.  
19:15 Beam off, rf off, start of repair

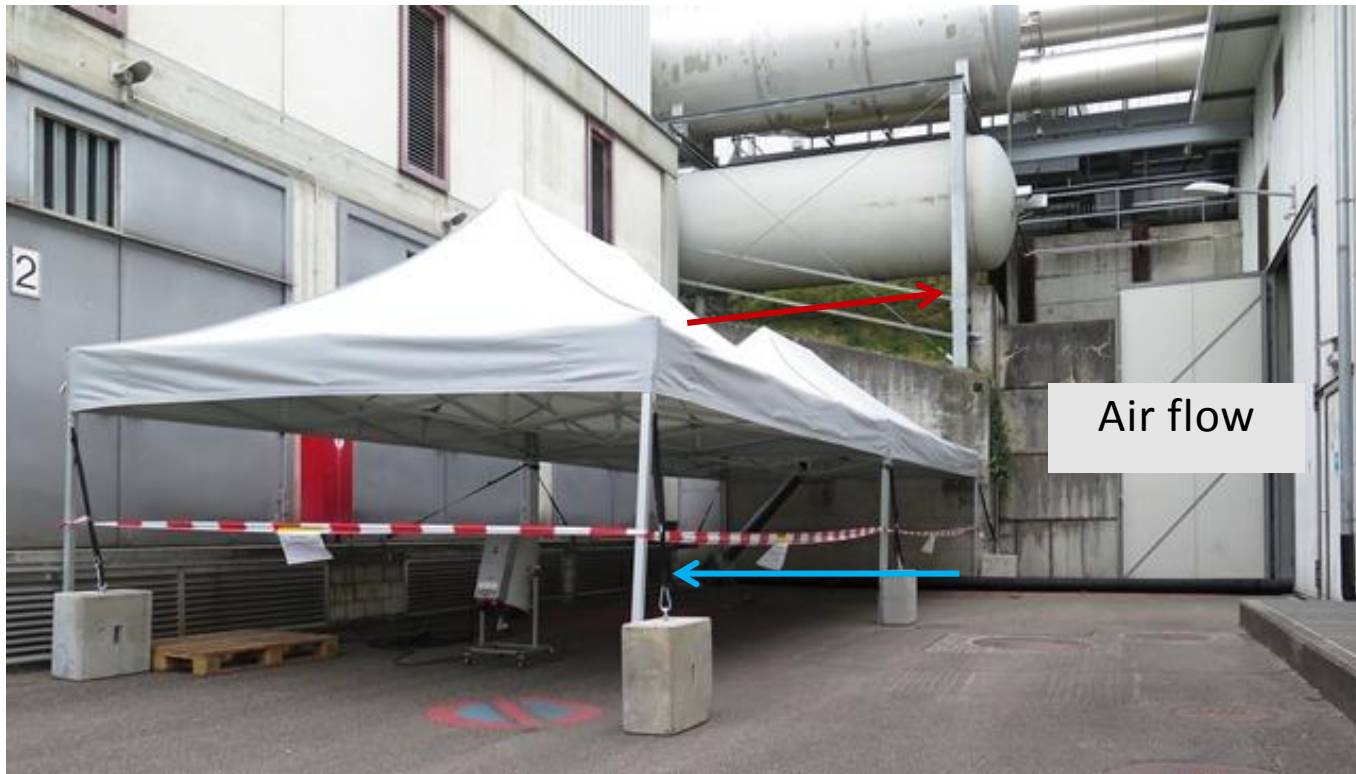
# Cav. 1 1MW amplifier fan failure Anode PS

Fan for transformer cabinet was running only on lower speed.  
No spare part in house.

Improved cooling by a party tent.

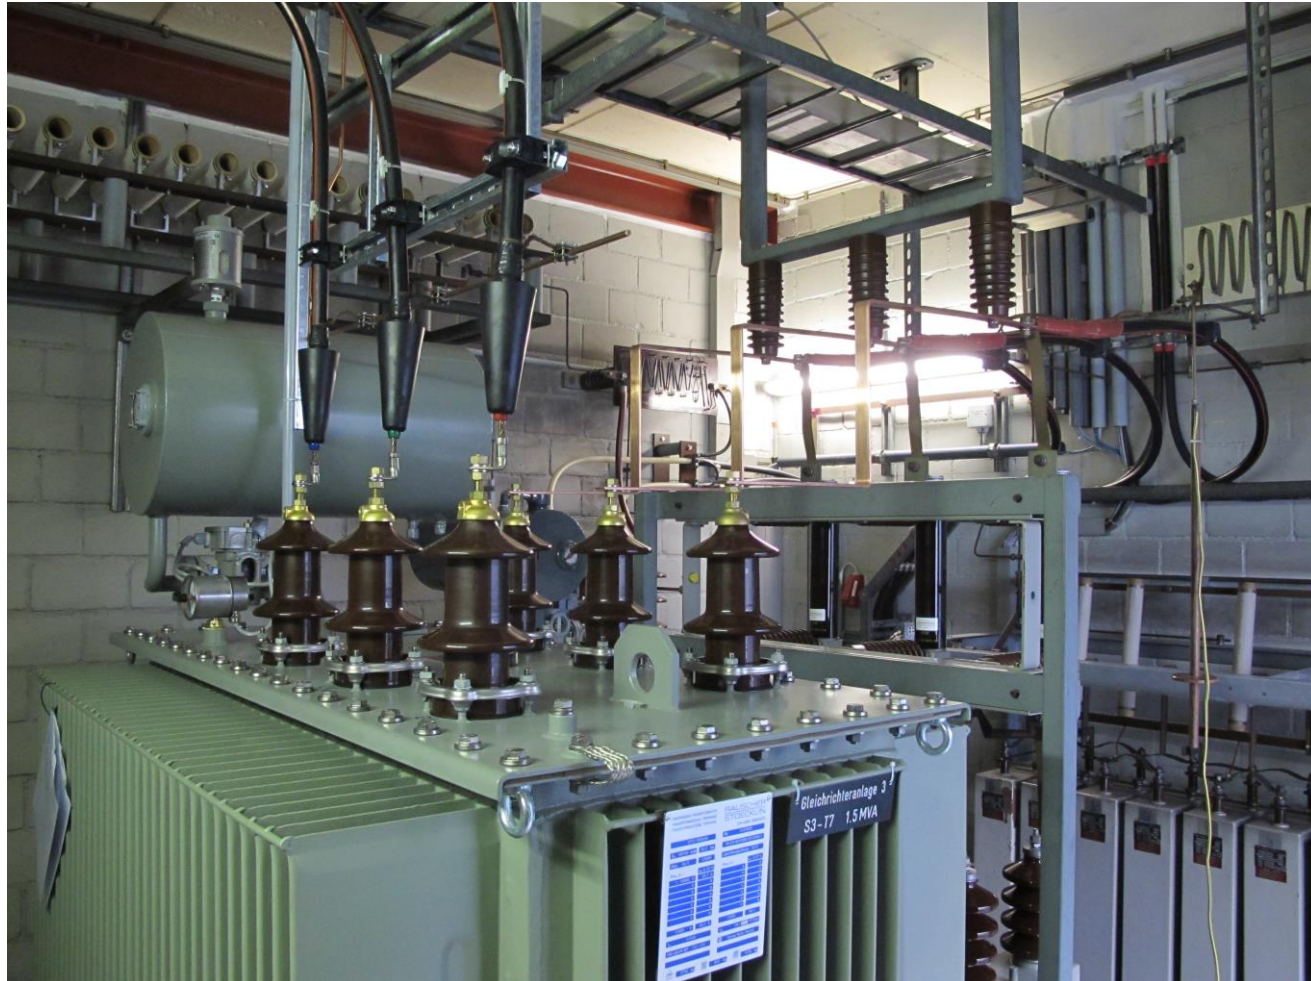
# New transformer in Anode PS station 3

Transformer installed during shutdown 2016

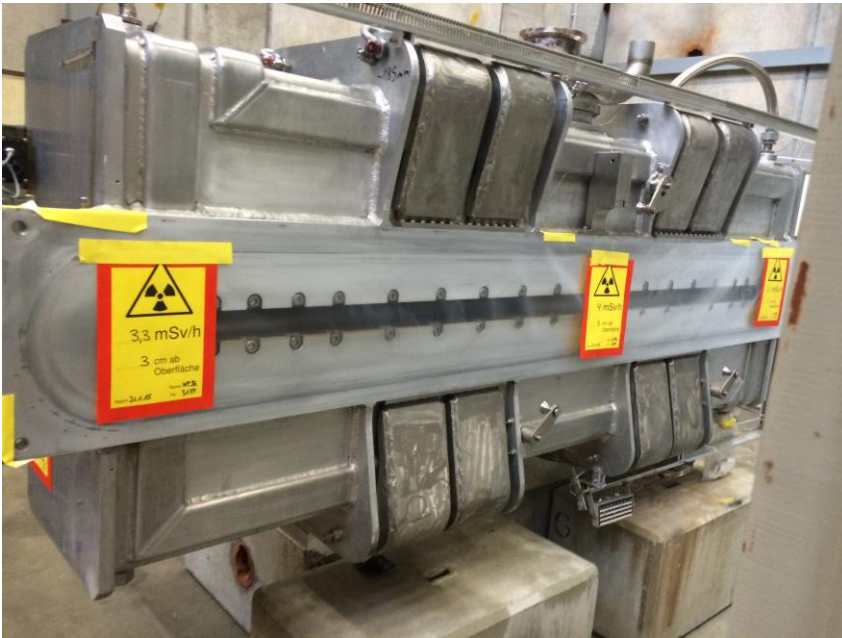
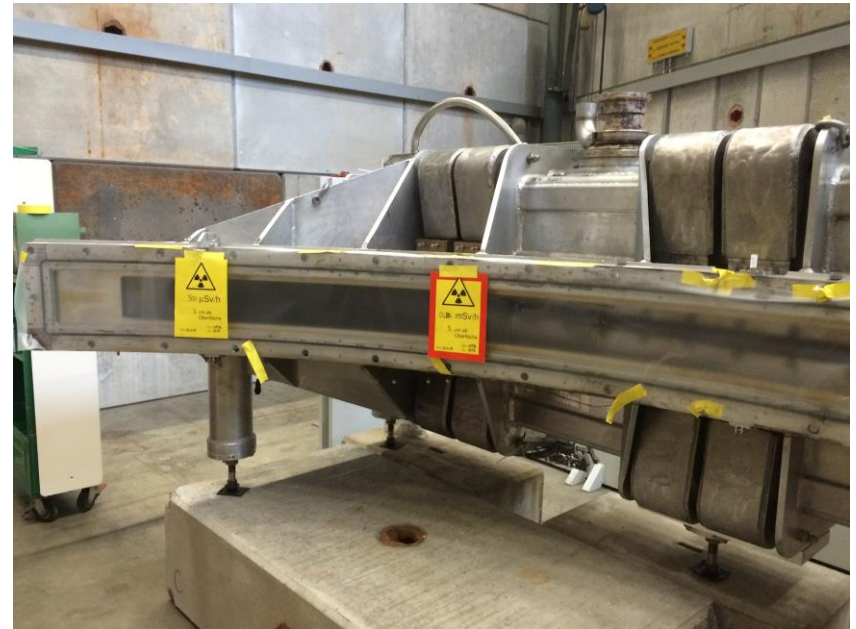
## Shutdown 2015

- remove cavity -> necessary preparations for defining machining process
- refurbish hydraulic tuning system
- Improve vacuum (new square sealing)
- painting with Aquadag

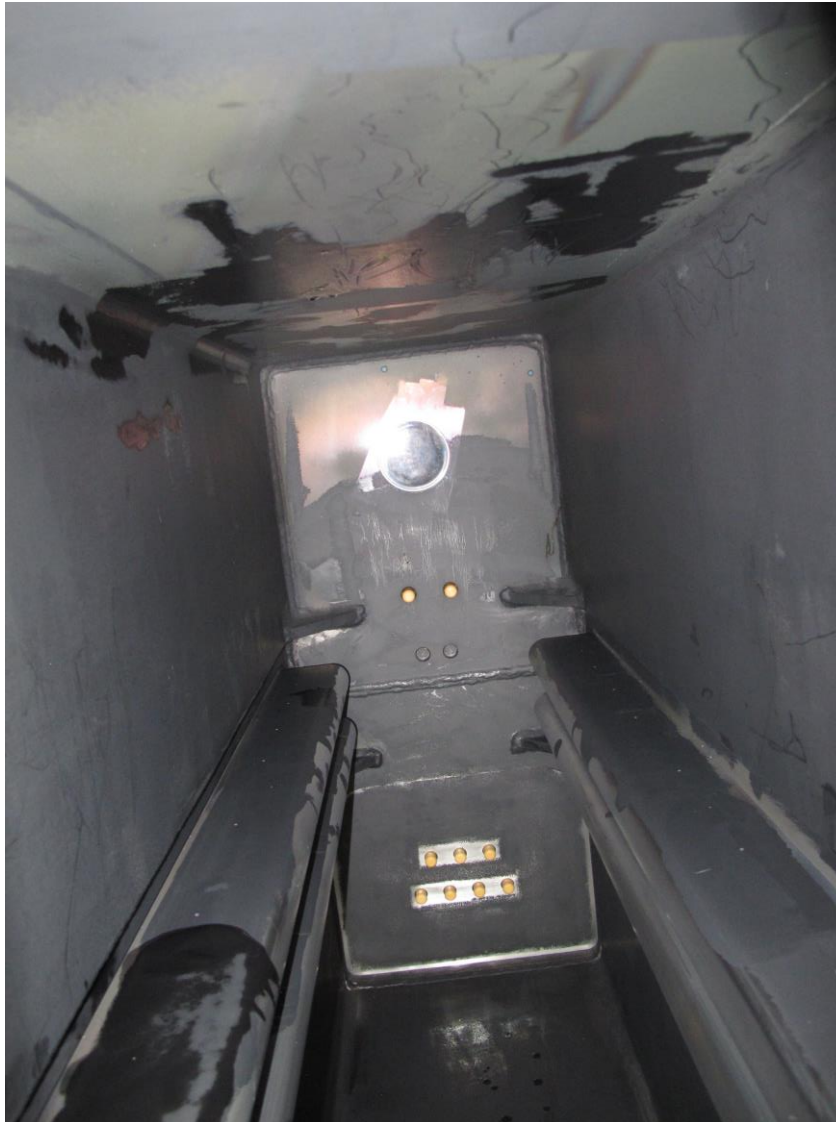
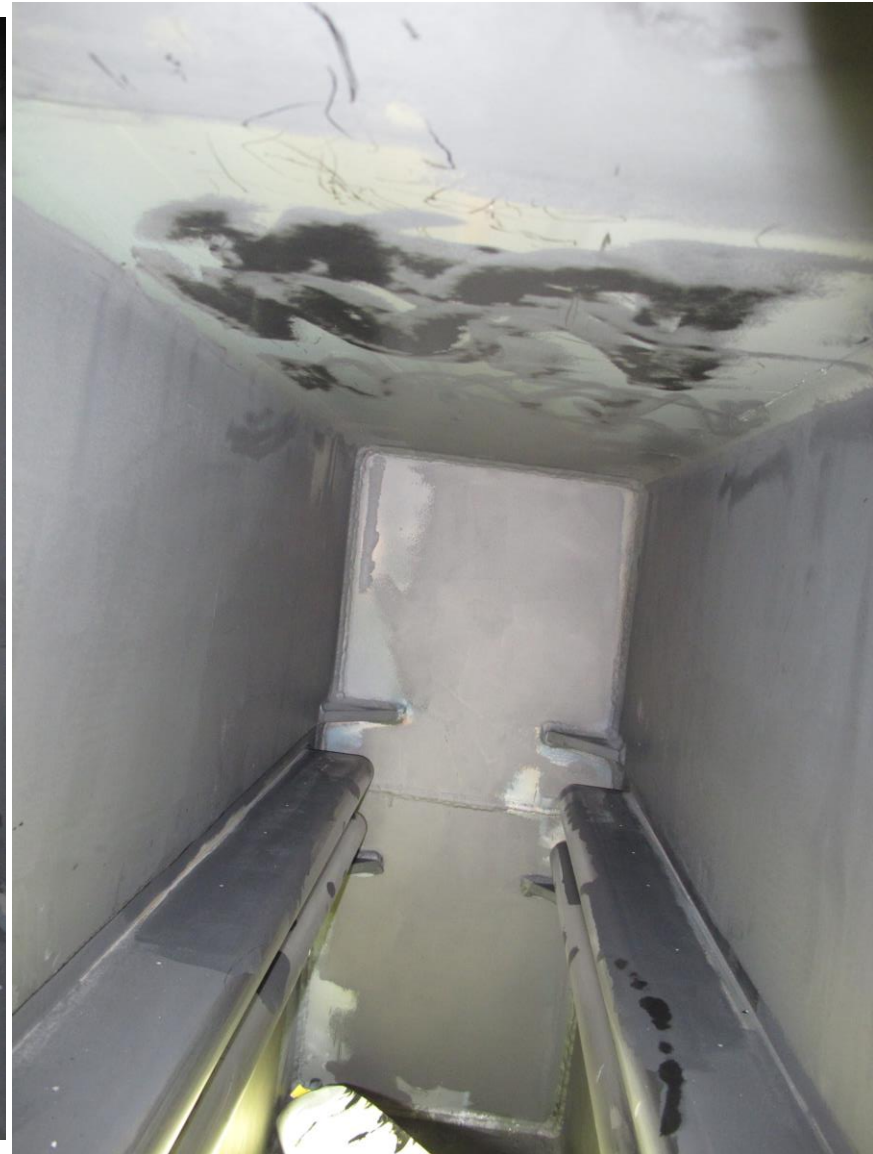
# Painting inside flattop cavity and....

- Cavity was reinstalled in cyclotron
- During conditioning for the nominal voltage 15 kW more power needed.
- High losses on ionization chambers

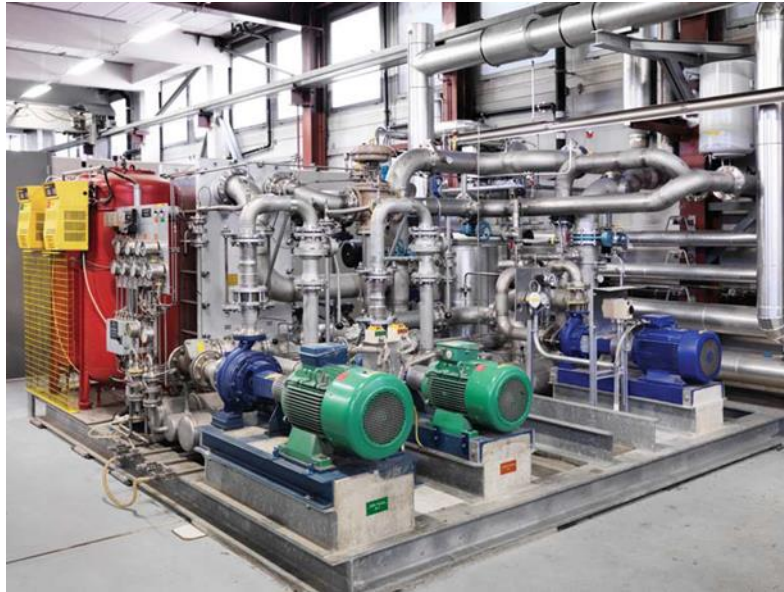
# Cooling system for tetrodes HF0

Cooling circuit HF0 for tetrode amplifiers for the ring cyclotron

- Demineralized water
- Inlet temperature at tube 55°C
- Outlet temperature up to 80°C
- Heat recovering system

in 2015 -> 3357 MWh recovered

Supplying  $\frac{1}{4}$  of heat for PSI buildings

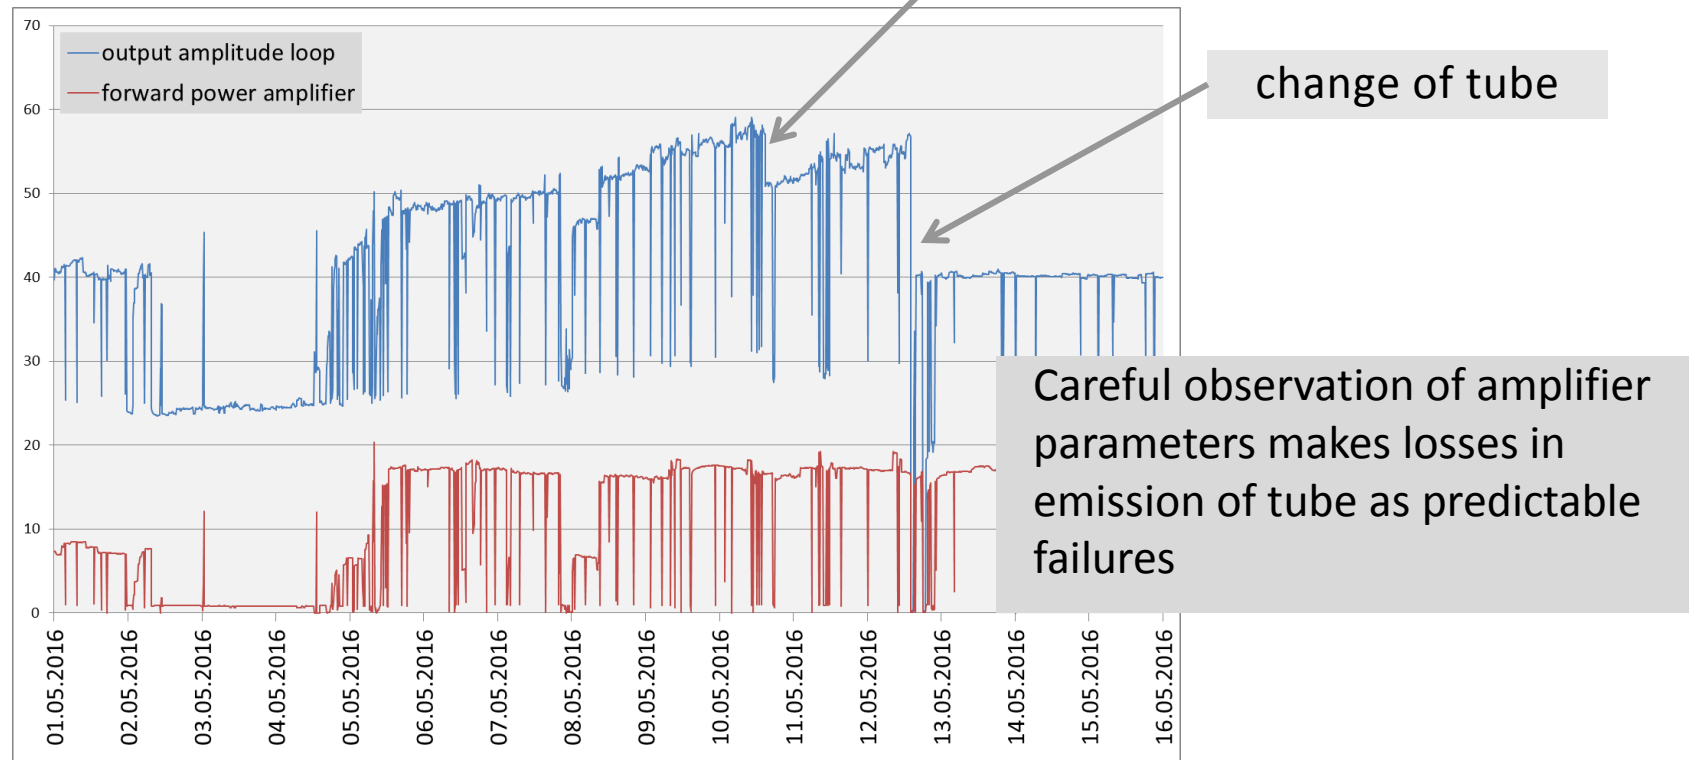
# Tetrode amplifiers

- Broken filament, short between grid/screen or grid/cathode are unpredictable failures
- Trained staff to handle tubes, high voltage and amplifier tuning is needed.
